RADIOLOGIC AND ENGINEERING ASSESSMENT

DOE ID NO.: GJ-10972-RS
ADDRESS: 304 TELLER AVENUE

AUGUST 1985

BENDIX FIELD ENGINEERING CORPORATION
P.O. Box 1569
Grand Junction, Colorado 81502

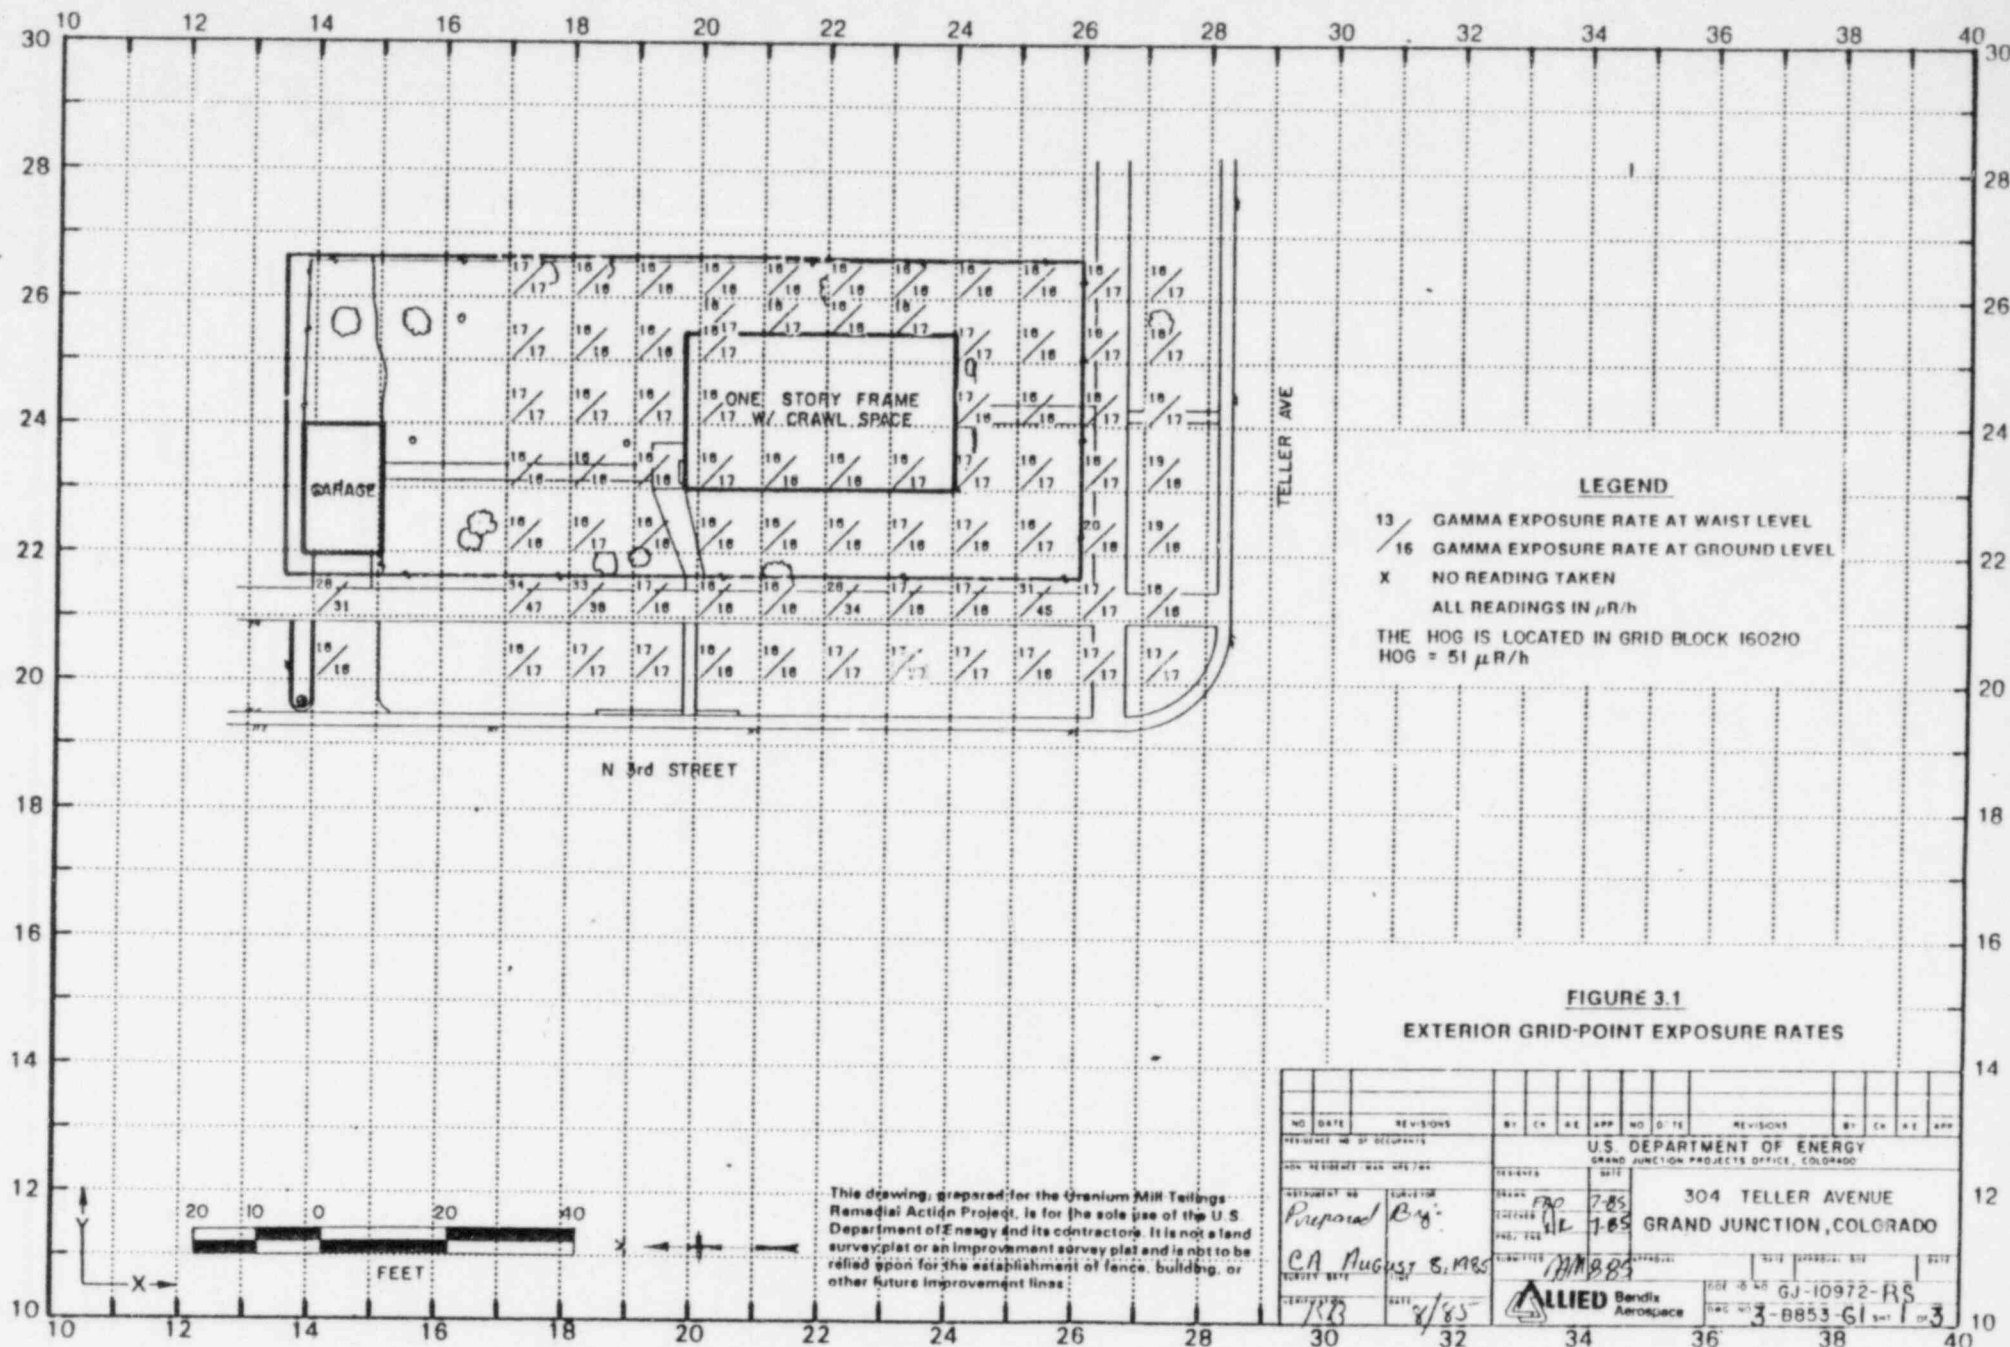
Exterior radium-concentration measurements are presented in Appendix Table 3.1. Exterior exposure-rate survey results are shown in Appendix Figure 3.1.

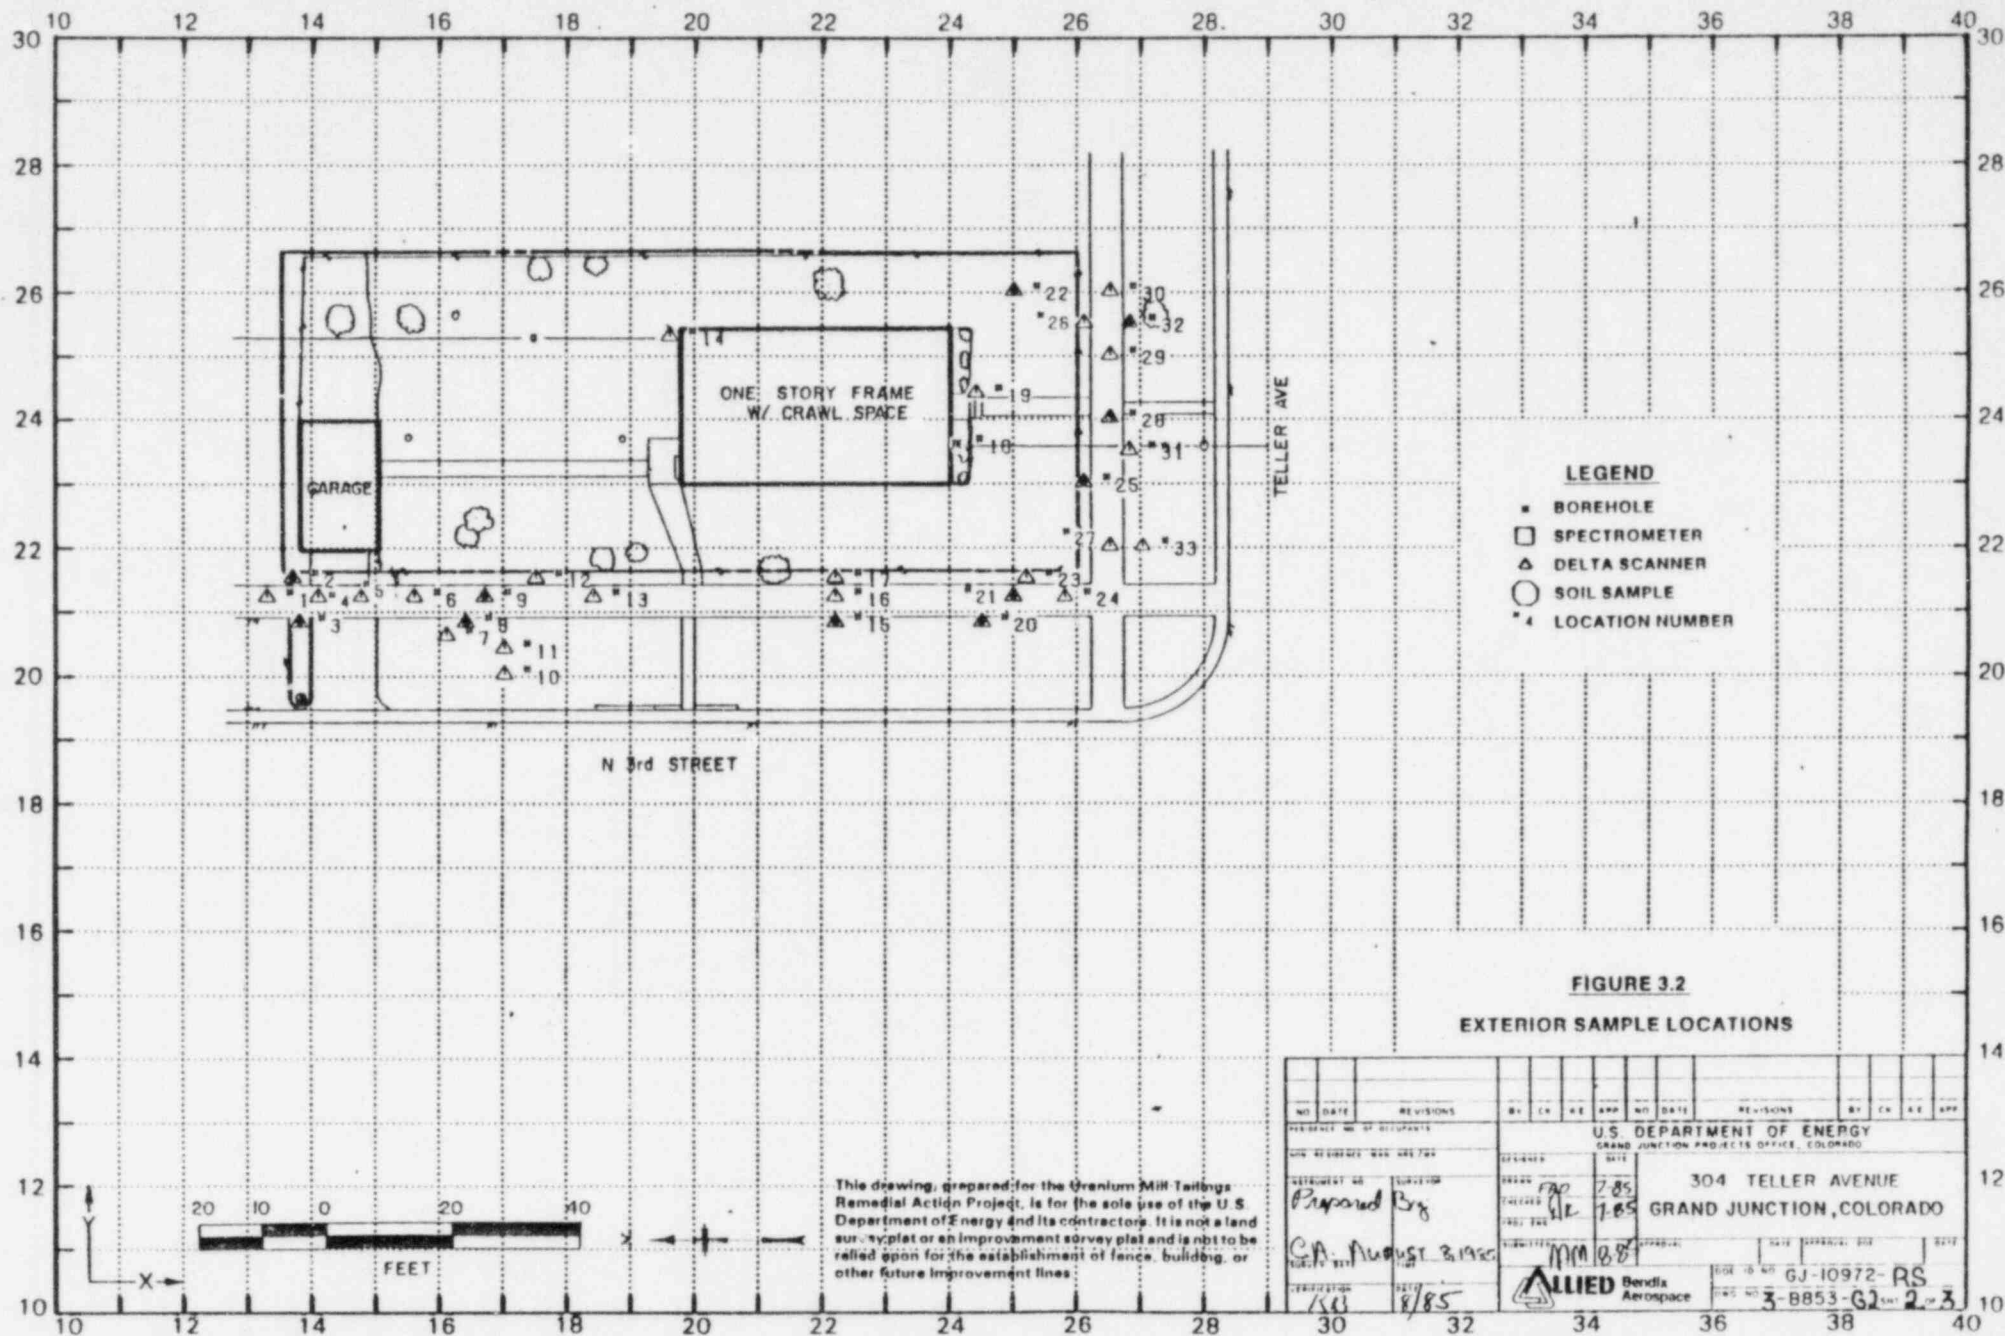
Areas which displayed elevated gamma levels were further investigated; the locations and types of these investigations are shown in Appendix Figure 3.2. Data from these investigations are included in Appendix Table 3.1.

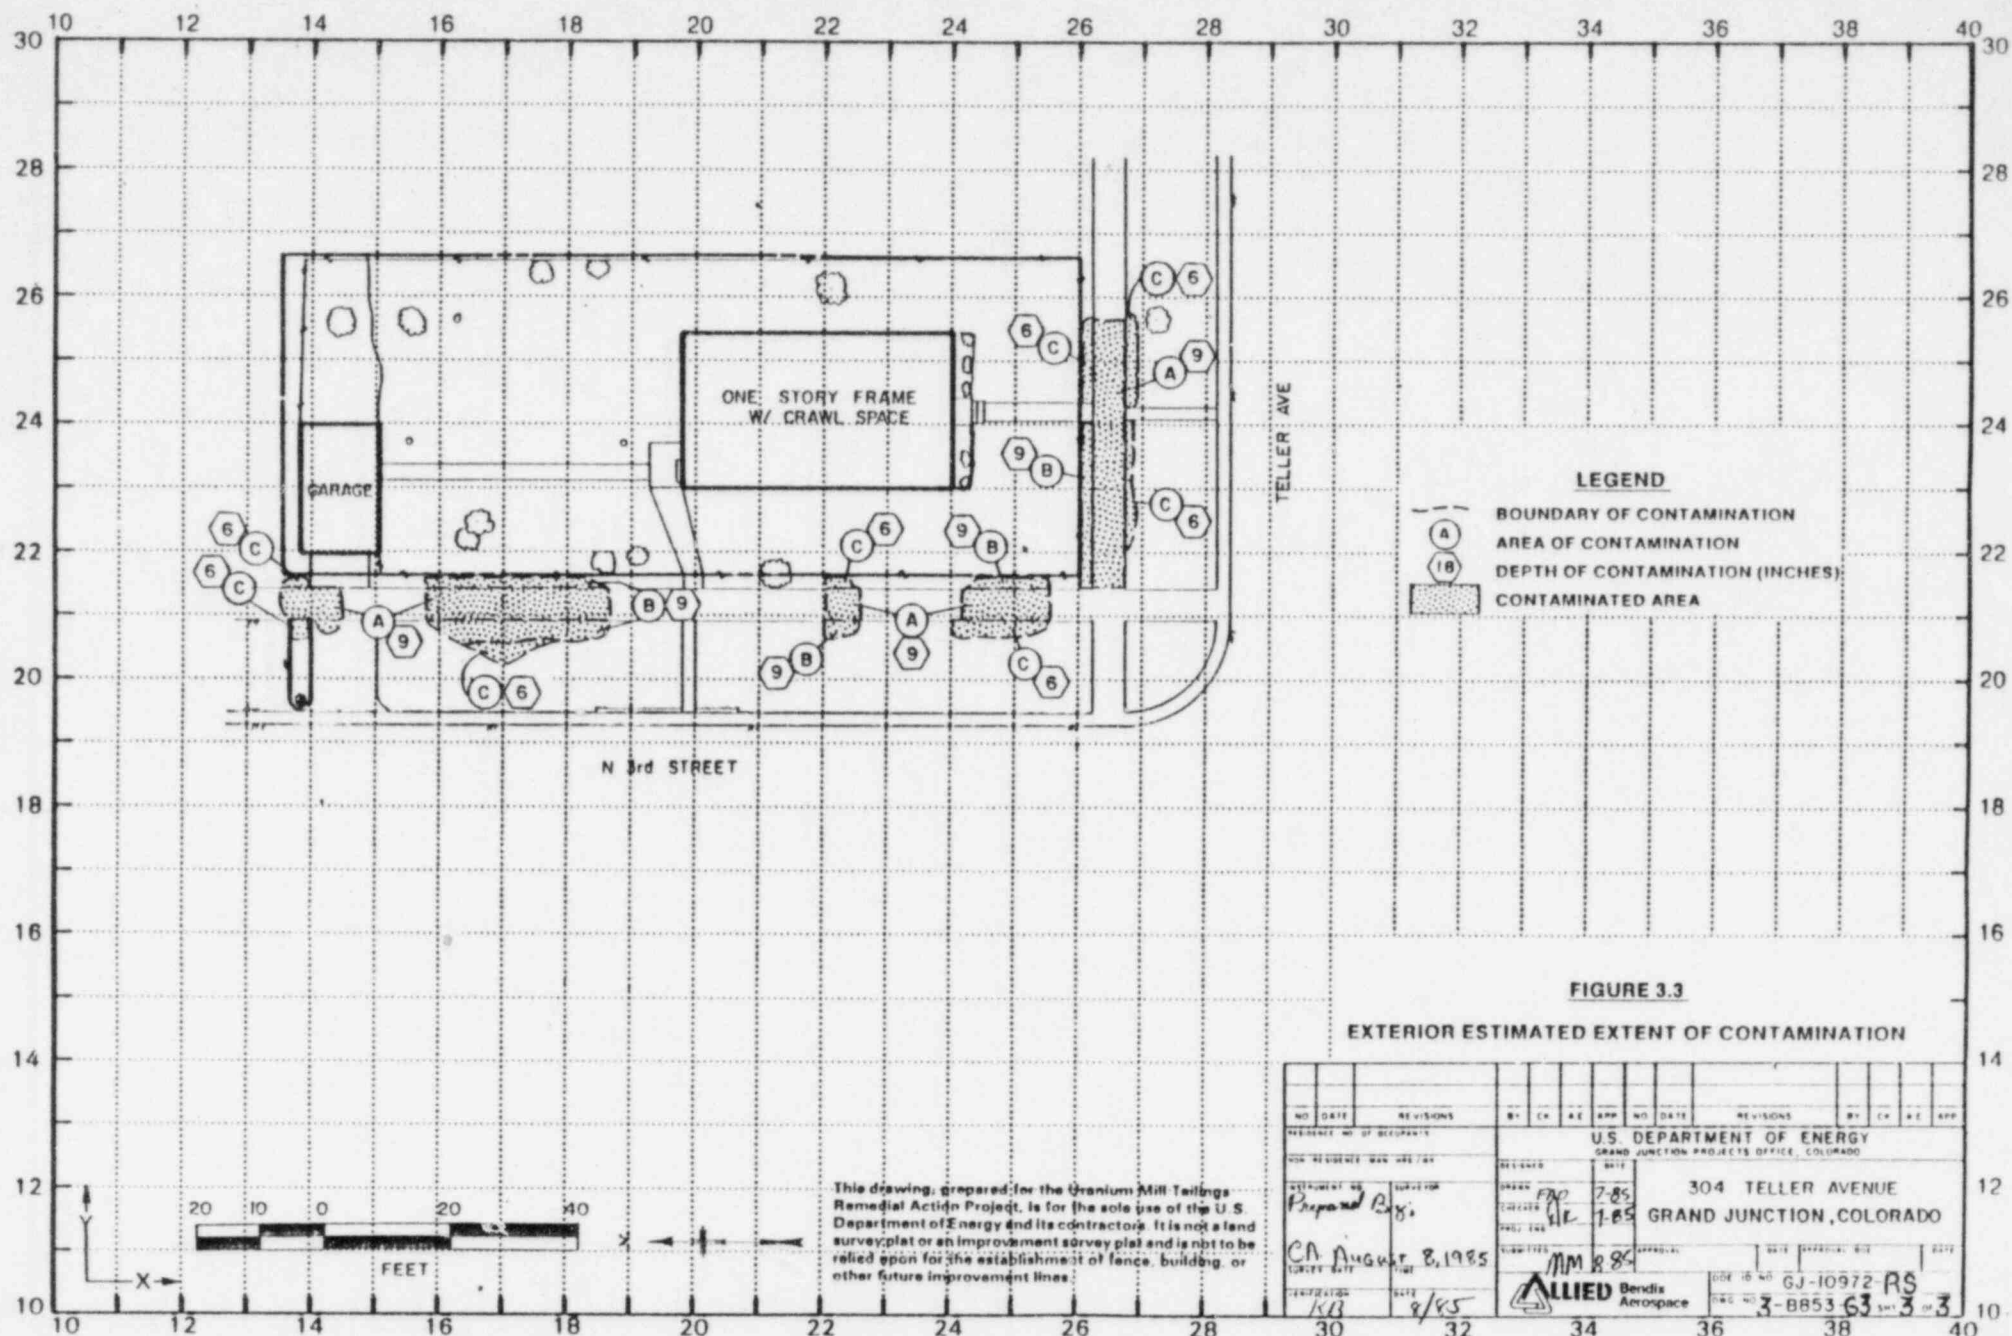
Appendix Figure 3.3 shows identified areas and estimated depths of contamination on this property, based on assessments of all measurements taken. As noted in this figure, areas recommended for remedial action that contain identified residual radioactive materials are:

- (Area A) Surface Material: Concrete
Direction From Primary Structure: Northwest, west,
and south
Total Depth of Contamination: 9 inches
Other (height or thickness): 4-inch-thick concrete
Comments: City sidewalk, 5 deposits
Approximate Square Footage: 480
- (Area B) Surface Material: Soil
Direction From Primary Structure: West and south
Total Depth of Contamination: 9 inches
Comments: 4 deposits
Approximate Square Footage: 241
- (Area C) Surface Material: Soil
Direction From Primary Structure: West and south
Total Depth of Contamination: 6 inches
Comments: 8 deposits
Approximate Square Footage: 168

The recommended remedial action for this property, DOE ID No. GJ-10972-RS, includes removal of all areas identified as containing radioactive material (as discussed in Section 3.5 and shown in Appendix Figure 3.3) and transport of removed material to the disposal site.

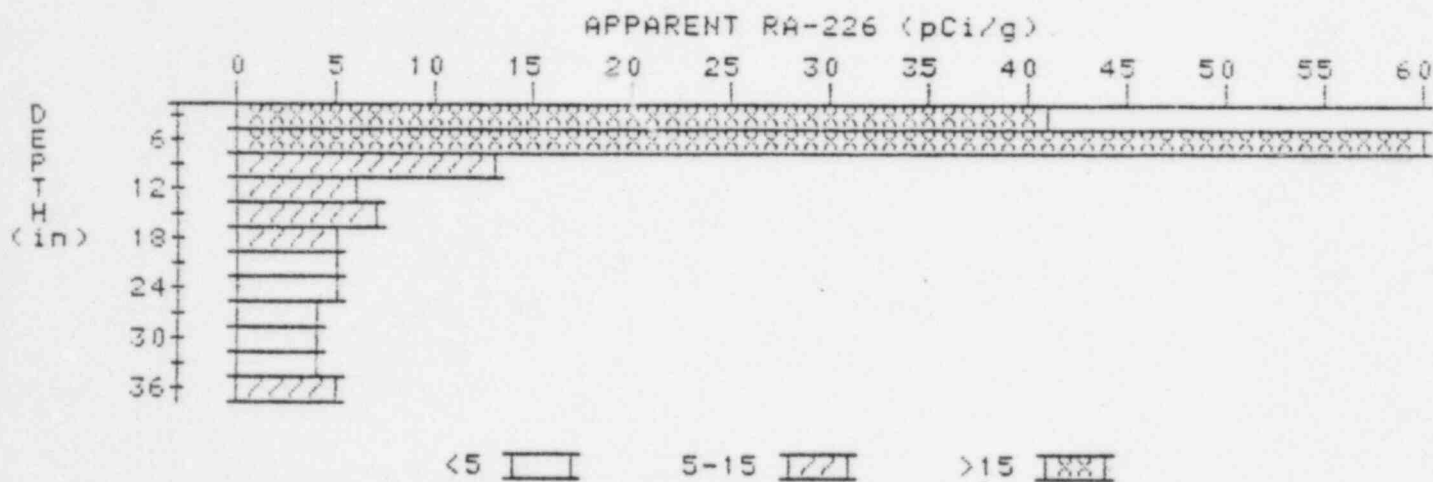
LOCATION: 167212

Depth (in)	Apparent Radium-226 (pCi/g) Undeconvolved	Apparent Radium-226 (pCi/g) Deconvolved
3	40.6	40.6
6	39.5	64.9
9	24.1	13.4
12	14.7	6.2
15	10.1	6.7
18	7.4	5.1
21	6.0	4.8
24	5.3	4.9
27	4.8	4.3
30	4.6	4.1
33	4.7	4.3
36	5.0	5.0

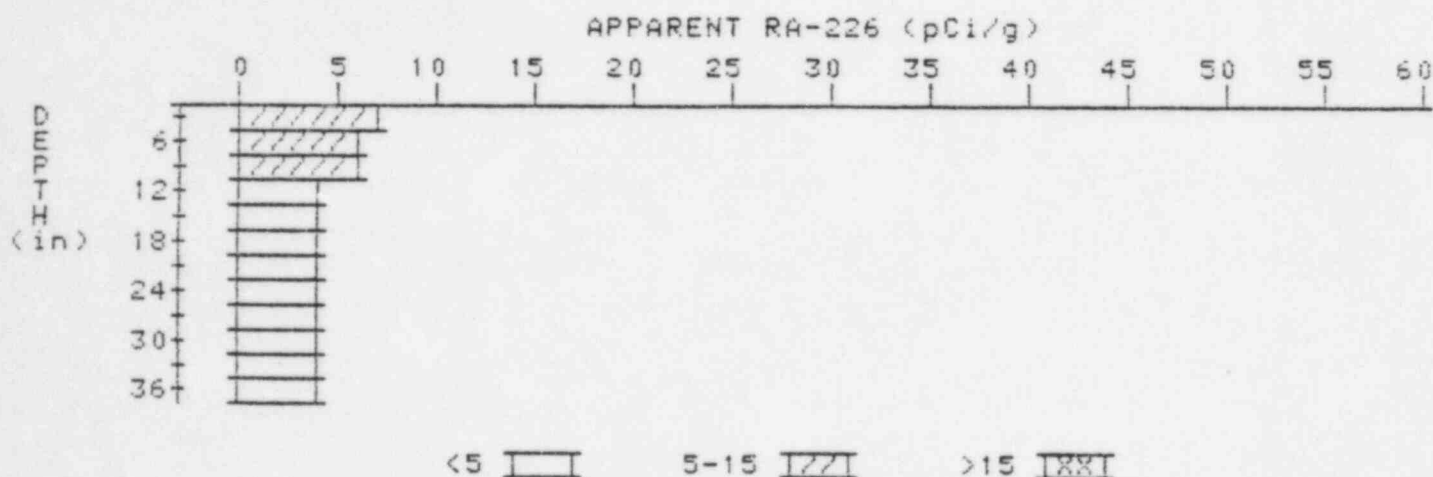
PROPERTY NUMBER: GJ-10972-RS
HOLE NUMBER: 15
LOCATION: 222208

Depth (in)	Apparent Radium-226 (pCi/g) Undeconvolved	Apparent Radium-226 (pCi/g) Deconvolved
3	7.0	7.0
6	6.1	5.6
9	5.5	5.5
12	4.9	4.4
15	4.6	4.4
18	4.4	4.2
21	4.3	4.3
24	4.2	4.0
27	4.2	4.4
30	4.1	4.1
33	4.0	4.2
36	3.8	3.8

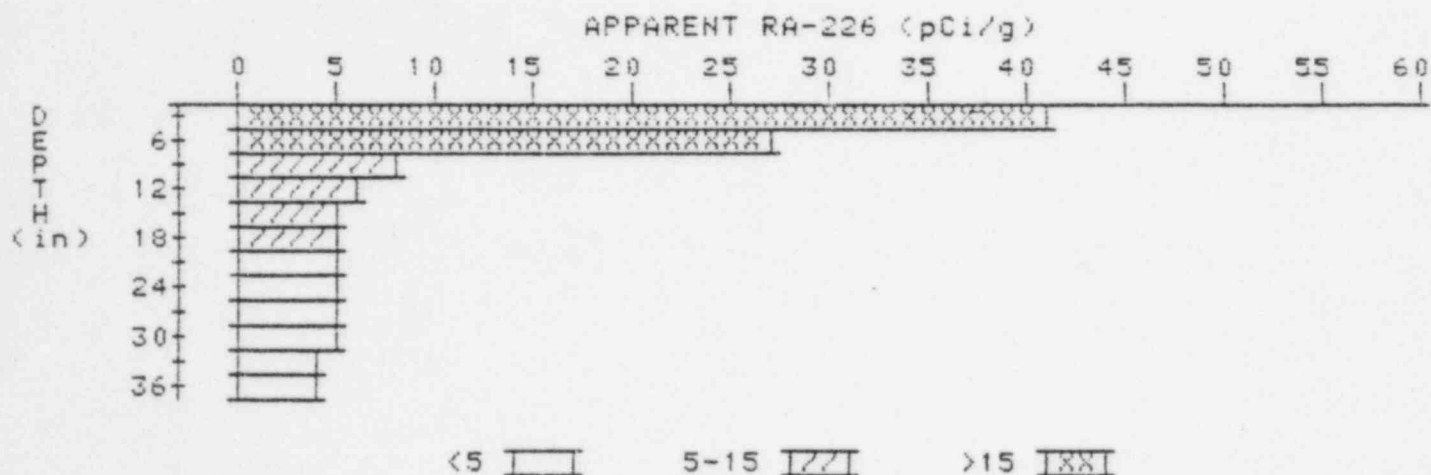
PROPERTY NUMBER: GJ-10972-RS
HOLE NUMBER: 21
LOCATION: 250212

Depth (in)	Apparent Radium-226 (pCi/g) Undeconvolved	Apparent Radium-226 (pCi/g) Deconvolved
3	41.0	41.0
6	28.7	27.1
9	17.3	7.7
12	11.3	6.3
15	8.1	5.3
18	6.5	5.3
21	5.6	4.9
24	5.1	4.7
27	4.8	4.6
30	4.6	4.6
33	4.4	4.0
36	4.4	4.4

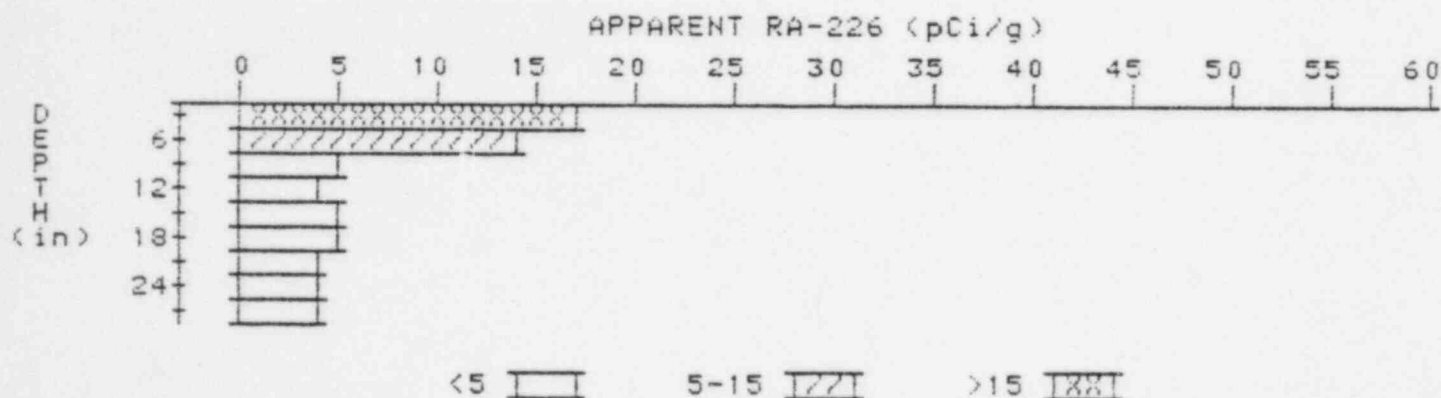
PROPERTY NUMBER: GJ-10972-RS
HOLE NUMBER: 25
LOCATION: 261230

Depth (in)	Apparent Radium-226 (pCi/g) Undeconvolved	Apparent Radium-226 (pCi/g) Deconvolved
3	16.6	16.6
6	12.8	13.7
9	8.5	4.6
12	6.4	4.4
15	5.4	4.5
18	4.9	4.5
21	4.6	4.4
24	4.4	4.0
27	4.4	4.4

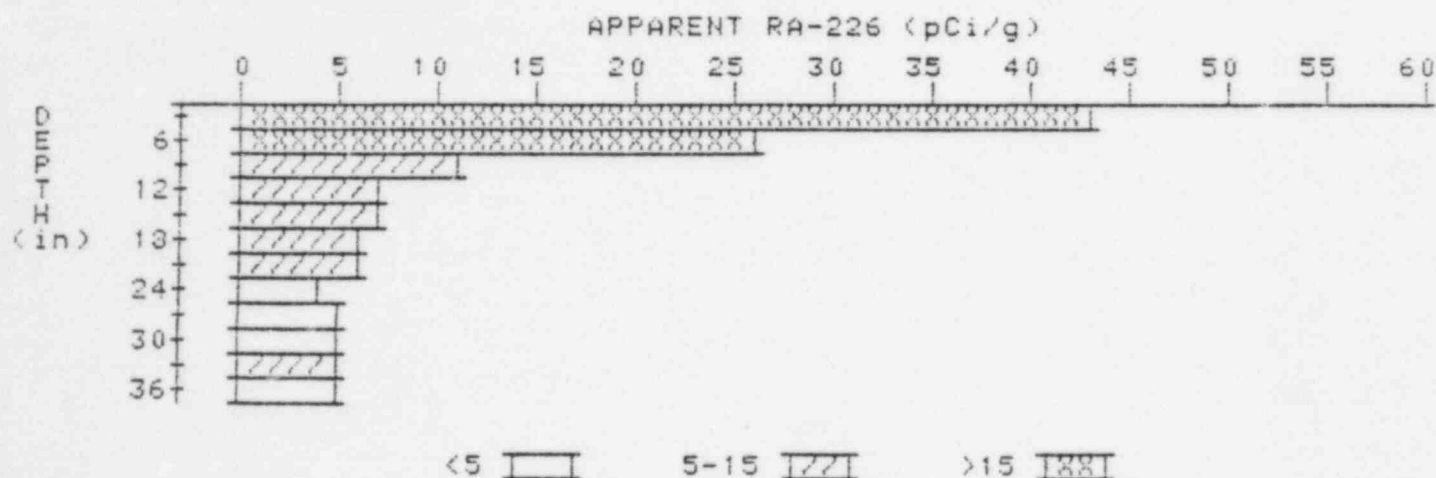
LOCATION: 265240

Depth (in)	Apparent Radium-226 (pCi/g) Undeconvolved	Apparent Radium-226 (pCi/g) Deconvolved
3	42.9	42.9
6	29.9	26.3
9	18.9	10.5
12	12.6	7.3
15	9.3	6.8
18	7.4	6.0
21	6.3	5.9
24	5.4	4.3
27	5.1	4.9
30	4.9	4.5
33	4.9	5.4
36	4.6	4.6
