RADIOLOGIC AND ENGINEERING ASSESSMENT

DOE ID NO.: GJ-08841-RS  
ADDRESS: 2519 SOUTH BROADWAY

APRIL 1985  
REVISED AUGUST 1985

URANIUM MILL TAILINGS REMEDIAL ACTION PROJECT OFFICE

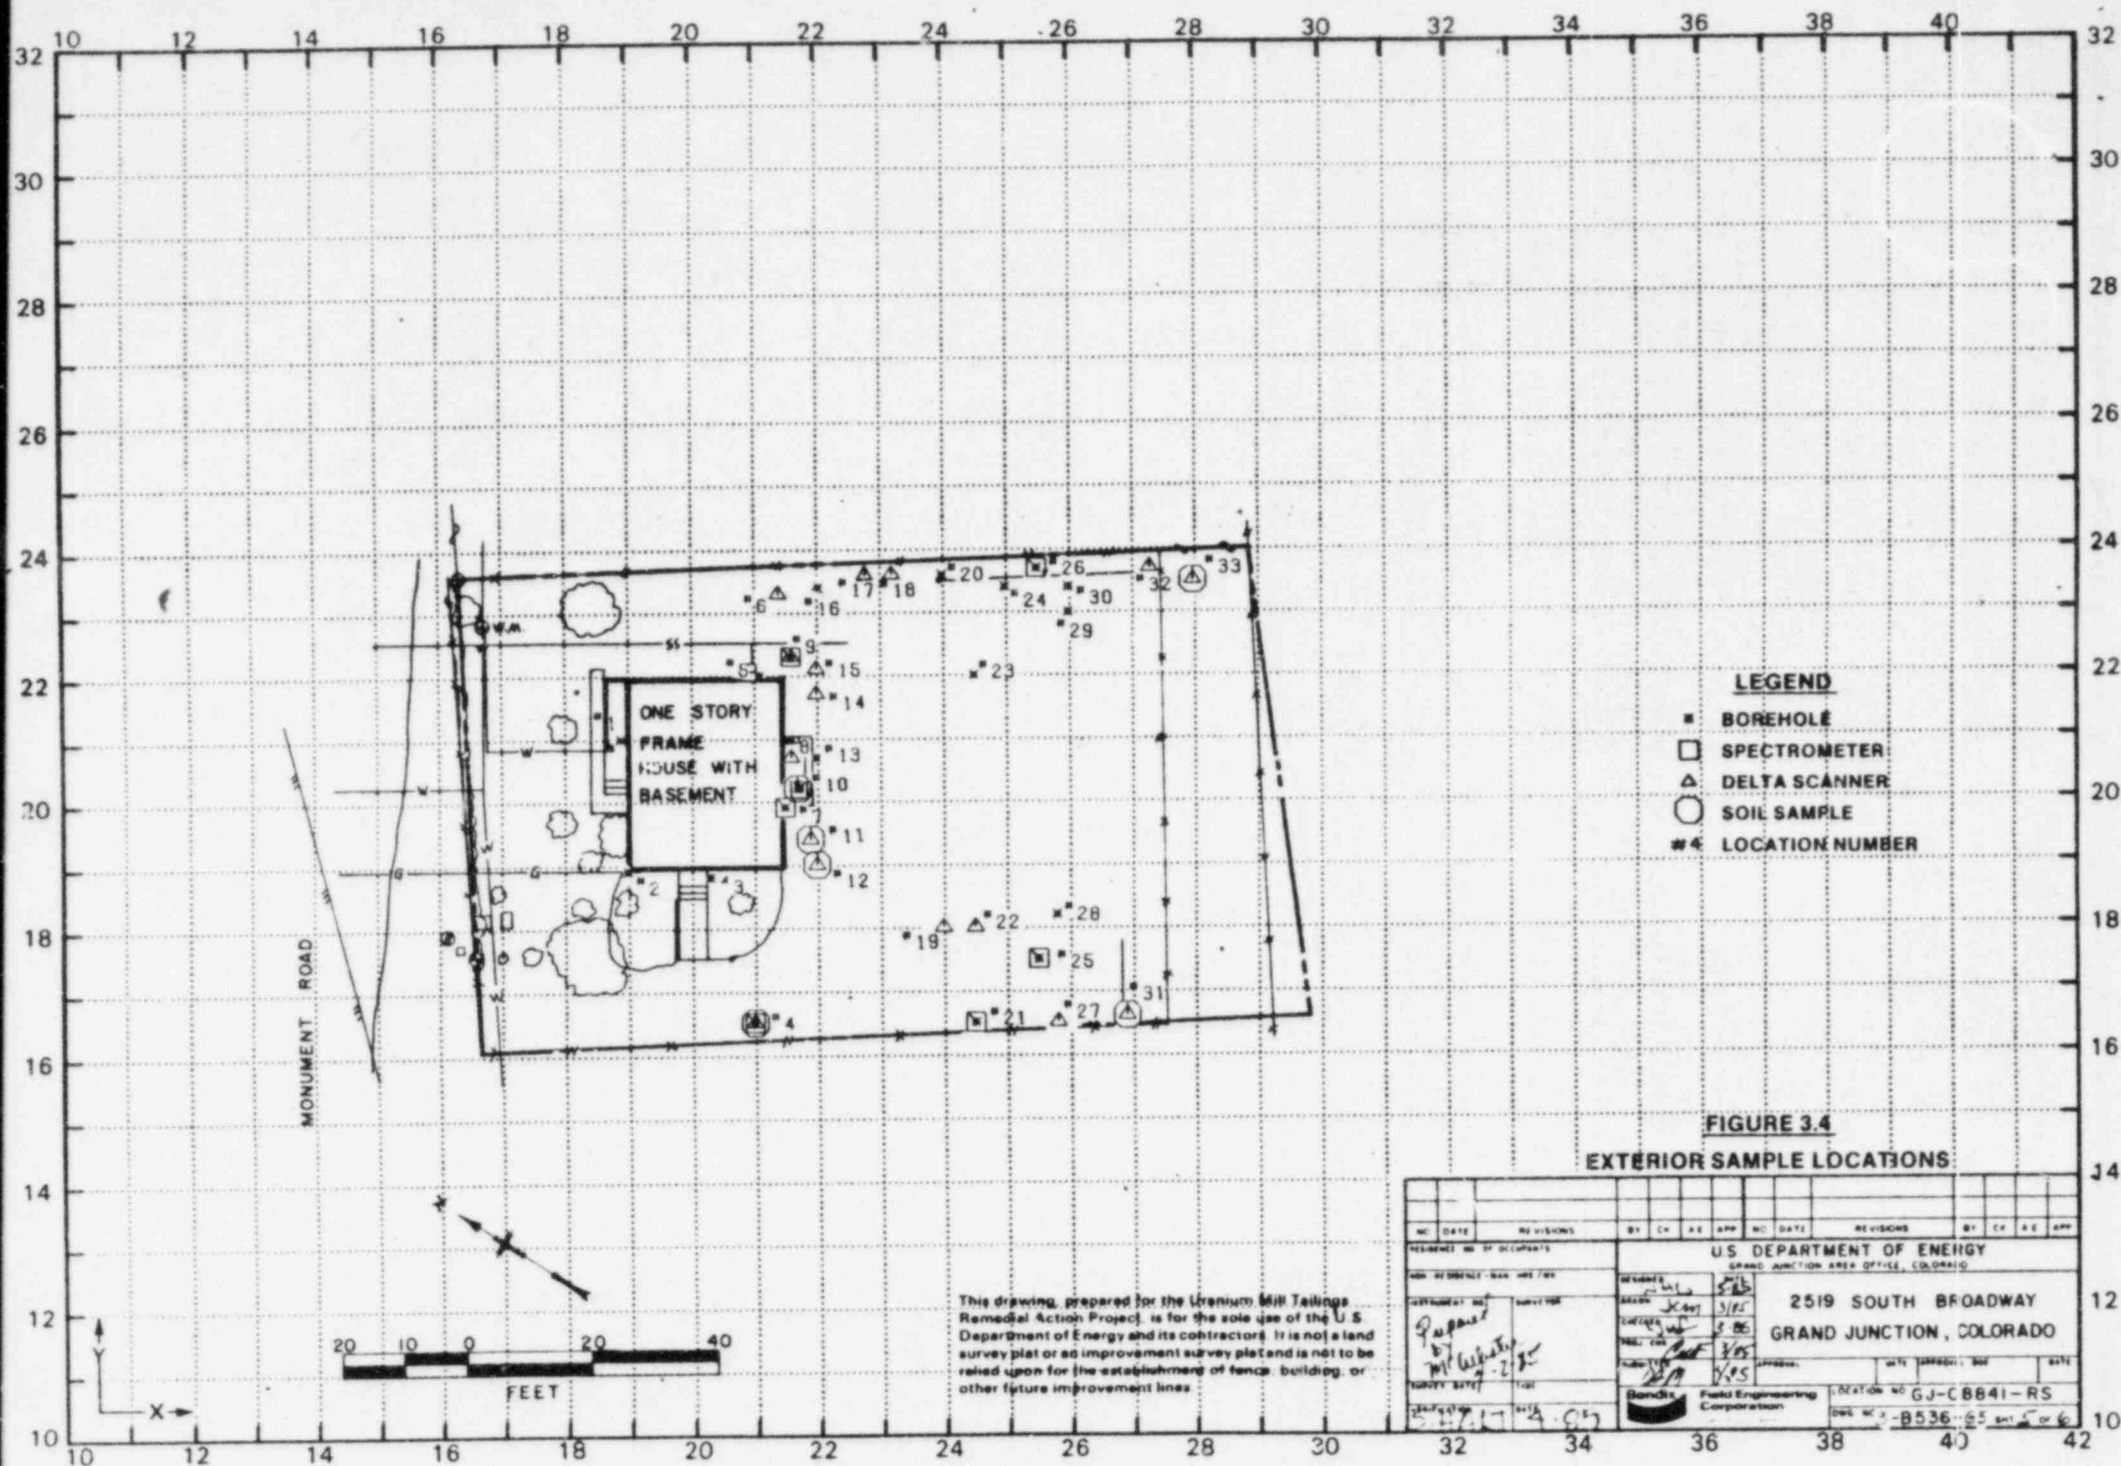
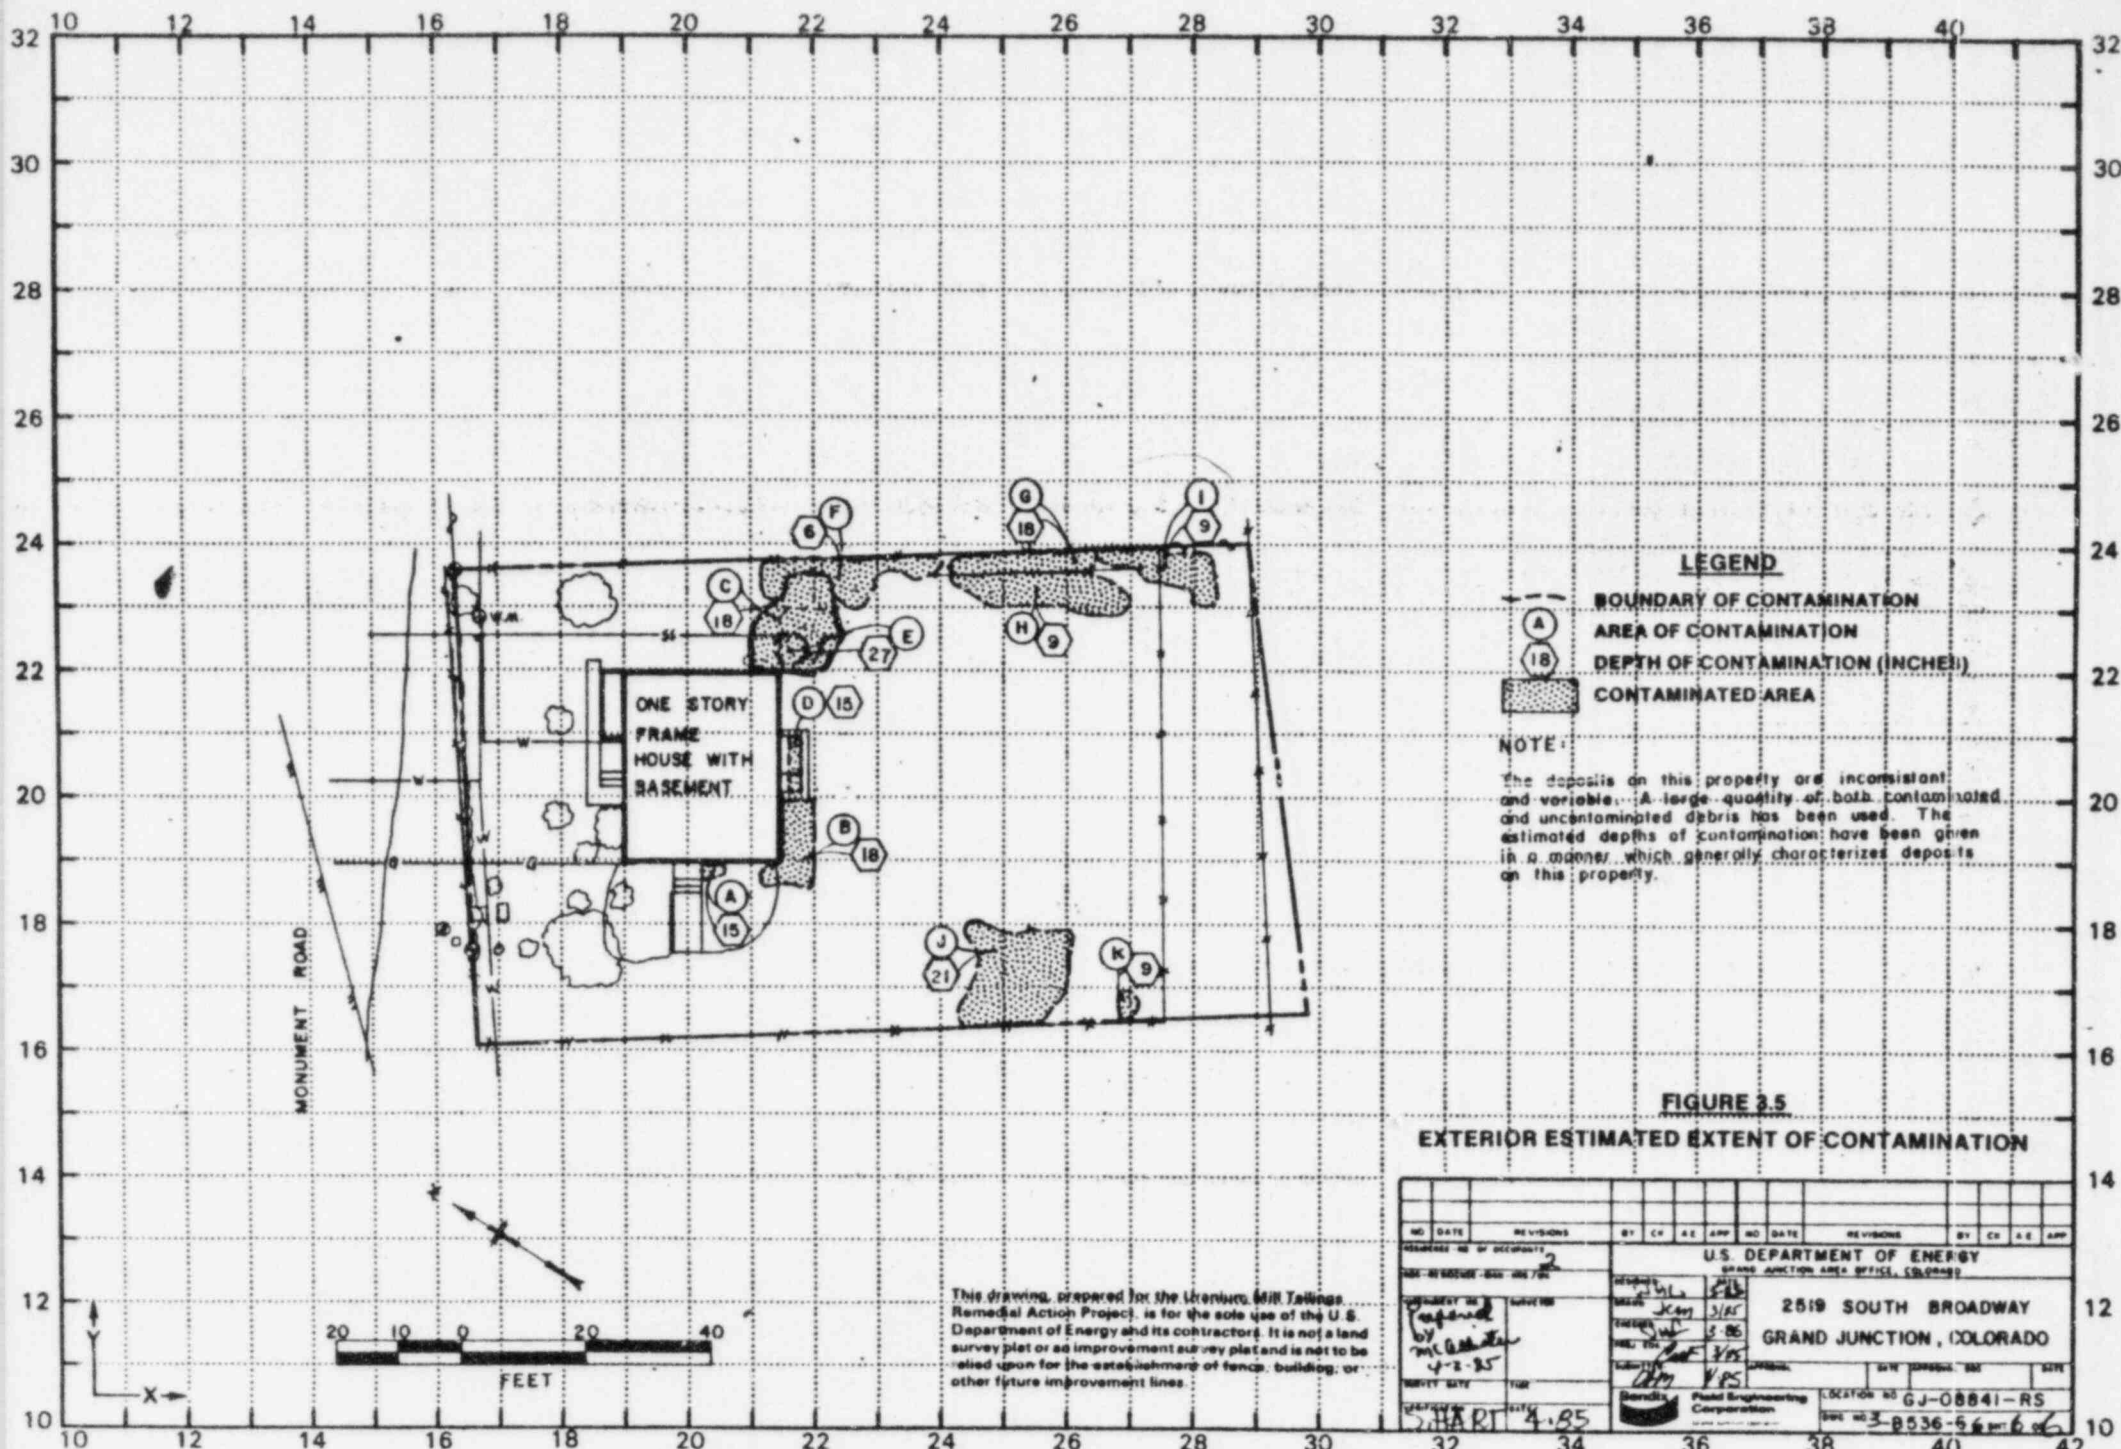
Appendix Figure 3.5 shows identified areas and estimated depths of contamination on this property, based on assessments of all measurements taken. As noted in this figure, areas recommended for remedial action that contain identified residual radioactive materials are:

- (AREA A) A small area adjacent to the west entry steps is contaminated to a depth of 15 inches (approximately 8 sf).
- (AREA B) A deposit along the south corner of the primary structure is contaminated to a depth of 18 inches (approximately 82 sf).

- (AREA C) Surrounding Area E there is contamination to a depth of 18 inches (approximately 152 sf).
- (AREA D) The fill material beneath the concrete basement entry is contaminated. The concrete is 6 inches thick. The total depth of contamination is 15 inches (approximately 18 sf).

- (AREA E) An area near the east corner of the primary structure is contaminated to a depth of 27 inches (approximately 20 sf).
- (AREA F) Along the east fence line, a portion of the yard adjacent to Area C is contaminated to a depth of 6 inches (approximately 129 sf).

- (AREA G) Immediately southeast of Area F there is a deposit which is contaminated to a depth of 18 inches (approximately 92 sf).
- (AREA H) A portion of the yard adjacent to the west side of Area G is contaminated to a depth of 9 inches (approximately 150 sf).

- (AREA I) Soil adjacent to the southeast portion of Area G is contaminated to a depth of 9 inches (approximately 90 sf).

- (AREA J) A deposit in the gravel driveway at the southwest side of property is contaminated to a depth of 21 inches (approximately 225 sf).
- (AREA K) A small deposit that abuts the southwest property line is contaminated to a depth of 9 inches (approximately 15 sf).

The recommended remedial action for this property, DOE ID No. GJ-08841-RS, includes removal of all areas identified as containing radioactive material (as discussed in Section 3.5 and shown in Appendix Figure 3.5) and transport of removed material to the disposal site.

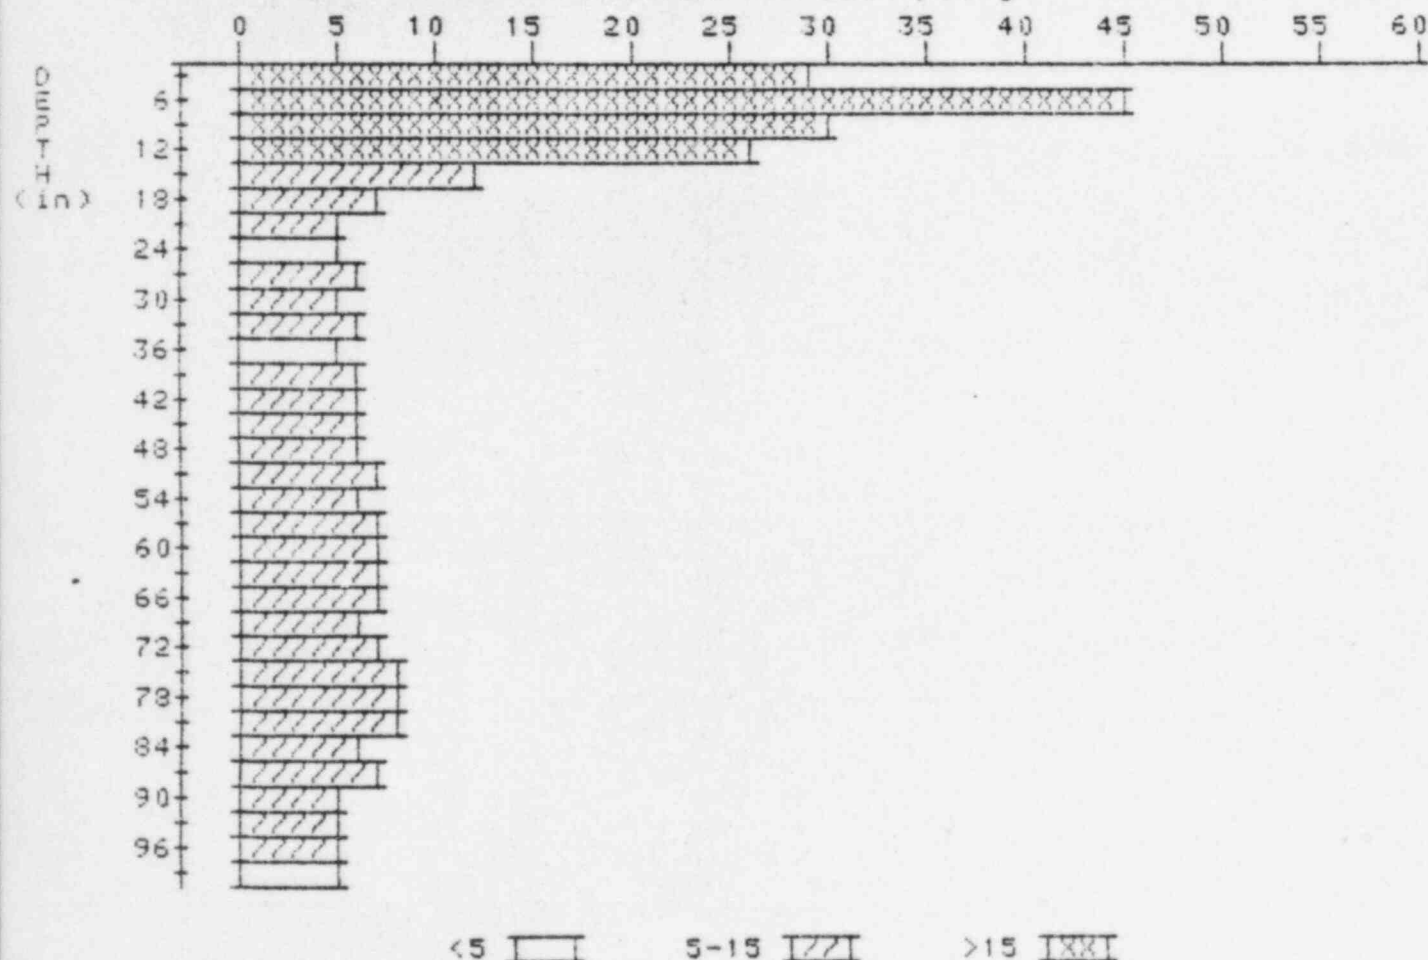
LOCATION: 255237

Your comment #3 stating that the possible "secondary radiation" exhibited between approximately 42" and 87" depth in borehole #26 (255237) was caused by a contaminated deposit on the adjacent property may in fact be correct. It is still recommended, however, that the location and possible contaminated involvement of the septic tank on this property (which may or may not be providing a shine contribution for this borehole) be adequately documented.
