SUBJECT: CRACKING IN SEGMENT OF CORE SPRAY PIPING, PEACH BOTTOM ATOMIC POWER STATION (PBAPS), UNIT 3 (TAC NO. M88098)

PEACH BOTTOM ATOMIC POWER STATION, UNIT 3  
CORE SPRAY DOWNCOMER

CORE SPRAY LINE DOWNCOMER BRACKET  
STRESS ASSESSMENT REPORT  
for  
PEACH BOTTOM ATOMIC POWER STATION, UNIT 3  
Modification P00335

SUBJECT: REPAIR OF FLAWS FOUND IN CORE SPRAY DOWNCOMER JOINTS, PEACH BOTTOM  
ATOMIC POWER STATION, UNIT NO. 3 (TAC NO. M92639)

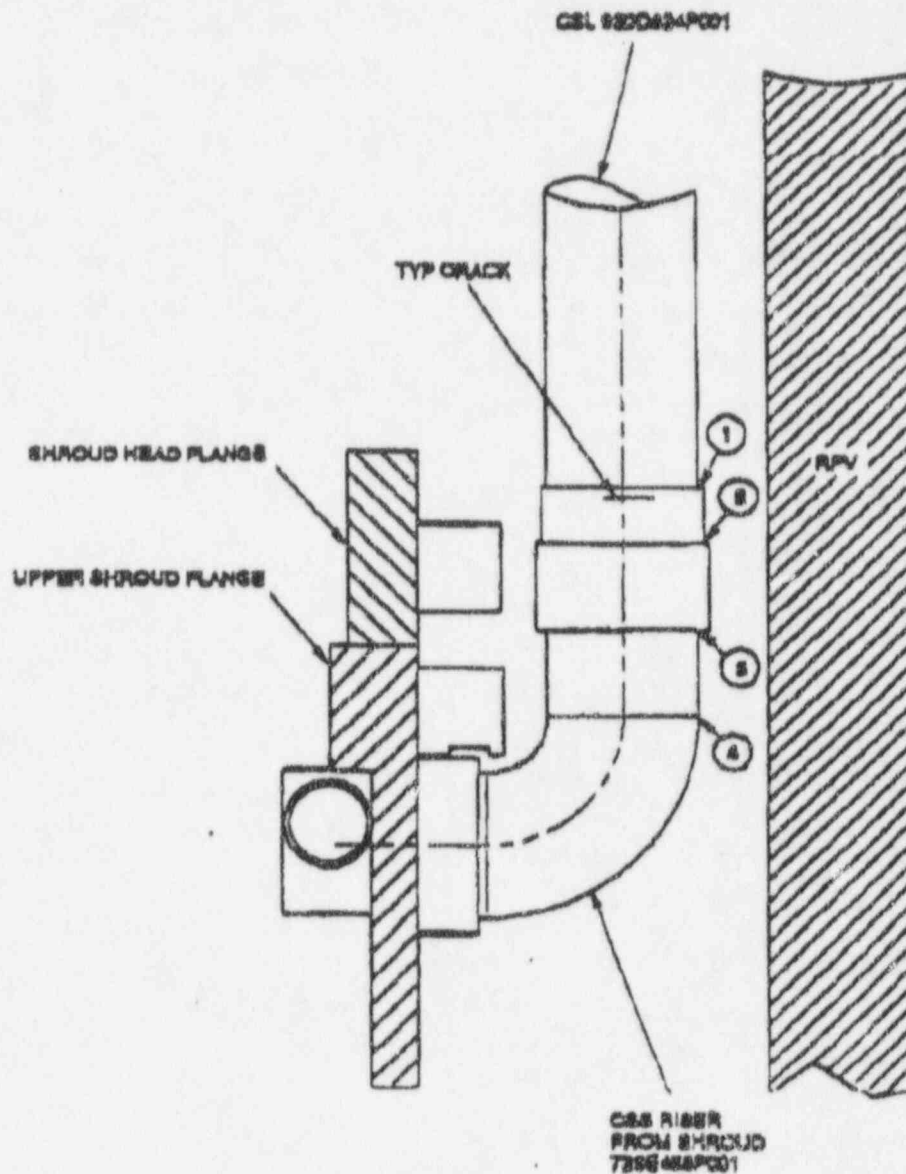
DOWNCOMER	CORE SPRAY LOOP	CRACK LENGTH (APPROX. DEG.) <sup>a</sup>
A (AZ 352.5°)	A	180
B (AZ 7.5°)	B	128
C (AZ 187.5°)	A	280
D (AZ 172.5°)	B	250

<sup>a</sup> Not continuous, summation of total crack lengths.

PECO Energy will be installing a repair clamp on each of the four CS downcomers. This repair modification was reviewed in accordance with 10 CFR 50.59. A previous revision of the modification package was reviewed by the NRC and documented in Inspection Report 50-277/95-18 and 50-278/95-18.

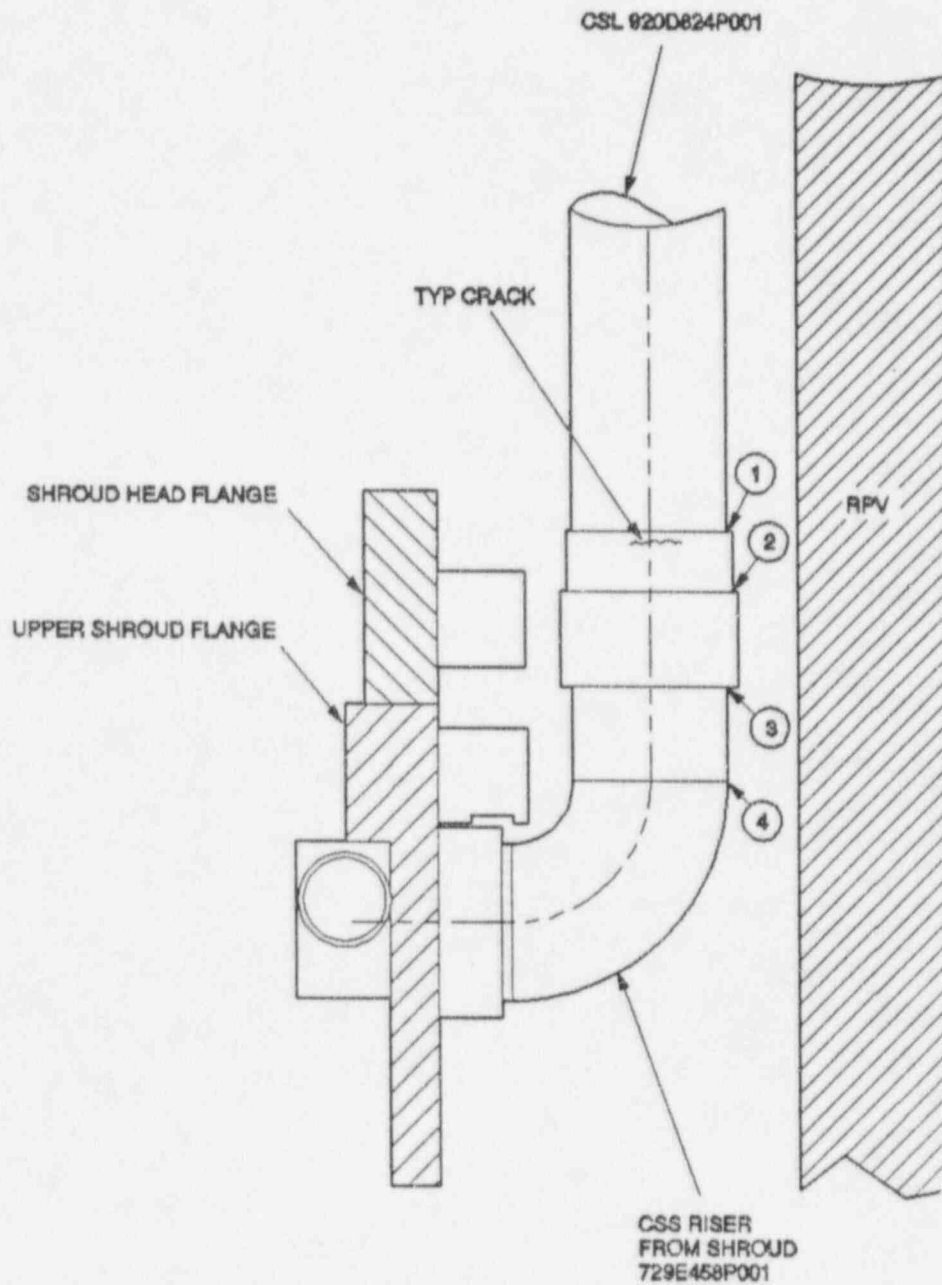
Figure 1. Core Spray Sparger Riser/Downcomer

A repair by modification was designed that addresses the identified crack indications (below weld 1, Figure 1) on the 7.5 degree, 172.5 degree, 187.5 degree and 352.5 degree azimuths. The repair at 172.5 degree azimuth also envelops welds 2, 3 & 4 of Figure 1. The additional design features for the 172.5 azimuth clamp were included prior to 3R10 in vessel inspections to envelop weld locations associated with the downcomer repair on a contingency basis.

No. Systems and components used to mitigate the (radiological) consequences of the accidents in the UFSAR are not degraded by this modification. All of the events in the Peach Bottom UFSAR were examined to determine if the consequences of any of these events is increased by the installation of the repair clamps. Consequences (i.e., radiological dose) associated with the design basis accidents are evaluated in the UFSAR. The existing core spray downcomer and repair clamps do not function to mitigate the consequences of any UFSAR event except the design basis LOCA event. No UFSAR dose calculation will be impacted by this change. For the design basis LOCA event discussed in the UFSAR, the core spray line and downcomer provide the flow path inside the RPV for the ECCS flow to the core spray spargers. Maintaining this flow path is required to ensure that core cooling capability is maintained following the design basis LOCA. This repair design, through its restraint of the joint, ensures the integrity of the core spray downcomer, with a 360 degree through wall crack in the pipe sleeve, under DBA conditions. The modification will also ensure the structural integrity of the 'D' downcomer in the event additional full circumferential cracking develops at weld locations 2 through 4 of Figure 1.

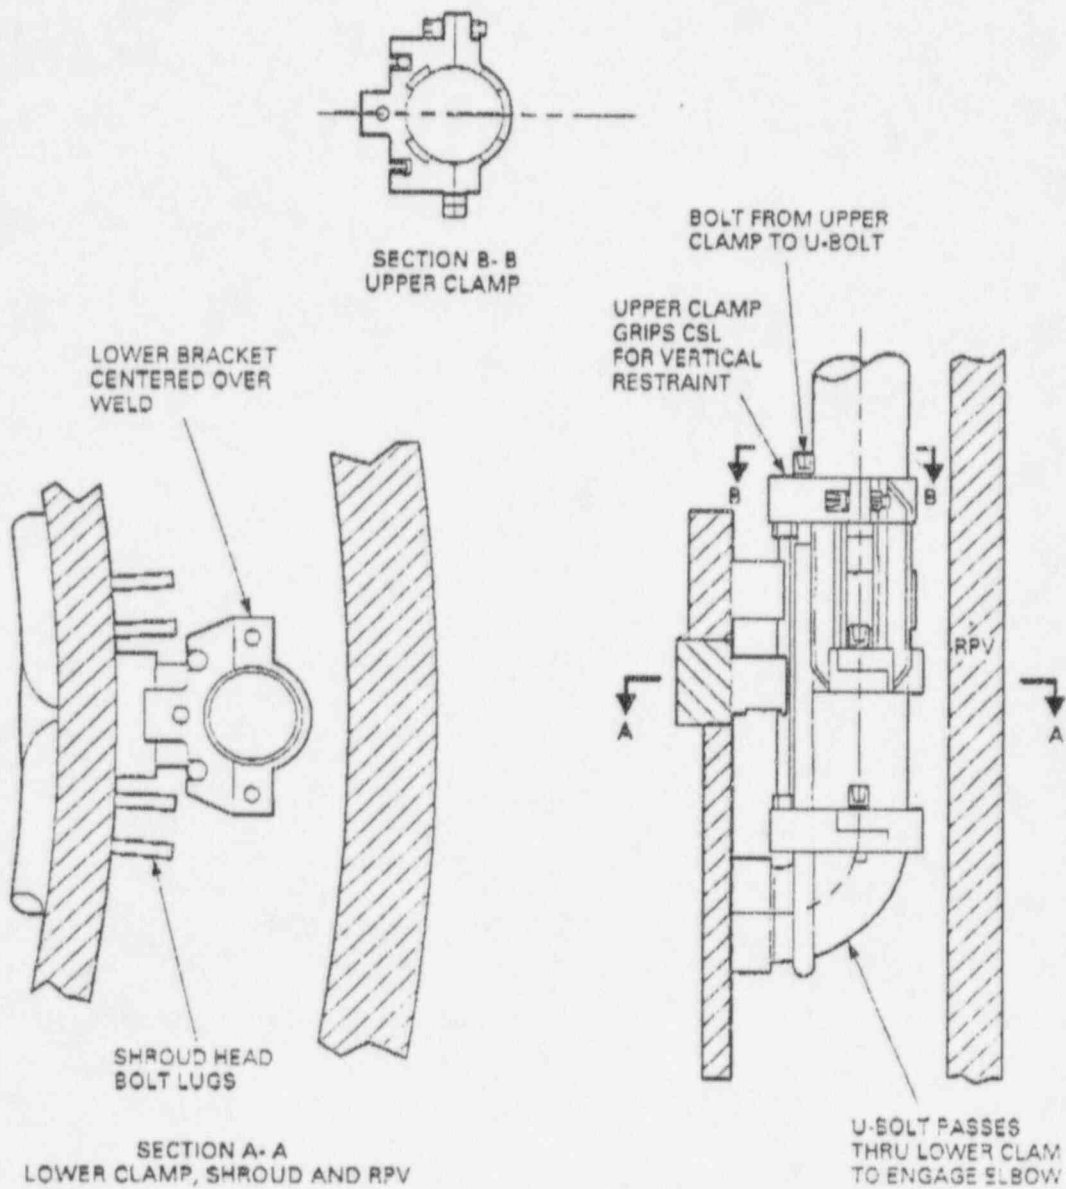
Figure 1. CSS Riser Repair Concept

1.2 CSS Downcomer Modification. During the Peach Bottom Unit 3 1993 refueling outage and inspections done in response to IE Bulletin 80-13, circumferential IGSCC defects were found on one of the CSS downcomer connections at 172.5°, adjacent to the upper horizontal weld to the vertical downcomer pipe, see Figure 3-1. In the 1995 refueling outage, cracks were also found in the 7.5 deg., 187.5 deg. and 352.5 deg. downcomer pipes. The cracks vary in length from a minimum of 7.5 inches to 17.5 inches are in the weld heat affected zone base material, on the connector sleeve, about 1/4 inch from the weld. A repair (by modification) is designed that addresses the identified cracking in the heat affected zone in the pipe sleeve of the downcomer sleeve/spigot joint, including potential additional cracking in the spigot/sleeve and elbow area for the 172.5 deg. azimuth downcomer.

1.3 Modification Repair. The modification repair of the CSS downcomer (172.5 deg.) includes an external clamp assembly which will be mechanically attached to the CSS downcomer at the defect area. The clamp is placed on the CSL downcomer above the junction with the CSS downcomer pipe and extends below the connector, as shown in Figure 1. A lower clamp is placed at the location of the pipe to lower elbow weld. This clamp encircles 360 degrees degrees of the weld.

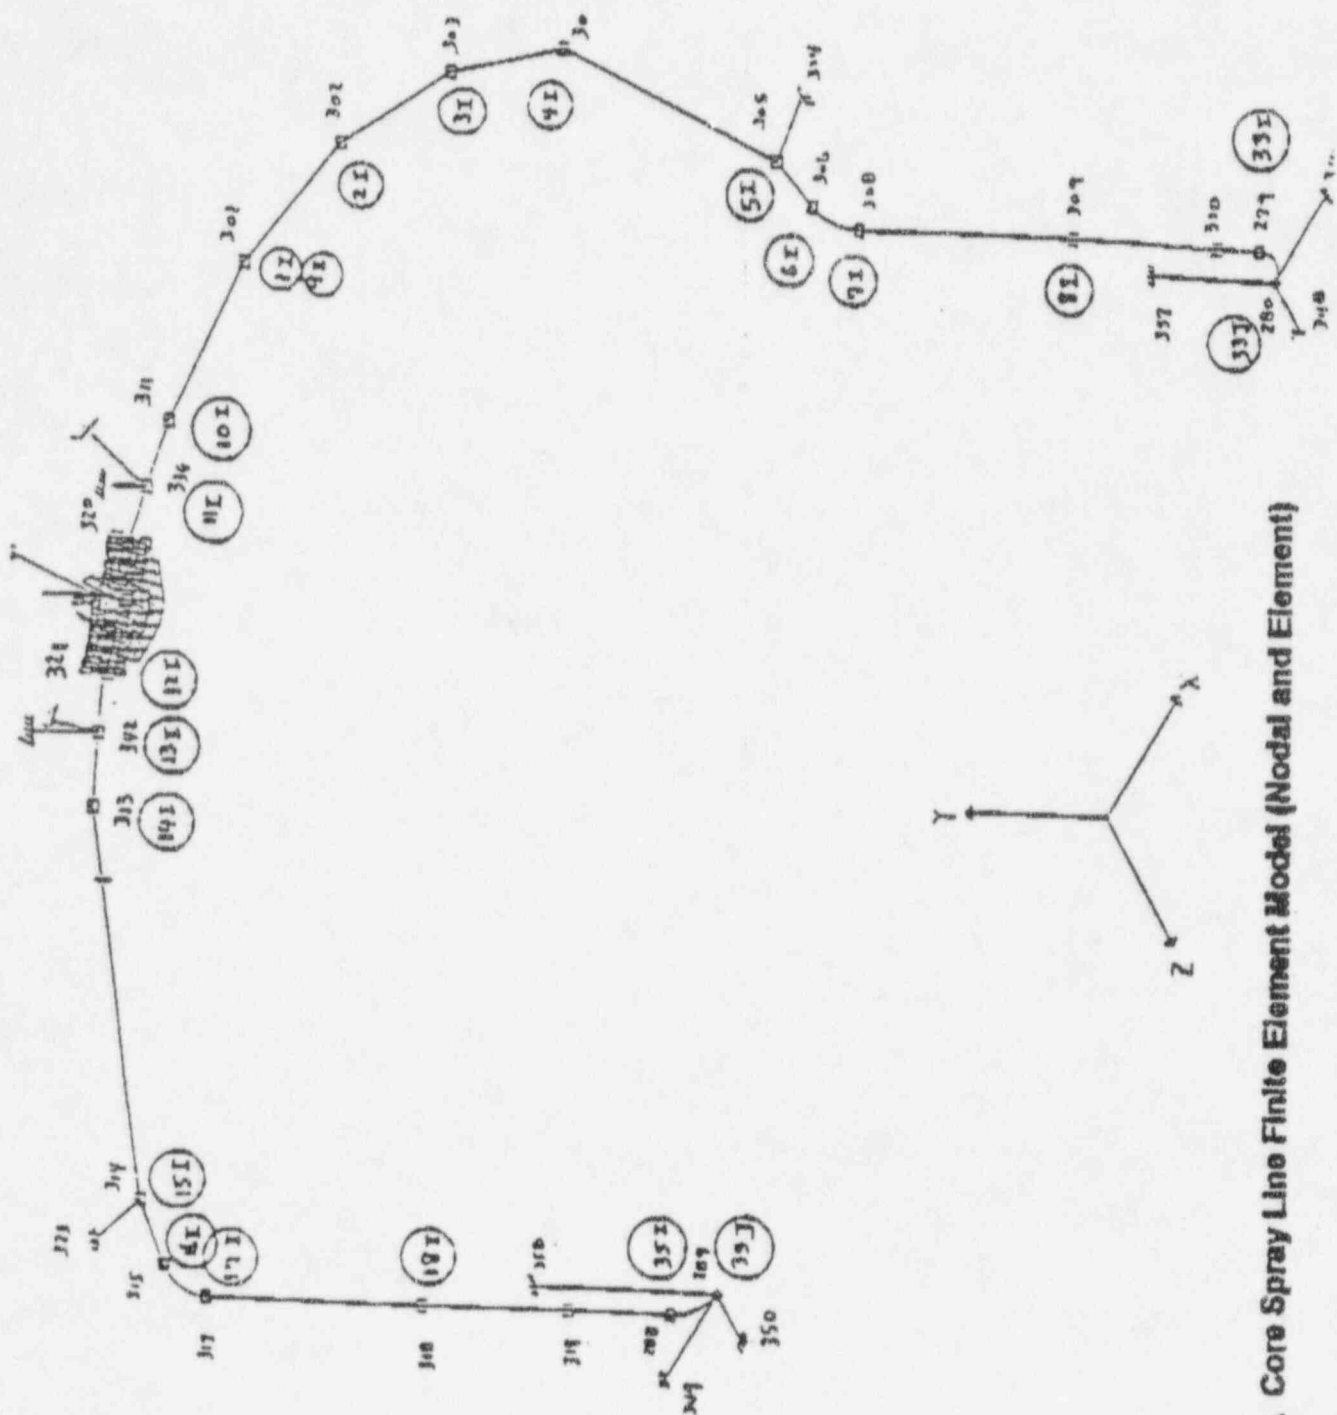
Figure 1A Core Spray Line Finite Element Model (Nodal and Element)

This analysis simulates the cracked condition equivalent to 10% moment of inertia exist for 8 inches length of the core spray pipe above the short elbow near the shroud.

The CSL pipe stresses satisfy the requirements of Article NB-3600 of ASME Section III. A summary of the results obtained by the solution of Subarticle NB-3650 equations for all significant joints in the piping system is contained in Appendix D of the analysis located in the referenced DRF's, and contained herein as Appendix A-3. The maximum primary stress ratio is the primary membrane stress for the Service Level B condition. The stress value for Service Level B is 5,952 psi as compared to the allowable stress of 25,500 psi. The maximum thermal expansion stress (Equation 12) for pipe element per NB-3600 is 20,902 psi with a stress ratio of 0.41. The maximum Equation 13 stress is 5,486 psi. The maximum fatigue usage factor is 0.001. The piping model at the sleeve crack causes moment relief at the joints. The analysis model assumes that 10% moment of inertia at the sleeve is existing. This assumption is considered reasonable because the both of OBED and OBEI can cause loads on the elbows and the T-box brackets.

The results of the stress analysis shows that the core spray line with the repair brackets is structurally adequate to withstand the operating load conditions.
