RADIOLOGIC AND ENGINEERING ASSESSMENT

DOE ID NO.: GJ-08847-MR  
ADDRESS: 2529 SOUTH BROADWAY

AUGUST 1985

URANIUM MILL TAILINGS REMEDIAL ACTION PROJECT OFFICE

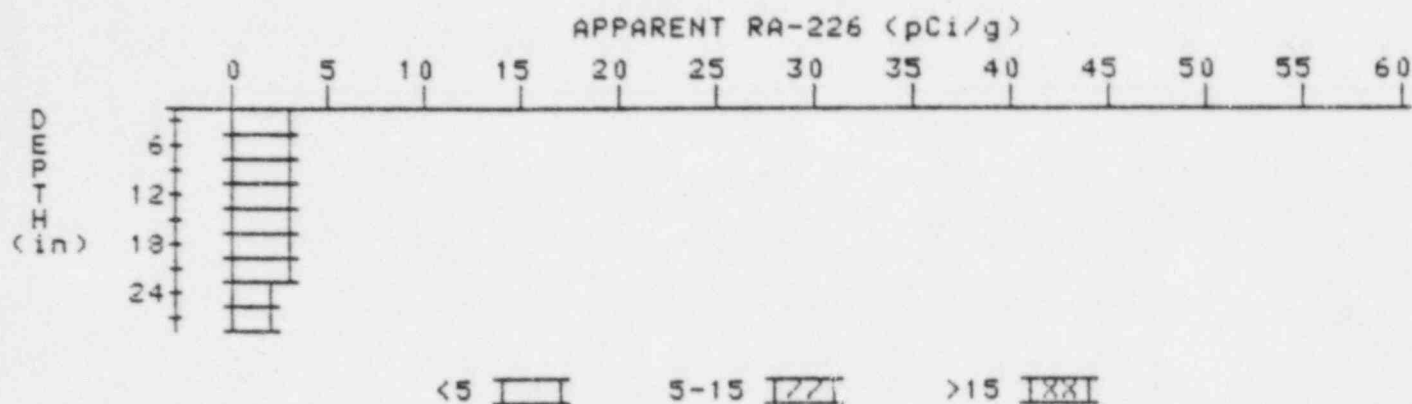
HOLE NUMBER: 8

Depth (in)	Apparent Radium-226 (pCi/g) Undeconvolved	Apparent Radium-226 (pCi/g) Deconvolved
3	2.6	2.6
6	2.9	3.3
9	3.0	3.2
12	3.0	3.2
15	2.9	2.9
18	2.8	2.8
21	2.7	2.9
24	2.5	2.3
27	2.4	2.4

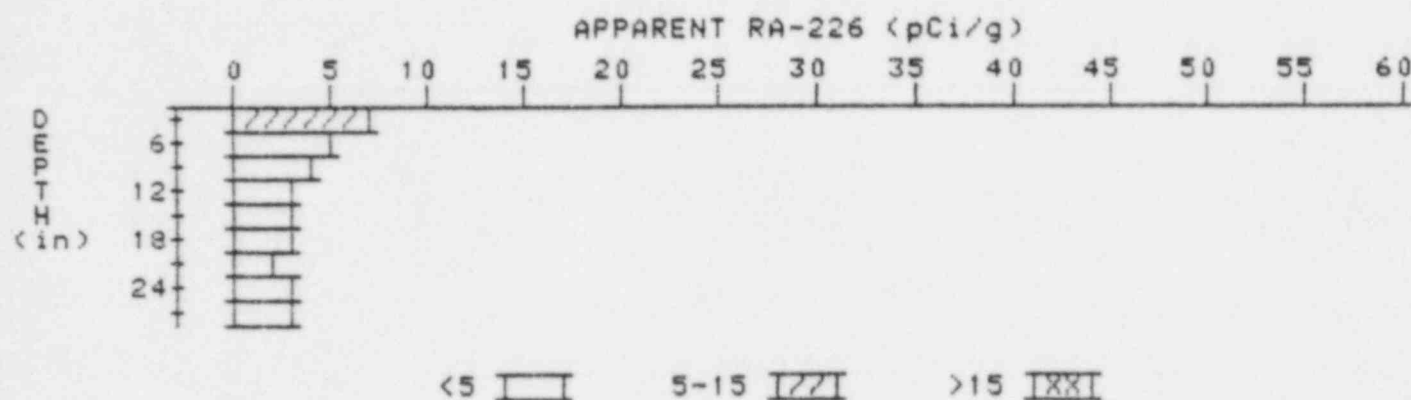
HOLE NUMBER: 10

Depth (in)	Apparent Radium-226 (pCi/g)	Apparent Radium-226 (pCi/g)
	Undeconvolved	Deconvolved
3	6.8	6.8
6	5.3	4.6
9	4.2	3.7
12	3.4	2.5
15	3.1	2.9
18	2.9	2.9
21	2.7	2.2
24	2.8	3.0
27	2.8	2.8

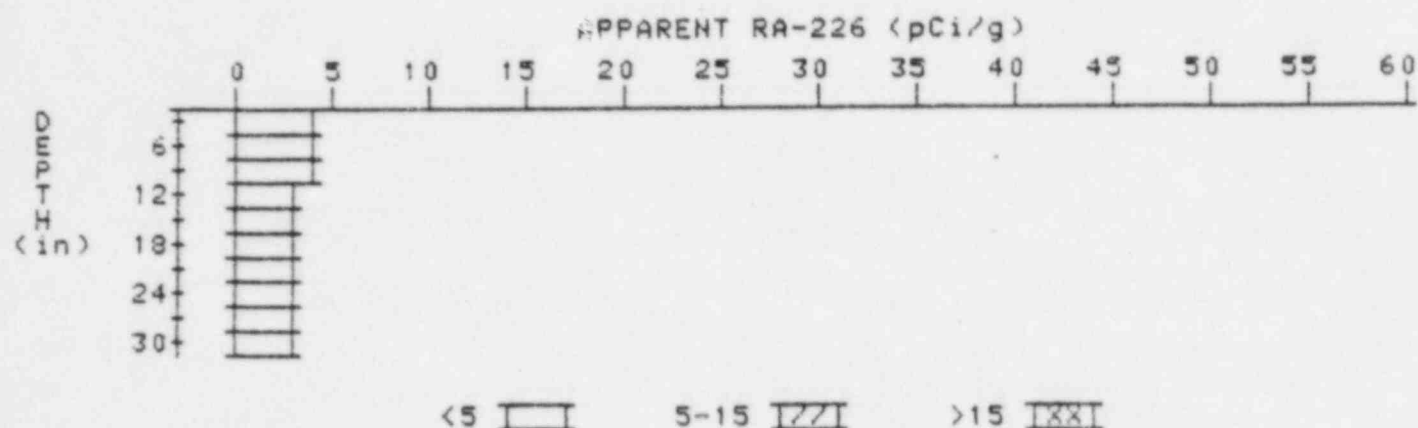
HOLE NUMBER: 16

Depth (in)	Apparent Radium-226 (pCi/g) Undeconvolved	Apparent Radium-226 (pCi/g) Deconvolved
3	3.5	3.5
6	3.7	4.4
9	3.5	3.5
12	3.3	3.1
15	3.2	3.2
18	3.1	3.1
21	3.0	3.0
24	2.9	2.7
27	2.9	3.1
30	2.8	2.8

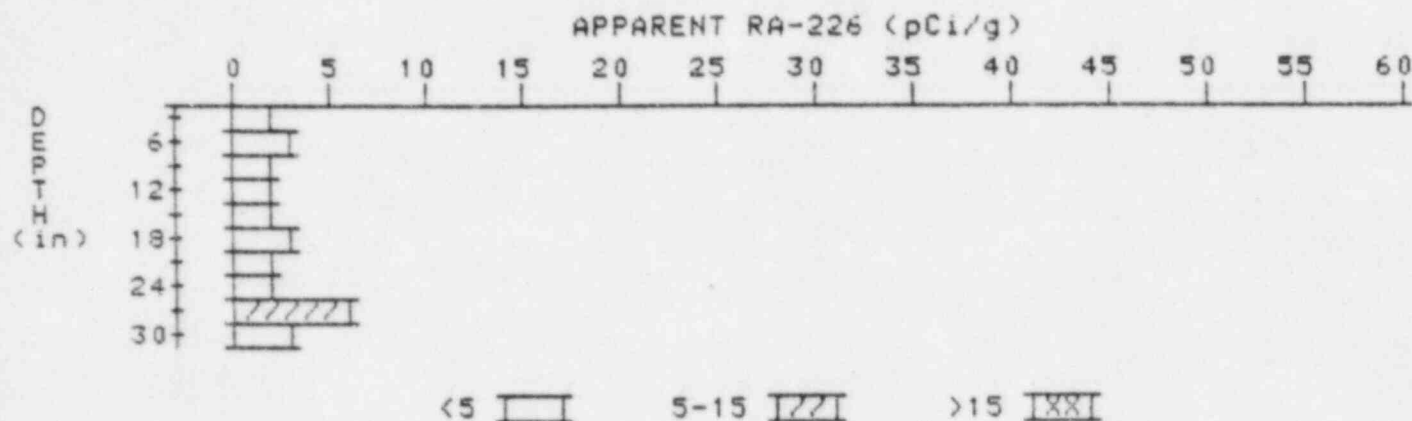
HOLE NUMBER: 17

Depth (in)	Apparent Radium-226 (pCi/g) Undeconvolved	Apparent Radium-226 (pCi/g) Deconvolved
3	2.0	2.0
6	2.2	2.6
9	2.2	2.4
12	2.1	1.9
15	2.1	1.6
18	2.4	2.6
21	2.6	2.2
24	3.0	2.3
27	3.8	6.5
30	3.1	3.1
