RADIOLOGIC AND ENGINEERING ASSESSMENT

DOE ID NO.: GJ-12935-MR
ADDRESS: 532 WEST COLORADO AVENUE

JULY 1985

BENDIX FIELD ENGINEERING CORPORATION
P.O. Box 1569
Grand Junction, Colorado 81502

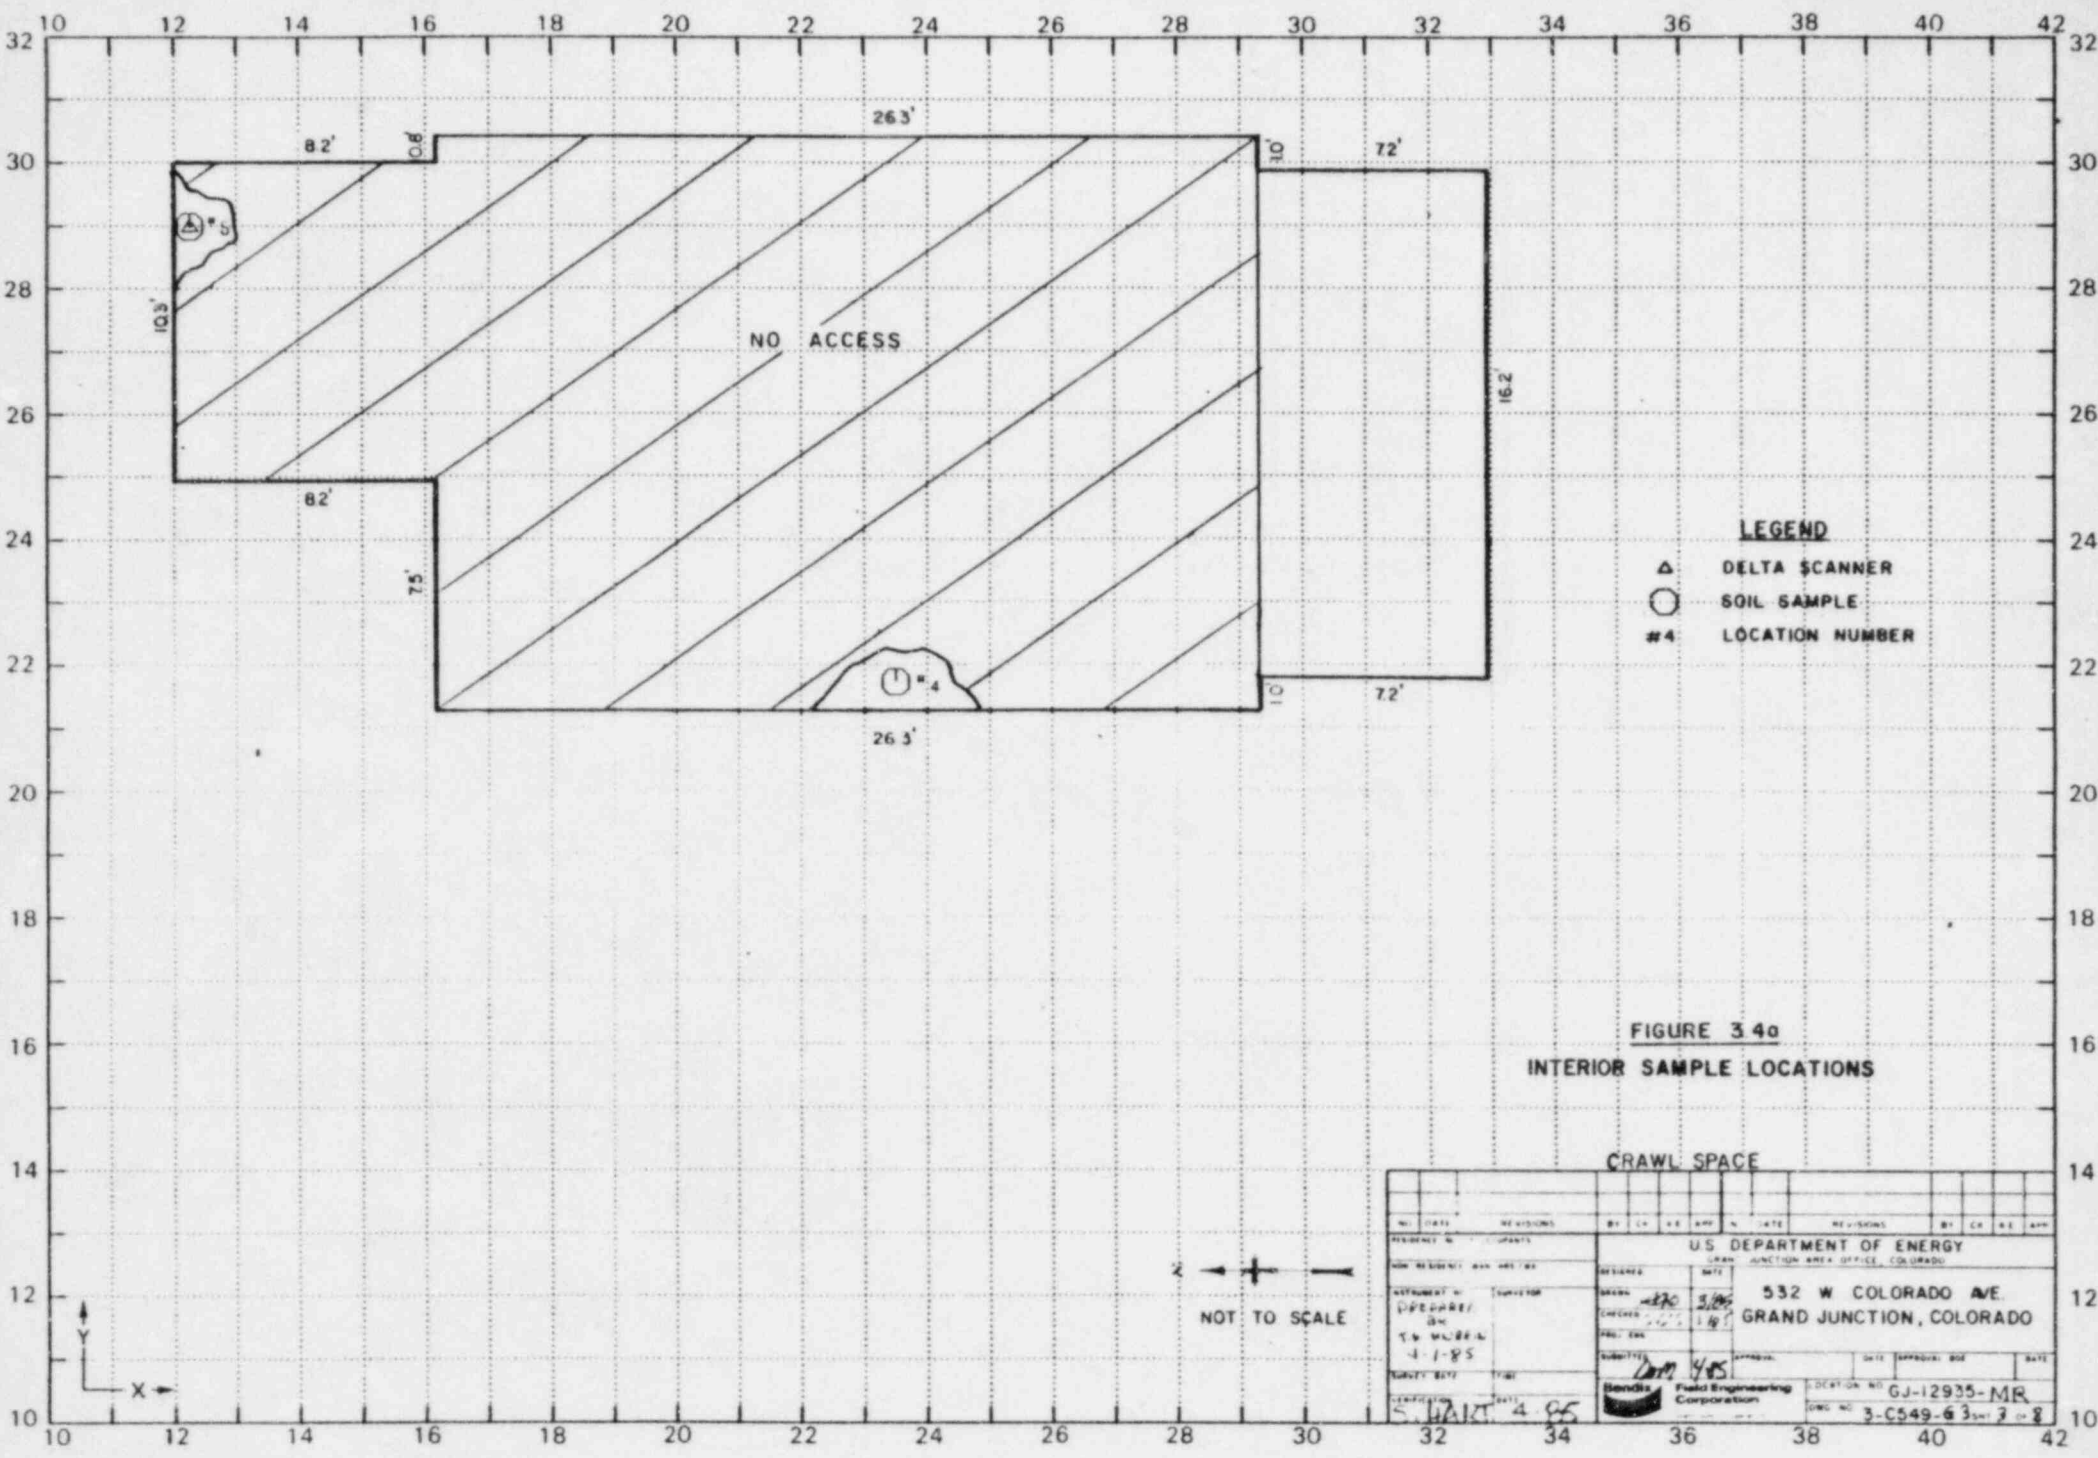
FIGURE 3.4a
INTERIOR SAMPLE LOCATIONS

Remedial action is recommended on the interior because of the 60.8 pCi/g chemical analysis results of a soil sample taken at location No. 5 (under the bathroom) as logged in Appendix Table 3.2 (Radium Concentrations at Interior Locations).

Areas which displayed elevated gamma levels were further investigated; these areas are shown in Appendix Figures 3.3a, 3.4a, and 3.4b. Data from these investigations are included in Appendix Tables 3.1 and 3.2.

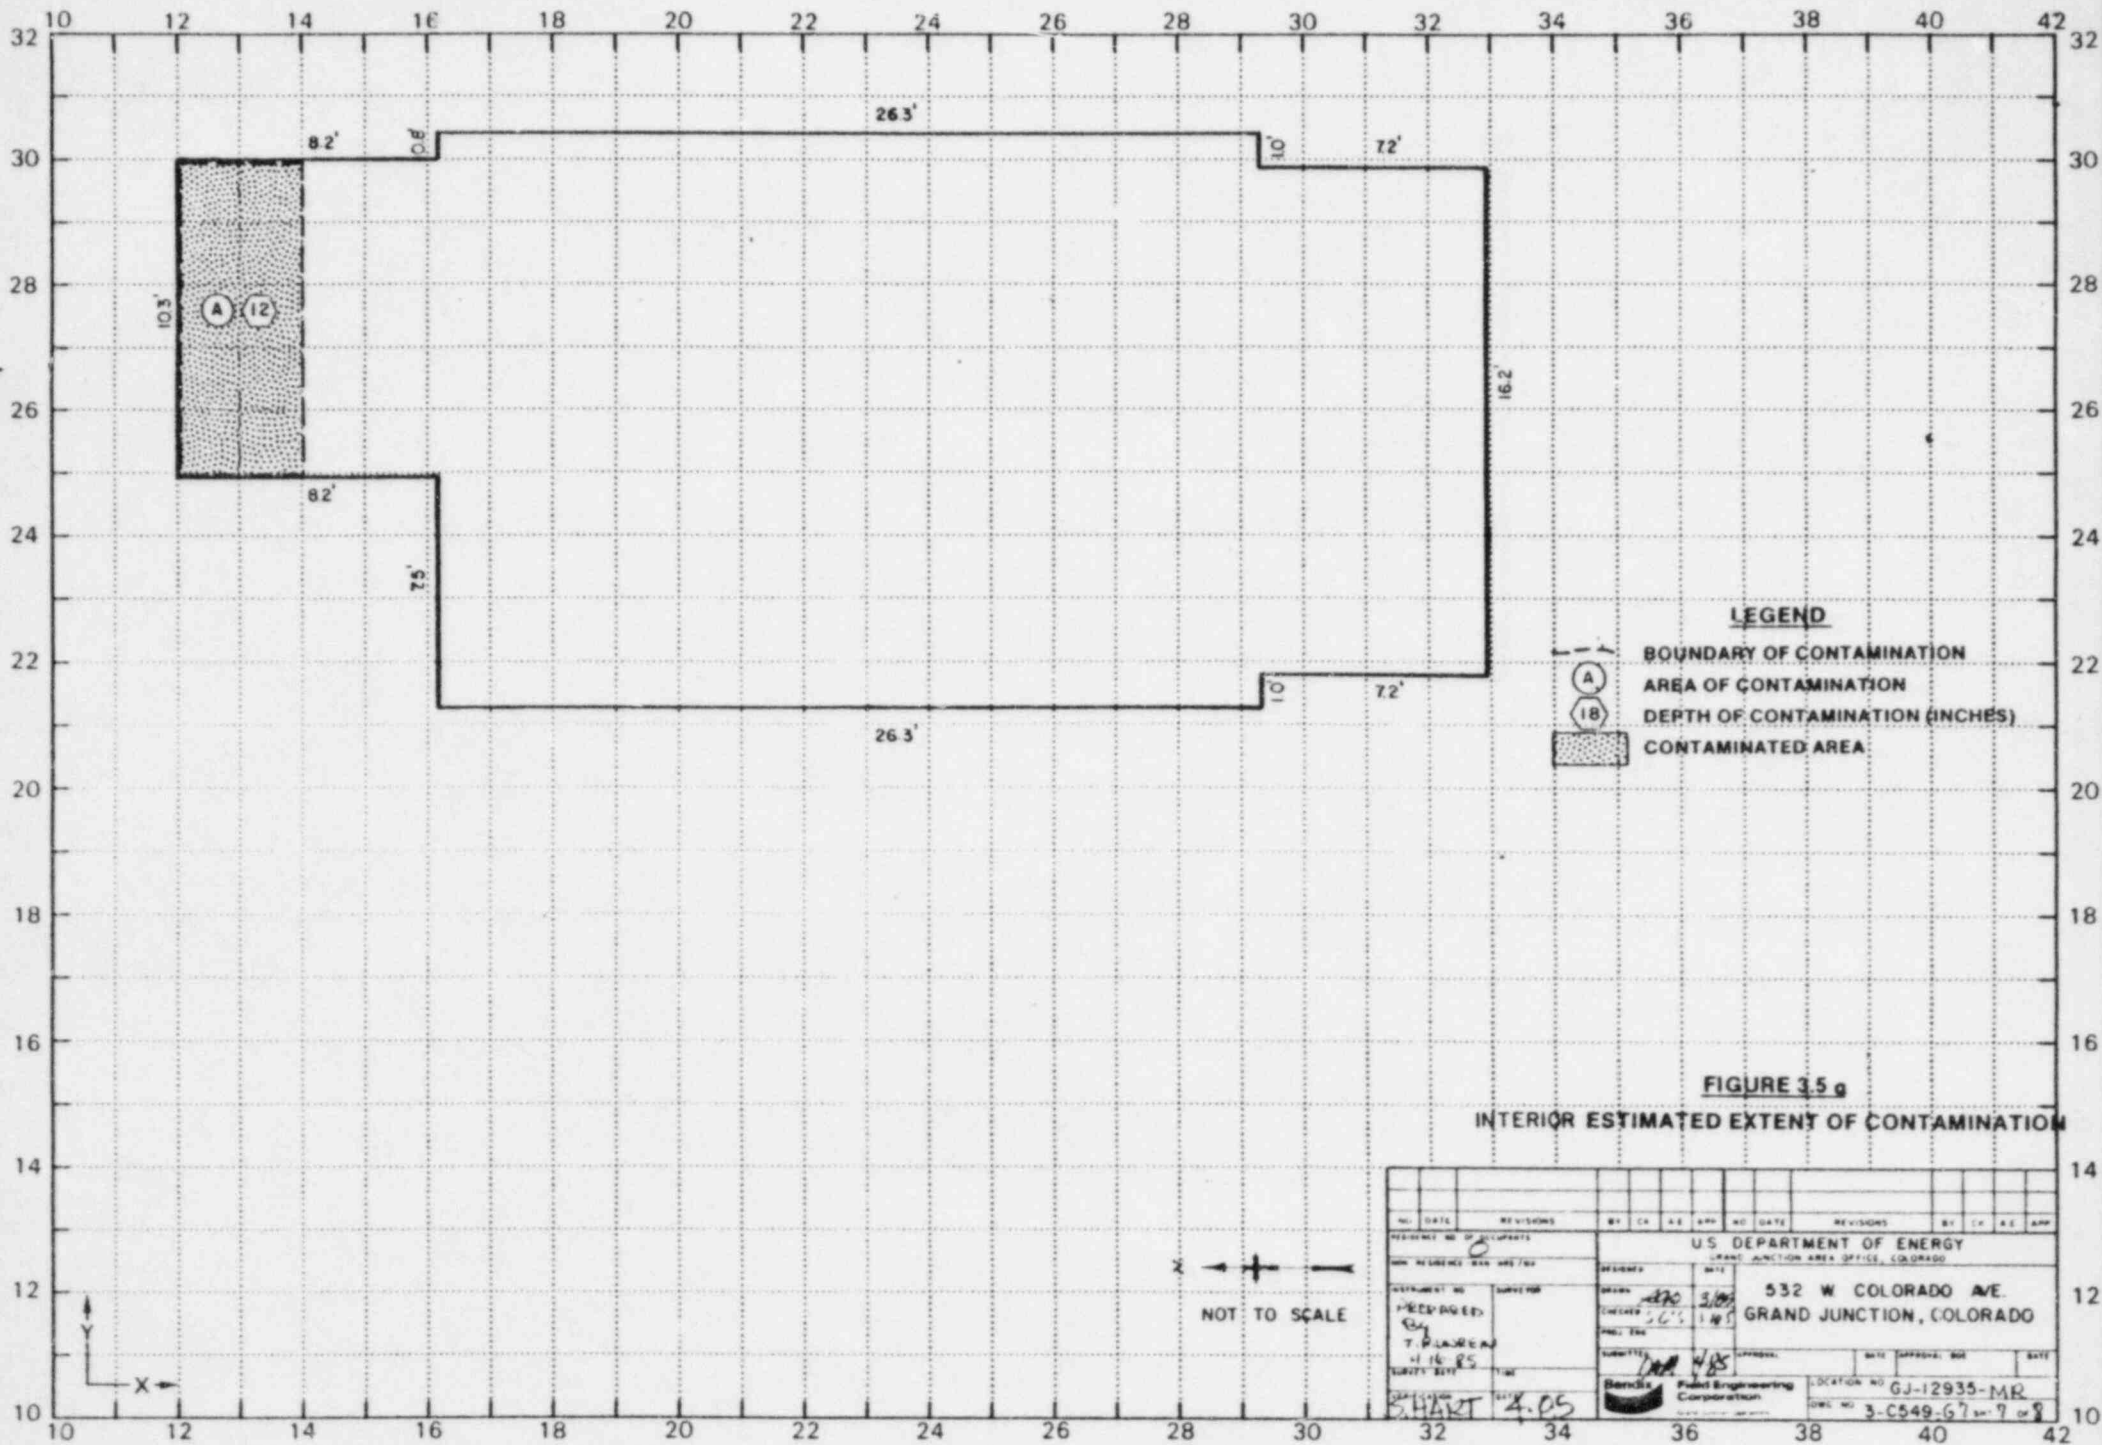
INTERIOR ESTIMATED EXTENT OF CONTAMINATION

- (AREA A) The portion of soil that underlies the bathroom addition of the primary structure is contaminated to a depth of 12 inches. This depth was measured from ground level under the structure (approximately 50 sf).

Under the north addition (Area A), elevated gamma readings were observed. Minimal exploration could be done to accurately identify the extent of this contamination. The deposit may extend beyond the boundaries indicated on Appendix Figure 3.5b.

The recommended remedial action for this property, DOE ID No. GJ-12935-MR, includes removal of all areas identified as containing radioactive material (as discussed in Section 3.5 and shown in Appendix Figures 3.5a and 3.5b) and transport of removed material to the disposal site.
