FACILITY NAME (1) Quad-Cities Nuclear Power Station, Unit 2										DOCKET NUMBER (2) 0 5 0 0 0 2 6 5					PAGE(S) 1 OF 0 4								
TITLE (4) Linear Indication on Reactor Recirculation System Welds																							
EVENT DATE (6)			LER NUMBER (8)				REPORT DATE (7)			OTHER FACILITIES INVOLVED (9)													
MONTH	DAY	YEAR	YEAR	SEQUENTIAL NUMBER	REVISION NUMBER	MONTH	DAY	YEAR	FACILITY NAMES NA				DOCKET NUMBER(S) 0 5 0 0 0										
0	4	0	1	8	5	8	5	0	0	8	0	1	0	7	1	5	8	5	0	5	0	0	0
OPERATING MODE (10)		THIS REPORT IS SUBMITTED PURSUANT TO THE REQUIREMENTS OF 10 CFR § (Check one or more of the following) (11)																					
2		20.402(b)				20.408(a)				80.73(a)(2)(iv)				73.71(b)									
POWER LEVEL (10)		20.408(a)(1)(i)				80.36(a)(1)				80.73(a)(2)(v)				73.71(e)									
0 0 0		20.408(a)(1)(ii)				80.36(a)(2)				80.73(a)(2)(vi)				OTHER (Specify in Abstract below and in Text, NRC Form 308A)

On March 18, 1985, Quad-Cities Unit 2 was shutdown for refueling. On April 1, a visual inspection revealed a Recirculation (AD) weld area with water seeping from a small crack. Subsequent to this discovery, while reviewing ultrasonic test data taken during the ongoing inspections

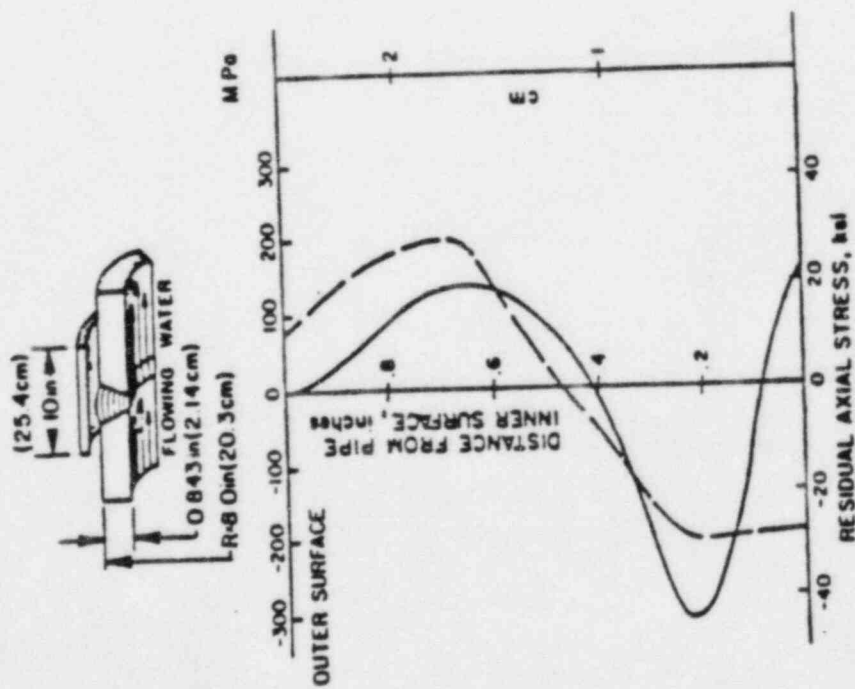
FIGURE 1

Table 1, attached, provides specific information related to the five weld overlays. Overlay dimensions are provided for all five welds. Table 2 provides predicted flaw growth for welds 10S-F5 and 02AS-S4. Figures 1 and 2 provide the residual stress distribution for those two welds.

16" NPS PRE- AND POST-IHSI
THROUGH-WALL RESIDUAL STRESS
DISTRIBUTIONS (FROM EPRI
NP-2662-LD)

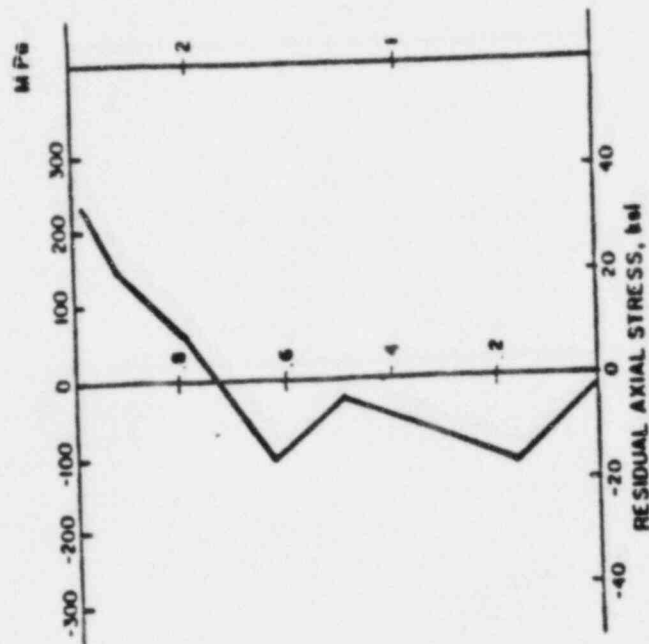
<u>Weld ID</u>	<u>Beginning- of-Cycle Flaw Depth Ratio</u>	<u>Predicted Flaw Depth Ratio w/o Mitigation</u>	<u>Predicted Flaw Depth Ratio w/ IHSI Mitigation</u>	<u>Predicted Flaw Depth Ratio w/ Overlay Mitigation</u>	<u>Allowable Flaw Depth Ratio (2)</u>
10S-F5	0.17	(3)	0.17	0.19	0.47
02AS-S4	0.20	0.36	0.20	0.20	0.48

WELD 10S-F5 (20" O.D. x 0.96" WALL)
THROUGH-WALL RESIDUAL STRESS
DISTRIBUTION AFTER TWO LAYER
OVERLAY (FROM NUTECH "WELDS II" ANALYSIS)

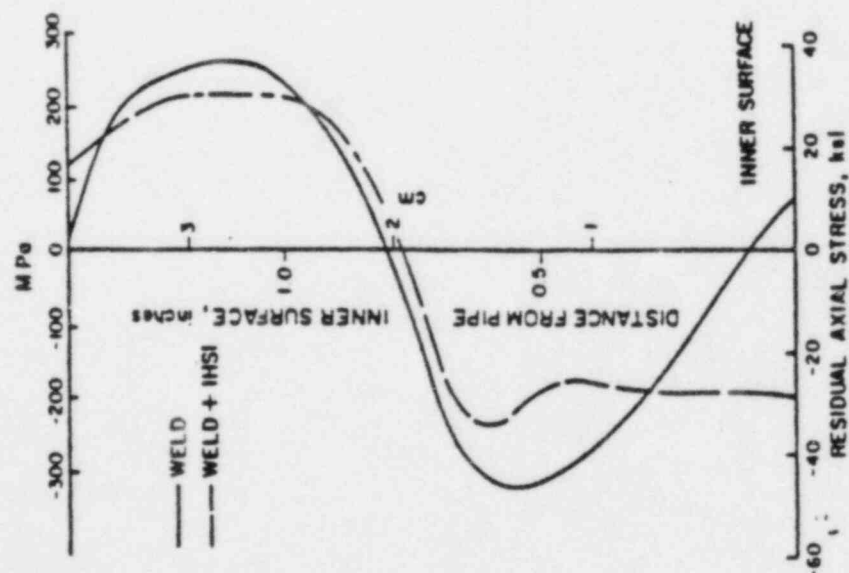
FIGURE 2

26" NPS PRE- AND POST-IHSI
THROUGH-WALL RESIDUAL STRESS
DISTRIBUTIONS (FROM EPRI
NP-2662-LD)

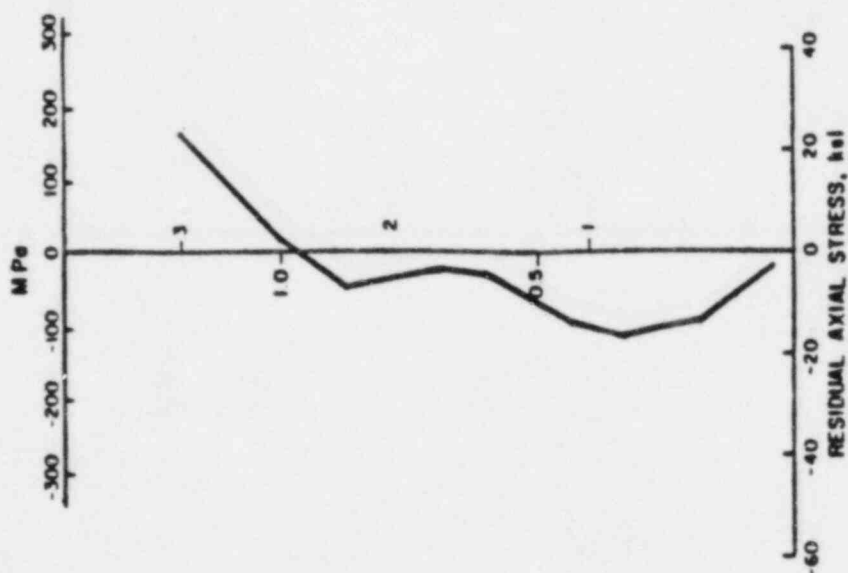
WELD 02AS-S4 (28" O.D. x 1.203" WALL)
THROUGH-WALL RESIDUAL STRESS
DISTRIBUTION AFTER TWO LAYER
OVERLAY (FROM NUTECH "WELDS II"
ANALYSIS)
