## Arizona Nuclear Power Project

Subject: Final Report - DER 85-23  
A 50.55(e) Evaluation Relating To Diesel Generator  
Start Failure Due To Mechanical Valve Failure  
File: 85-019-026; D.4.33.2

FINAL REPORT - DER 85-23  
DEFICIENCY EVALUATION 50.55(e)  
ARIZONA NUCLEAR POWER PROJECT (ANPP)  
PVNGS UNITS 1, 2, 3

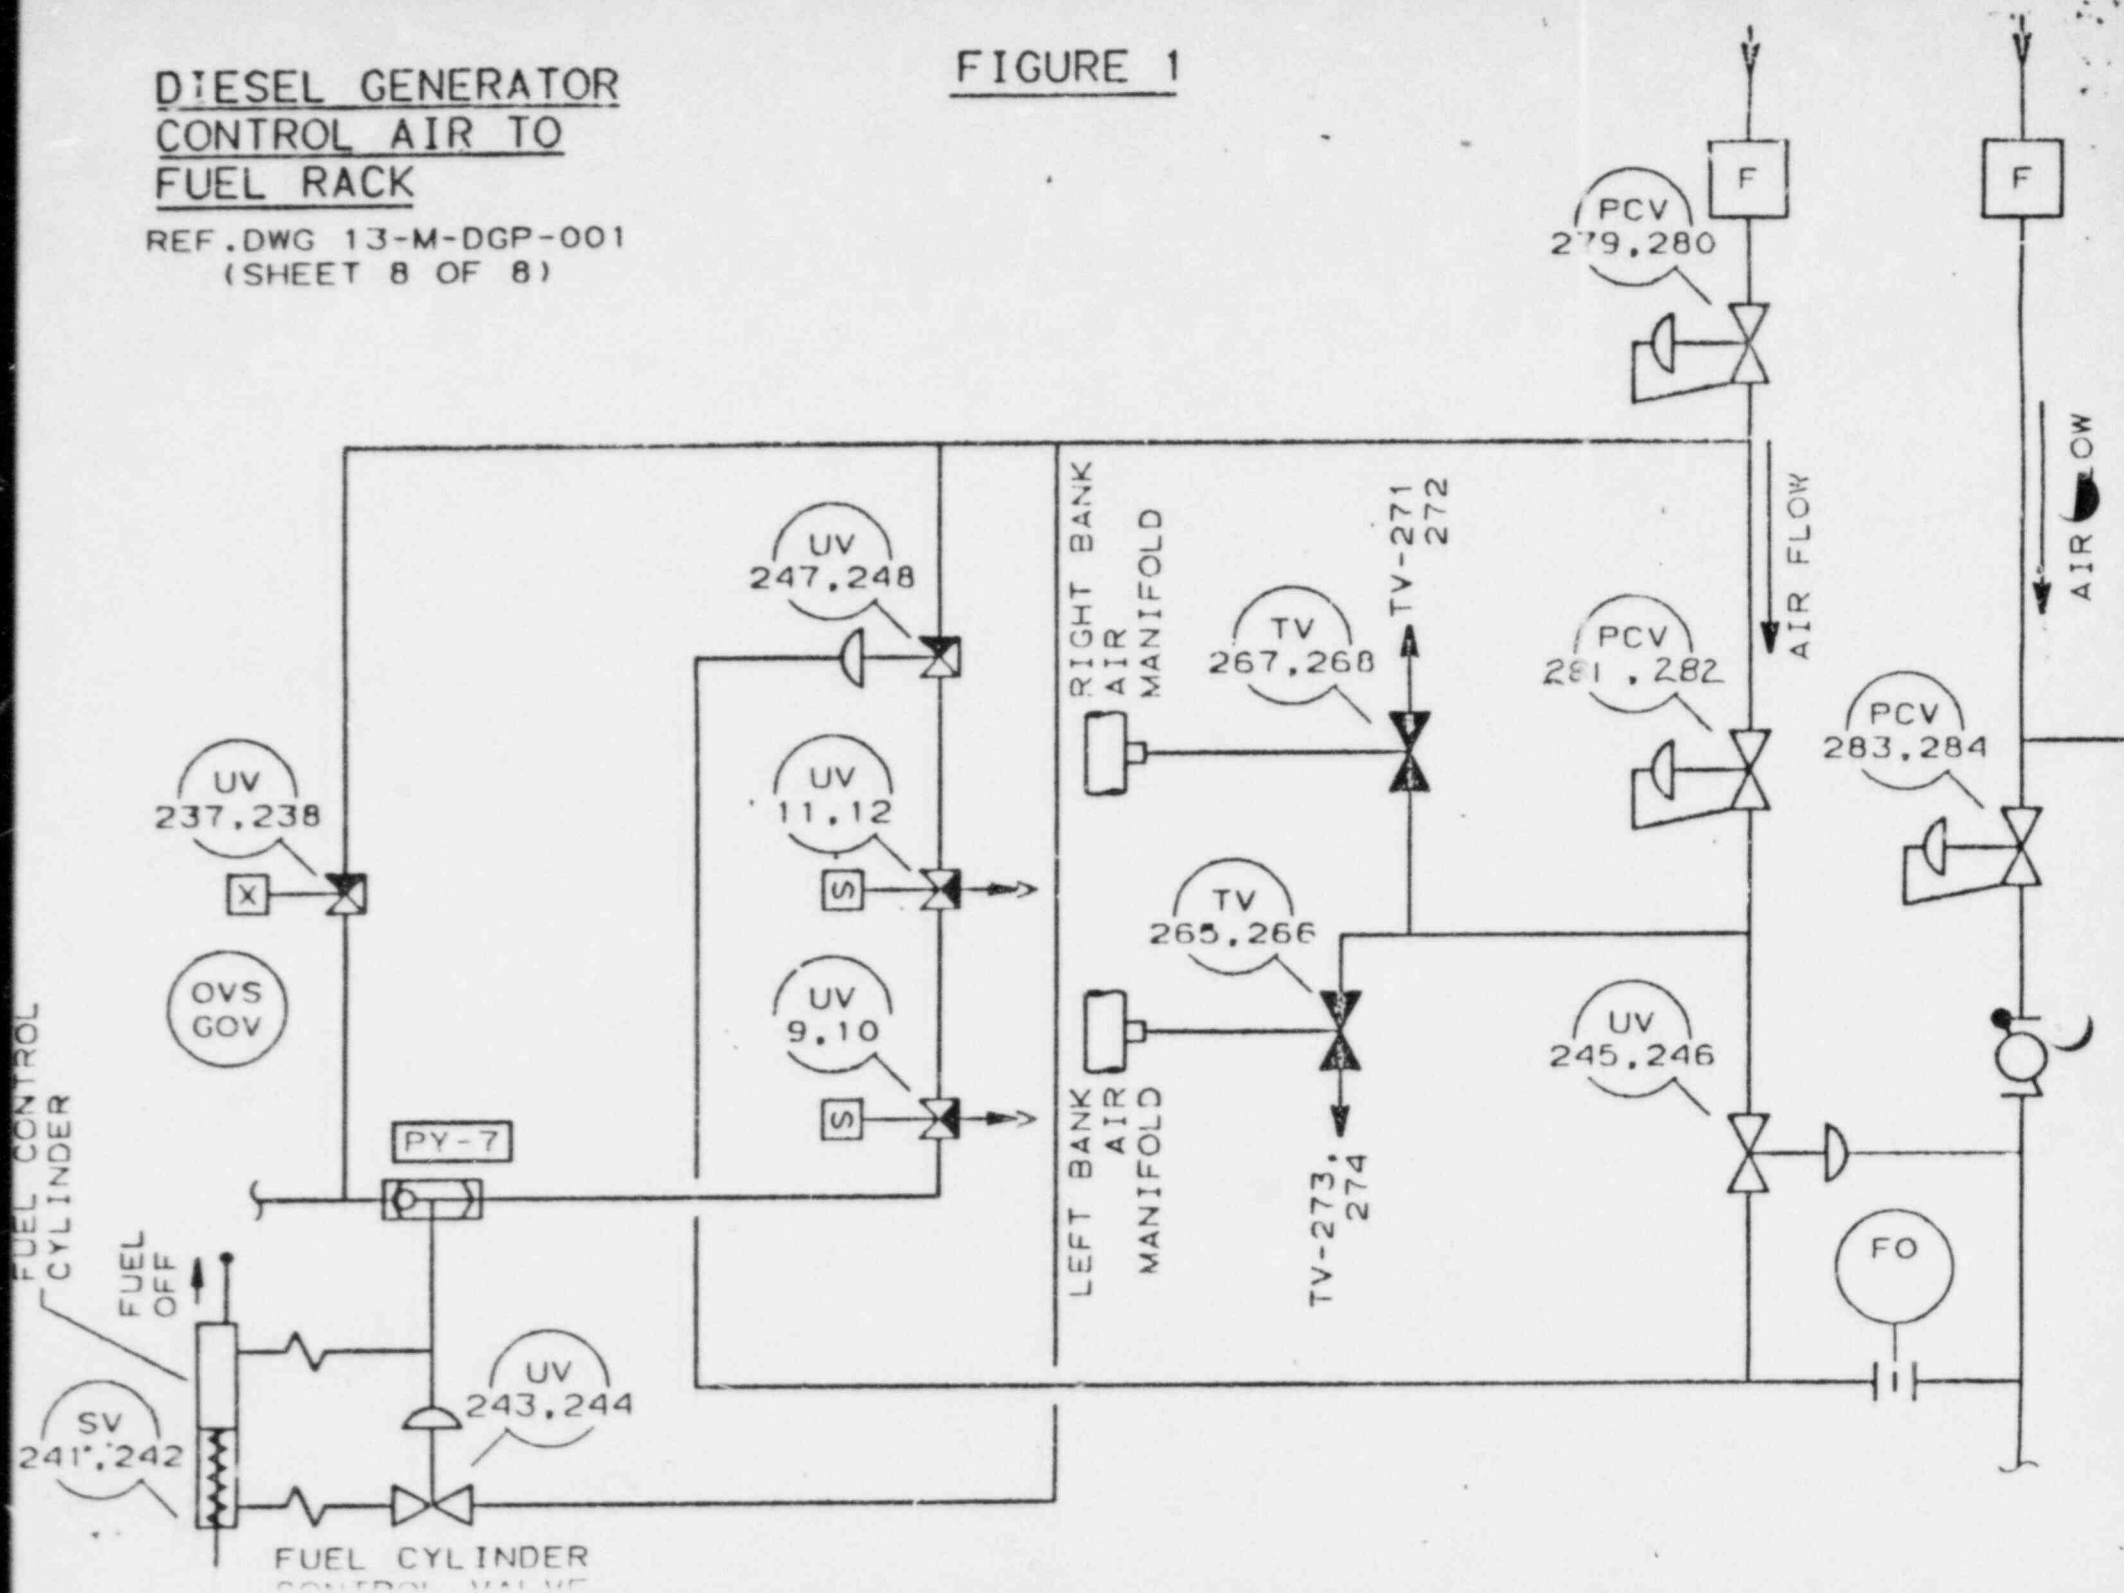
FIGURE 1

Air to the temperature control valves is taken off the control air system header. (See attached sketch, Figure 1.) The valves bleed air, thus reducing air pressure in the control air header. When a diesel start signal (test mode) is initiated, reduced air pressure in the air header is not sufficient to fully actuate the pneumatic valve that vents air from the fuel cylinder control valve pneumatic actuator and the fuel control cylinder (UV-248 and SV-242, respectively, Figure 1). Air is not vented from the "OFF" side and admitted to the "ON" side of the fuel control cylinder fast enough to enable the diesel generator to start in 10 seconds.

The installed valves are the valve port overlap type which bleed continuously. This was determined by dismantling and inspecting the valve internals. Valve port overlap valves have two grooves in the spool as did the PVNGS valves (Reference 1). The root cause of the failure of the temperature control valves to operate properly is that the valves now installed do not have the correct internals. Per Cooper Energy Services letter, Reference 2, the proper valves for the system are center dead spot valves which do not bleed air during actuation. These valves perform a non-safety-related function and are designated, and were procured, as a non-"Q" component.

Replace the existing valves TV-265, TV-266, TV-267, and TV-268 with center dead spot valves Amot Corporation model number 4021C11C7. The work will be performed under Work Request number 108529 for Unit 1, Work Request number 108530 for Unit 2, and a subsequently issued DCP for Unit 3. Work is expected to be completed prior to fuel load for Units 2 and 3 and during the first outage for Unit 1.
