RADIOLOGIC AND ENGINEERING ASSESSMENT

DOE ID NO.: GJ-12294-RM
ADDRESS: 2848-1/2 ORCHARD AVENUE

JULY 1985

BENDIX FIELD ENGINEERING CORPORATION
P.O. Box 1569
Grand Junction, Colorado 81502

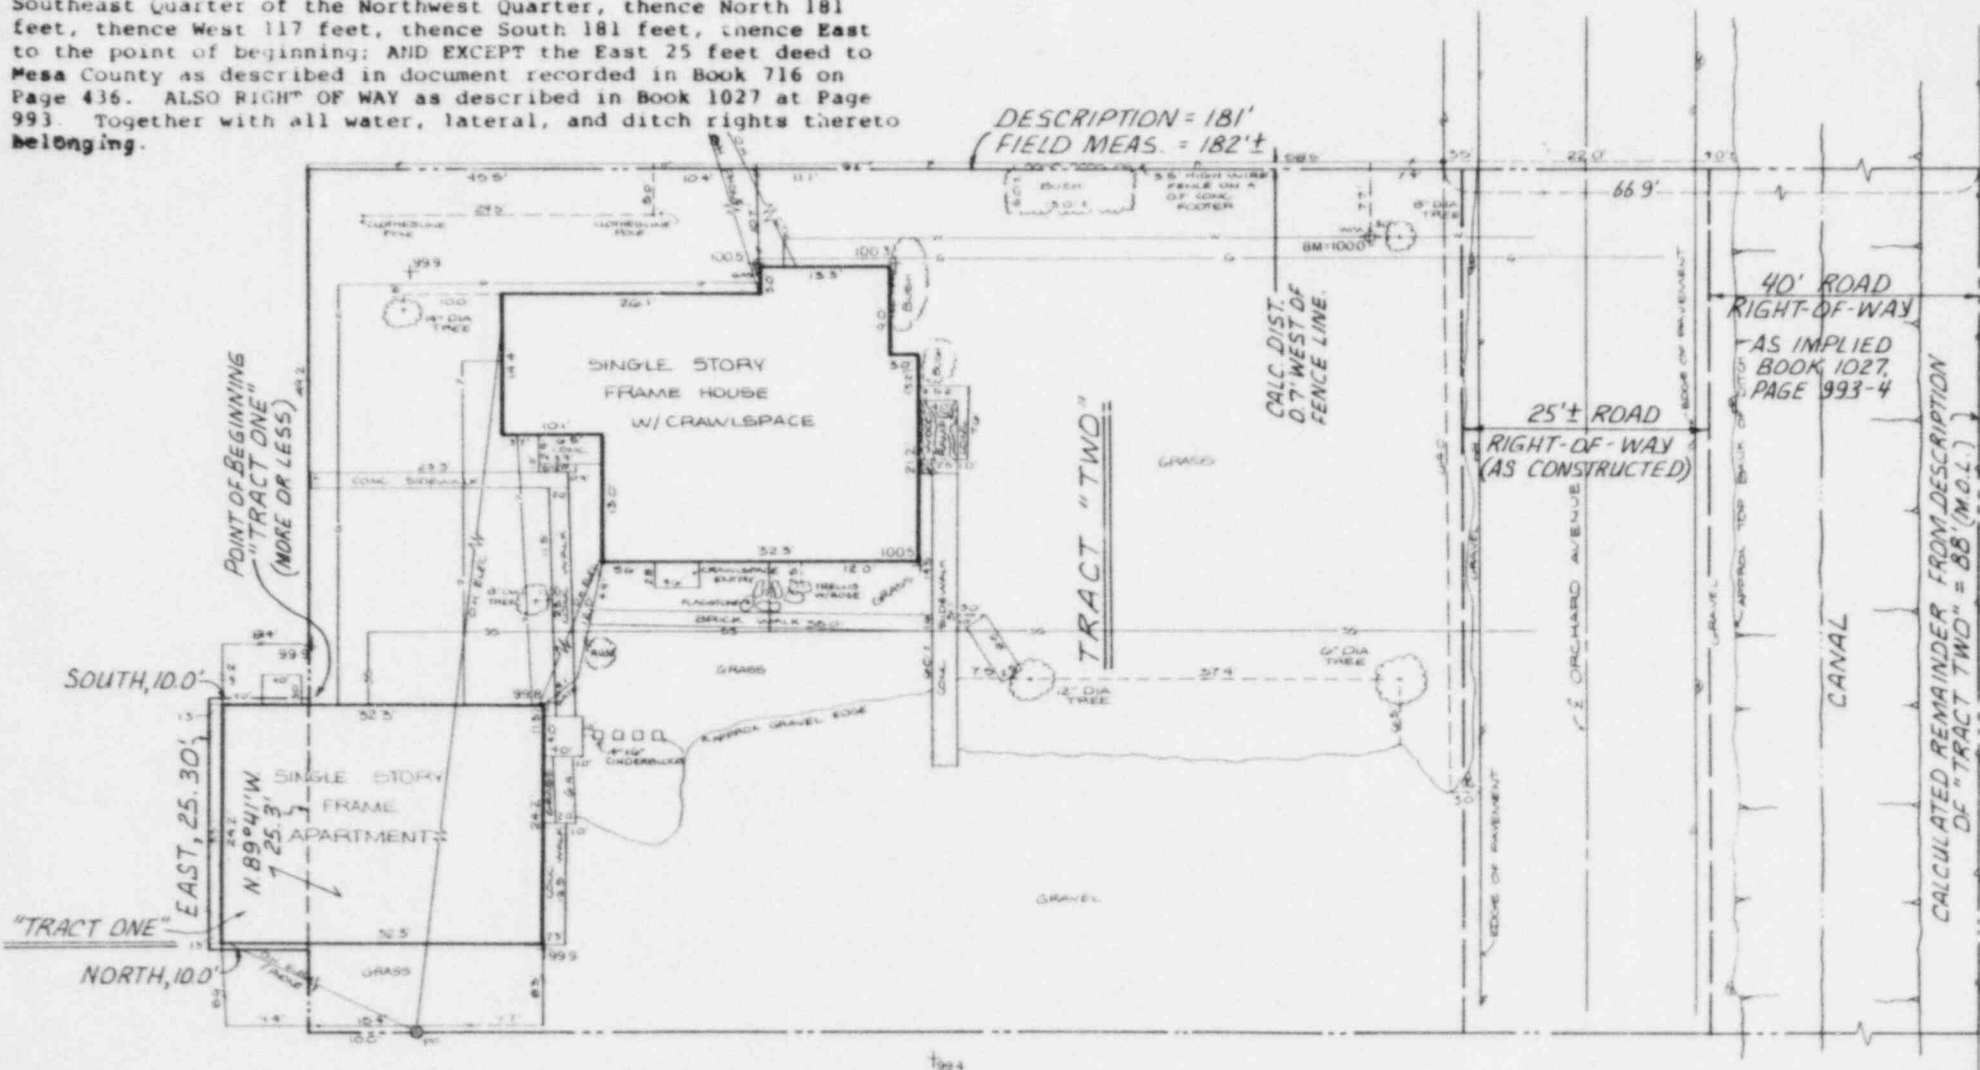
FIGURE 2.2 SITE PLAN

Structures, utilities, landscaping, and other special features of this property are included in Appendix Figure 2.2.

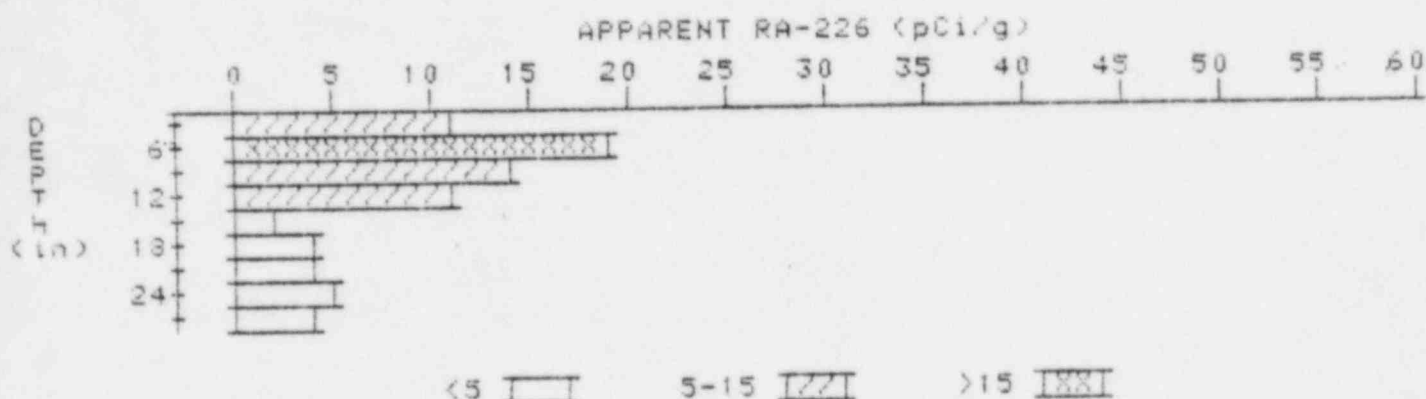
HOLE NUMBER: 3

Depth (in)	Apparent Radium-226 (pCi/g) Undeconvolved	Apparent Radium-226 (pCi/g) Deconvolved
3	11.4	11.4
6	13.4	19.3
9	12.1	14.1
12	9.7	11.3
15	6.4	2.5
18	5.3	4.4
21	4.7	4.0
24	4.5	4.5
27	4.3	4.3

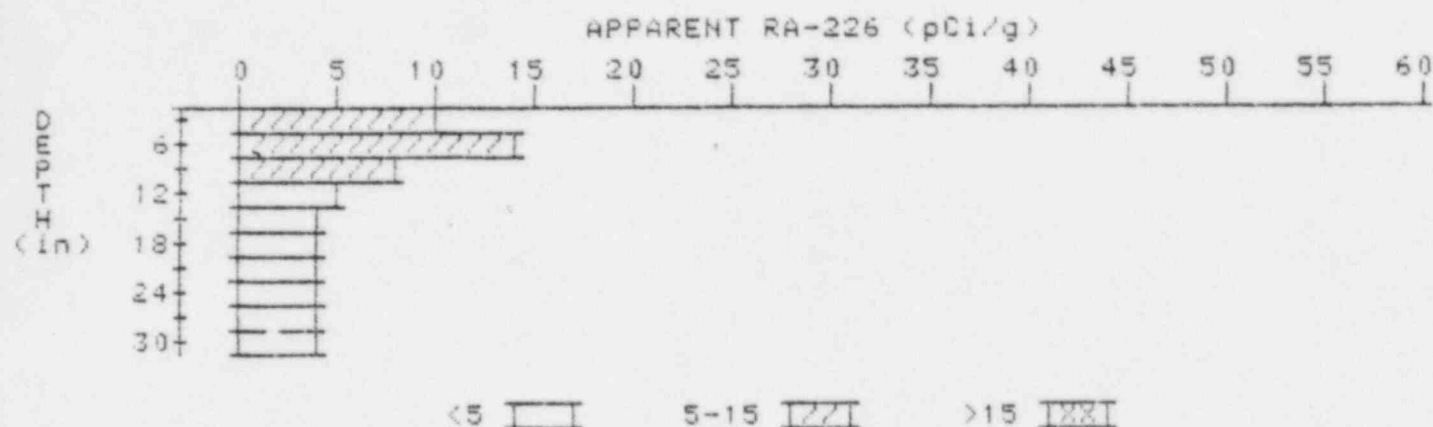
HOLE NUMBER: 4

Depth (in)	Apparent Radium-226 (pCi/g) Undeconvolved	Apparent Radium-226 (pCi/g) Deconvolved
3	10.3	10.3
6	10.3	14.2
9	8.1	7.6
12	6.2	5.0
15	5.0	3.8
18	4.5	3.8
21	4.4	4.2
24	4.4	4.4
27	4.4	4.4
30	4.4	4.4

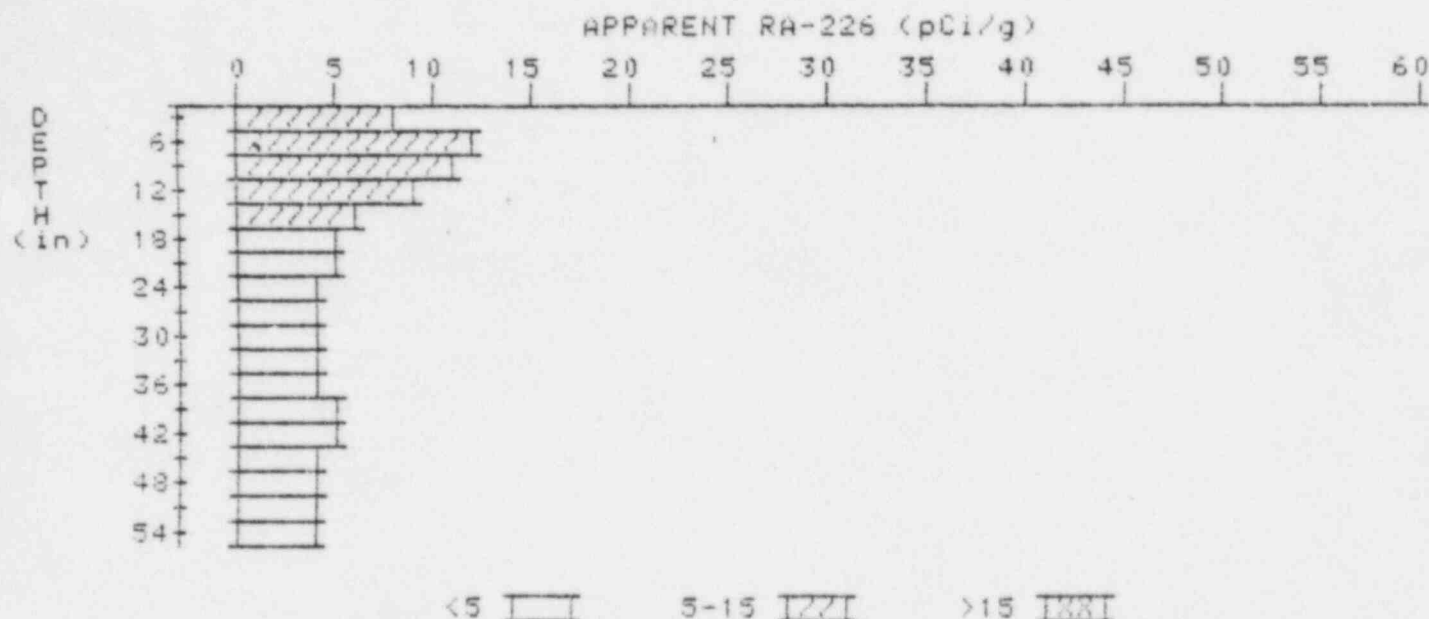
HOLE NUMBER: 5

Depth (in)	Apparent Radium-226 (pCi/g) Undeconvolved	Apparent Radium-226 (pCi/g) Deconvolved
3	8.3	8.3
6	9.6	12.4
9	9.3	10.7
12	8.2	8.7
15	6.8	6.4
18	5.6	4.5
21	5.0	4.8
24	4.5	4.0
27	4.3	3.9
30	4.3	4.1
36	4.3	4.1
39	4.4	4.6
42	4.4	4.8
45	4.2	3.8
48	4.2	4.4
51	4.1	3.7
54	4.2	4.2

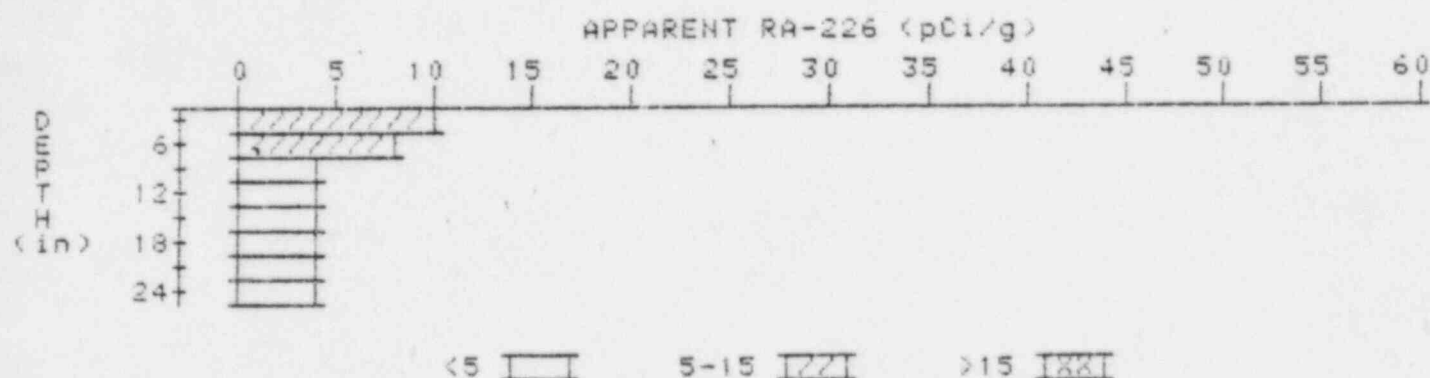
PROPERTY NUMBER: GJ-12294-RM
HOLE NUMBER: 7
LOCATION: 145235

Depth (in)	Apparent Radium-226 (pCi/g) Undeconvolved	Apparent Radium-226 (pCi/g) Deconvolved
3	9.5	9.5
6	7.6	7.6
9	5.7	3.7
12	4.9	4.4
15	4.4	3.9
18	4.2	3.3
21	4.2	4.0
24	4.3	4.3

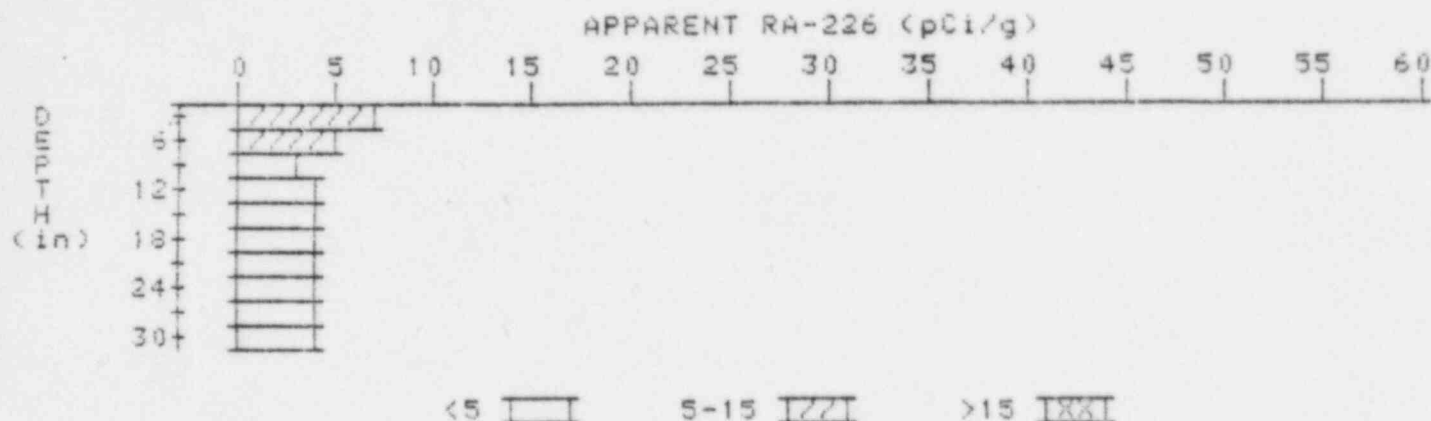
HOLE NUMBER: 16

Depth (in)	Apparent Radium-226 (pCi/g) Undeconvolved	Apparent Radium-226 (pCi/g) Deconvolved
3	7.2	7.2
6	5.3	5.3
9	4.7	3.5
12	4.3	3.9
15	4.1	3.9
18	4.0	3.3
21	4.0	4.0
24	4.0	4.0
27	4.0	3.3
30	4.1	4.1

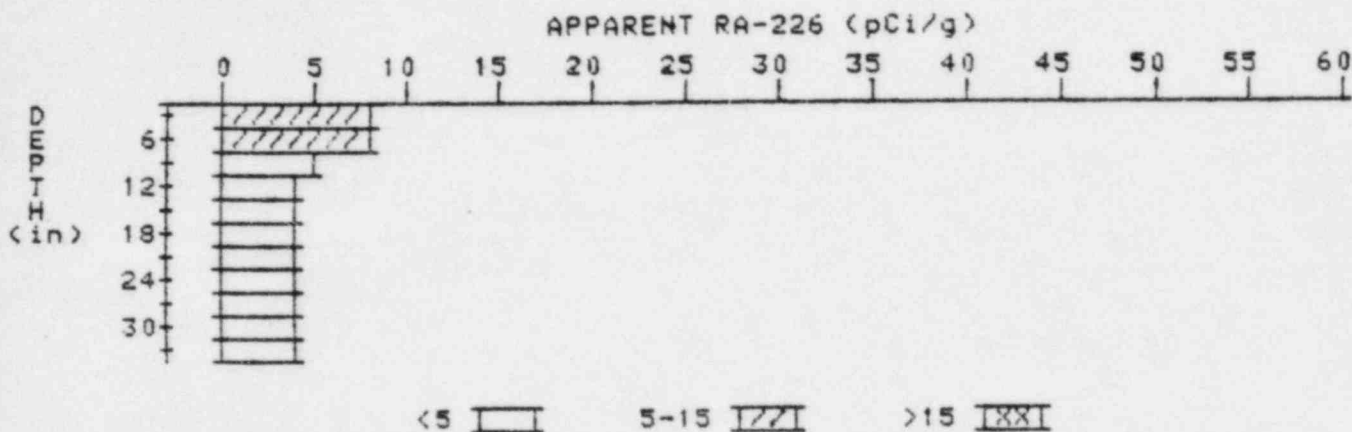
PROPERTY NUMBER: GJ-01133-RS
HOLE NUMBER: 10
LOCATION: 238278

Depth (in)	Apparent Radium-226 (pCi/g) Undeconvolved	Apparent Radium-226 (pCi/g) Deconvolved
3	8.1	8.1
6	7.1	7.8
9	5.7	4.8
12	4.8	3.9
15	4.4	4.0
18	4.2	3.7
21	4.3	4.5
24	4.3	4.5
27	4.2	4.0
30	4.2	4.2
33	4.2	4.2

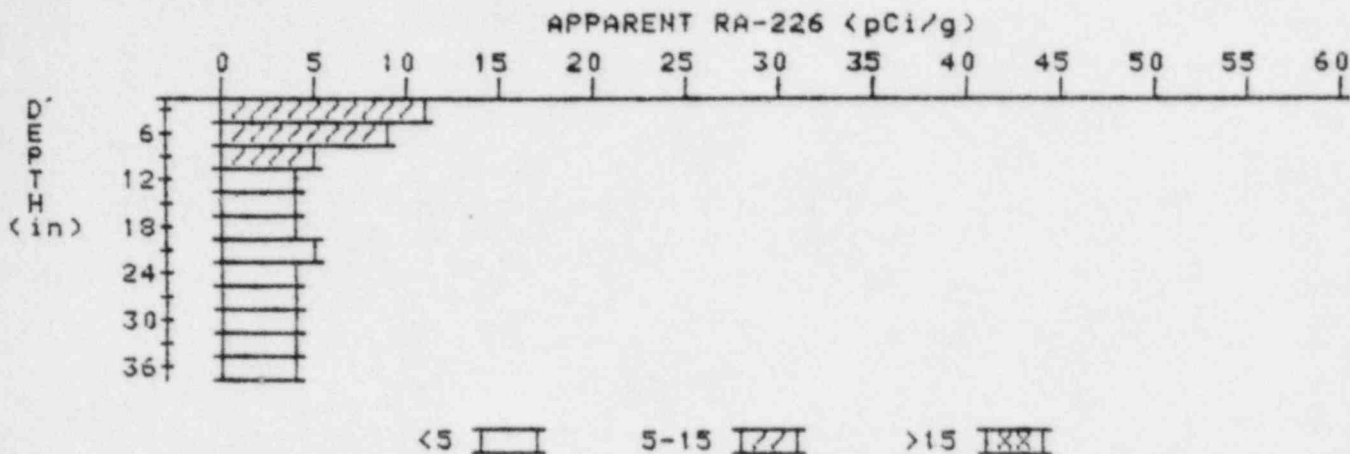
PROPERTY NUMBER: GJ-01133-RS
HOLE NUMBER: 13
LOCATION: 246276

Depth (in)	Apparent Radium-226 (pCi/g) Undeconvolved	Apparent Radium-226 (pCi/g) Deconvolved
3	11.3	11.3
6	9.0	8.8
9	6.8	5.2
12	5.5	4.3
15	4.9	4.4
18	4.6	4.2
21	4.5	4.5
24	4.4	4.4
27	4.3	4.3
30	4.2	4.4
33	4.0	4.0
36	3.8	3.8

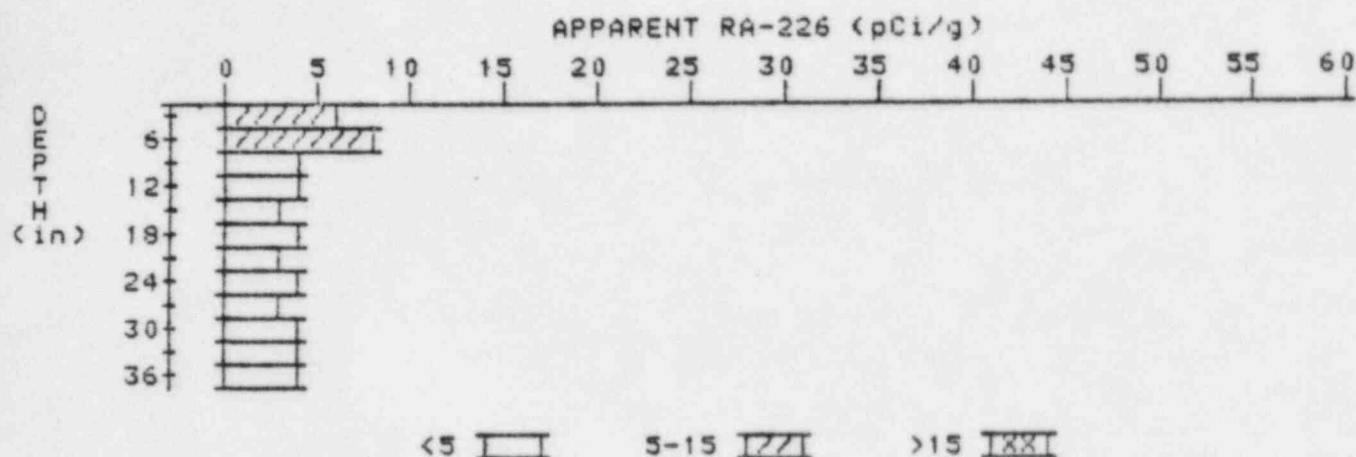
HOLE NUMBER: 16

Depth (in)	Apparent Radium-226 (pCi/g) Undeconvolved	Apparent Radium-226 (pCi/g) Deconvolved
3	6.2	6.2
6	6.1	7.9
9	5.0	4.5
12	4.2	3.7
15	3.7	3.0
18	3.6	3.6
21	3.5	3.1
24	3.6	4.0
27	3.5	3.1
30	3.6	3.8
33	3.6	3.8
36	3.5	3.5

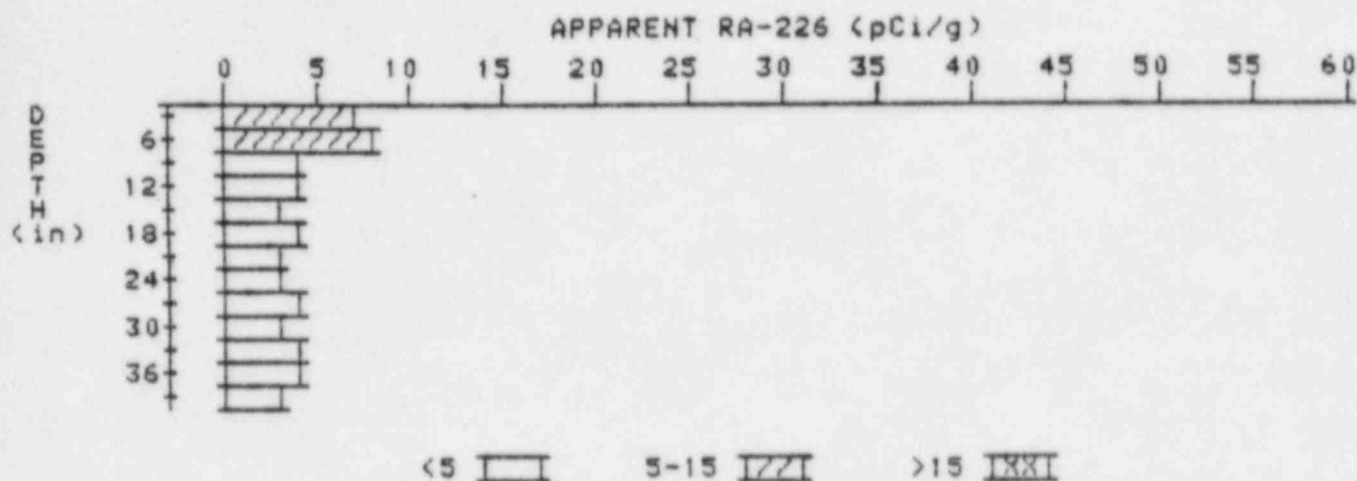
HOLE NUMBER: 17

Depth (in)	Apparent Radium-226 (pCi/g) Undeconvolved	Apparent Radium-226 (pCi/g) Deconvolved
3	6.5	6.5
6	6.1	7.7
9	4.8	3.7
12	4.1	3.6
15	3.7	3.2
18	3.6	3.6
21	3.5	3.3
24	3.5	3.3
27	3.6	4.0
30	3.5	3.3
33	3.5	3.5
36	3.5	3.9
39	3.3	3.3

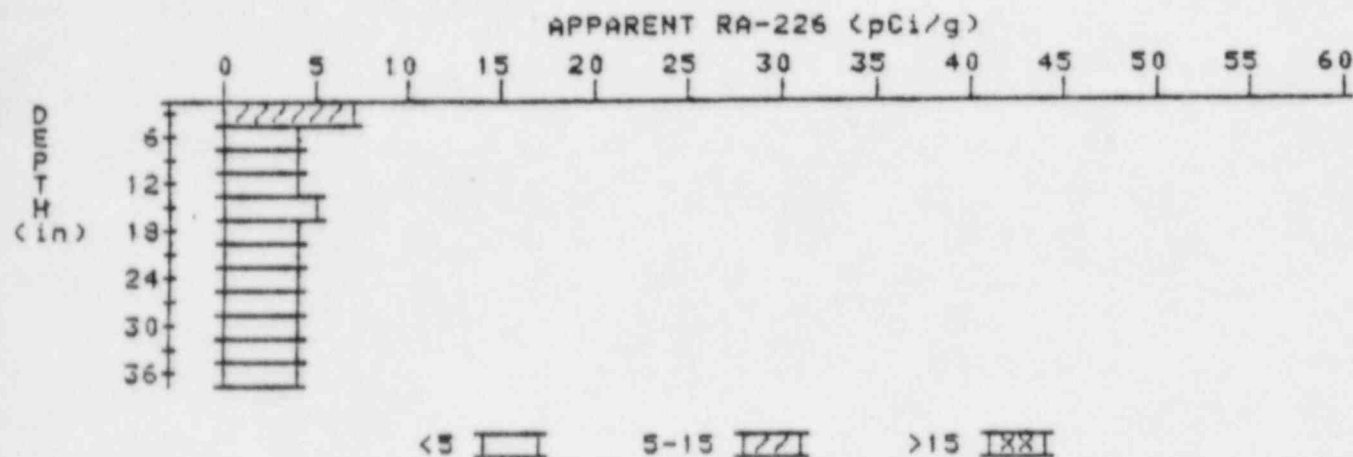
PROPERTY NUMBER: GJ-01133-R3
HOLE NUMBER: 19
LOCATION: 249261

Depth (in)	Apparent Radium-226 (pCi/g) Undeconvolved	Apparent Radium-226 (pCi/g) Deconvolved
3	7.0	7.0
6	5.4	3.6
9	4.8	4.4
12	4.4	3.7
15	4.4	4.6
18	4.3	4.1
21	4.3	4.3
24	4.3	4.5
27	4.2	4.2
30	4.1	4.1
33	4.0	4.4
36	3.7	3.7
