LICENSEE EVENT REPORT (LER)

FACILITY NAME (1)
RANCHO SECO NUCLEAR GENERATING STATION UNIT NO. 1DOCKET NUMBER (2)
0 5 0 0 0 3 1 2 1 OF 0 2TITLE (4)
CRD BREAKER FAILURE

QUALITY ASSURANCE SURVEILLANCE ACTIVITIES REPORT

I. Location: Rancho Seco I&C Shop/GE-Atlanta
B&W-Lynchburg QA Surveillance No. 342A
Activity Dates: June 7-12, 1985 Report Date: June 24, 1985
MOD No. _____ ECN No. _____ WR No. _____ NCR No. _____ CRITERIA No. IV, V, VIII, X
XIII, XV
MSRC No. _____ Tech Spec _____ SOQAP _____ QA Hours _____
Prepared By Harvey L. Canter *H. Canter* Date June 18, 1985

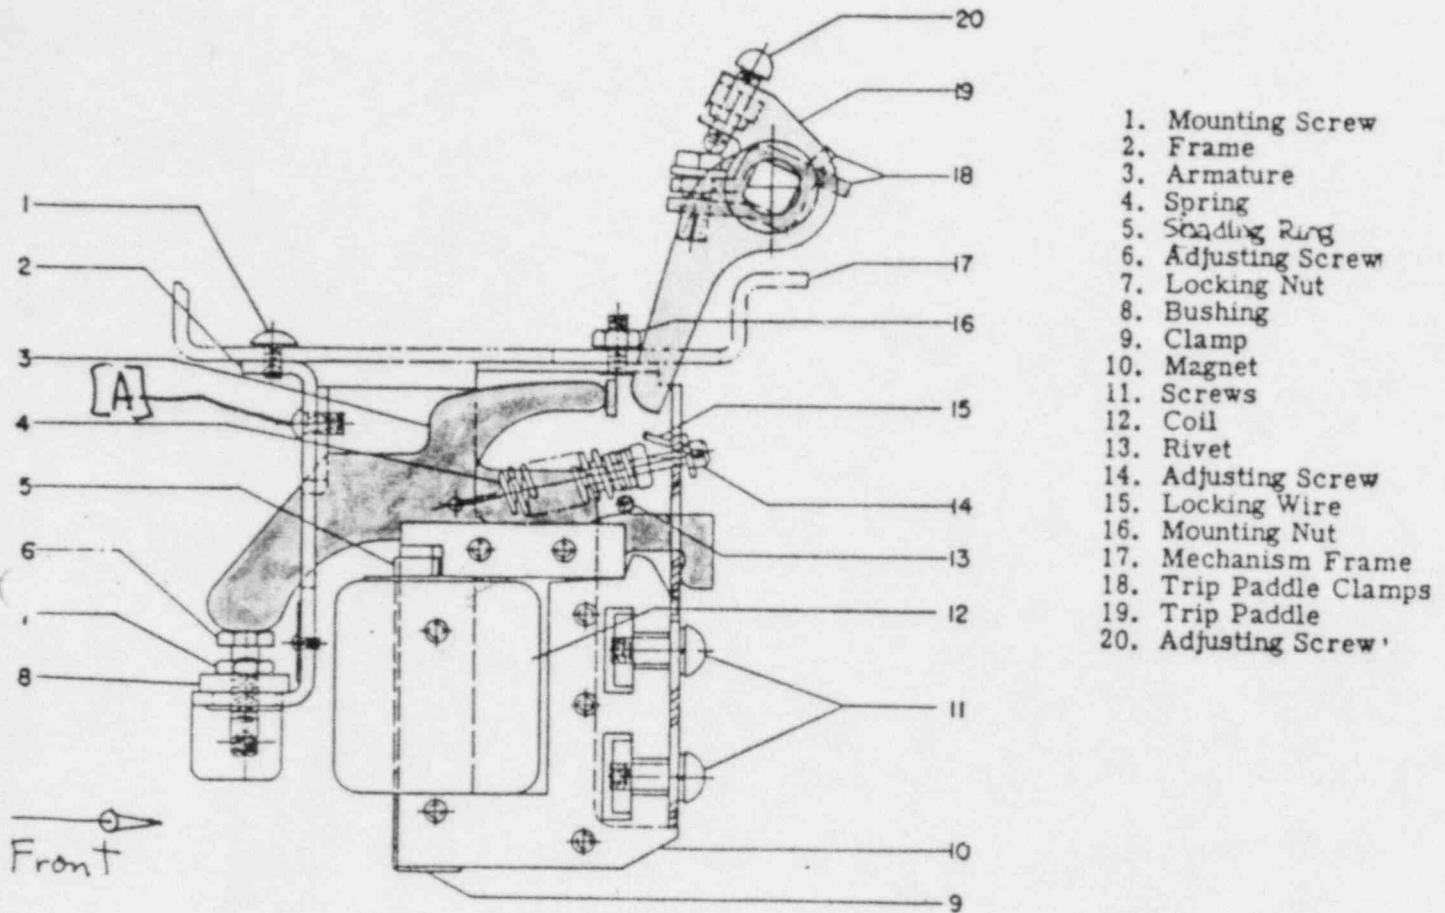
Figure 23. (0152C9206) Undervoltage Tripping Device

- 4) The monitor saw a trip paddle on a spare GE-AK-2 in the shop - It looked exactly the same as the failed breaker's paddle. Figure 28 which shows a side view of the paddle is not an accurate representation of the corner radii. The end of the paddle shows two relatively sharp radii rather than the gradual slope depicted in the drawing. (Figure 28 is attached.)

- a. Figure 28 (attached) in GEI-50299E was referred to extensively.
- b. Procedure calls for a 1-5 mil play at the armature-to-rivet clearance. It says that the clearance should be done with uvd removed and with a feeler gage inserted through the side of the frame and armature manually closed. The measurement should be taken at the outer edges of the armature where a constant radius is in close proximity to the rivet. The gap should be relatively constant for all armature positions.

- c. If play is too much, loosen 2 screws (Item 11 in Figure 28, attached) holding coil assembly to frame and move frame as required.
- d. The procedure talks about adjustment of the armature stop bracket. Adjust the armature stop bracket to allow a 1/4 inch clearance between armature (Item 3) and magnet (Item 10) when the armature is OPEN. Screw [A] is used for this adjustment. The armature air gap is set by; loosening [A], placing a .201 inch rod in the "step" on the magnet, lowering armature to stop on the .201 diameter pin, sliding the air gap step plate against arm and tightening the screw. If adjustment is correct, a .2055 inch pin won't go through the gap. If .201" goes but a .209" doesn't, then the air gap is ok. Perform this adjustment after the armature-to-rivet adjustment is made only, and before pick-up is checked. Reseal screw with RTV108.
