U.S. NUCLEAR REGULATORY COMMISSION
REGION I

INSPECTION REPORT

Report No. 040-08936/96-001 Program Code 11300
Docket No. 040-08936
License No. STB-1505 Priority 3 Category E
Licensee: B & B Tool Co.
83 Erna Avenue
Milford, CT 06460
Facility Name: B & B Tool Co.
Inspection At: 83 Erna Avenue
Milford, CT 06460
Inspection Conducted: November 7, 1996

Inspection Summary: Announced inspection conducted on November 7, 1996.

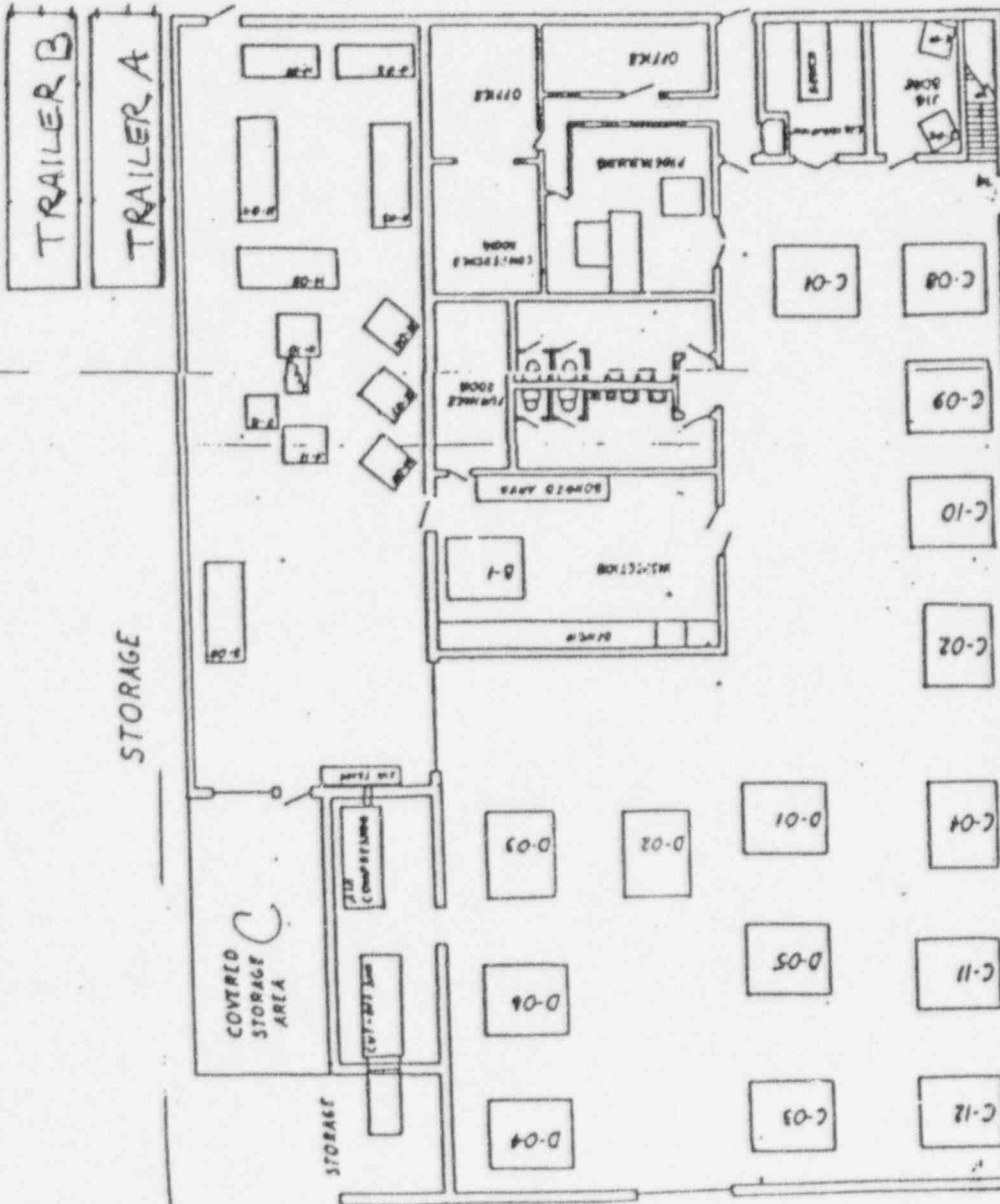
Attachment 1

A diagram of the first floor of the facility, at 83 Erna Avenue, is attached (Attachment 1). Licensed material is stored in two locations, a Trailer B outside the northeast end of the building and a covered storage area C, at the northwest end of the building. There were twenty 55-gallon drums (two rows of ten each) in Trailer B. There were twenty-four 55-gallon drums (two rows of six each piled two high) in the covered storage area C, which were covered with a blue plastic tarpaulin.

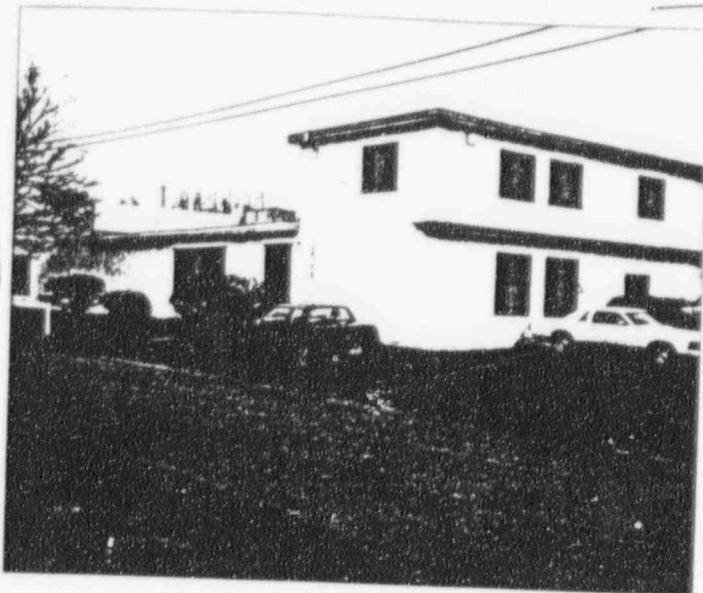
<u>No.</u>	<u>Location</u>
1	Toward southeast corner of building at a distance of 50 feet, front door visible at left of center
2	Toward southeast corner of building at a distance of 50 feet, trailers visible at extreme right of center
3	Toward northeast corner of building at a distance of 30 feet, back ends of two trailers visible
4	Toward northeast corner of building at a distance of 30 feet, back ends of two trailers visible and door into area occupied by B & B Tool Co. visible at left of center
5	Toward inside of Trailer B at roll-up door, drums visible in center
6	Toward inside of Trailer B at five feet inside roll-up door, drums visible in center
7	Toward northwest corner of building at a distance of 50 feet, Covered storage area C visible in center, drums stacked two high and covered with blue tarp visible left of center
8	Toward northwest corner of building at a distance of 25 feet, Covered storage area C visible in center, drums stacked two high and covered with blue tarp visible left of center

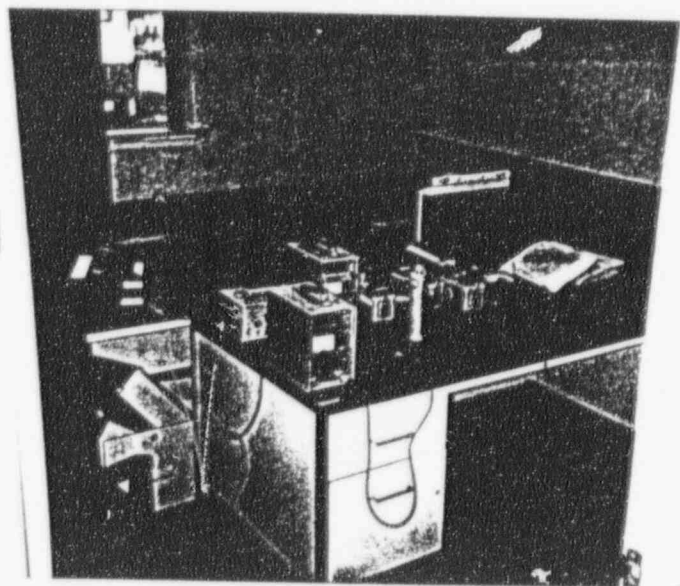
Survey instrument calibrations for 1995 and for 1996 apparently had not been performed. No calibration records were available to verify compliance with this requirement. Condition 18 of the current license dated July 12, 1995, requires that licensed material be possessed and used in accordance with the statements, representations, and procedures contained in an application dated November 26, 1986. Item 13, in the cover letter, for the application dated November 26, 1986, requires that survey instruments be calibrated at least annually.

Failure to calibrate survey instruments in 1995 and 1996 is an apparent violation of the above-cited requirement.

9	Toward northwest corner of building at a distance of 5 feet, drums stacked two high and covered with blue tarp visible in center
10	Toward northwest corner of covered storage area C, from entrance to inside of building, drums stacked two high and covered with blue tarp visible in center and concrete pad visible in foreground
11	Radiation survey and counting instruments displayed in office on second floor of building
