**RADIOLOGIC AND ENGINEERING ASSESSMENT**

DOE ID NO.: GJ-00110-RS  
ADDRESS: 2524 MESA AVENUE

JULY 1985

URANIUM MILL TAILINGS REMEDIAL ACTION PROJECT OFFICE

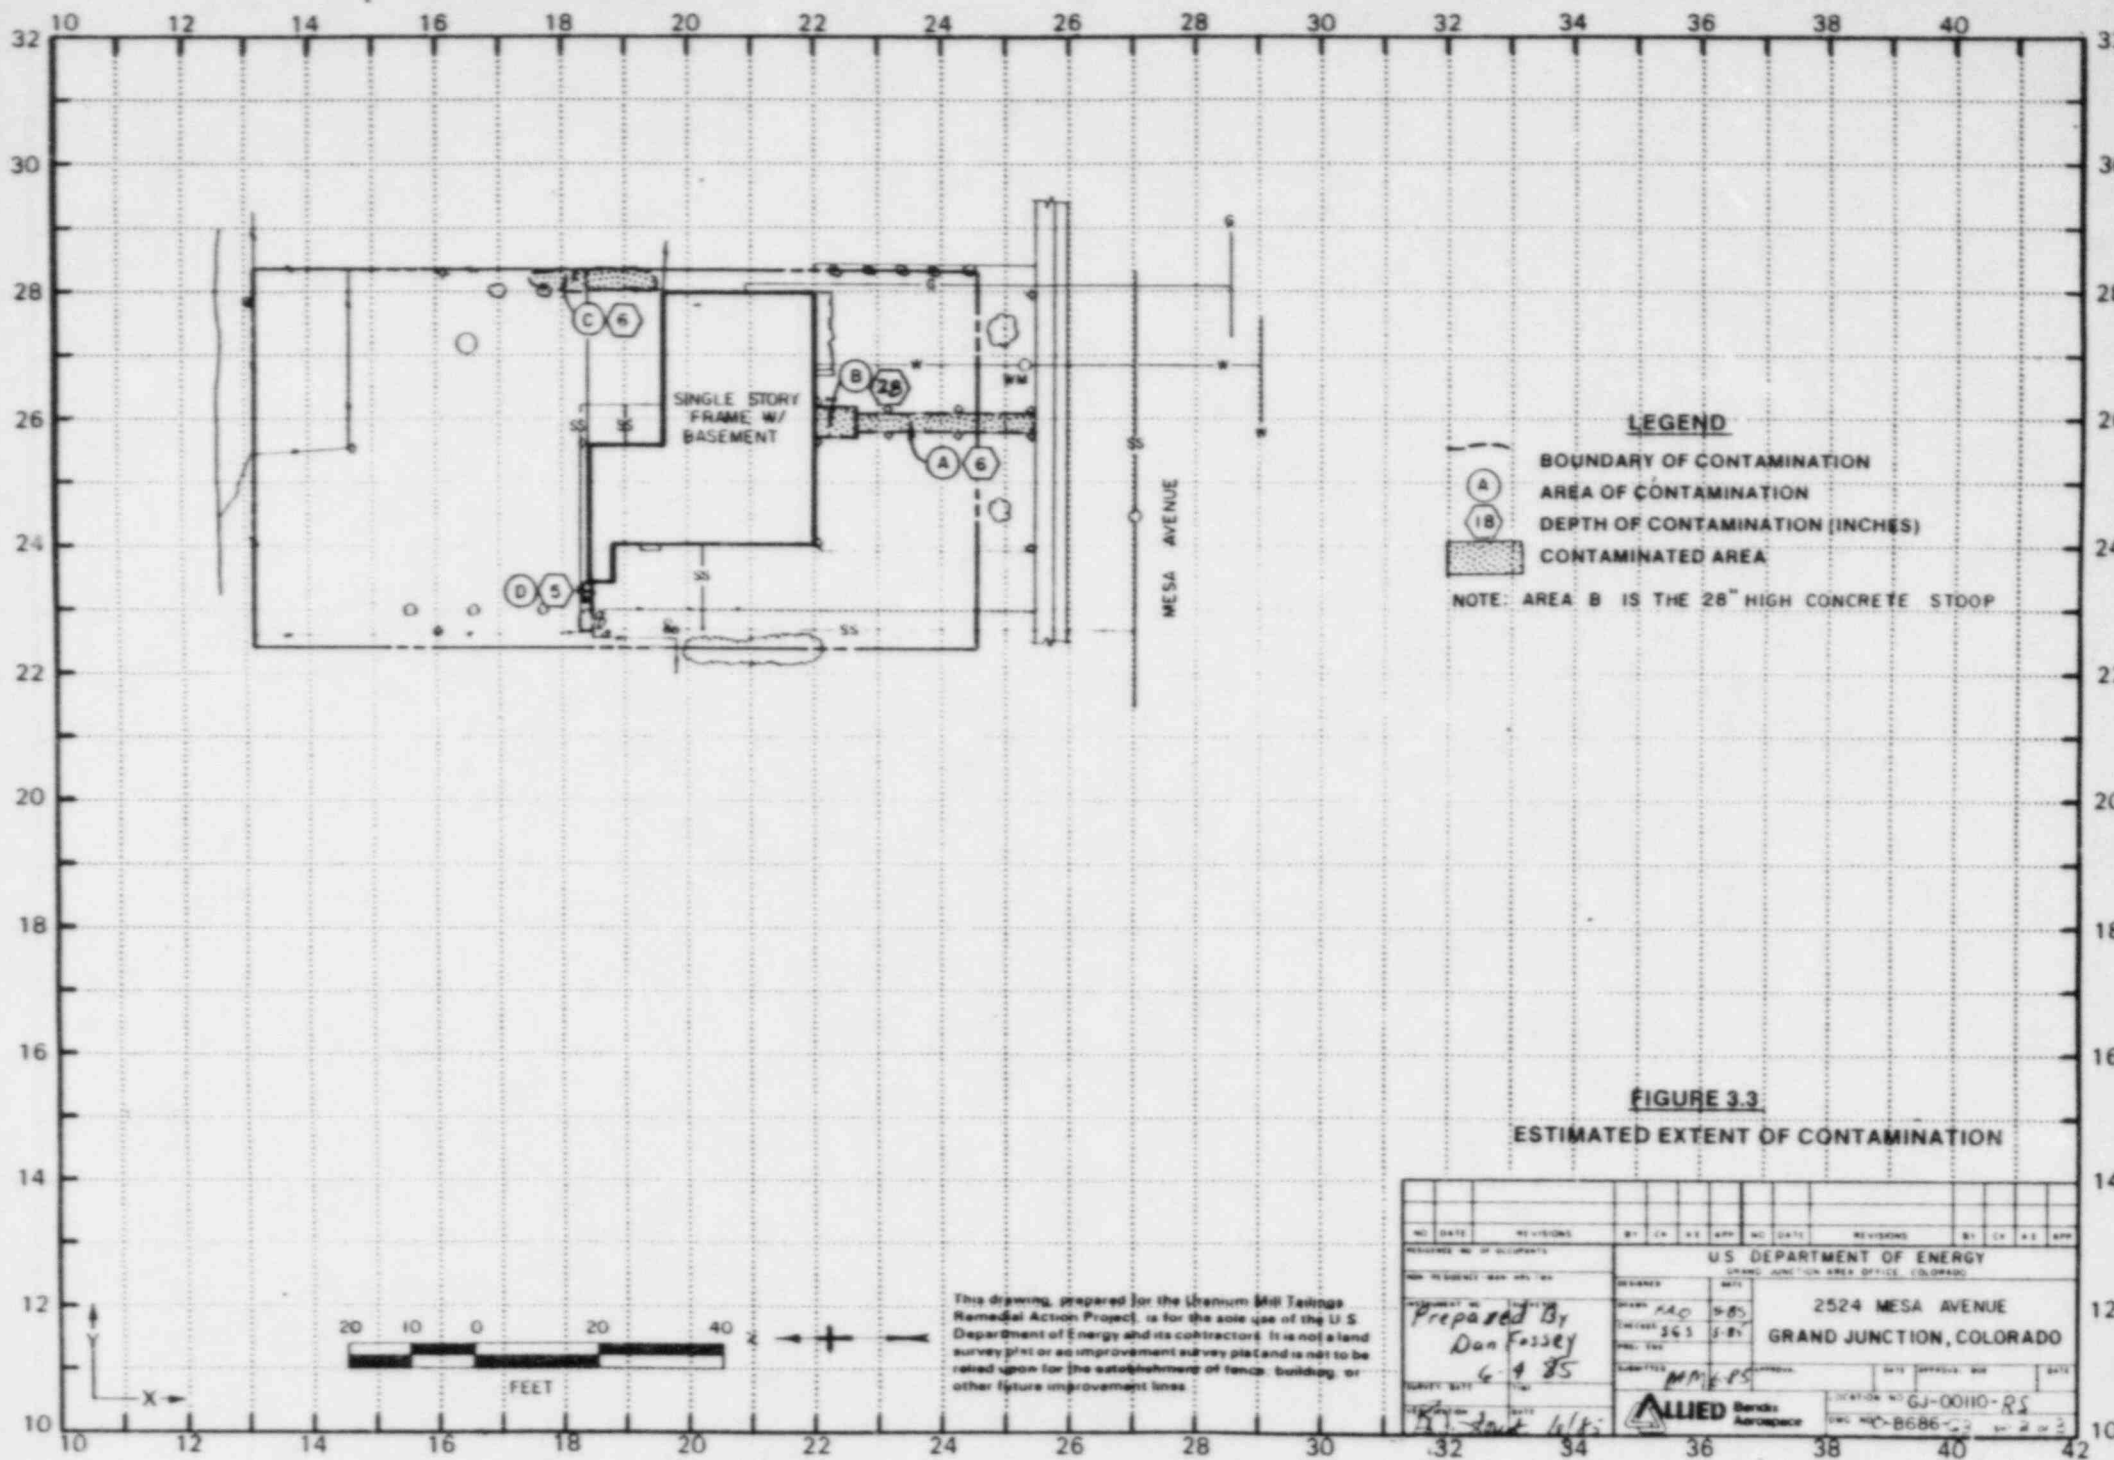
**FIGURE 3.3**  
**ESTIMATED EXTENT OF CONTAMINATION**

Appendix Figure 3.3 shows identified areas and estimated depths of contamination on this property, based on assessments of all measurements taken. As noted in this figure, areas recommended for remedial action that contain identified residual radioactive materials are:

- (AREA A) The 6-inch-thick concrete sidewalk that extends from the primary structure to the city sidewalk is contaminated (approximately 87 sf).
- (AREA B) The concrete stoop located at the south entrance of the primary structure is contaminated. The stoop is 28 inches in height (approximately 30 sf).
- (AREA C) A deposit of soil along the eastern property boundary is contaminated to a depth of 6 inches (approximately 84 sf).
- (AREA D) A small 5-inch-thick concrete pad at the north end of the carport is contaminated (approximately 3 sf).

We do not recommend decontamination and restoration of this property. It is recommended that no remedial action be performed and that a brief Property Completion Report be prepared for use in the DOE certification process.

The recommendation that no remedial action be performed on this property is made because the levels of radioactivity on this property fall below the EPA Standards (40 CFR 192):
