SUBJECT: MANAGEMENT MEETING TO DISCUSS SERVICE WATER SYSTEM
PERFORMANCE

Zebra Mussels

Condition Description and Corrective Actions

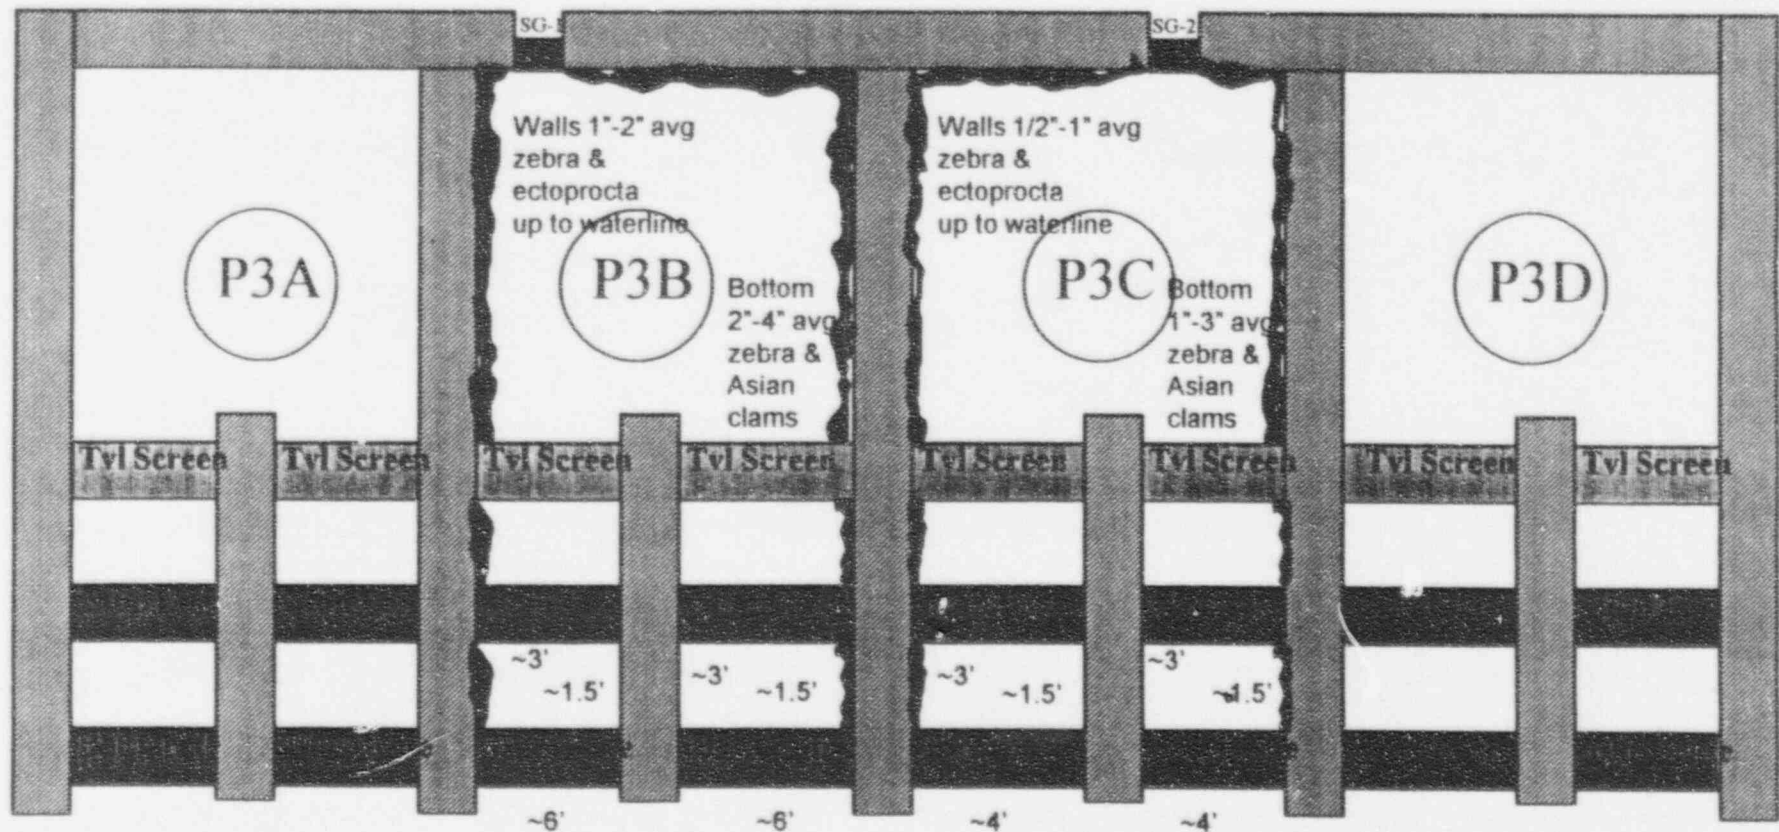
Initial Unit 1 Circulating Water Bay Mappings

- A zebra mussel infestation of the circulating water (CW) system bays on Unit 1 and of the intake structure forebays on Unit 2
 - » The degree of infestation was graduated from very heavy on Unit 1 "B" CW to light in front of Unit 2
 - » No live marine growth observed in the SW system or established live marine growth in structures downstream of the service water (SW) bay inlets
 - Verified by component inspections and Unit 1 emergency cooling pond (ECP) suction line video inspection
 - Routine monitoring and treatment for zebra mussels in the ECP
 - SW bay inspections
- Silt deposits in the intake canal settling basin area immediately in front of the intake structure and in SW bays

- Drained and cleaned all Unit 1 SW bays during 1R13
- Inspected and cleaned all Unit 2 SW bays with divers
- Drained and cleaned Unit 1 "B" and "C" CW bays during 1R13
- Cleaned loose material from Unit 2 forebays with divers
- Cleaned sediment basin twelve feet in front of Unit 1 intake structure with sloping transition to remaining sediment deposits
- Scheduled dredging of entire sediment basin in first quarter 1997

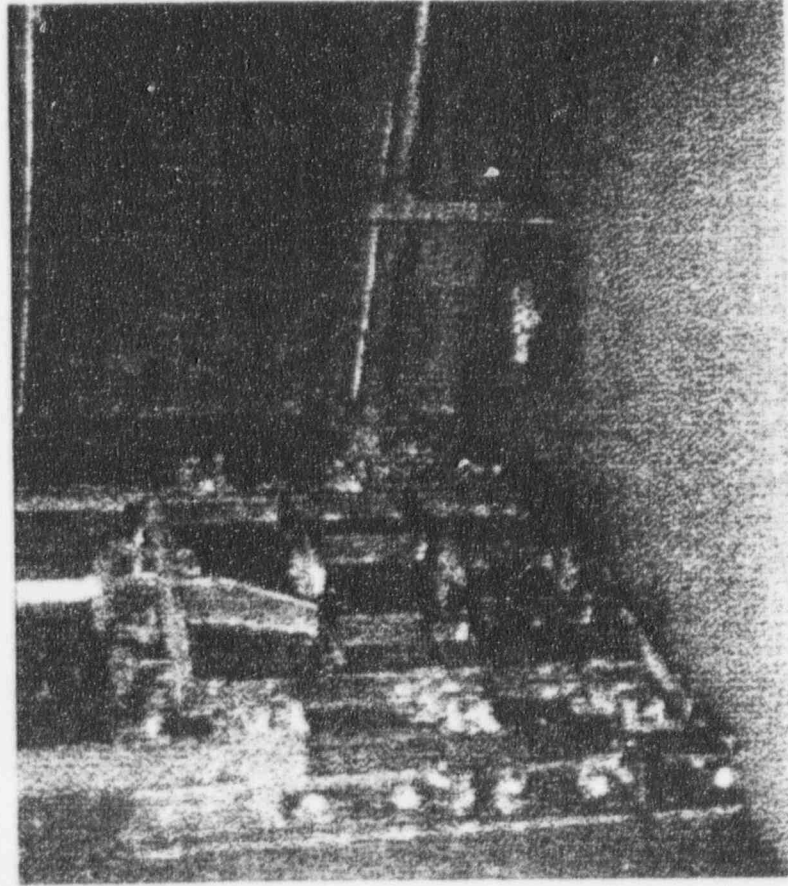
"B" Service Water Bay sluice gate
(Treated Area)

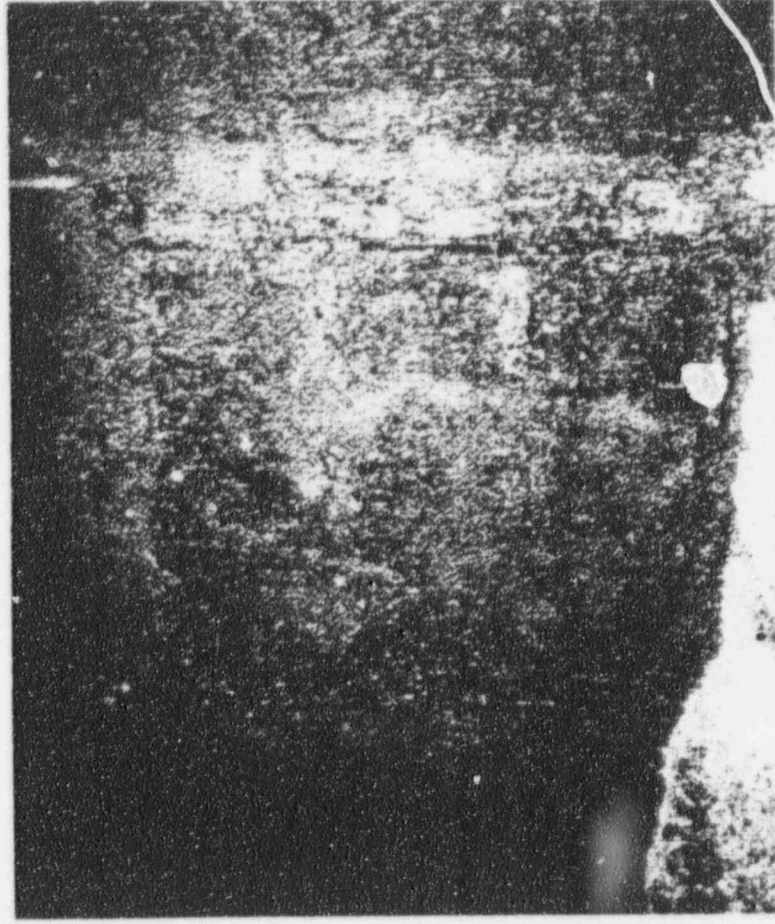
"B" Circulating Water Bay sluice gate
(Untreated Area)

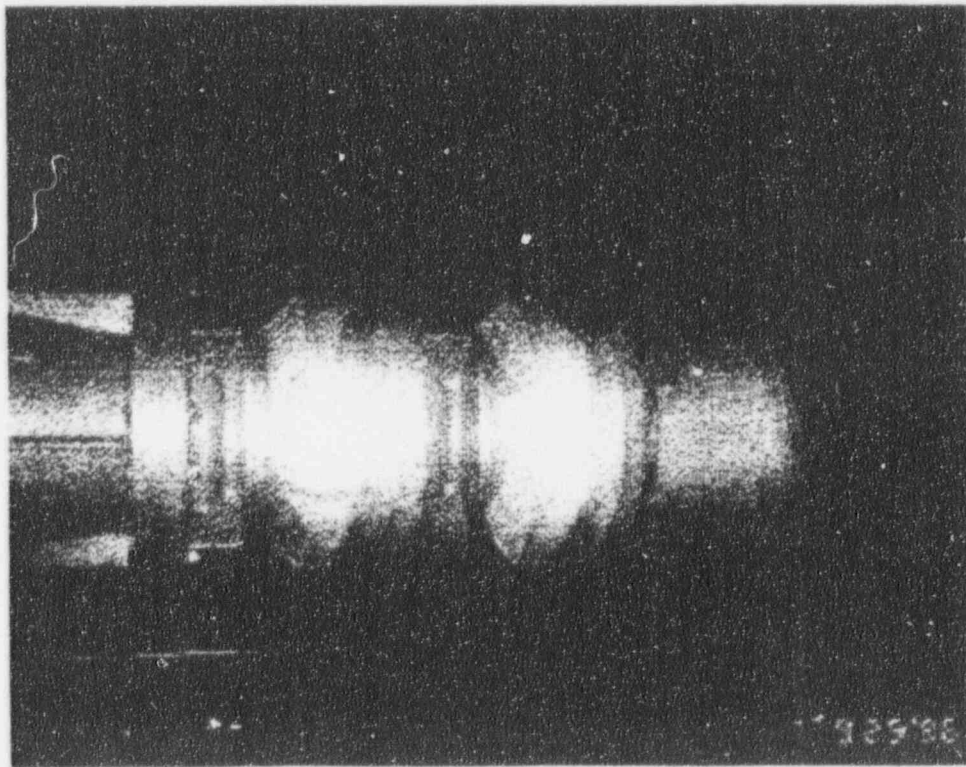
"B" Service Water Pump
(Treated Area)

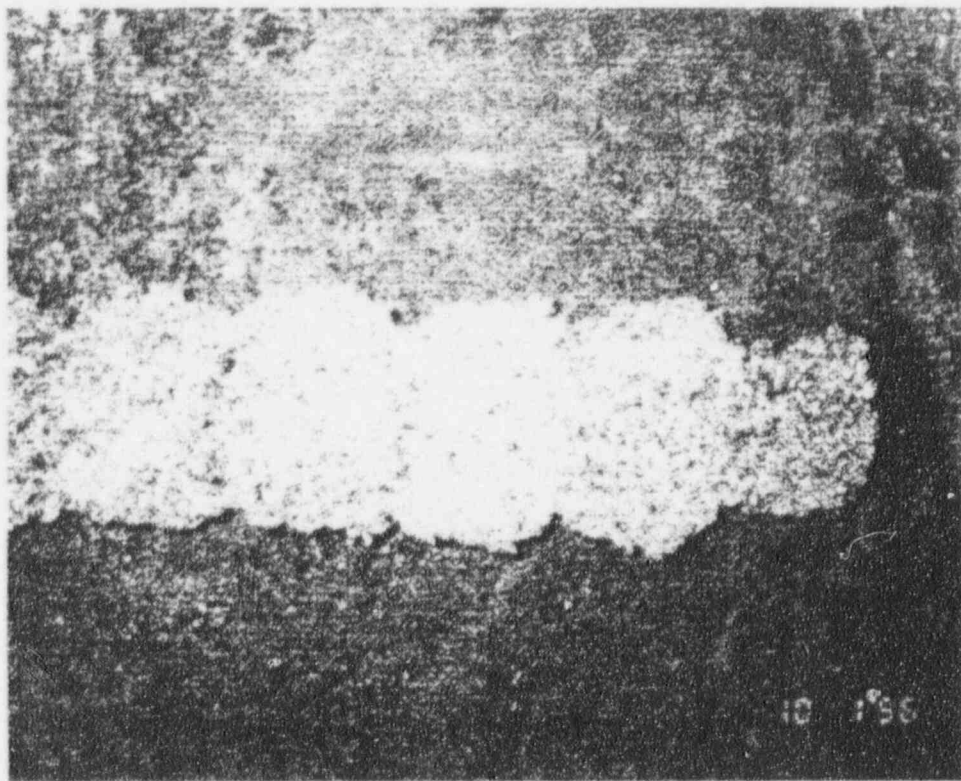
"C" Circulating Water Bay Screen Wash Pump
(Untreated Area)
