LER 96-008

Davis-Besse Nuclear Power Station, Unit No. 1

LICENSEE EVENT REPORT (LER)

Switchyard Circuit Inoperable Due To Switchyard Breaker Alignment

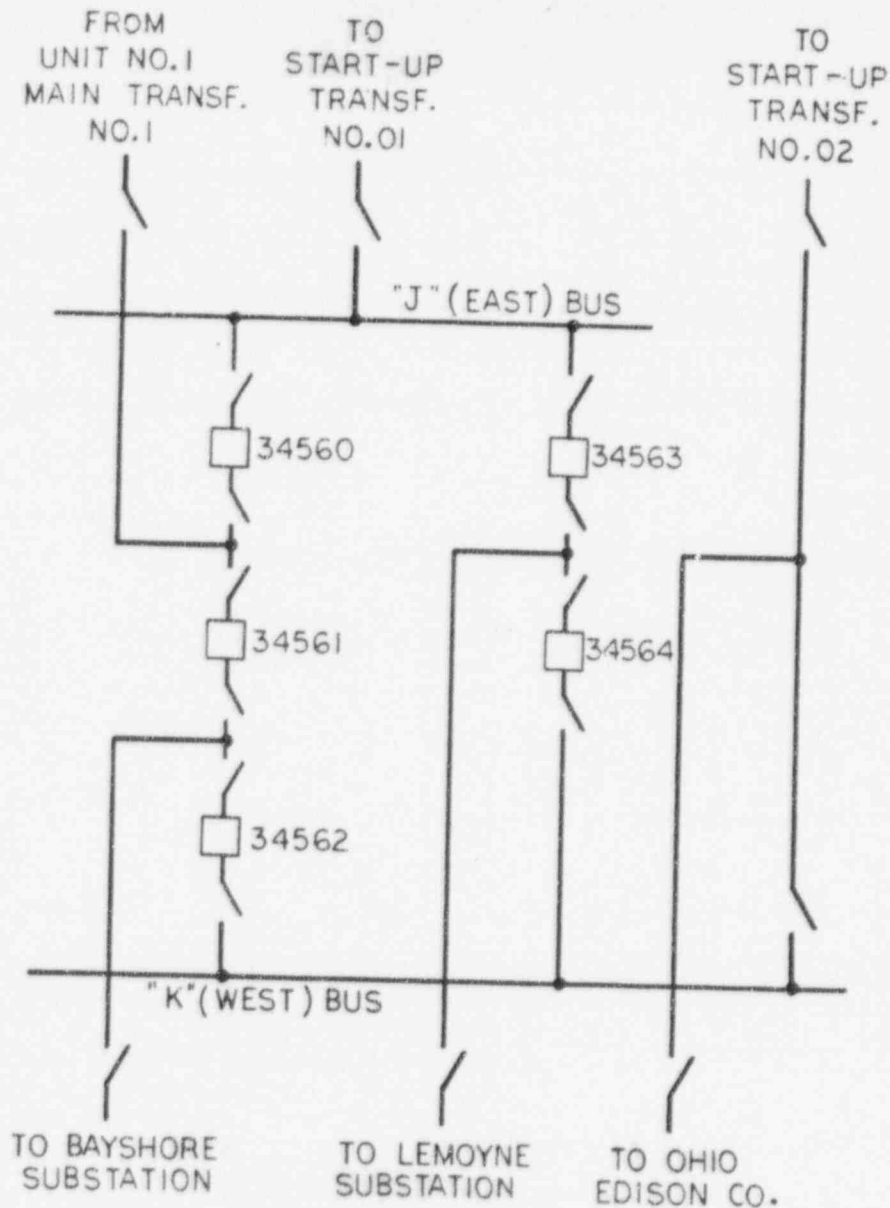
FIGURE 1

At 1410 on November 13, 1996, with the unit in Mode 1 at approximately 100 percent power, a condition was identified that could result in a complete loss of offsite power. When a fault is detected on a breaker, protective relays open the breaker to clear the fault. There is also protective relaying for detecting when a breaker has failed to properly isolate a circuit. This relaying initiates a lockout of the circuits adjacent to the failed breaker, which opens all breakers associated with those circuits. If this relaying fails and initiates a lockout of breaker 34562, breaker 34561 would open (34564 would also receive an open signal), as well as the breakers on the Bayshore and Ohio Edison lines (refer to Figure 1). With the Lemoyne line already out of service, this results in a loss of offsite power. A similar condition can occur if breaker 34561 is open and breaker 34564 experiences a lockout. The lockout of breakers 34562 and 34564 is discussed in Updated Safety Analysis Report (USAR) Section 8.2.1.1, Offsite Power System Reliability Considerations, but the configuration of the switchyard during maintenance is not discussed. At the time of discovery, the Lemoyne 345 kV transmission line was out of service for maintenance, and the Bayshore and Ohio Edison 345 kV transmission lines were in service. Breakers 34563 and 34564 were open to isolate the Lemoyne line from the switchyard.

The apparent cause of occurrence is a misunderstanding of the design and operability requirements for the switchyard. This misunderstanding is due in part to the design of the switchyard. There are three lines connecting the switchyard to offsite sources, and the Technical Specifications require only two qualified offsite circuits to be operable. However, the Ohio Edison line is connected only to the K bus. A lockout of either breaker 34562 or 34564 de-energizes the K bus, which de-energizes the Ohio Edison line. This lockout also results in the loss of either the Bay Shore or Lemoyne line, leaving only one offsite source available. Since the loss of one circuit (the K bus) leaves only one circuit in operation (the J bus), there are effectively only two total circuits. These interconnections were not fully understood, so it was previously assumed that there were two complete circuits capable of meeting the General Design Criterion 17 requirements even if any one of the offsite lines was out of service. The connection of the Ohio Edison line only to the K bus was made originally as a temporary connection, and it would have been connected to both buses with appropriate breakers when the switchyard was finished to accommodate Davis-Besse Unit 2.

Davis-Besse Nuclear Power Station 345 kV Switchyard One-Line Diagram
