SUBJECT: Calvert Cliffs Nuclear Power Plant  
Unit No. 2; Docket No. 50-318; License No. DPR 69  
Licensee Event Report 96-005  
Automatic Reactor Trip Due to Closure of Feedwater Regulating Valve

**LICENSEE EVENT REPORT (LER)**

Automatic Reactor Trip Due to Closure of Feedwater Regulating Valve

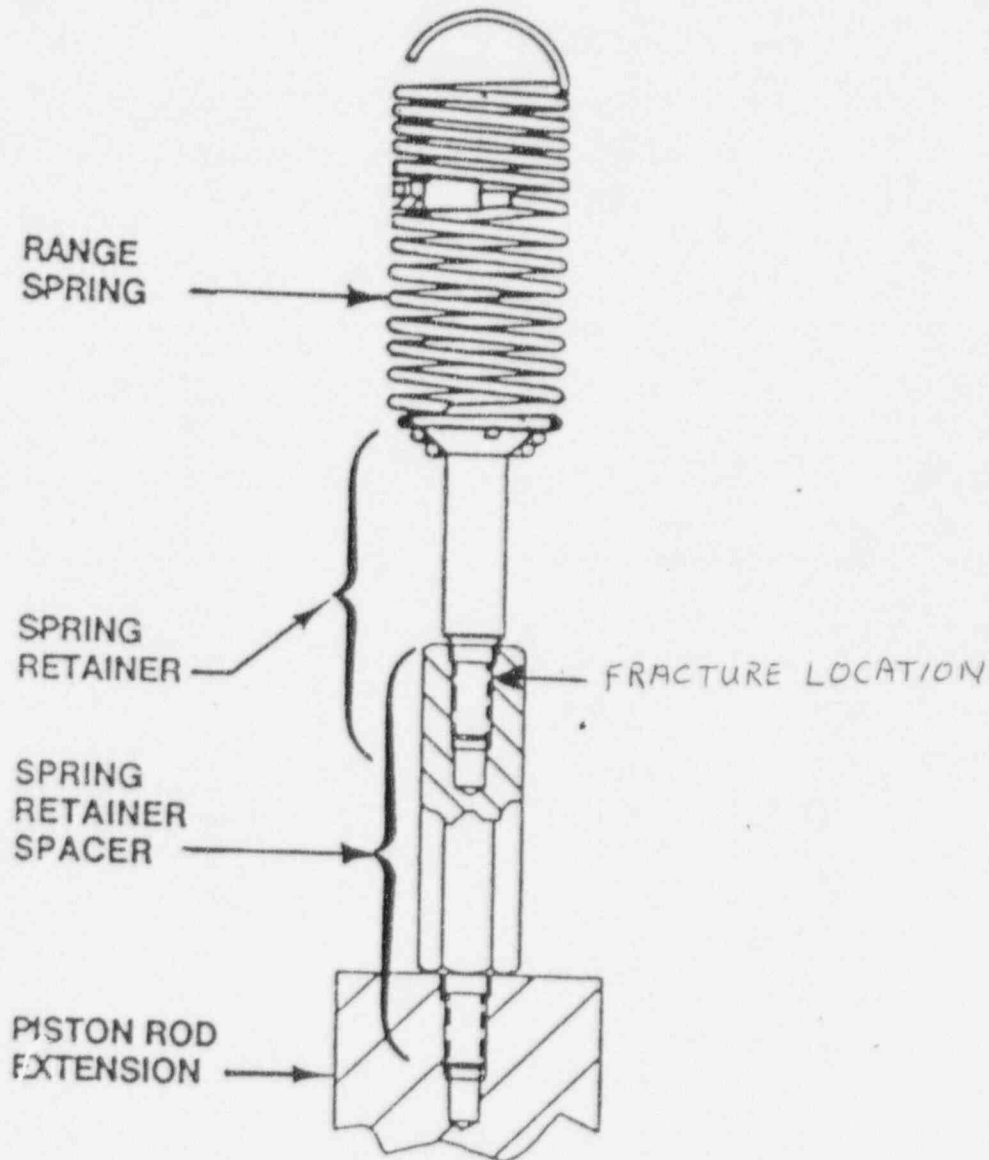
FIGURE 1  
(Not drawn to scale)

The cause of the reactor trip was a valid RPS signal generated as a result of low water level (-50 inches) in No. 21 Steam Generator. This signal resulted when No. 21 Steam Generator FRV unexpectedly closed. Investigation of No. 21 FRV discovered a broken bolt (spring retainer) in the valve positioner mounted on top of the valve actuator. The spring retainer is approximately 2 inches long and 1/4 inch in diameter. The actuator stem position feedback is provided to the valve positioner through movement of the range spring attached by the spring retainer to an extension of the actuator piston rod (see Figure 1). This feedback arrangement is designed to prevent over-correction and insure a definite position of the actuator piston rod for a given input signal to give a stable and accurate response to a change in controlled conditions. When the spring retainer gave way, the range spring released causing the valve positioner for No. 21 Steam Generator FRV to sense that the valve was full open. The valve positioner responded by sending a closing signal to No. 21 Steam Generator FRV actuator and the valve shut.

Following the event, the Plant General Manager established a Significant Incident Finding Team (SIFT) to determine the cause(s) of the event, initiate corrective action, and formulate recommendations to prevent recurrence. Results of the ongoing investigation indicate that the immediate cause of this event was the failure of No. 21 FRV positioner spring retainer due to torsional overload, equivalent to overtightening the spring retainer. The SIFT identified other plausible causes for No. 21 FRV closure, then refuted each one on a case by case basis. The spring retainer is manufactured from low carbon steel. The failure mode of the spring retainer was determined from a metallurgical failure analysis on the broken retainer. This failure analysis also determined that the failure was not recent and was probably many months old. The failure analysis could not determine whether the fracture was complete or if a small amount of the retainer remained intact, most probably at the thread, which then failed later. The failure analysis stated that approximately one thread remained intact above the fracture surface and this may have been sufficient to keep the retainer and the actuator extension piece together during the previous Unit 2 operation.

Following the event, five new replacement spring retainers were obtained from the vendor. Each retainer underwent a magnetic particle examination. No indications were found. Plant technicians replaced the spring retainer in Nos. 21 and 22 FRV positioners using an approved maintenance order. Post-maintenance calibration of the these FRV positioners and FRV stroke time-response testing were completed satisfactory. The removed spring retainers were saved for analysis.
