Arizona Nuclear Power Project

Subject: Final Report - DER 85-24
A 50.55(e) Reportable Condition Relating To Broken
Diesel Generator Turbocharger Bolts
File: 85-019-026; D.4.33.2

FINAL REPORT - DER 85-24
DEFICIENCY EVALUATION 50.55(e)
ARIZONA NUCLEAR POWER PROJECT (ANPP)
PVNGS UNITS 1, 2, 3

SUBJECT: Failure of Unit 1 Diesel Generator
Turbocharger Mounting Bolts (EER-85-DG-028)

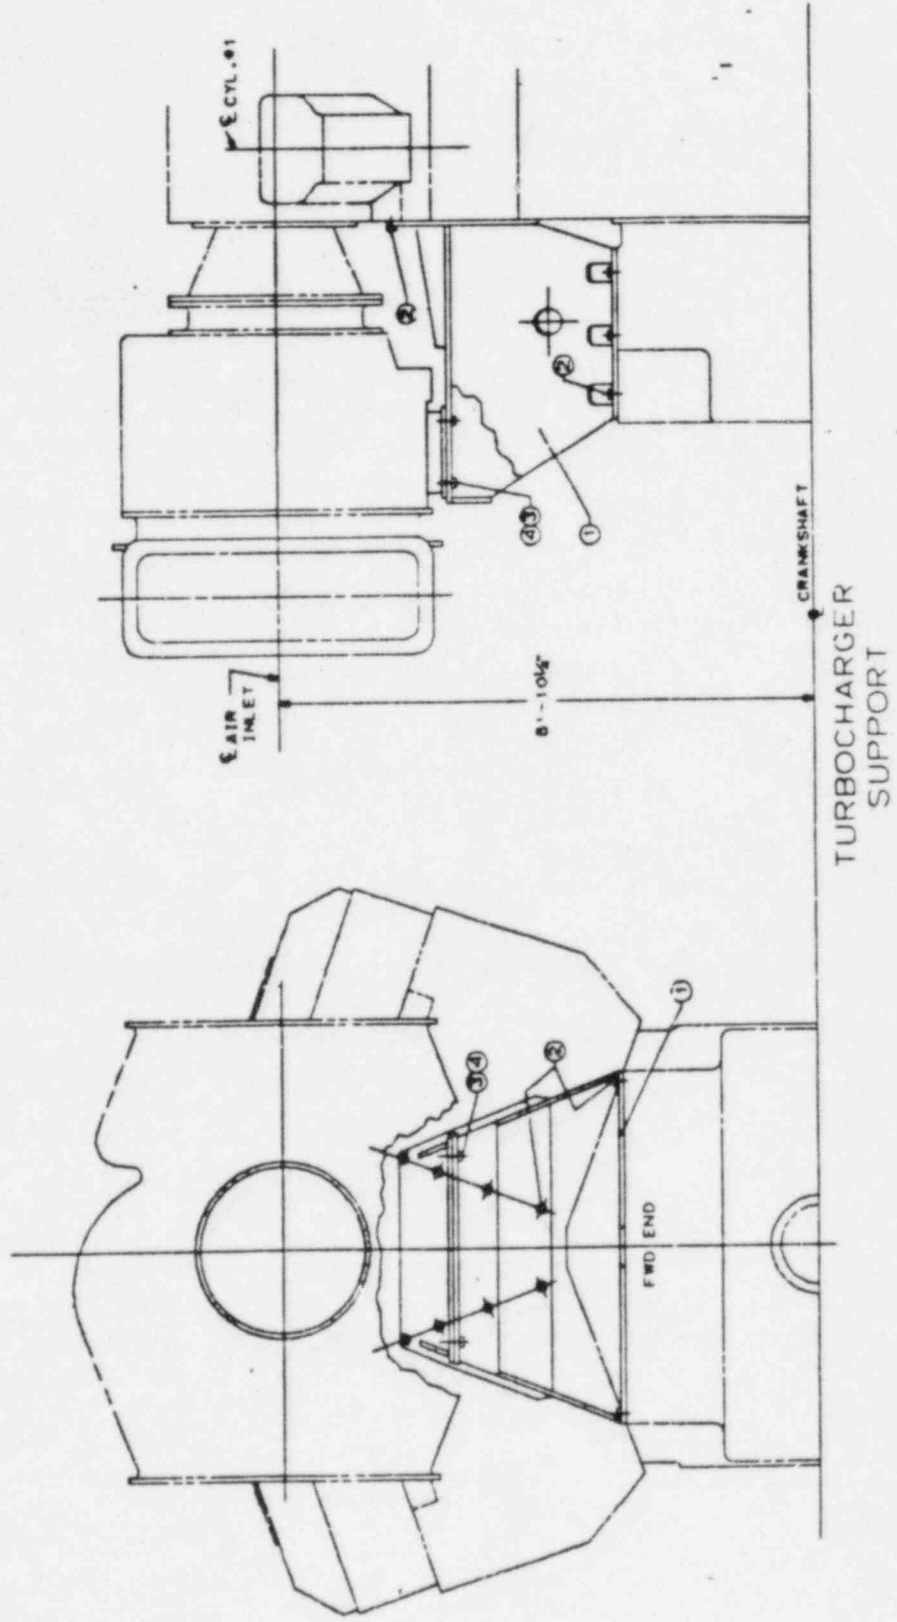
The turbocharger is mounted on a support bracket which is attached to the engine by eight 5/8" x 11 x 1 1/4" bolts in the vertical plane and six 5/8" x 11 x 1 1/4" bolts in the horizontal plane (see attached drawing, item 2). The bolt material is SAE J429, Grade 5. NCR SM-5849 states that bolts in the vertical support member on both trains of the Unit 1 and 2 diesels have either been sheared off or vibrated loose and fallen out.

The vertical bolts in question (eight bolts, three of which have failed on each unit) are installed for seismic reasons only. Cooper Energy Services (CES), the vendor, has reviewed the seismic study conducted on the turbocharger support bracket and determined that six bolts out of the eight bolt pattern could fail before seismic integrity would be compromised (Reference 1).

The root cause of the bolt failure is attributed to fatigue due to engine vibration as discussed in Reference 2 (attached). The low pre-stress specified for the bolts provided clamping forces which were insufficient to prevent bolt fatigue failure due to vibratory loads.

The existing SAE Grade 5 bolts are to be replaced with longer ASTM A-193, Grade B7 full threaded studs and A-194, Grade 2H nuts. The torque value is to be increased to 110 ft/lbs., which will increase the pre-stress and eliminate vibratory loads. DCPs 20M and 30M-DG-049 have been issued to perform this work on Units 2 and 3. Bechtel calculation 13-CC-ZQ-M01 verifies that 110 ft/lbs. is adequate for this application and has been confirmed by ANPP surveillance procedure 73TI-1DG01. Unit 1 has been corrected under Work Authorizations 87104 and 87109. Work on Units 2 and 3 to be completed prior to fuel load.
