TITLE: Auxillary Feed Pumps Overspeed Trips

TITLE: AUXILIARY FEED PUMPS OVERSPEED TRIPS

REPORT BY: Dan Wilczynski, Chuck Rupp

Plan No.: 1A and 1B

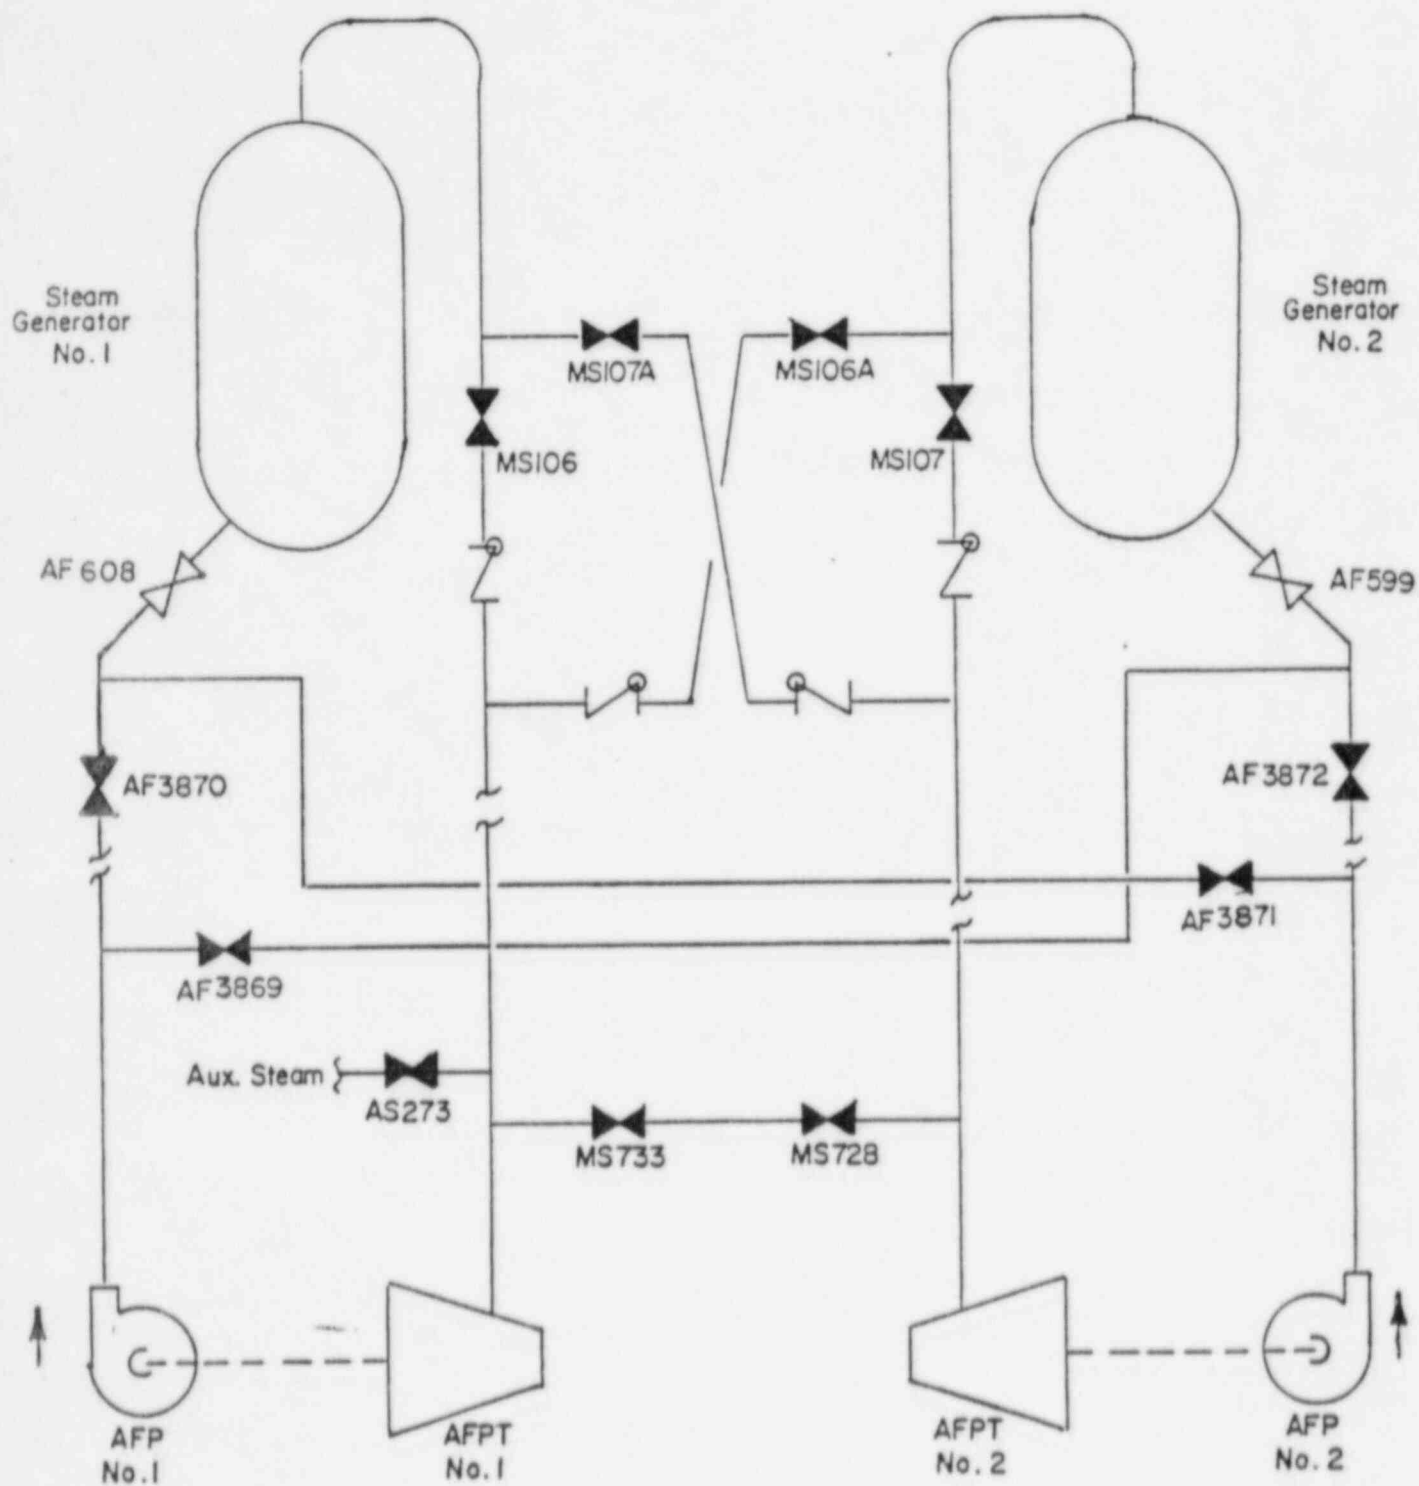
Figure 1

SCHEMATIC REPRESENTATION OF
AUXILIARY FEED PUMP TURBINE STEAM PIPING SYSTEM

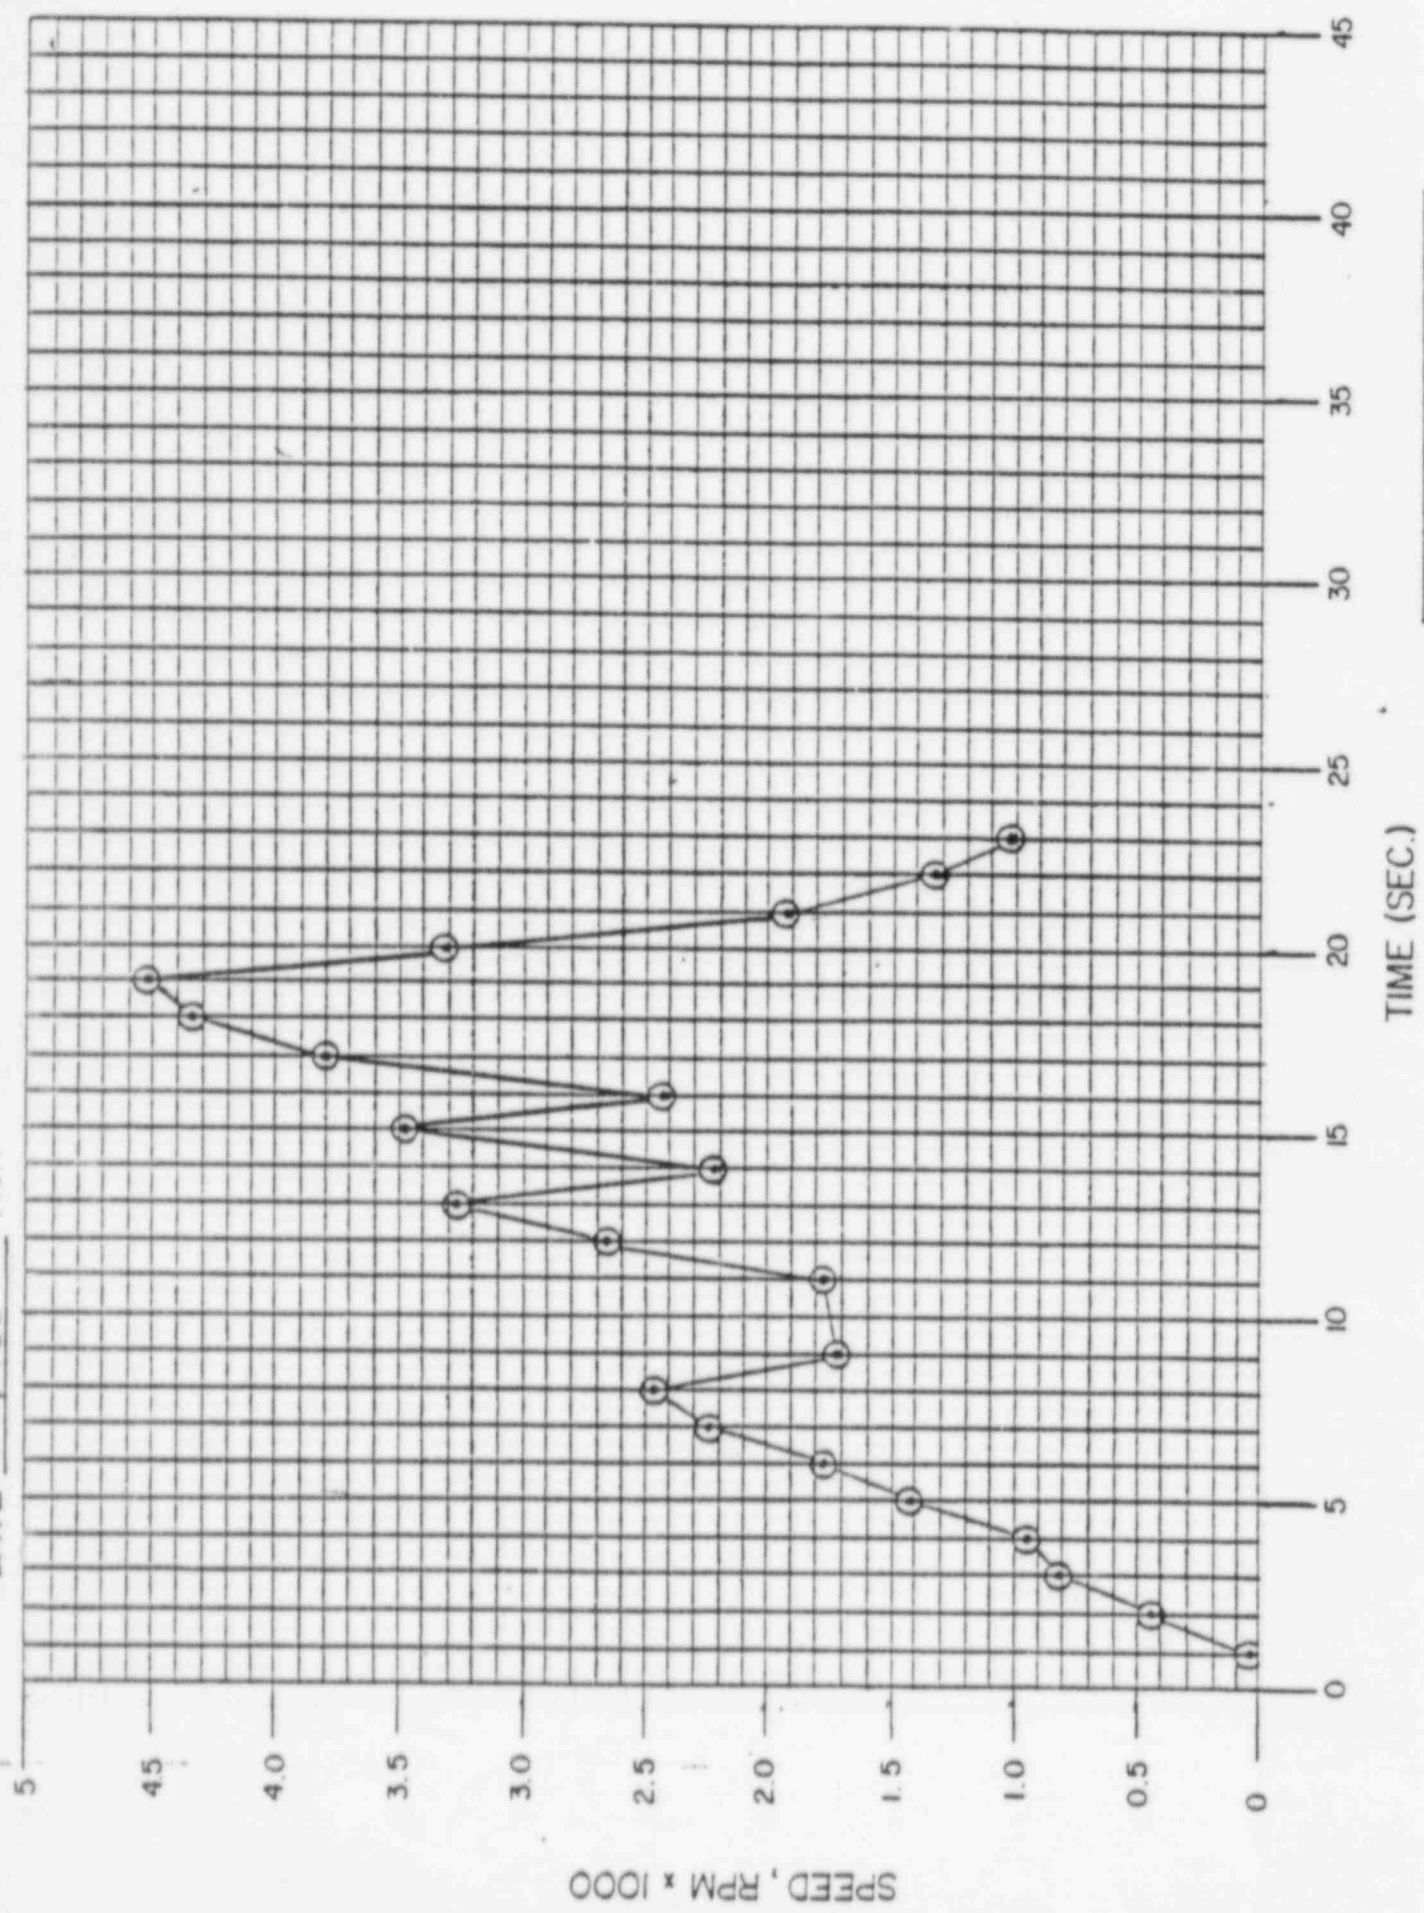
Figure 2

The speed characteristics are shown on Figures 2 and 3 of Attachment 2. A review of the speed vs. time characteristics for AFPT #1 shows the typical characteristics of several oscillations prior to reaching rated speed but the final oscillation was uncontrolled and increased turbine speed to the overspeed trip setpoint.

AUX.-FEED PUMP # 1
DATE: 6/9/85 TRIP

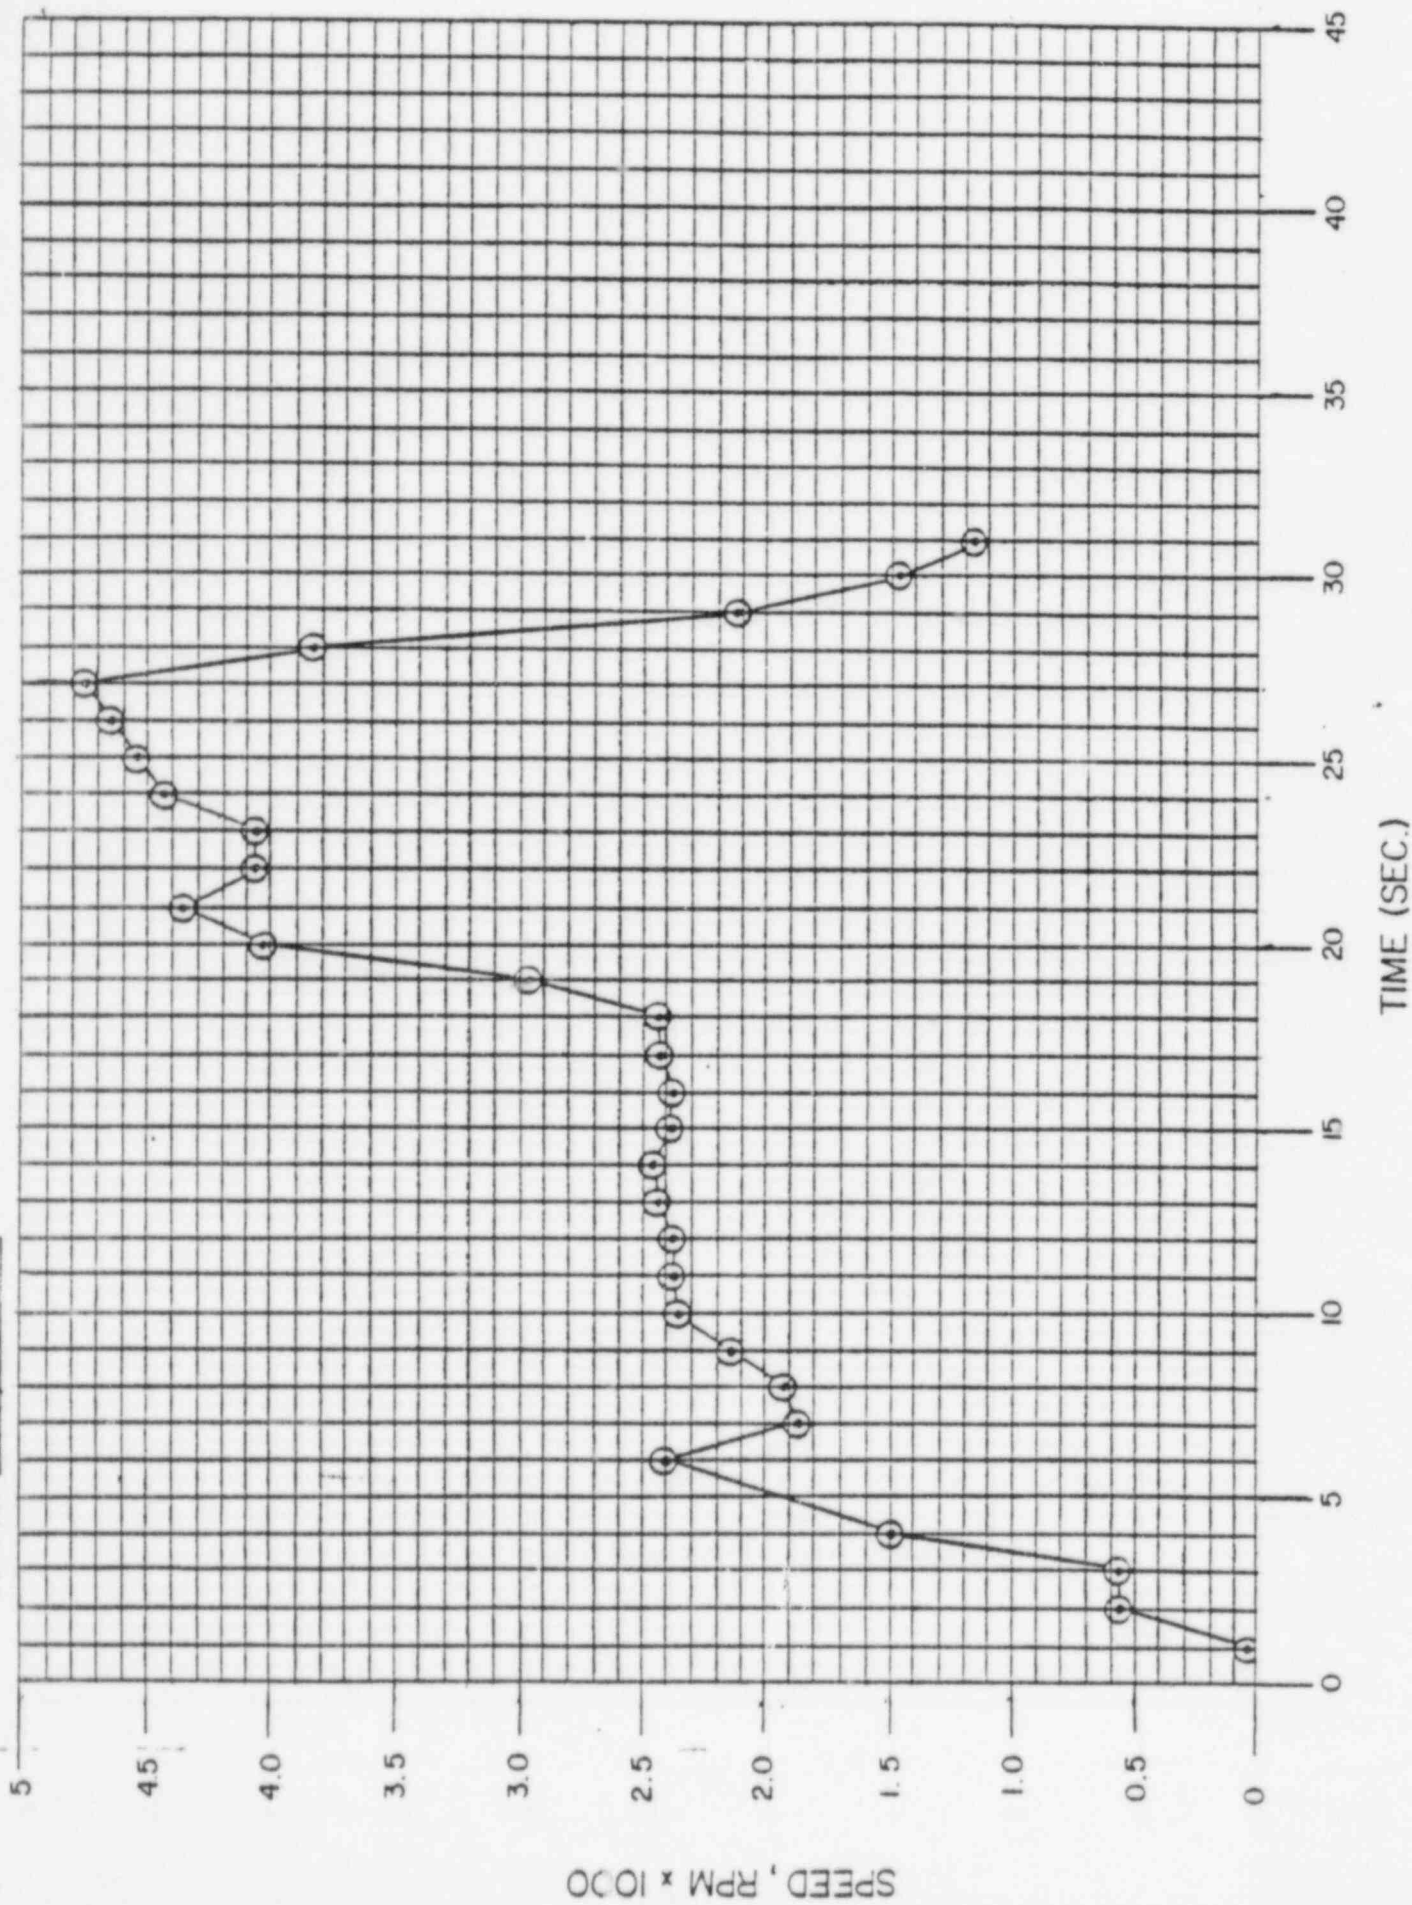
Figure 3

A review of the speed characteristics for AFPT #2 shows an uncharacteristic leveling off at approximately 2500 RPM for about eight (8) seconds from which point turbine speed quickly increases to above 4100 RPM, decreases slightly and then continues to increase to the overspeed trip setpoint. The pause at 2500 RPM could be due to excessive water induction into the turbine.

DATE: 6/9/85 TRIP

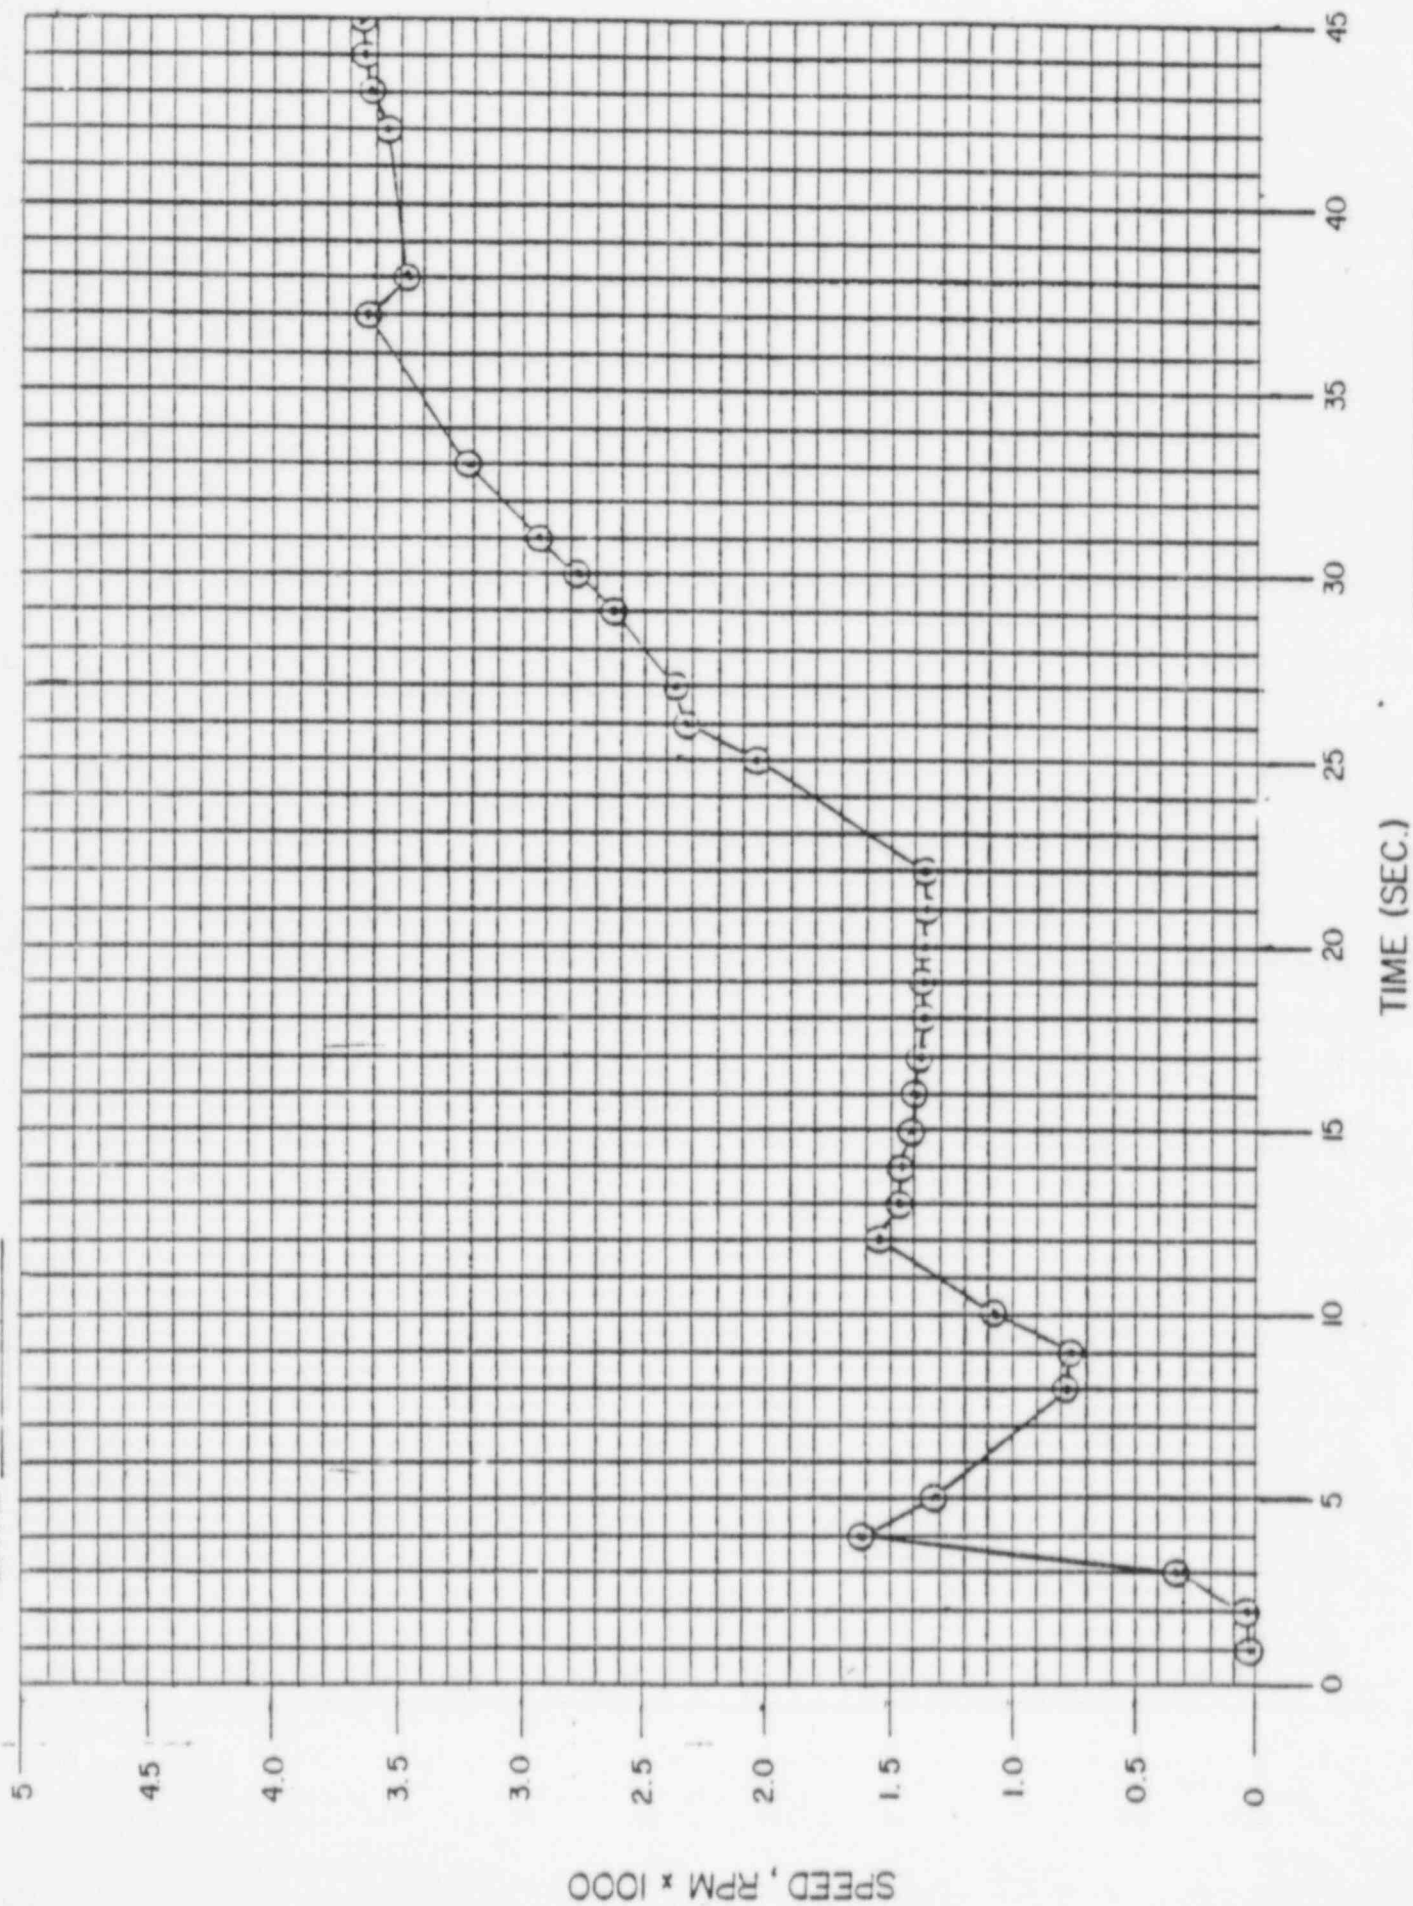
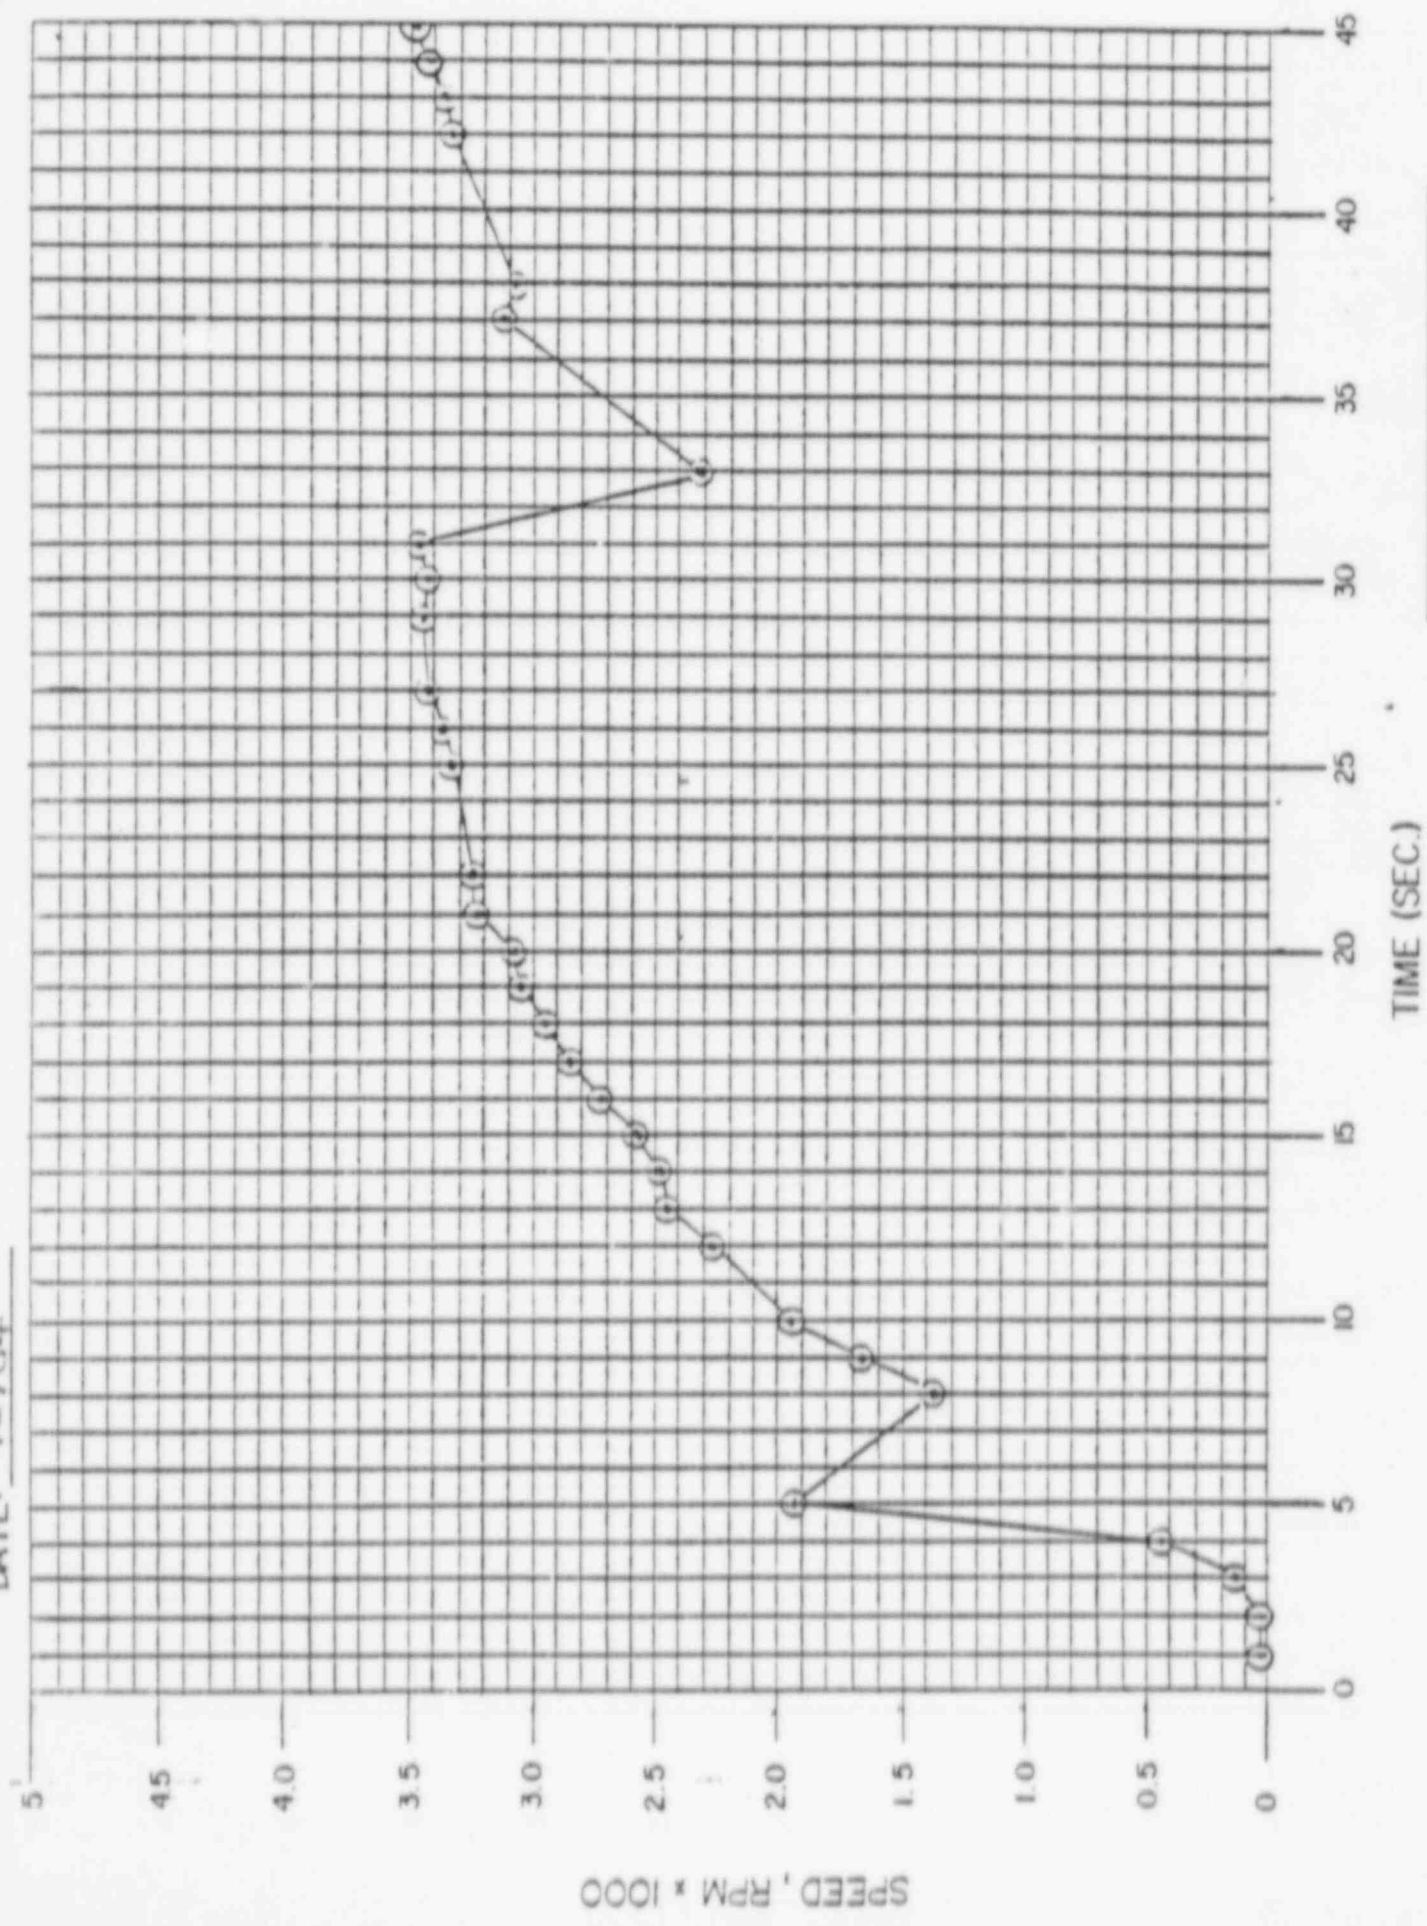
the steam supply valve (MS 107) from SG #2 to AFPT #2 and opened the cross connect valve MS 107A to supply steam to AFPT #2 from SG #1. This switch of steam supply occurred 21 seconds (12:37:55) after both AFPTs had been started via MS 106 and MS 107. A review of the speed vs. time characteristics (see Figures 4 and 5 of Attachment 2), show that AFPT #2 experienced a decrease of approximately 1000 RPM at sixteen (16) seconds after the SFRCS low pressure trip. This speed decrease may be attributed to excessive water being picked up from the MS 107A line and being carried to the turbine.

- On 3/2/84, since MS 107 was open and heating the line, opening MS 107A introduced only 250' of cold piping, thereby reducing the amount of water introduced to the turbine.
- On 3/2/84, additional water may have been introduced by opening MS 107A because the steam lines were not drained periodically at this time.
- On 3/2/84, since AFPT #2 was pumping approximately 1000 GPM, if a slug of water occurred from opening of MS 107A, there would have been more resistance to a speed increase as compared to the 6/9/85 event when only a min-recirc flow path was available.
- On 3/2/84, both AFPTs had the Woodward PG-PL governors installed.

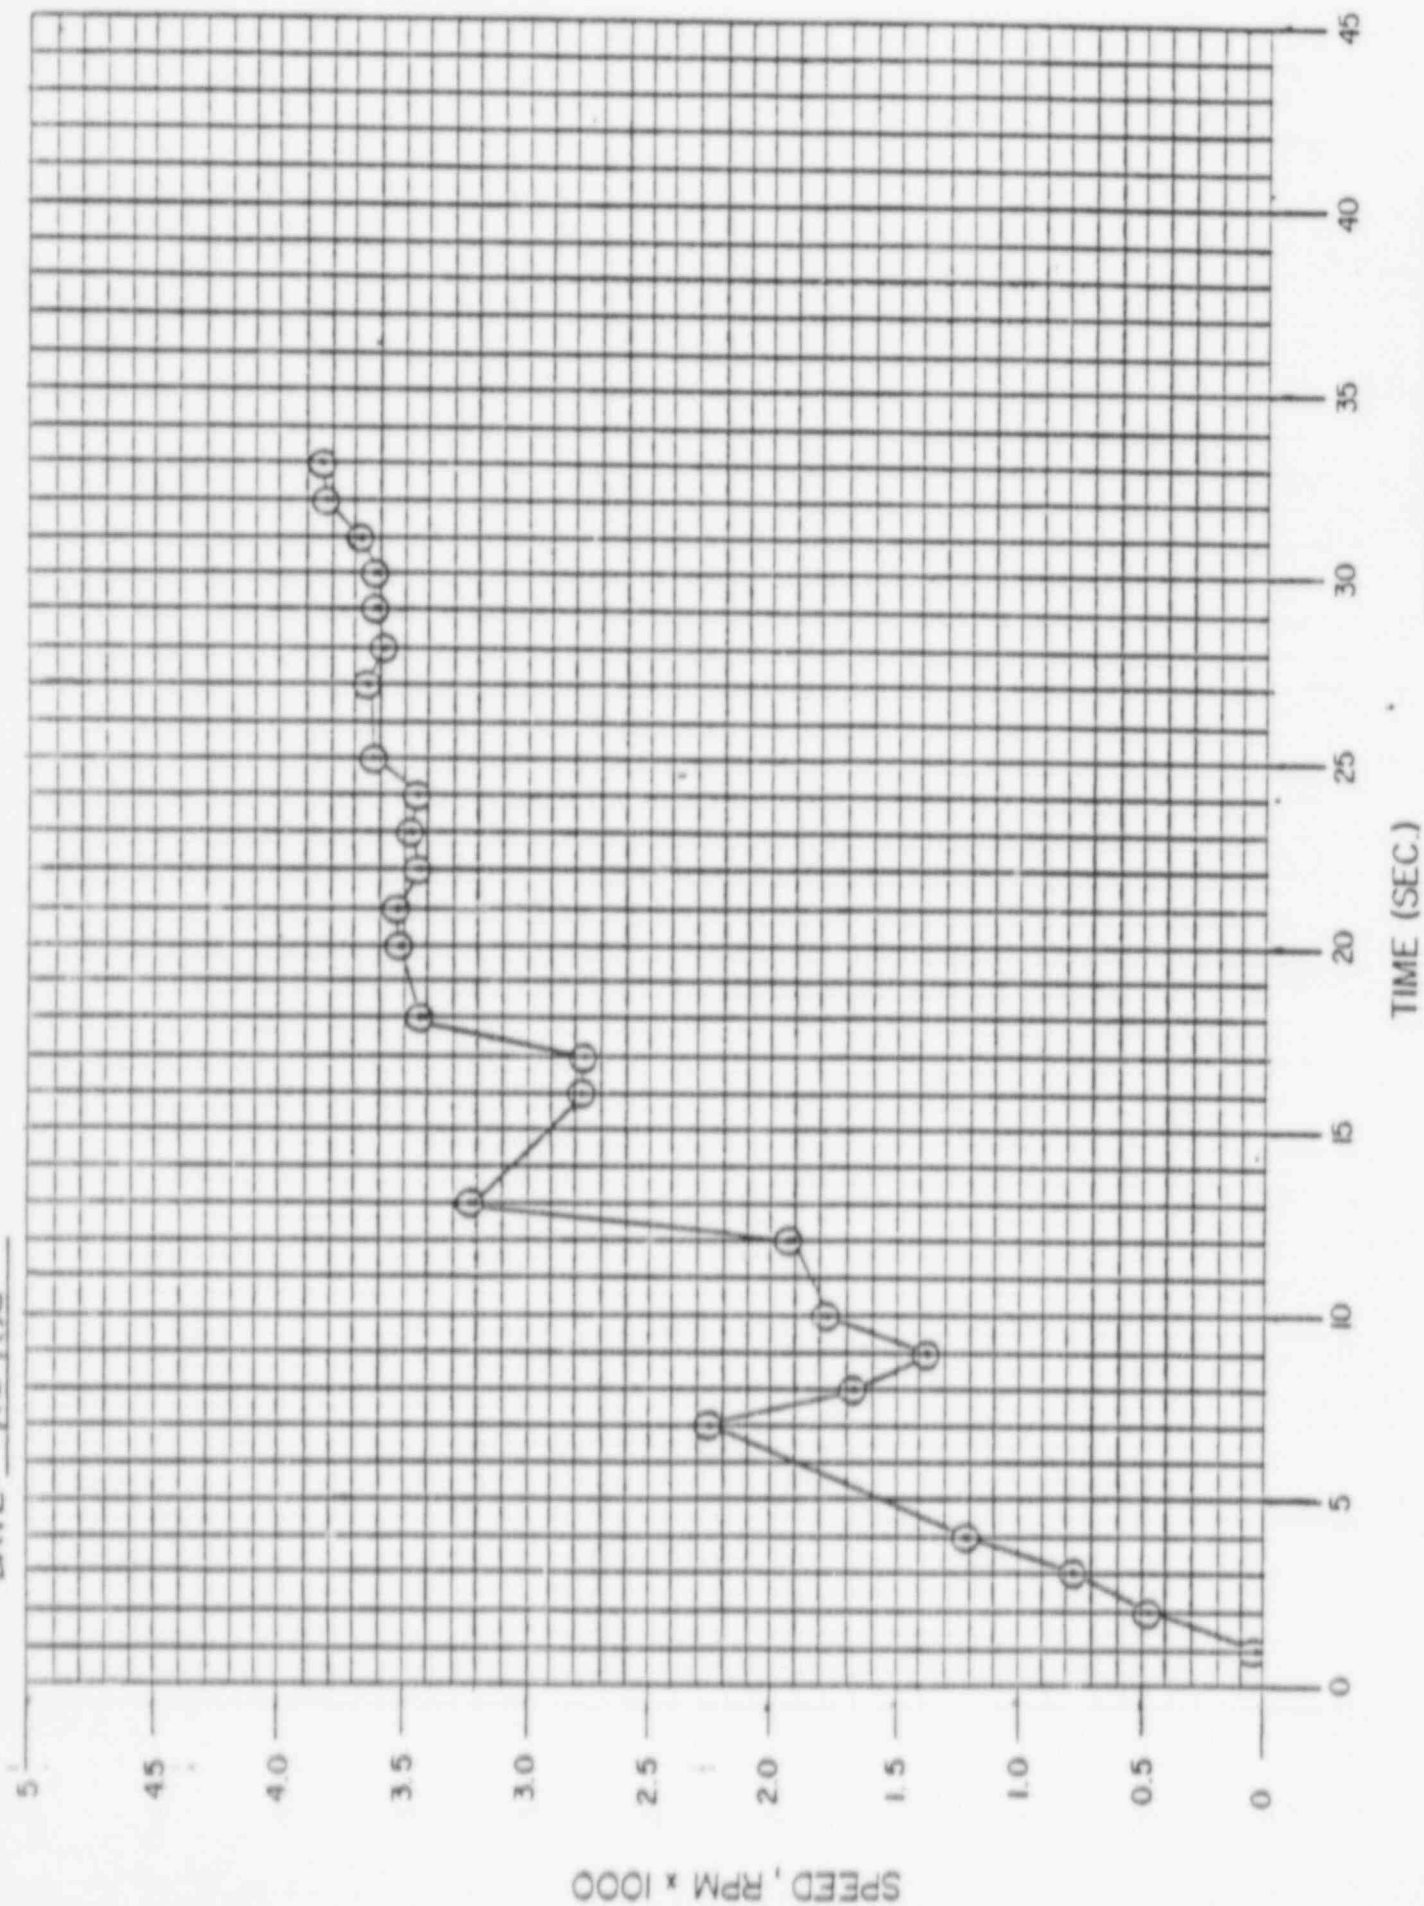
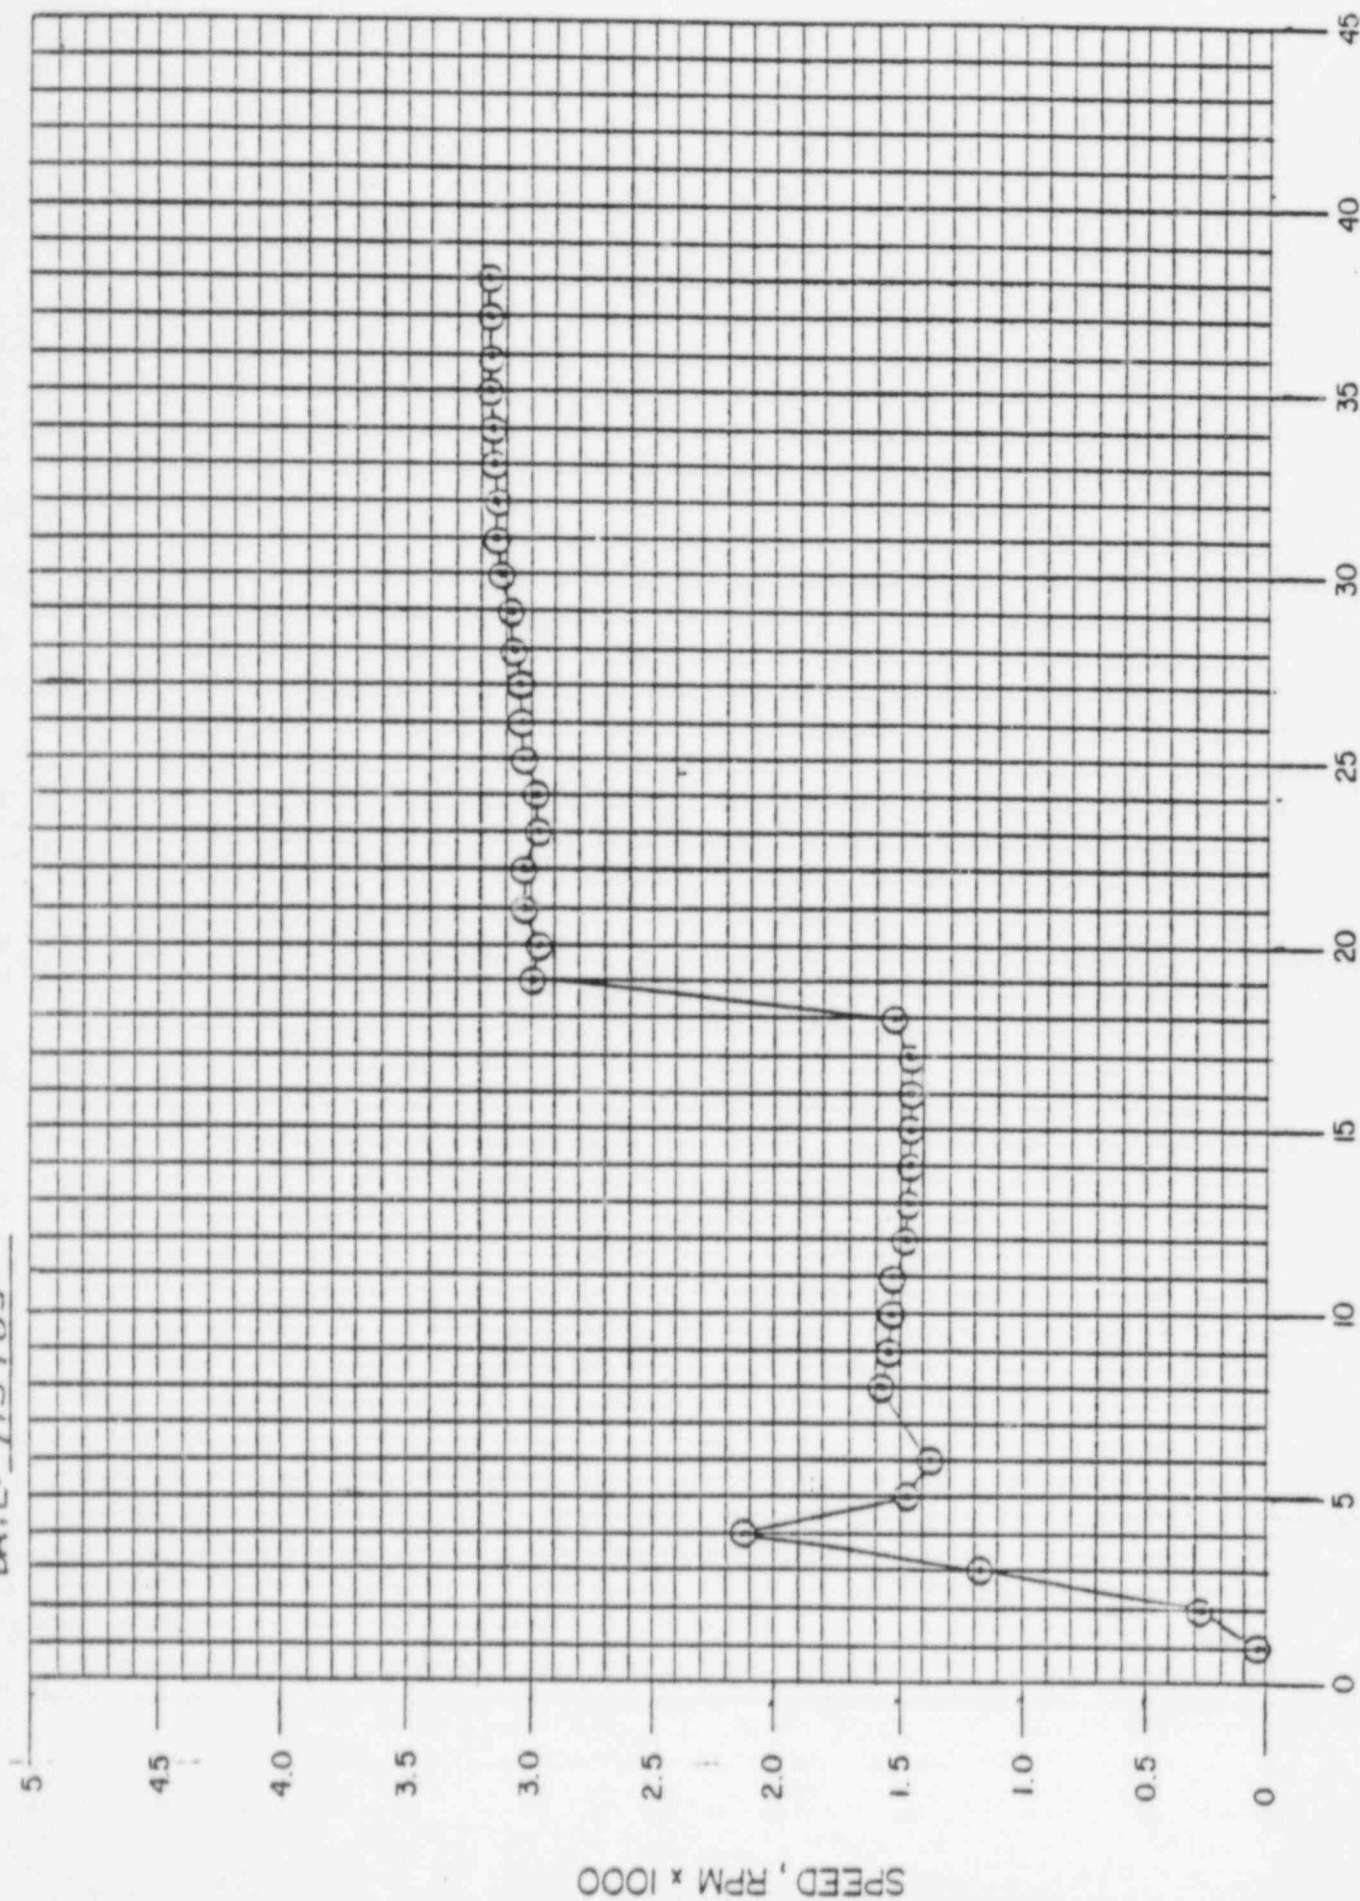
This event initiated a SFRCS trip on low SG level which, due to valve control changes made during the 1984 refueling outage, opened all four steam supply valves to the AFPTs. Also, AFPT #2 had the new PGG governor installed during the 1984 refueling outage. The speed characteristics are shown on Figures 6 and 7 of Attachment 2.

- On 1/15/85, due to the pipe configuration, initial steam flow to both turbines would have been via the normal flow paths, MS 106 and MS 107. Therefore, initial heating of the respective lengths (360' and 125') may have occurred prior to steam flow through the cross connects resulting in less total mass of

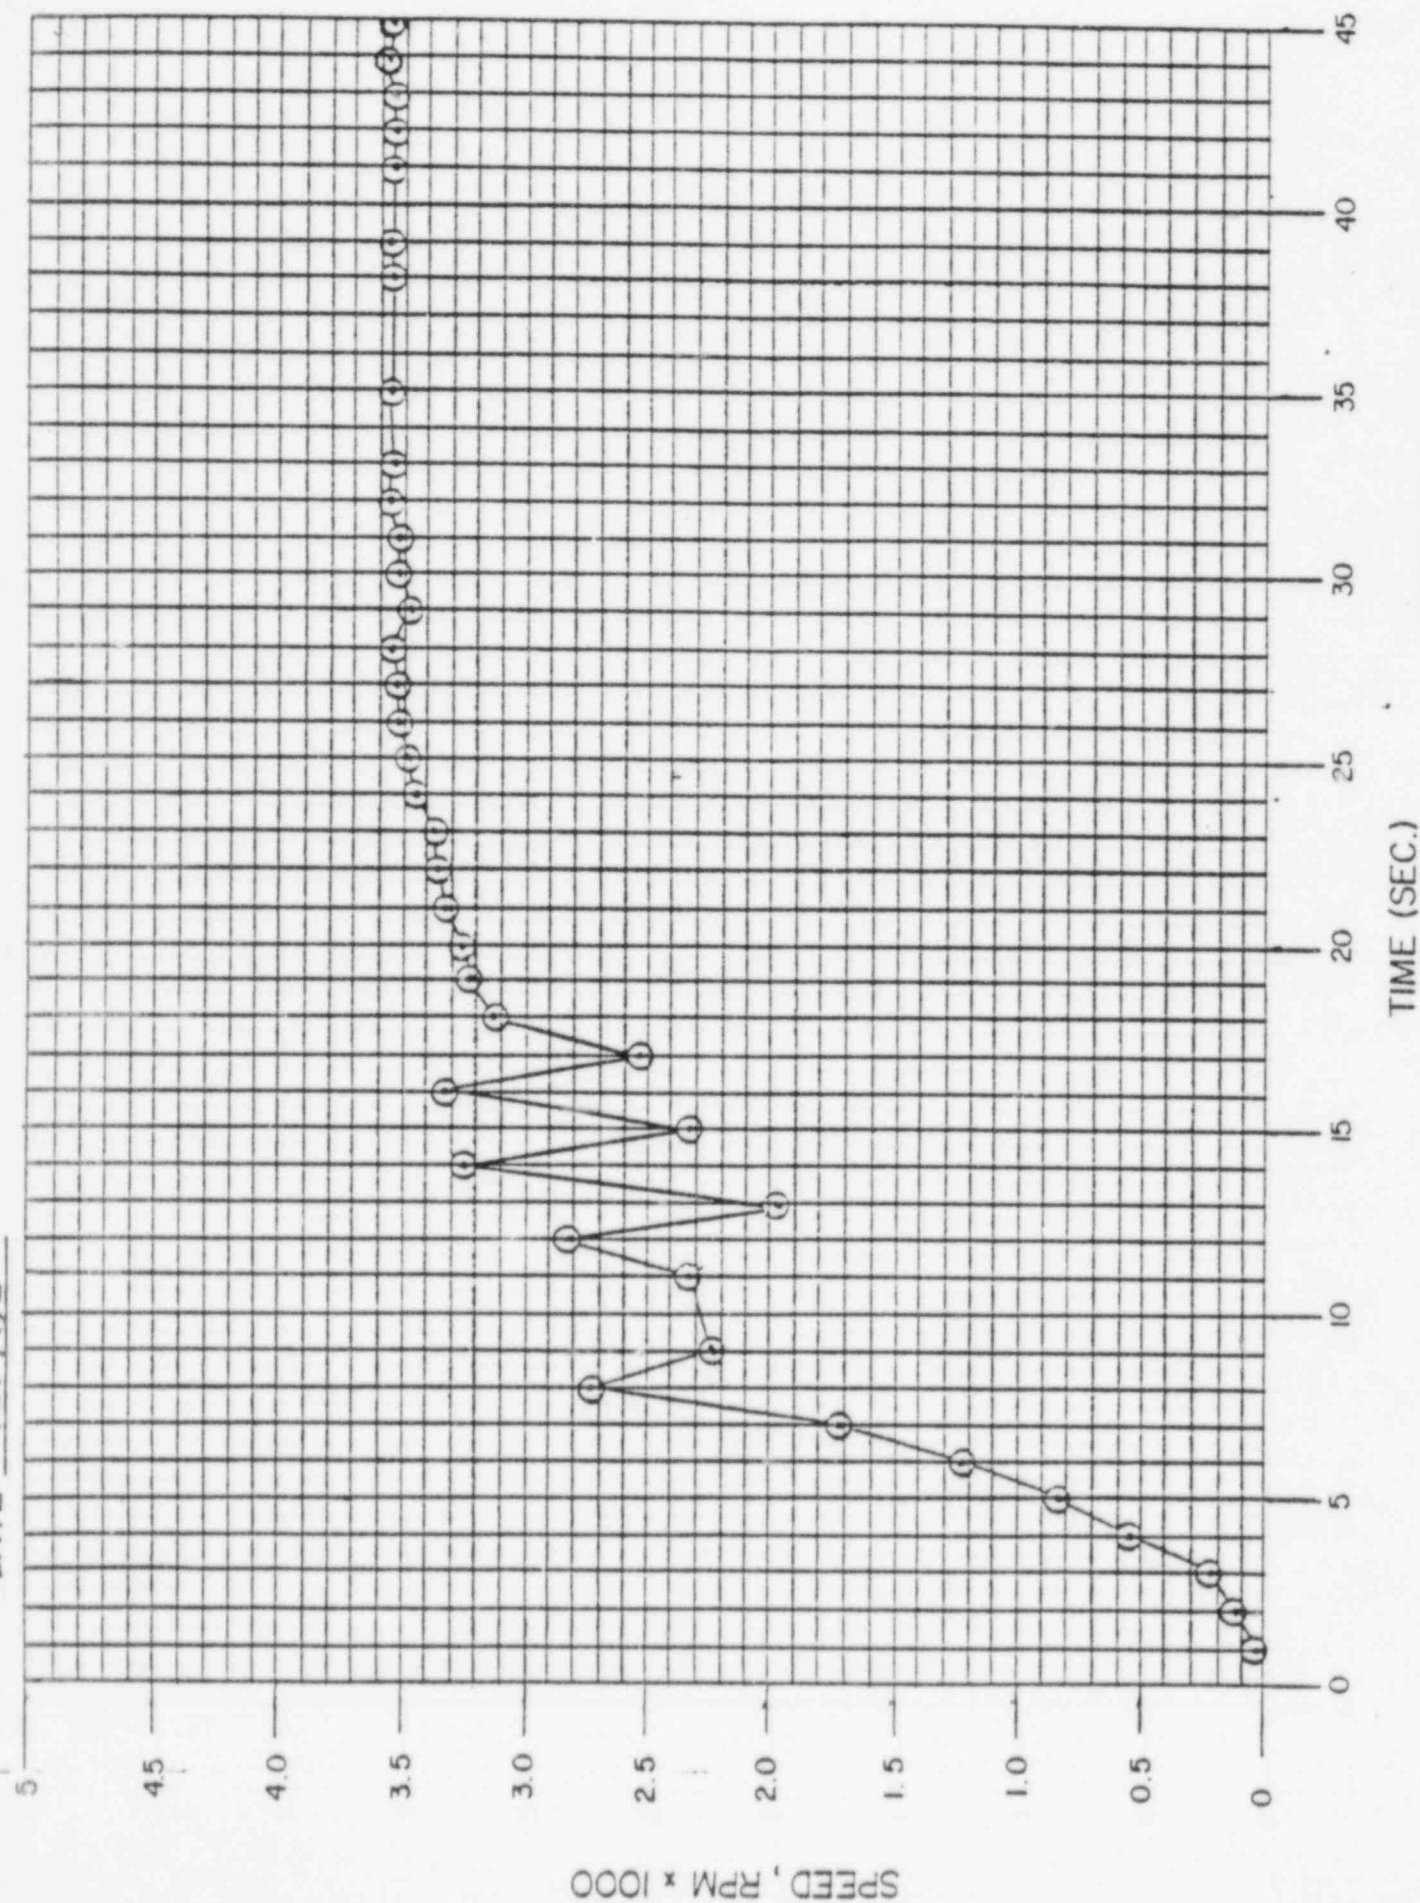
Figure 8

The speed characteristics are shown on Figures 8 and 9 of Attachment 2. A review of the speed characteristics for AFPT #1 show the typical characteristics consistently seen on AFPT #1 (i.e., several oscillations prior to reaching rated speed).
