TITLE: Auxillary Feed Pumps Overspeed Trips

TITLE: AUXILIARY FEED PUMPS OVERSPEED TRIPS

REPORT BY: Dan Wilczynski, Chuck Rupp

Plan No.: 1A and 1B

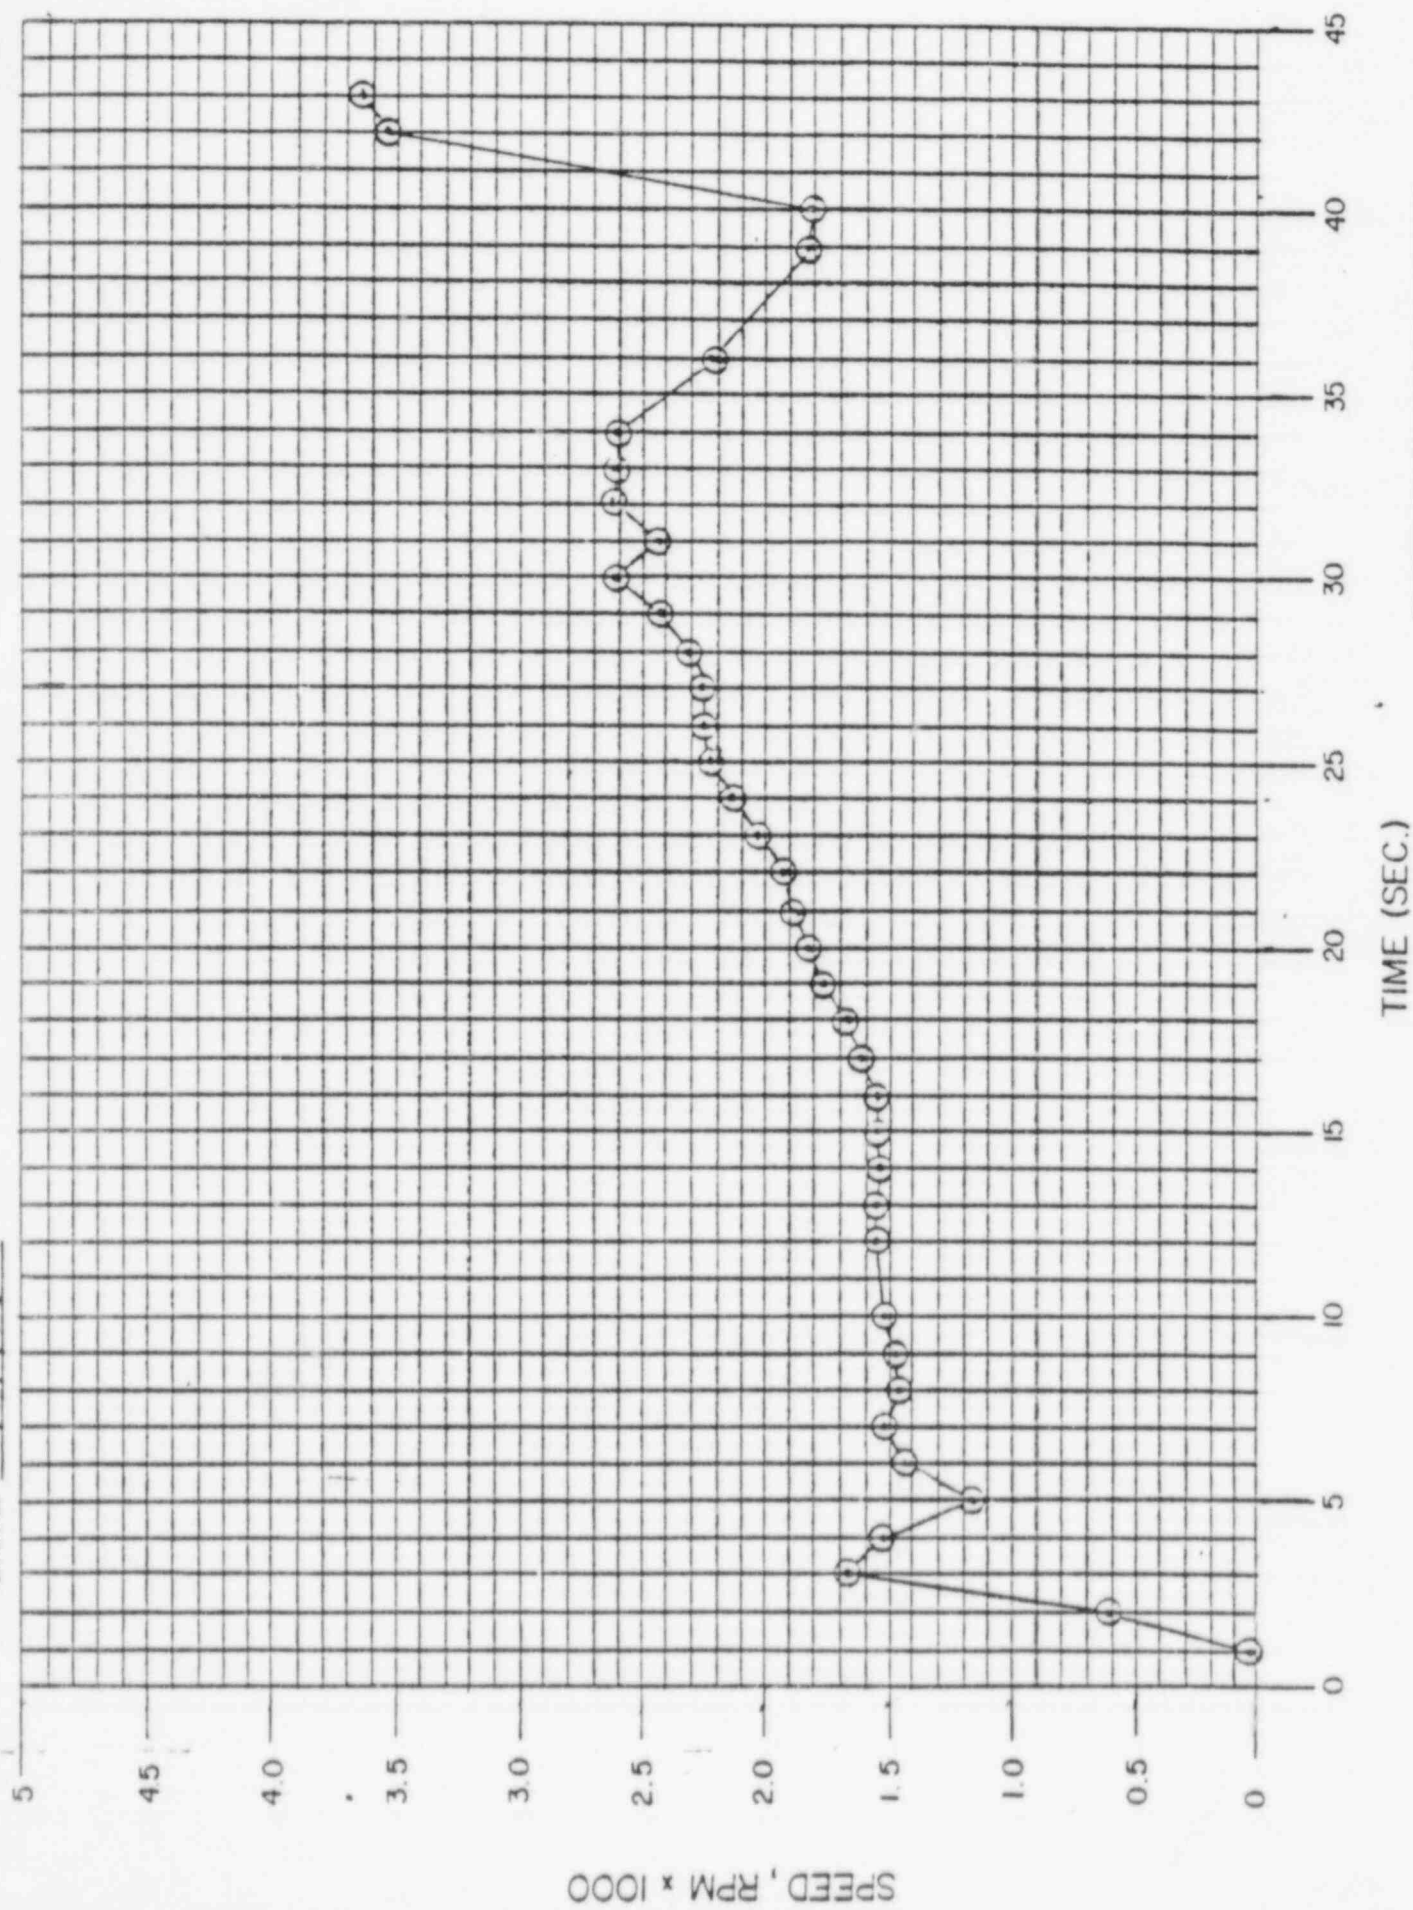
Figure 9

A review of the speed vs. time characteristics show that AFPT #2 indicates a constant rate of acceleration until approximately 35 seconds after initial roll at which time there was an 800 RPM decrease in 2 seconds followed by an 1800 RPM increase in 3 seconds. This oscillation may be due to slugs of water.

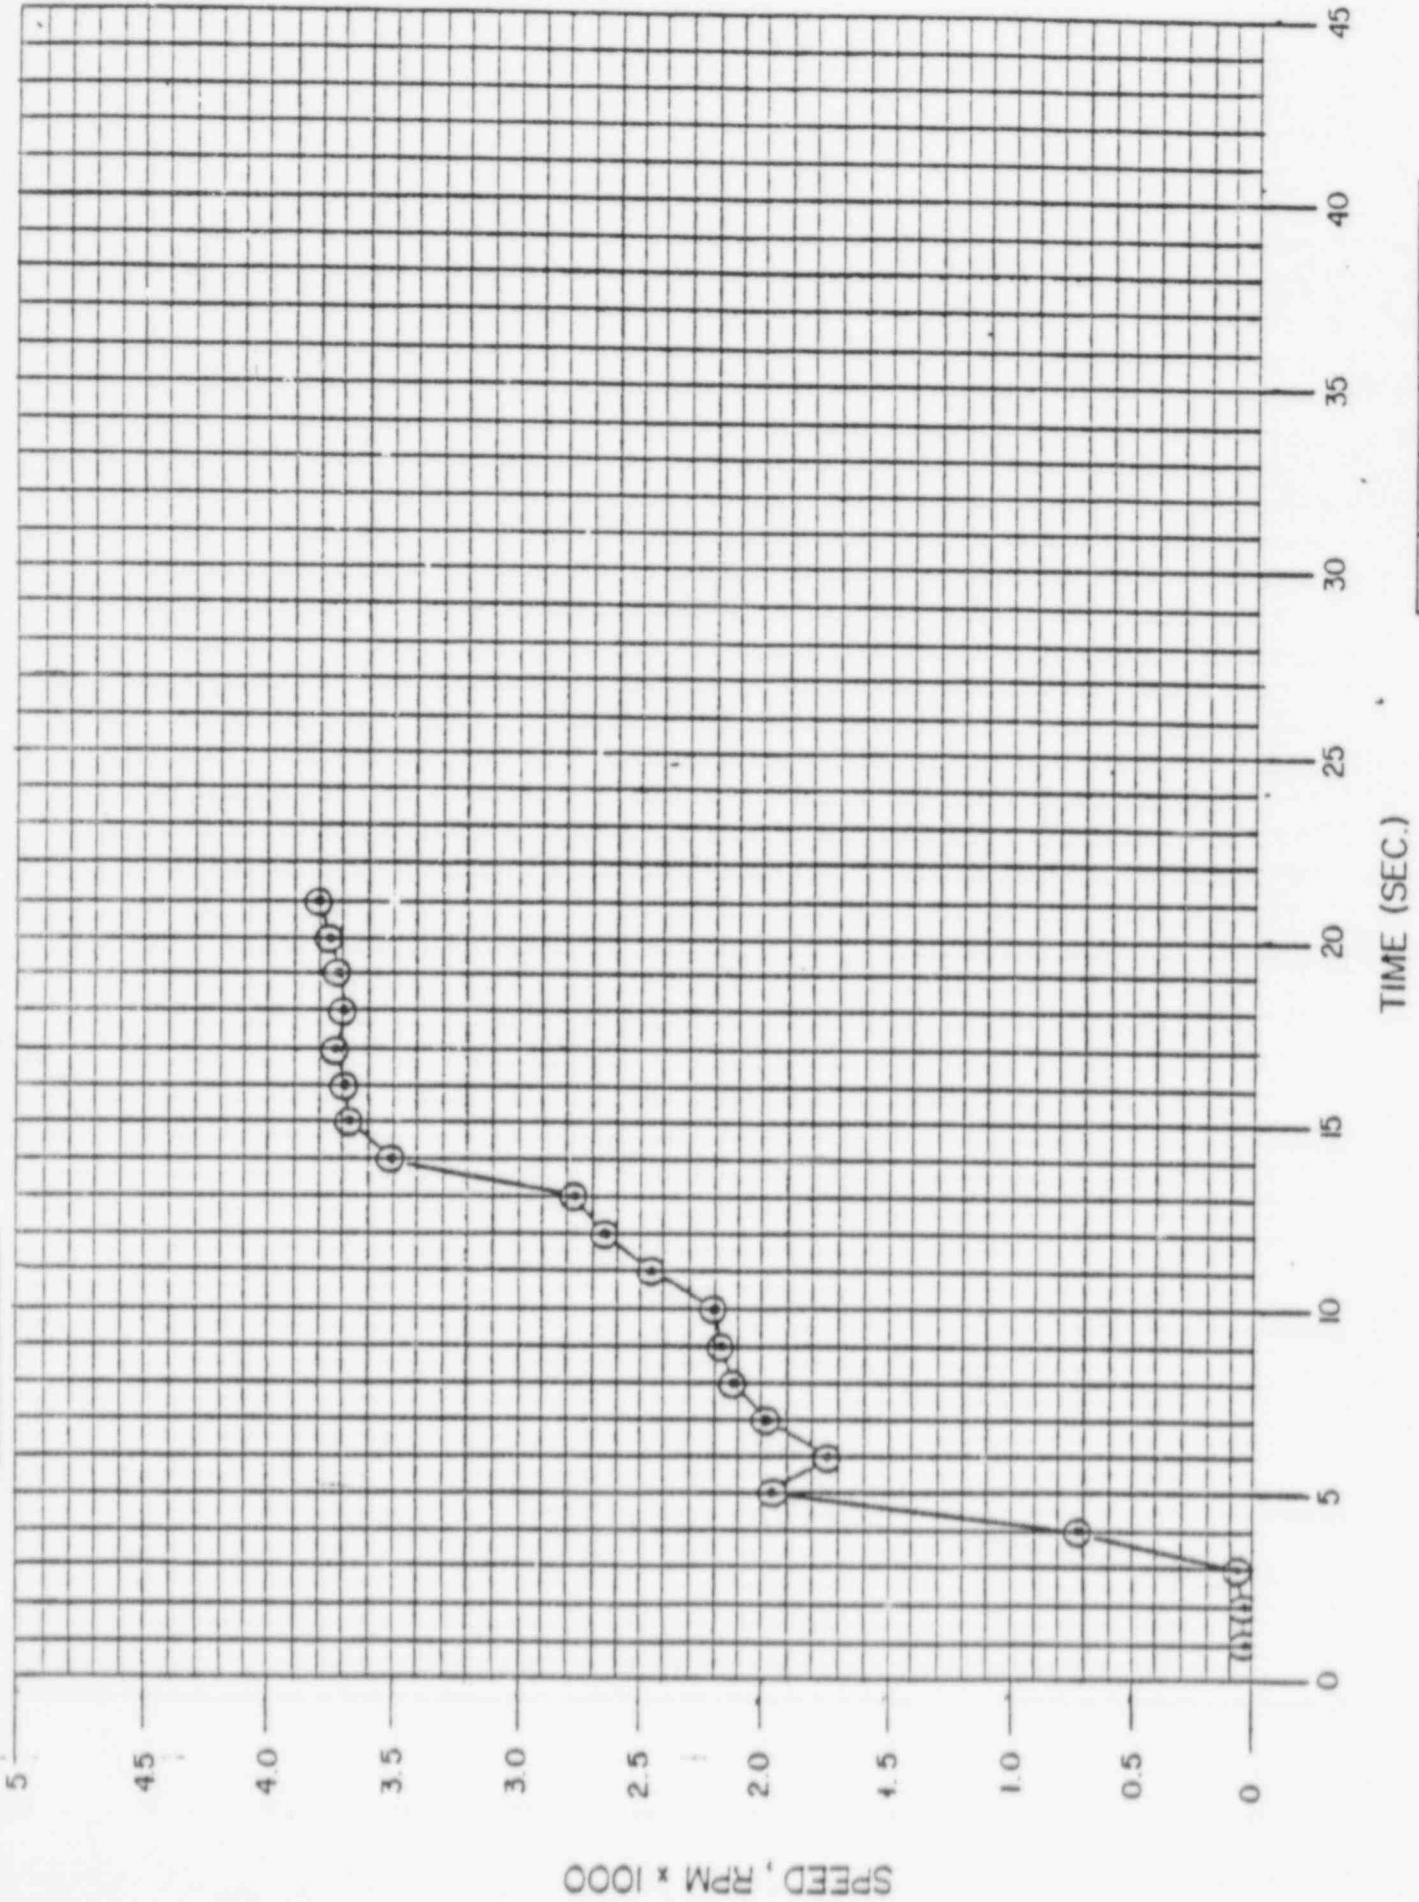
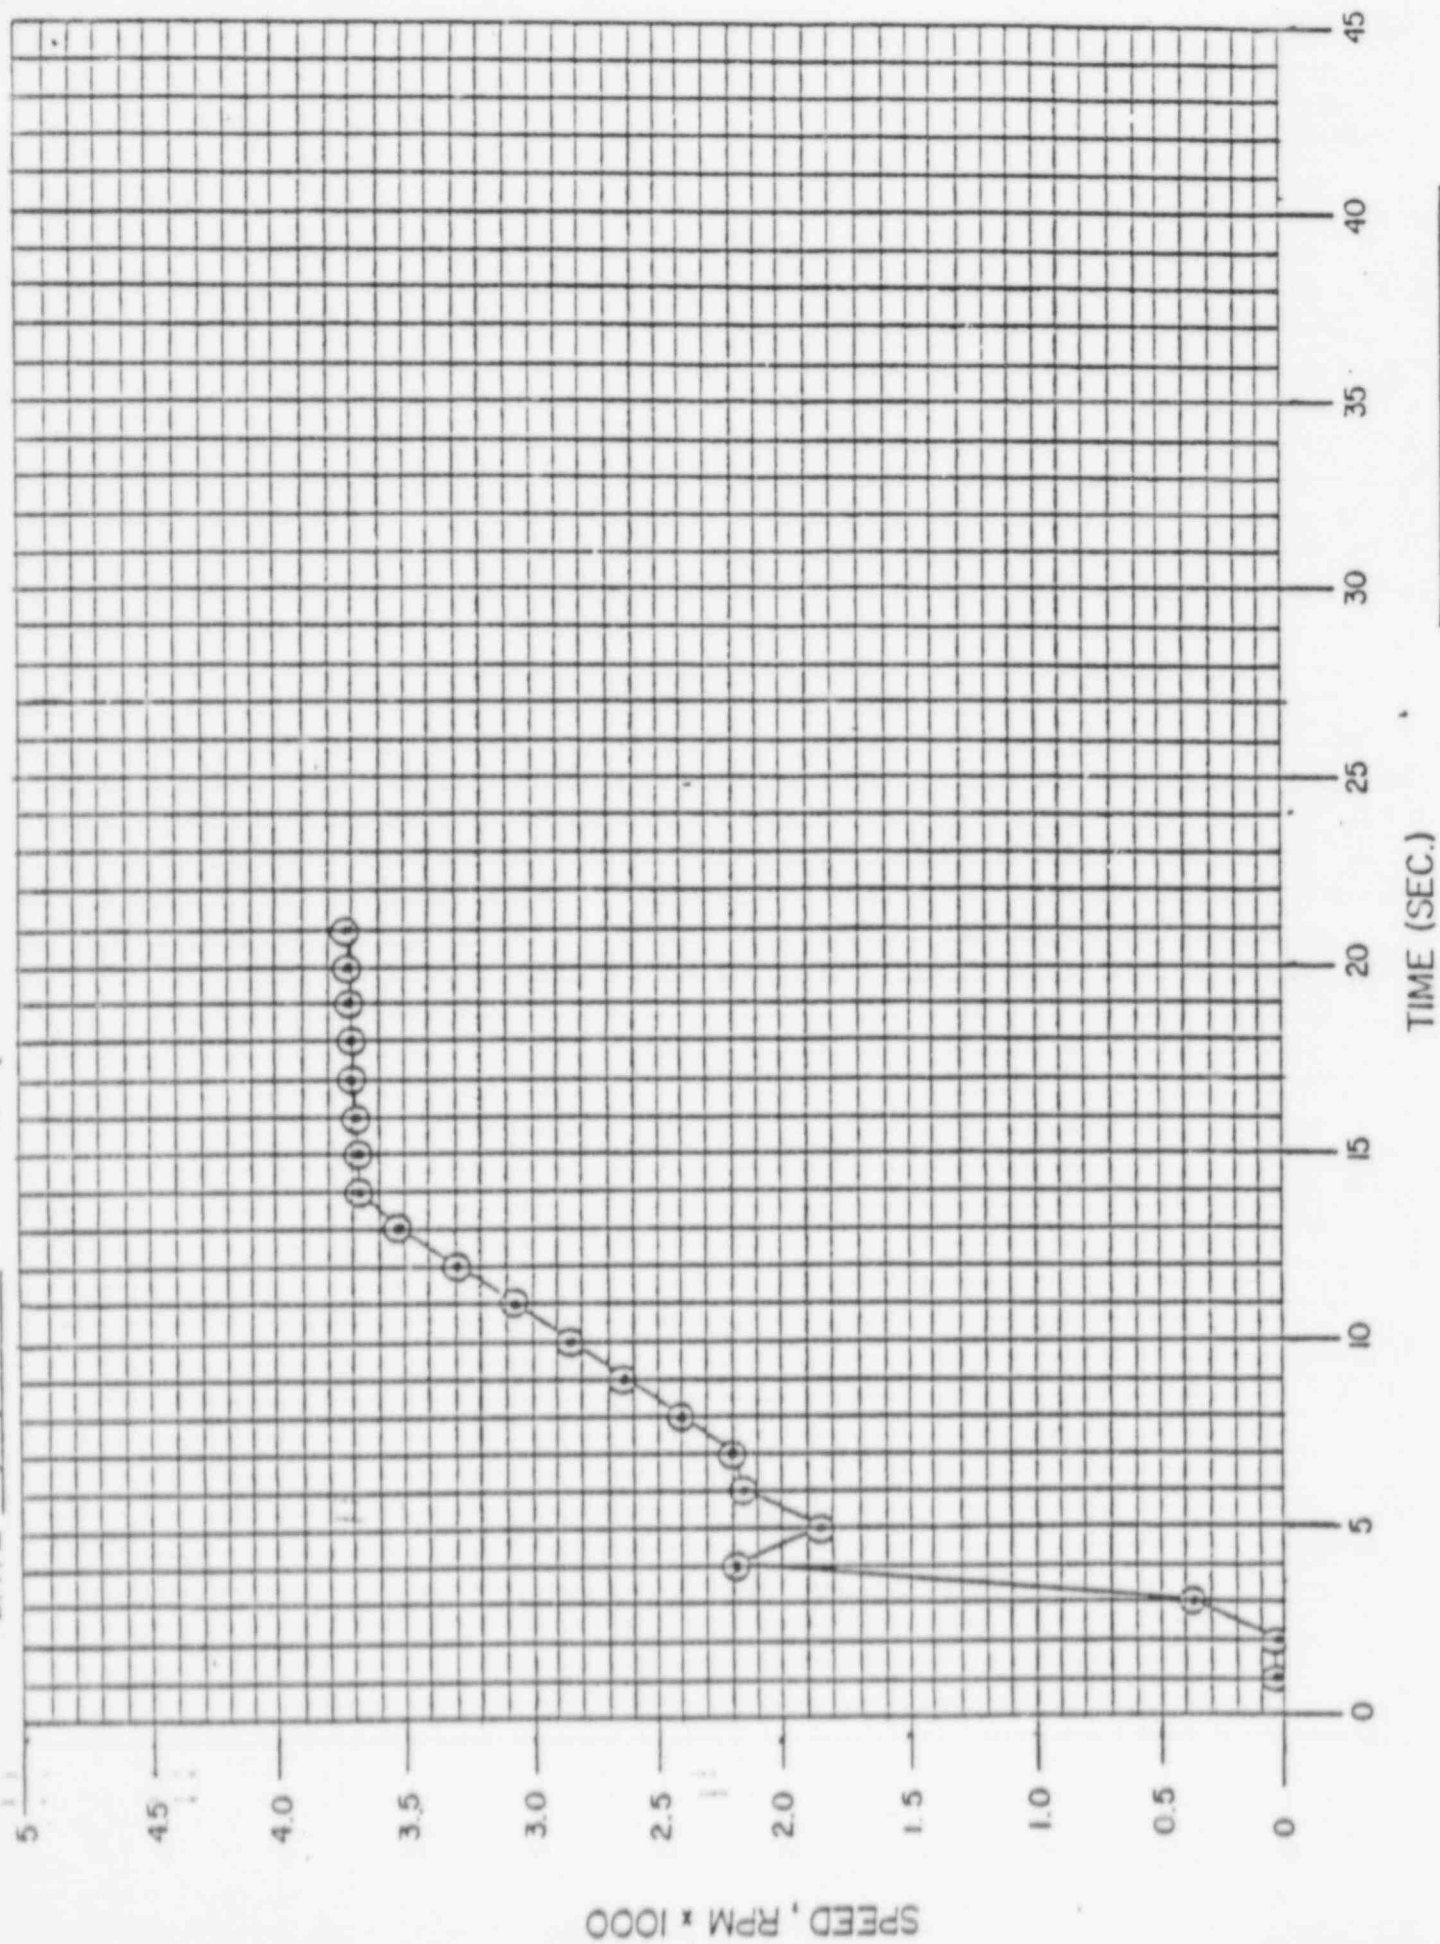
A review of the speed vs. time characteristics shows that the first run exhibited speed increases which appear to be a series of step changes rather than a constant acceleration to rated speed. The second run (performed immediately after the first) shows a constant rate of acceleration to rated speed. This is attributed to the fact that the steam lines were already heated, therefore, there would have been less condensation.

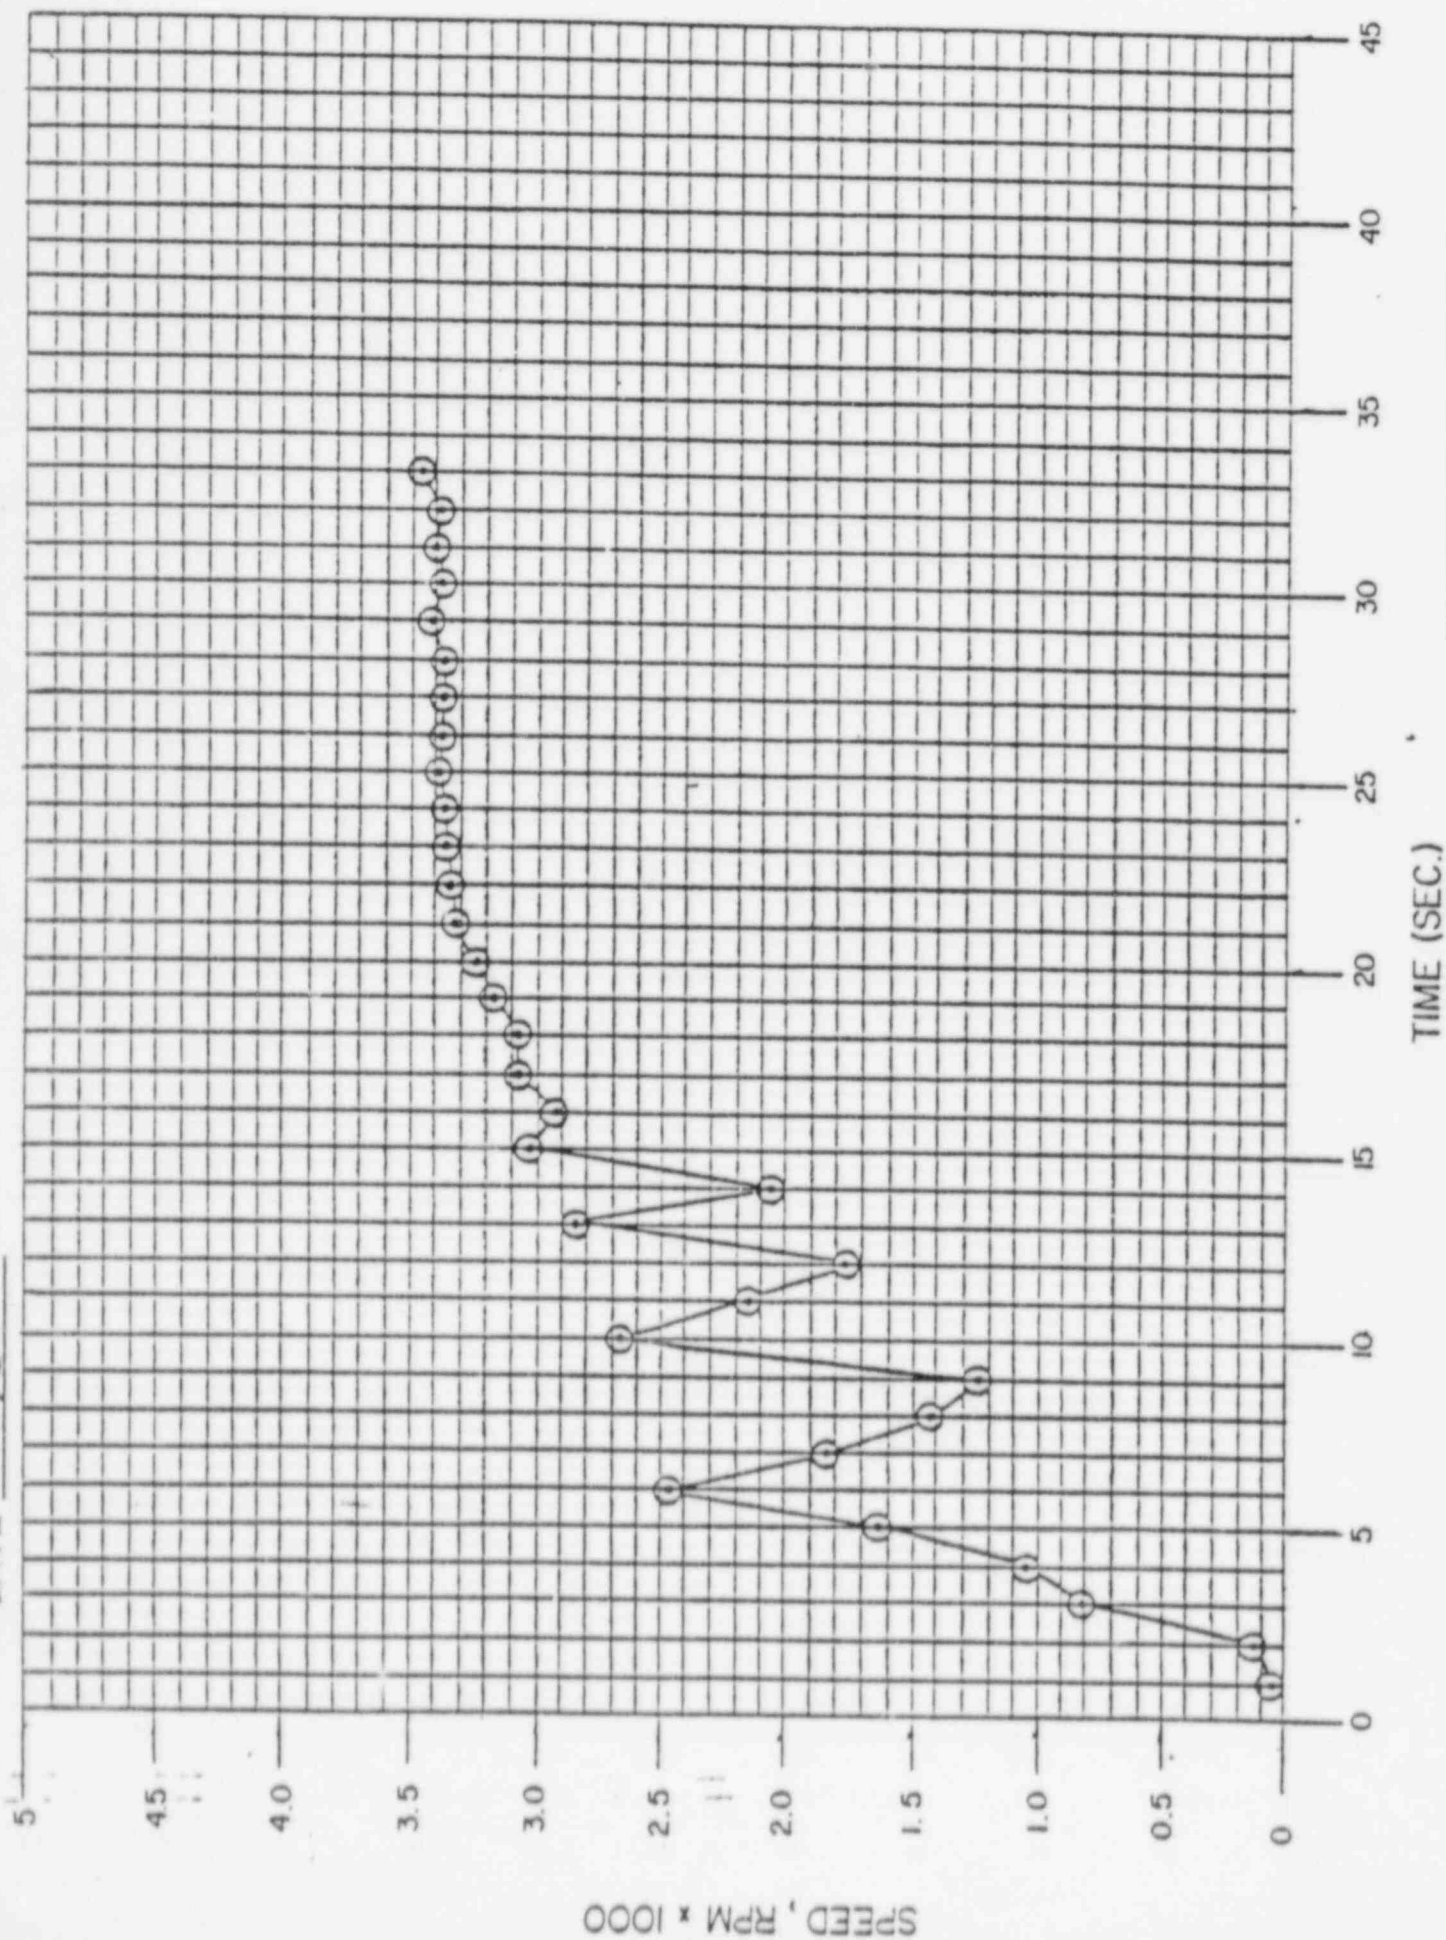
Figure 12

The speed characteristics are shown on Figures 12 and 13 of Attachment 2. A review of the speed characteristics for AFPT #1 shows the typical characteristics consistently seen on AFPT #1 (i.e., several oscillations prior to reaching rated speed).

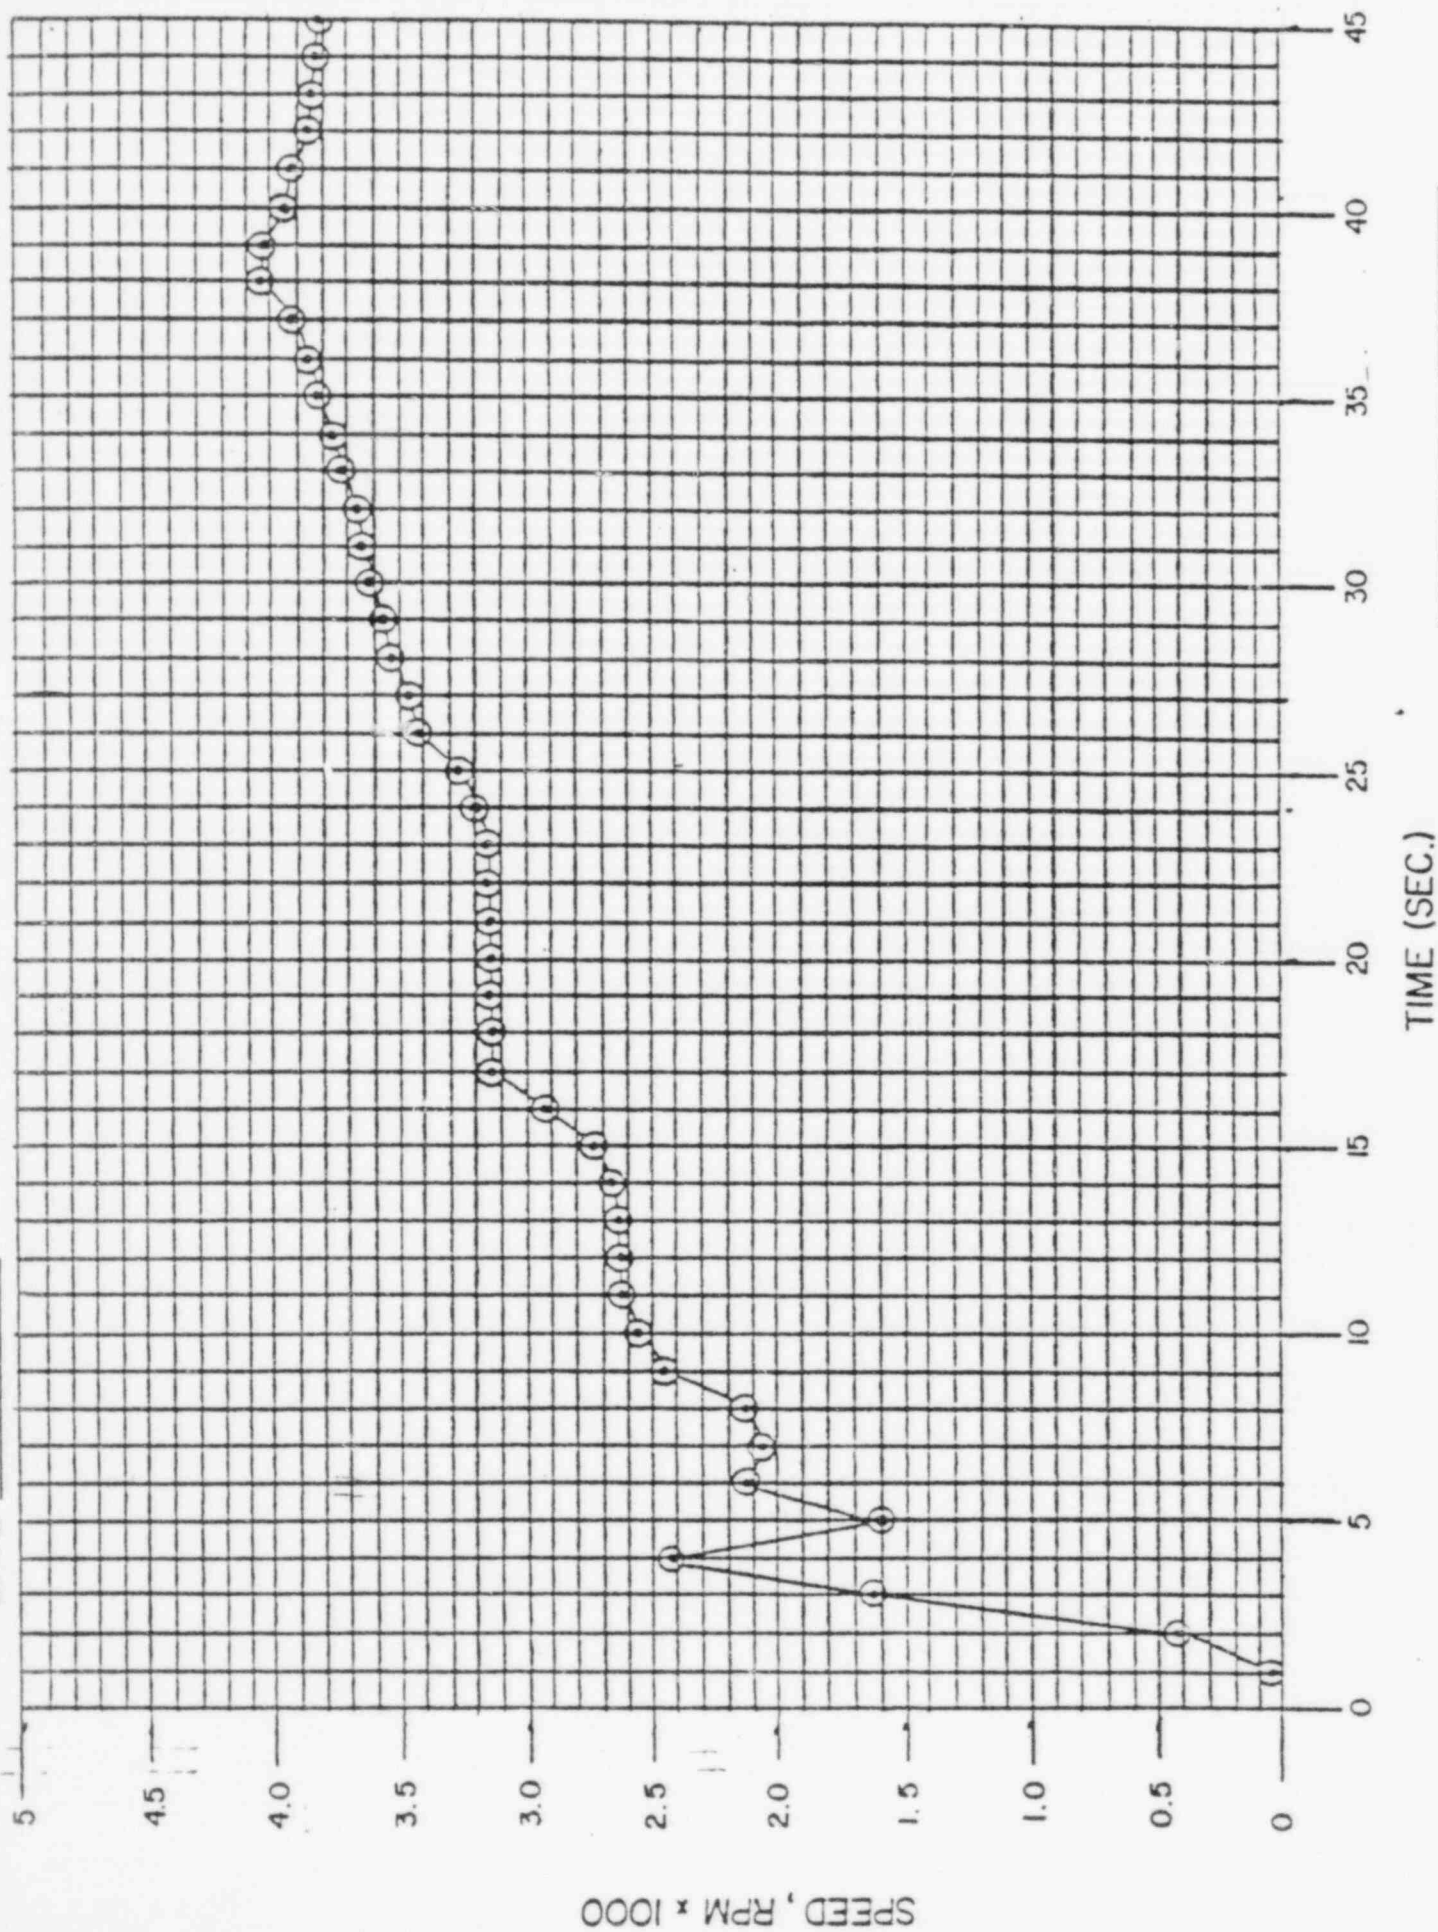
Figure 13

A review of the speed vs. time characteristics for AFPT #2 shows a fairly steady increase to rated speed but the speed continues past the high speed setpoint (3710 RPM) to approximately 4000 RPM for about three (3) seconds. The turbine then decreased speed and controlled at the high speed setpoint. During the initial increase to rated speed, the speed increases are seen as step changes rather than a straight line. These step changes, and the increase to approximately 4000 RPM, may be attributable to water slugs.

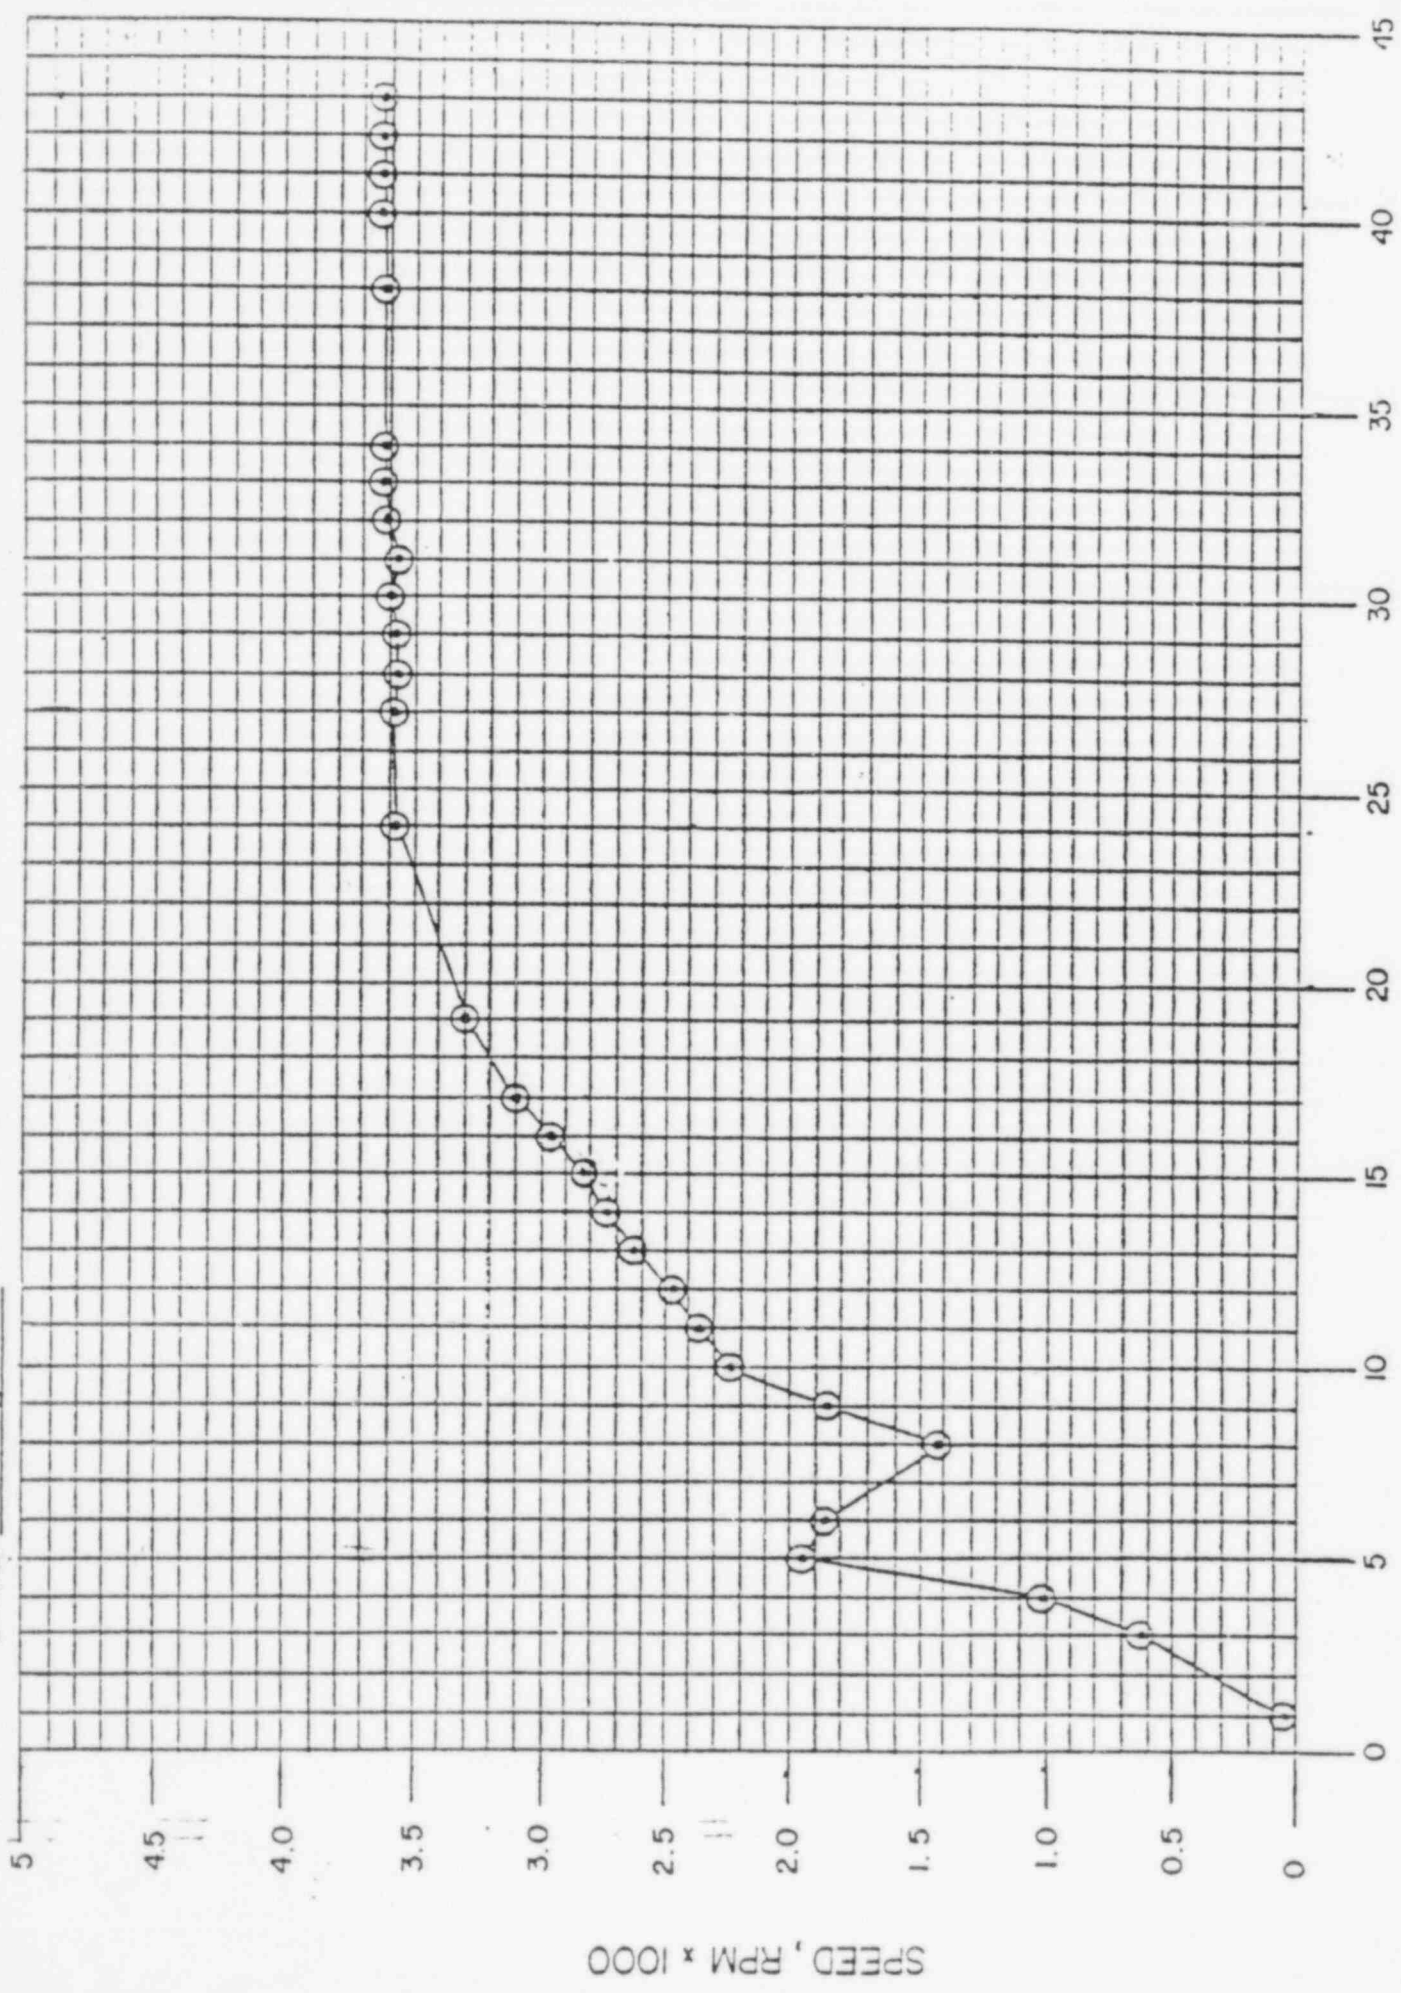
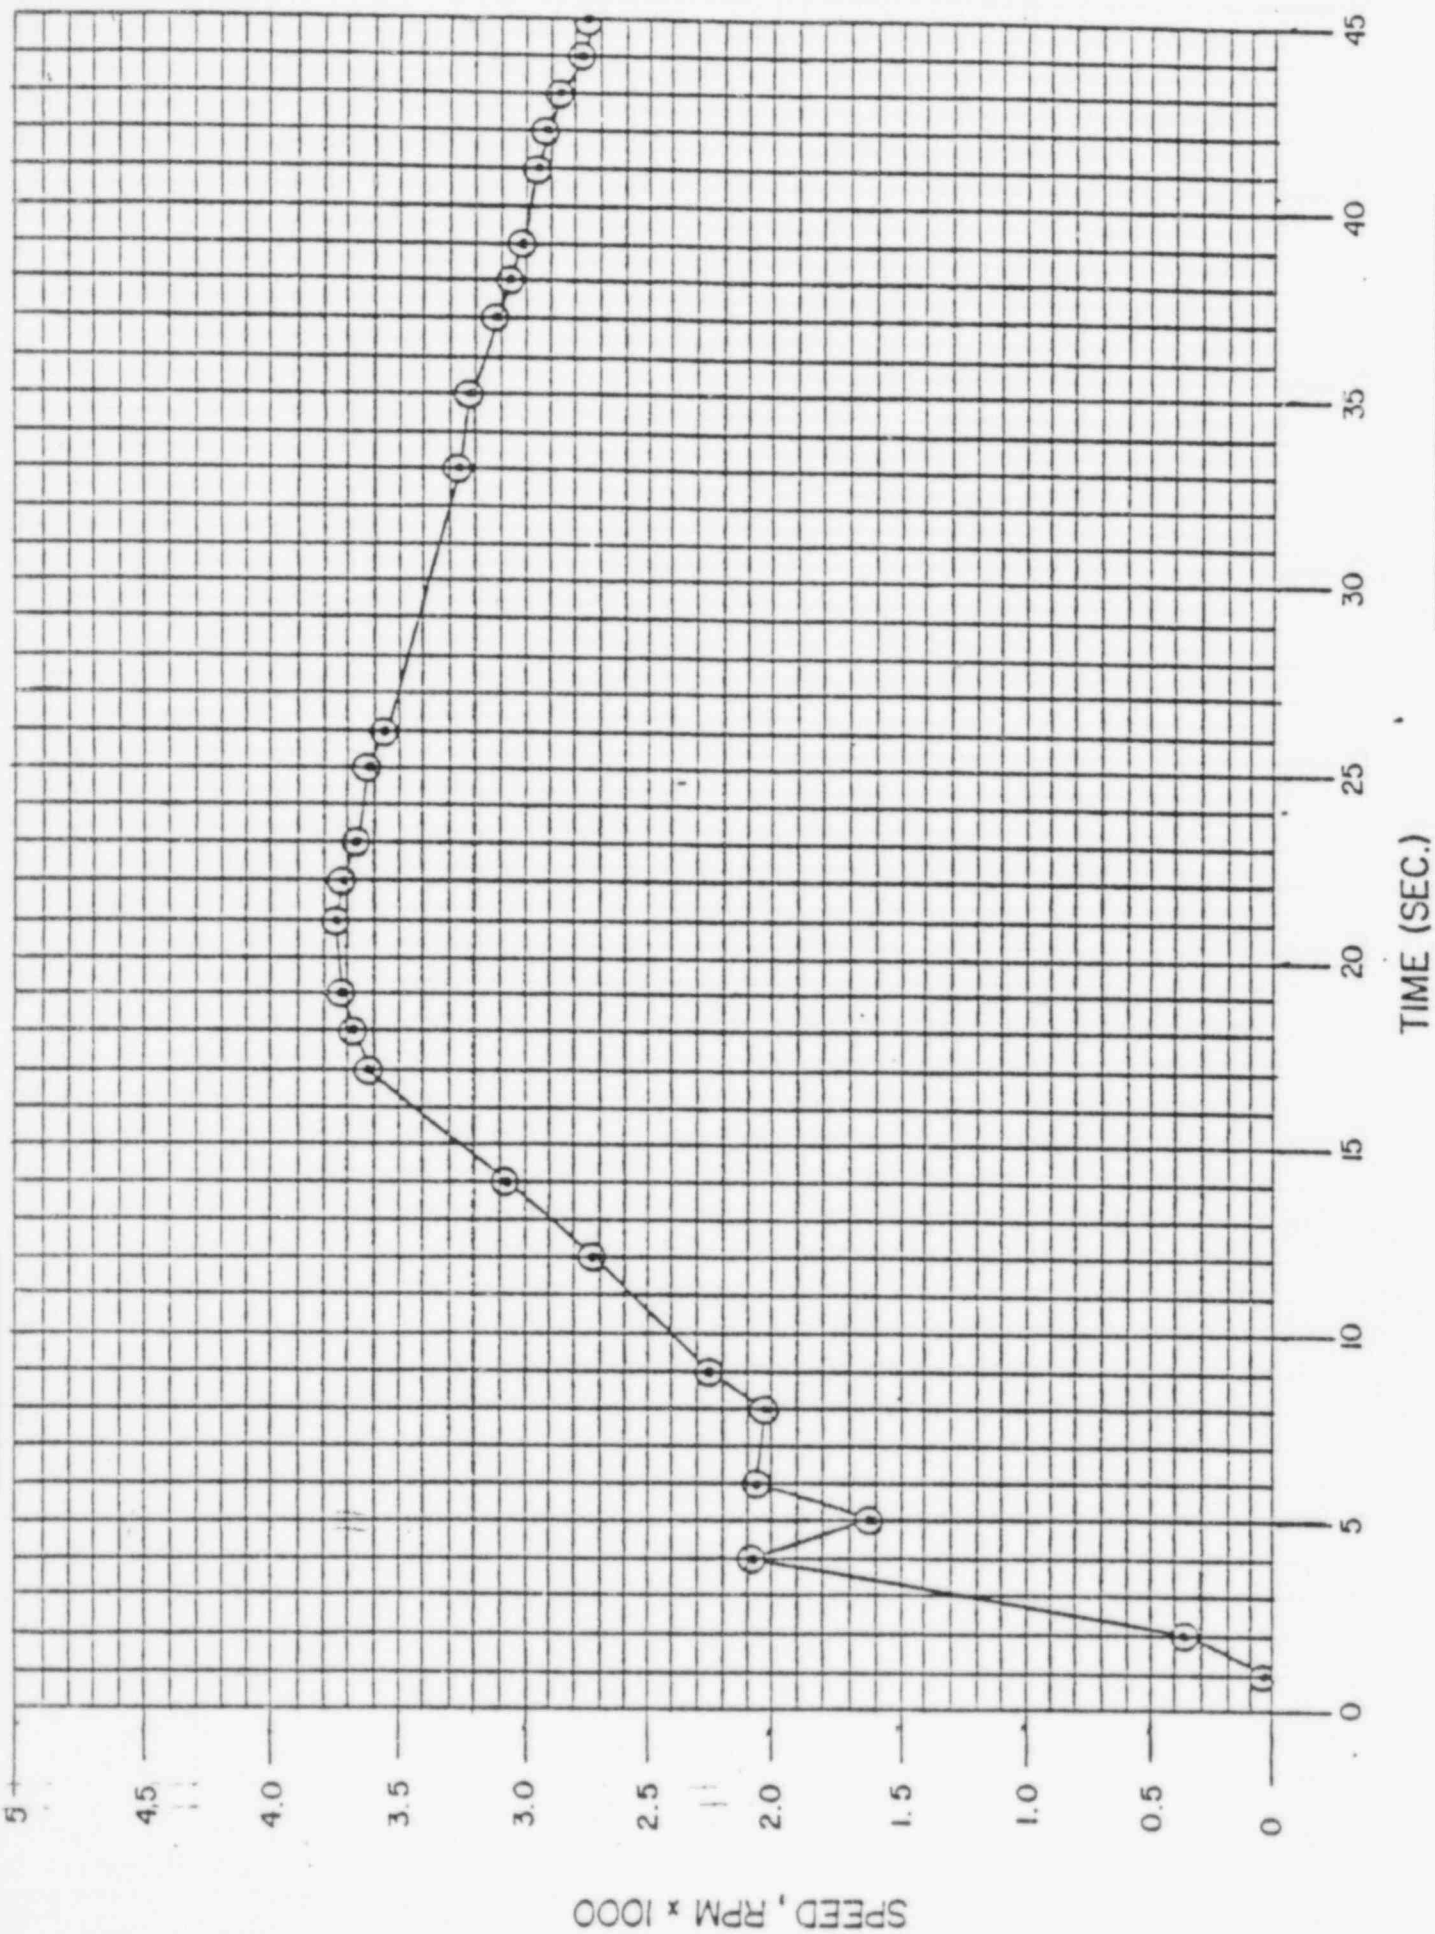
The speed characteristics are shown on Figures 14 and 15 of Attachment 2. A review of each speed vs. time characteristic shows a constant acceleration to rated speed. AFPT #1 does not exhibit oscillations seen at other times. The "smoothness" of these graphs may be attributable to the fact that minimal condensation would be expected since the lines were already heated.
