UNITED STATES OF AMERICA
NUCLEAR REGULATORY COMMISSION

COMMISSION MEETING

Briefing on Davis Besse

Date: Wednesday, July 24, 1985

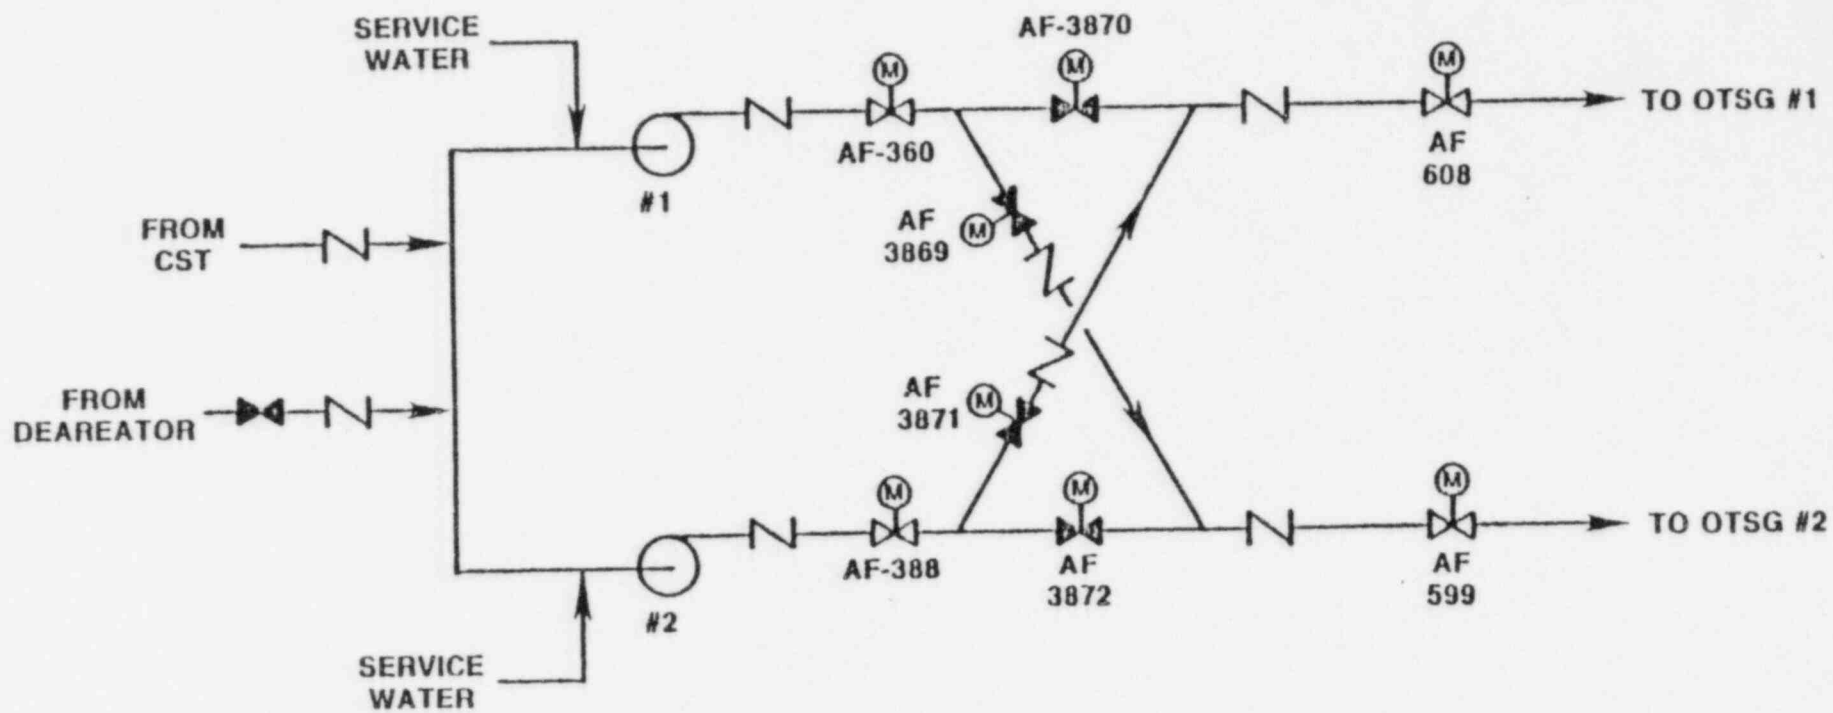
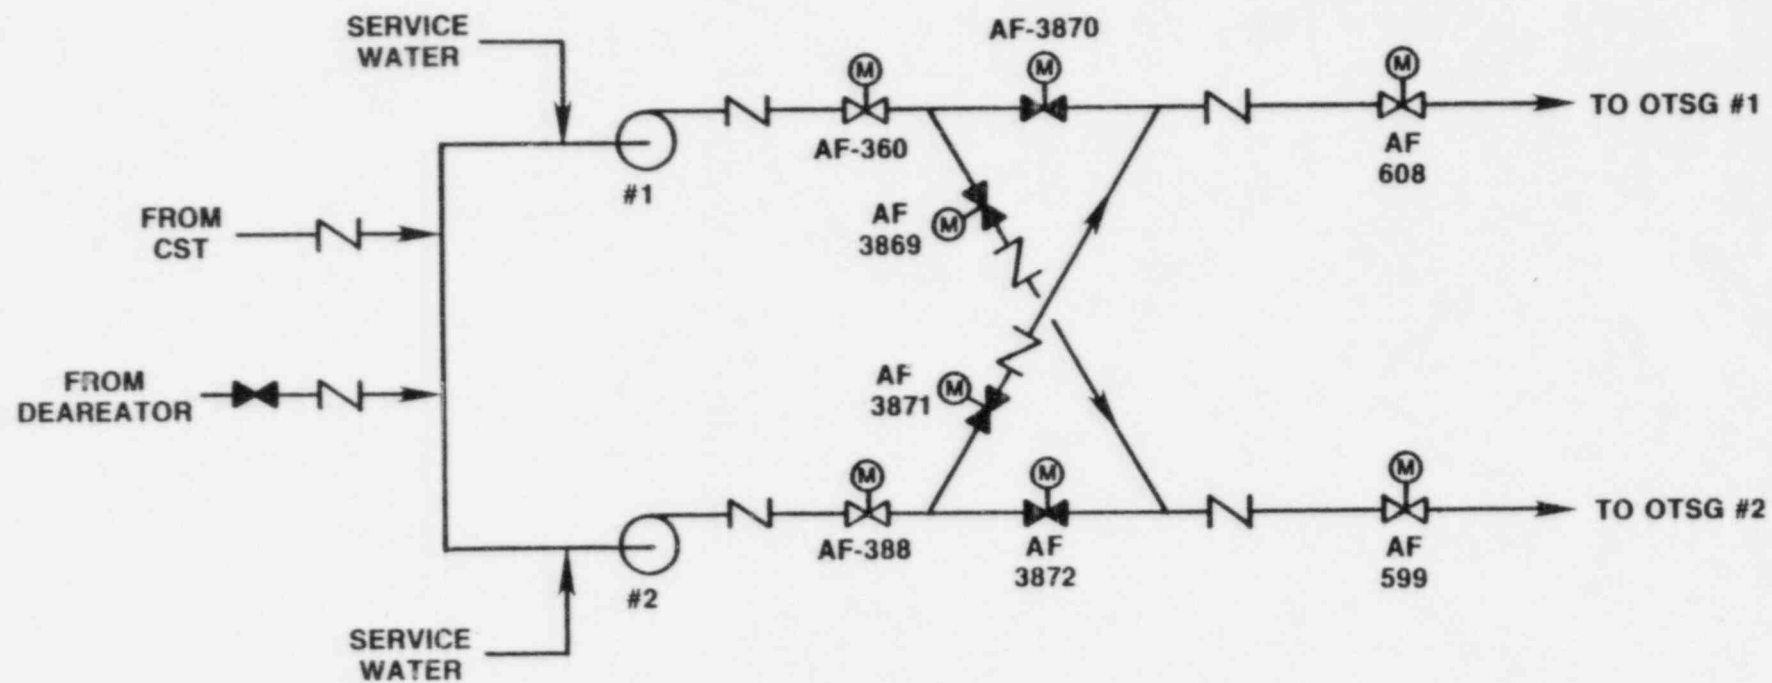
Figure 4.4 Auxillary Feedwater System

21 However, the auxiliary feedwater valves failed to
22 reopen. These are the valves that are shown in the next
23 Vu-graph. Why don't you put that next Vu-graph up.

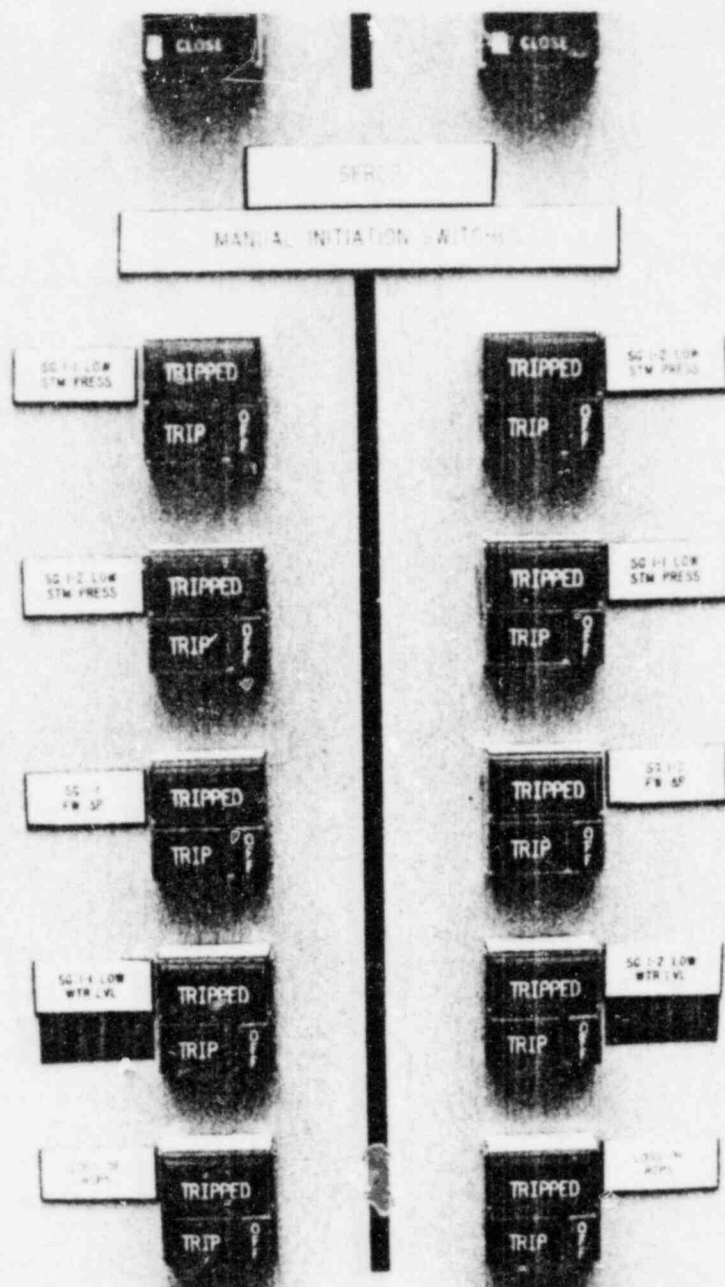
Figure 3.6 Manual Initiation Switches for SFRCs

12 This Vu-graph shows the steam and feedwater rupture
13 control system switches that the operator used. The low
14 pressure actuation switches which were actually initiated are
15 the two top buttons. It's the top one in each column. These
16 switches are not frequently used. The correct buttons that
17 the operator should have initiated are four buttons down on
18 each column, so he should have initiated the fourth button
19 down on each of the two columns.

20 Had low pressure actuation actually been the
21 intended operator action, because of what is considered to be
22 a human factors deficiency in the layout of these buttons,
23 actuated the steam and feedwater rupture control system on low
24 pressure would have required pushing the buttons on a
25 diagonal.

1 For example, the operator would have had to push the
2 first button in one column and the second button down in
3 another column in order to correctly actuate it on low steam
4 line pressure. Again, what he actually did was he pushed the
5 top two, which was in error, which basically indicated to the
6 system that both steam generators had a steam line rupture and
7 it shut off the auxiliary feed to the two steam generators.

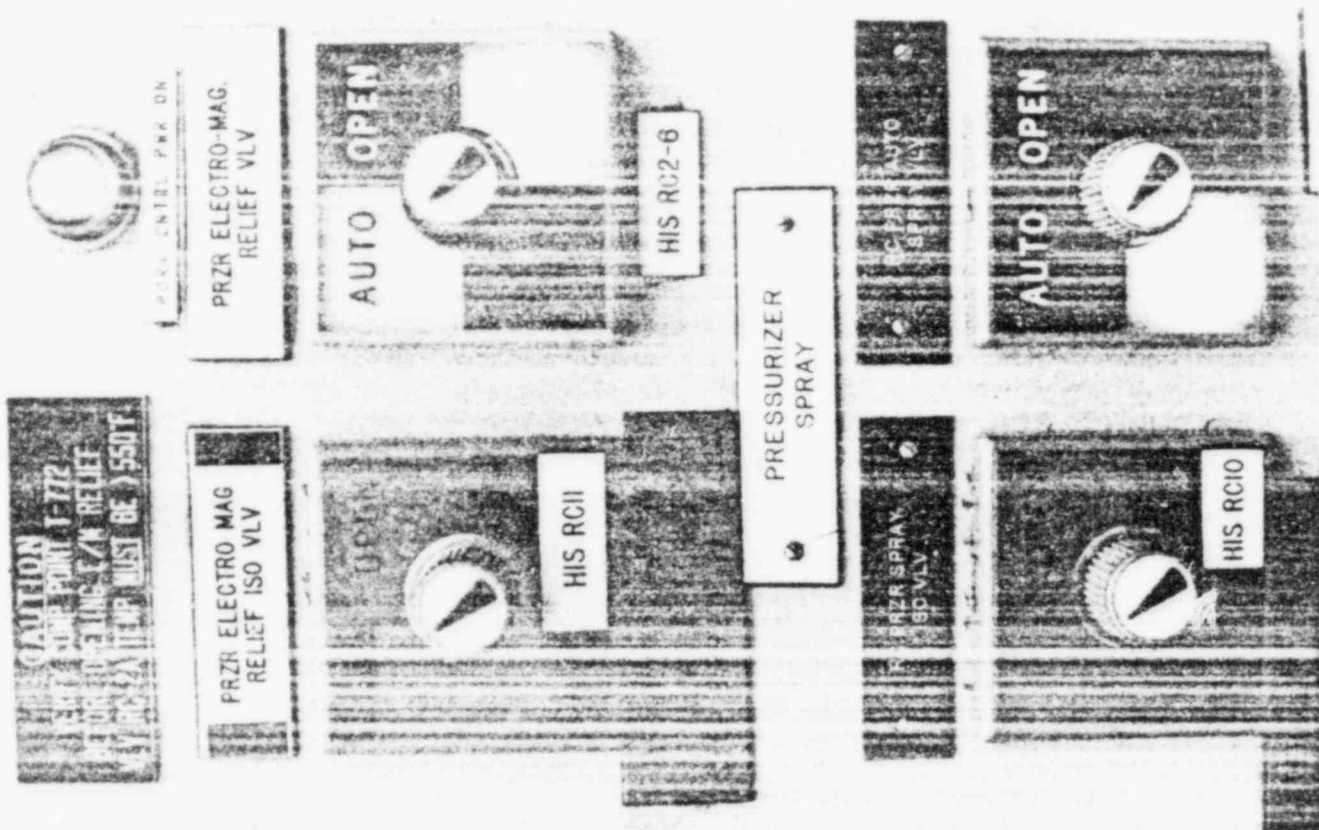
Figure 3.11 Control Station for Pressurizer PORV

17 At 16.25 minutes, the pressurizer pilot-operated
18 relief valve failed to close. This was actually the third
19 time that it had lifted during the transient, and this time it
20 failed to close. The associated block valve, however, was
21 closed by the operator within about a half-minute of that.

The acoustic monitor for the PORV was installed as one of the post-TMI safety improvements. Two redundant accelerometer sensors are mounted on the discharge piping. Each sensor channel provides a signal to drive the remote 0-100% (open) PORV position meter on the post-accident monitoring (PAM) panel, and an adjustable position signal switch to drive the remote PORV open/closed lights on the PAM panel. The Team was told that the adjustable switch was set such that the red (open) light would be energized if the flow signal is greater than 22% of the full flow value.

If PORV/block valve flow is less than 22%, the red (open) light would be turned off and the green (closed) light would be energized. The meter could be used to obtain more precise position/flow information. The PAM panel is a separate panel mounted about 7 feet to the left of where the reactor operator assigned to the primary system would be standing. Both redundant red/green PORV indicating lights are easily visible to the operator if he turns his head. However, the 0-100% meters are relatively small, i.e., about a 3-inch tall vertical edge-mounted meters. To read this meter, the operator would have to step a pace or two toward the PAM panel.
