AEOD/S503

EVALUATION OF RECENT VALVE OPERATOR
MOTOR BURNOUT EVENTS

Special Study Report
Office for Analysis and Evaluation
of Operational Data

September 1985

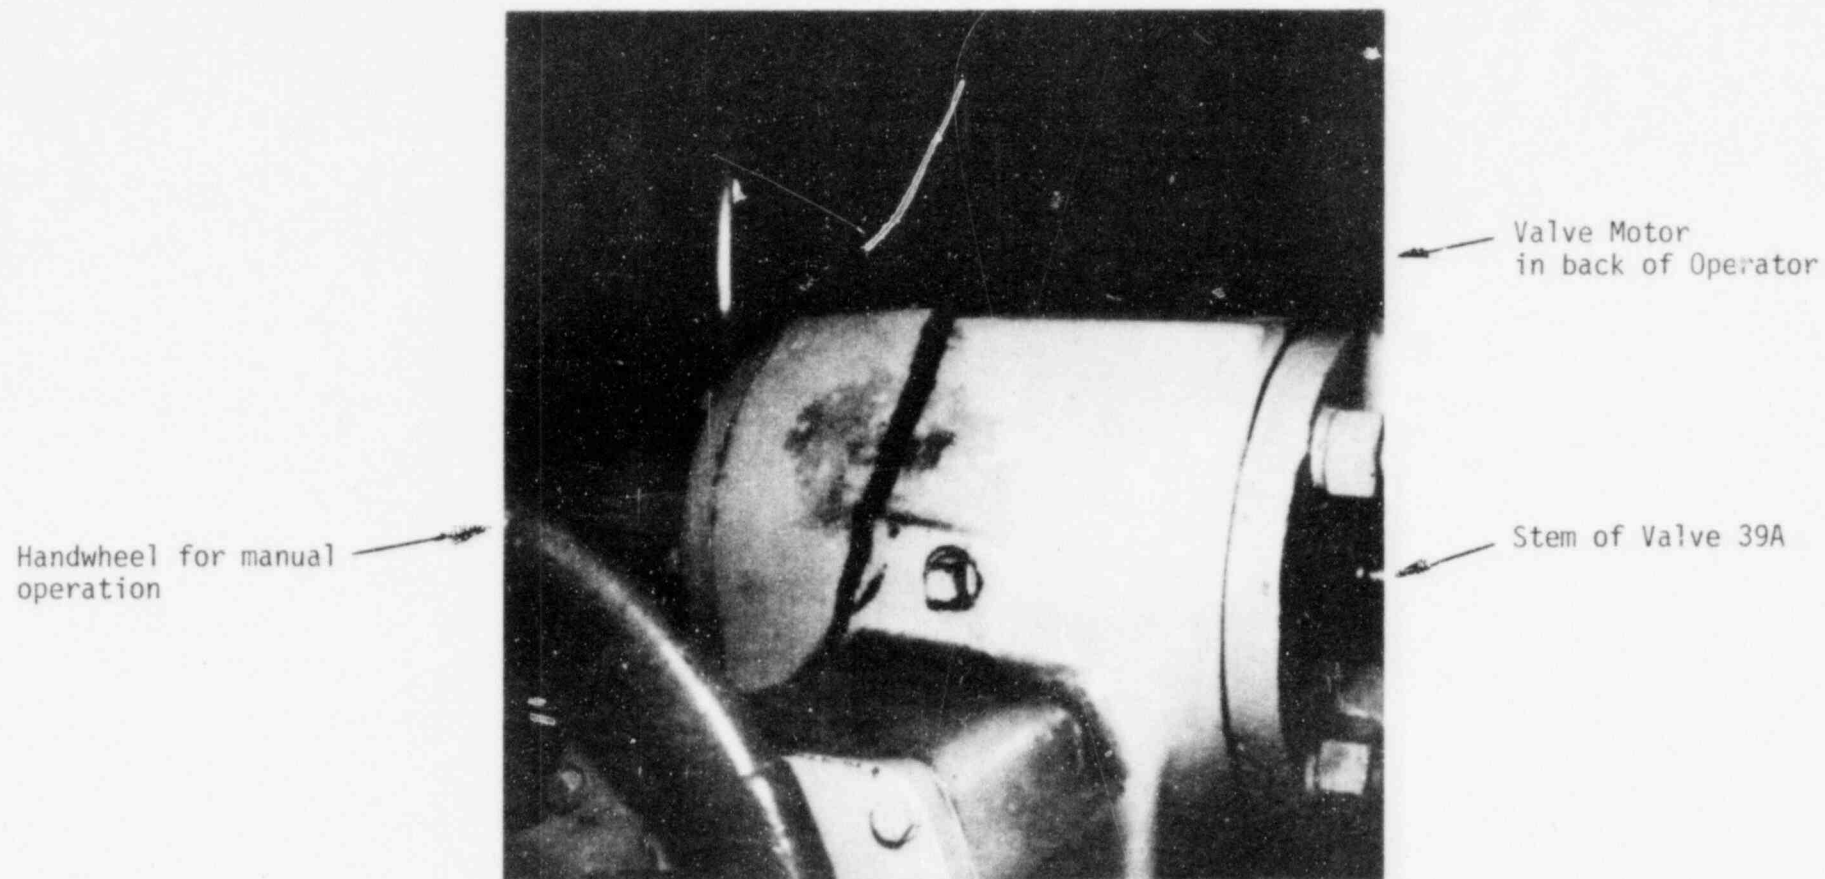
The other items in Appendix A appear to indicate lack of TOL protection because either the TOL device was oversized (such as 300% of full load current) or the TOL devices were routinely reset after the trip without an attempt to determine the root cause of the TOL trip. In addition to lack of TOL protection, item 14 illustrates a potentially serious side effect of the motor burnout mode of failure. In that event, the closing torque switch did not stop the motor when the valve reached the fully closed position. Also, the TOL device was sized at 300% of the full load current and did not trip to stop the motor. The motor housing was found cracked open (see Figure 1) and dislocated sufficiently to cause the internal mechanism to jam which also prevented manual operation of

the valve. Hence, motor burnout resulted in loss of both motor and manual operational modes of the valve. This aspect could have serious implications involving several safety systems that have valves outside containment where valve operability may have been presumed assured by manual means (although possibly delayed) even if the valve operator motor was damaged. Therefore, this event appears to represent a potential generic failure mechanism which could prohibit both remote and manual valve operation.

Fig. 1 Failed SMB-0 Motor Operator For Valve 39A

14. 271 Vermont Yankee	Inspection Report 50-271/84-08	Torus cooling was secured by closing upstream isolation valve V10-39A. Approximately one minute after closing, a 125% overload condition was annunciated in the control room and the circuit breaker tripped open. Torque switch had not stopped motor when valve closed. Motor circuit shorted and caused magnetic overcurrent trip. The TOL was set at 300% and did not actuate to de-energize the motor to provide protection. Motor operator housing was cracked and prevented both motor and manual operation of the valve.
