UNION ELECTRIC COMPANY  
Callaway Plant

DOCKET NUMBER 50-483  
CALLAWAY PLANT UNIT 1  
FACILITY OPERATING LICENSE NPF-30  
SPECIAL REPORT 85-09  
LOOSE PARTS MONITORING SYSTEM

SPECIAL REPORT 85-09  
LOOSE PARTS MONITORING SYSTEM CABLE FAULT

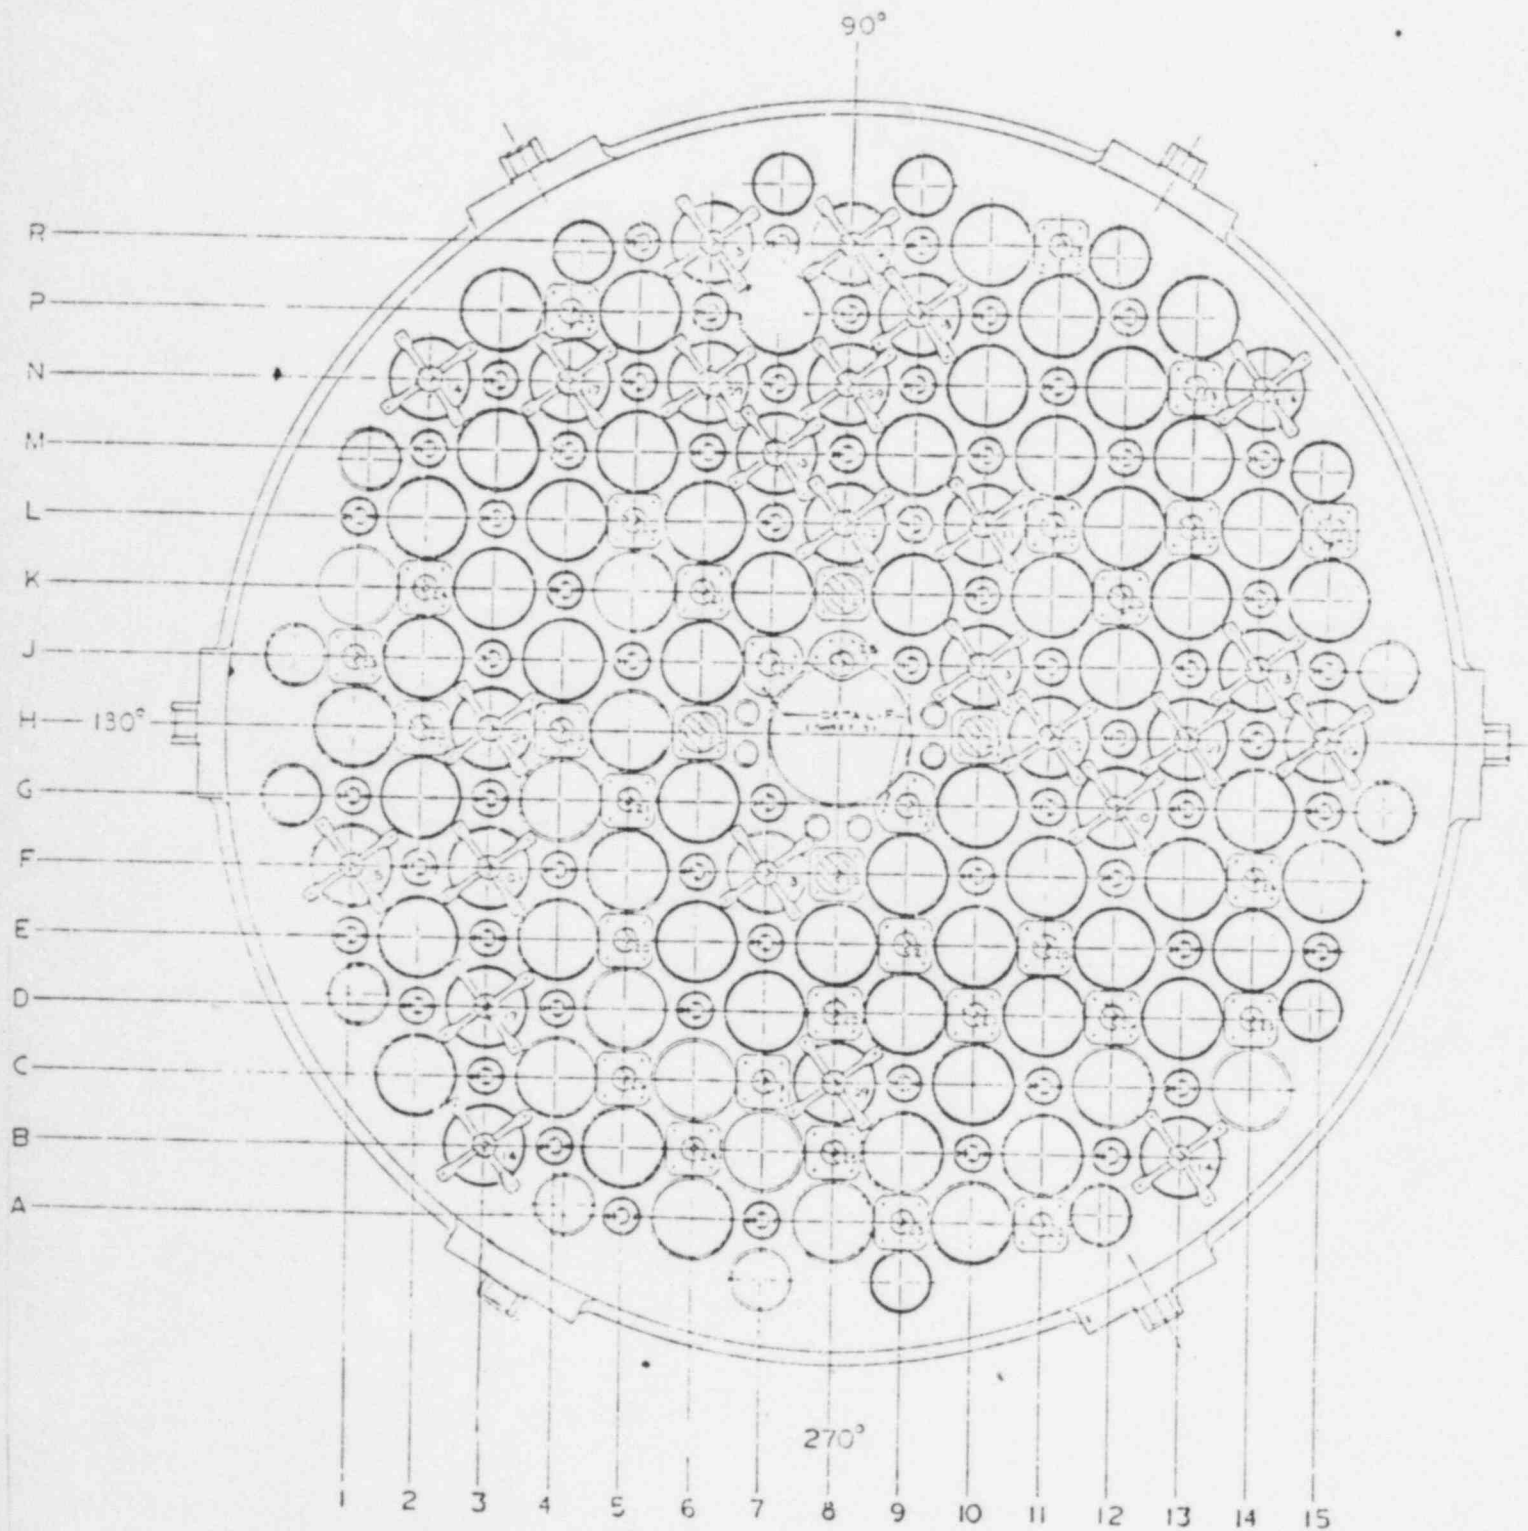
Lower Core Support Assembly

At approximately 1812 CDT on 8/23/85 Channel 1 of the Loose Parts Monitoring System indicated a cable fault during the Control Room Shift and Daily Log Readings and Channel Check Surveillance. The channel would not reset after receiving and indicating the test alarm signal. The plant was in Mode 1 at 97% power.

The Channel 1 accelerometer is located on in-core instrumentation guide tube 44 at a distance of not more than 6 inches from the bottom of the reactor vessel. An additional accelerometer (Channel 2) is also located on the lower reactor vessel on guide tube 42. Channel 2 was verified operable upon discovery of the cable fault on Channel 1.

A Work Request was initiated to troubleshoot Channel 1. Verification and investigation of the Channel 1 circuitry from the Control Board to the Bio-Shield did not indicate the cause for the malfunction. No further investigation inside the Bio-Shield has been done due to the radiation level.

guide tube 44 located at R6  
guide tube 42 located at D3

Additional investigation inside the Bio-Shield will be conducted at the first outage of sufficient duration. Channel 1 will be returned to operable status no later than restart following the first refueling.
