UNIVERSITY OF ALASKA, FAIRBANKS  
Fairbanks, Alaska 99701

June 27, 1985

The present letter concerns the recent NRC inspection of Licenses 50-02430-09 and 50-02430-07 on June 20 and 21, 1985 and provides corrective measures taken to alleviate non-compliance items found during that inspection.

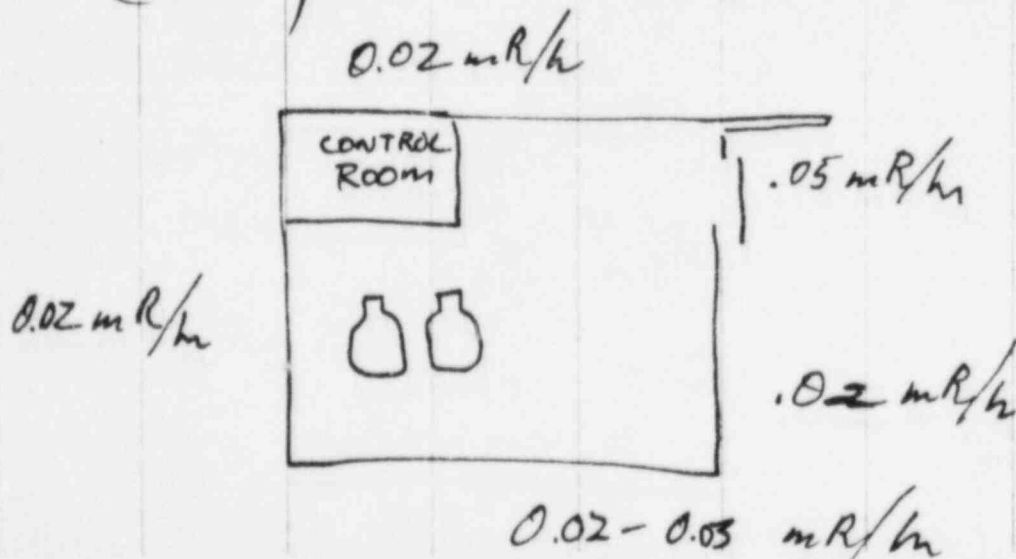
A survey was conducted with the irradiators (outside the building) in the irradiate position - readings were as indicated (Survey Meter NC 2560 was used)
