ATOMIC POWER COMPANY •

September 24, 1985
MN-85-167

Subject: Additional Information on IE Bulletin 80-11 - Masonry Wall Design

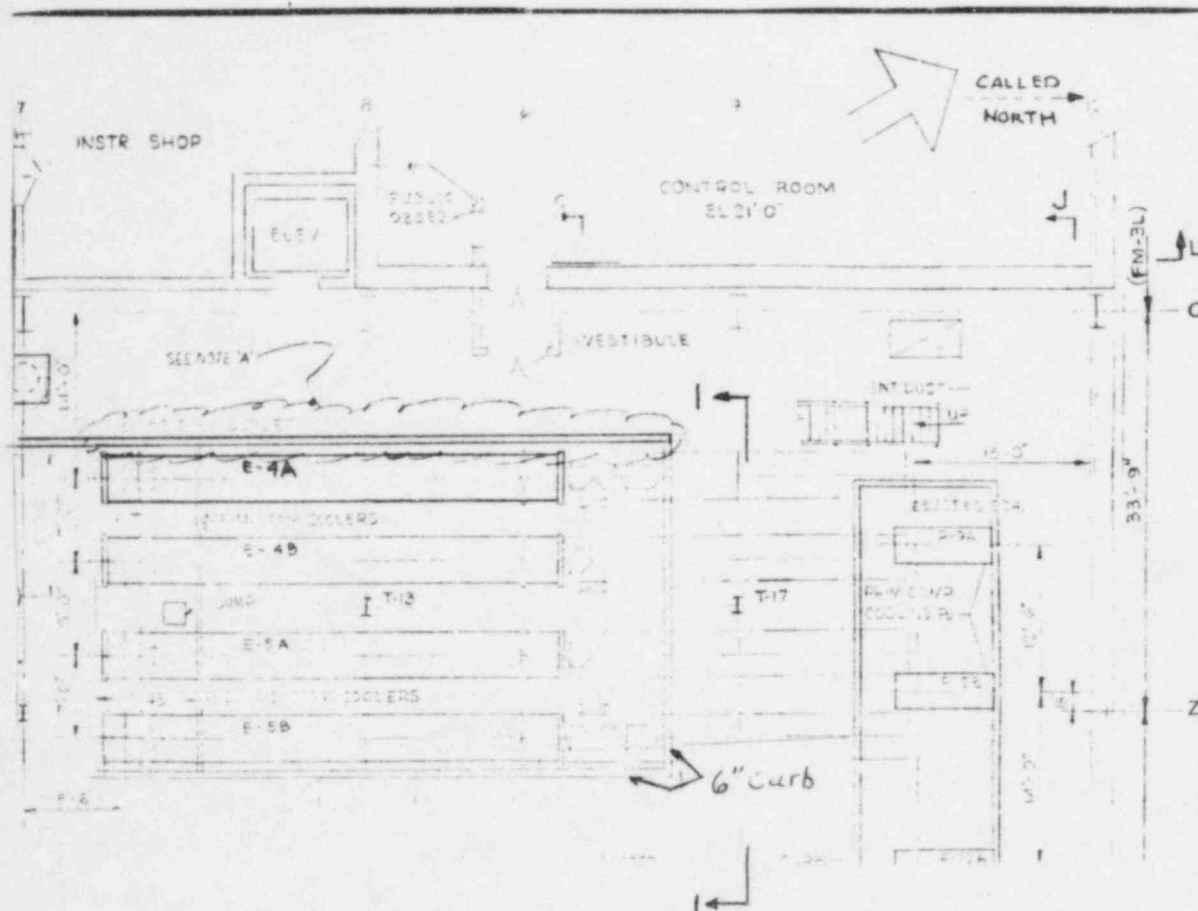
PLAN VIEW
ELEV. 21'-0" TURBINE BLDG.
 (REFER TO NEXT SKETCH FOR SECT. 1-1)

As shown on the attached sketches the block wall adjacent to Hx E-4A is within 1"-4" of the heat exchanger and the top of the wall is only 4" above the centerline of the heat exchanger.

The consequence analysis performed to assess the impact of this wall collapsing during a seismic event consisted of two tasks. First, the wall was assumed to pivot about its base and strike the heat exchanger with a line load along its longitudinal centerline. This impact resulted in a shell stress of approximately 4 ksi, well below the shell material allowable. Second, a detailed reinspection of the heat exchanger was performed by Yankee Nuclear Services Division on September 19, 1985, to ensure that there were no small attachments to the heat exchanger shell which could be damaged by block debris. This reinspection found no attachments which could be damaged (the heat exchanger was originally inspected on or about December 15, 1980).

NOTE A : 8" BLOCK WALL NEAR PCC HX E-4A
