Enclosed is the trip report written by the NRC staff following their visit to the Canonsburg UMTAP site on May 16 and 17, 1985. The report provides recommendations for DOE and NRC to consider in the performance of this remedial action. We hope that our observations and perceptions of the status of construction at Canonsburg will be helpful to you.

CANONSBURG UMTRA ON-SITE CONSTRUCTION REVIEW - MAY 16-17, 1985
prepared by
Steve Smykowski (WMEG) and William L. Dam (WMGT)

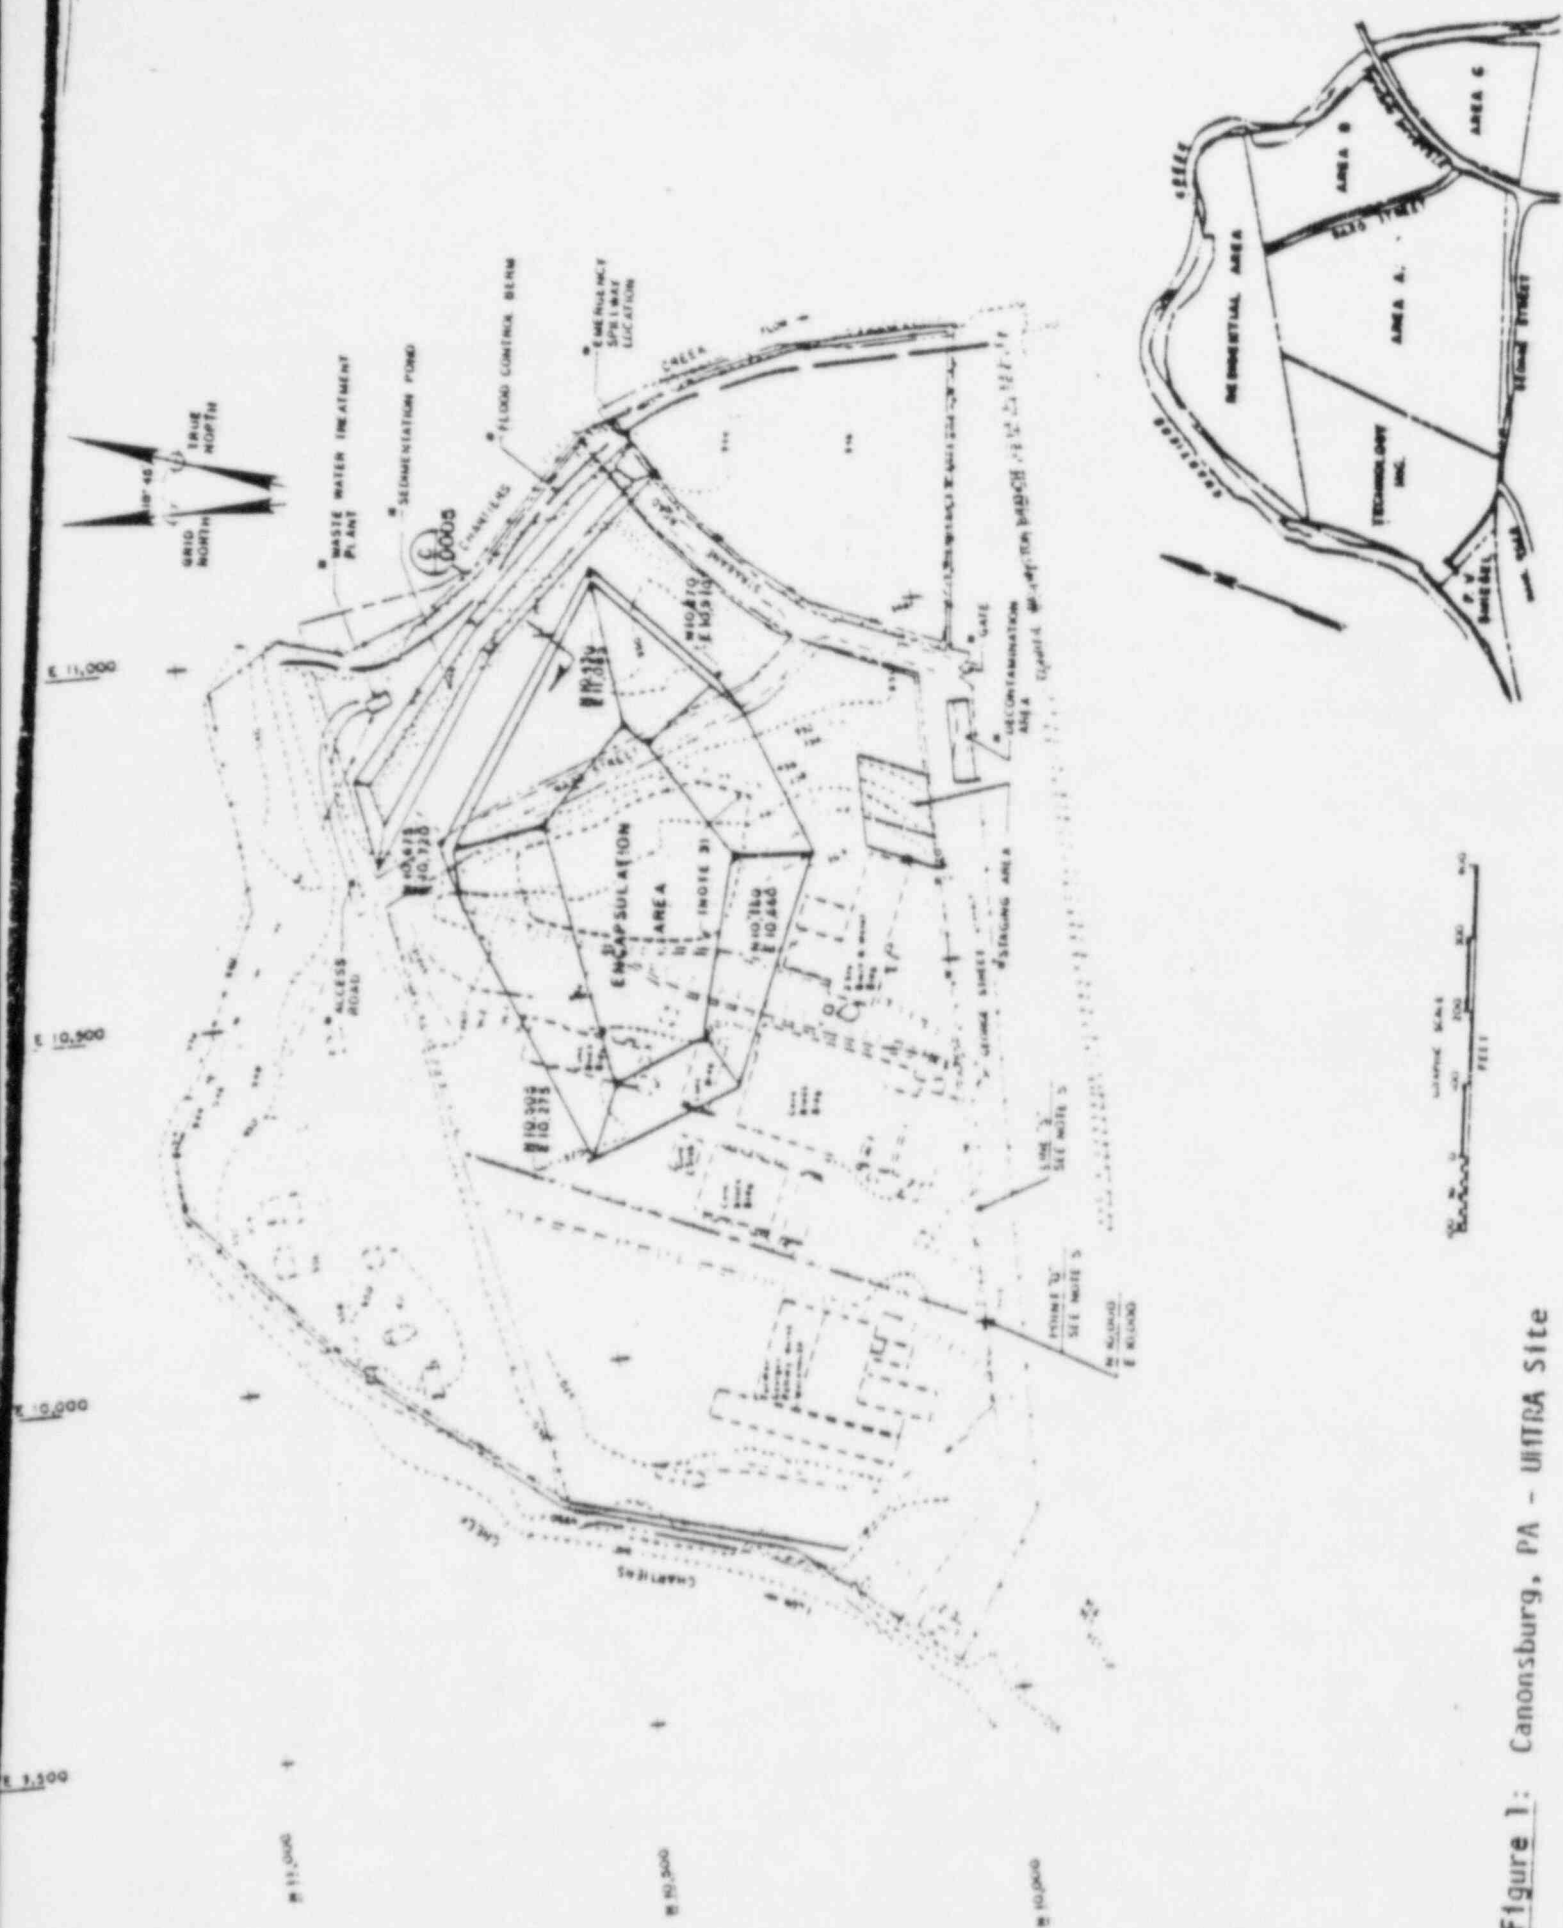
SITE AREA DESIGNATIONS

A plan view of the site is shown in Figure 1. The site is bounded by Chartiers Creek on three of its boundaries. For remedial action purposes, the site has been divided into five areas. The encapsulation cell is being placed in Area A and Area B as shown in Figure 1. Figure 2 shows a typical cross-section of the design through the encapsulation area.

Area B is contiguous to Area A and is located east of its boundary (Figure 1). The major portion of the highly contaminated soil lens (estimated average radium concentration of 505 pCi/g) that the DOE has proposed to stabilize-in-place outside the encapsulation cell is located in this area. Although this lens also extends into the eastern portion of Area A where it will be covered by the encapsulation cell, a large portion of the lens in Area B will not be covered by the cell.

By letter dated April 3, 1985 from Themelis (DOE) to Nixon (NRC), the DOE and RAC indicated that the contaminated soil lens extends from the eastern edge of the encapsulation cell to the surface water collection pond. However, during the site visit, we learned that the lens is more extensive than what was originally communicated to the NRC. Larry Farnes (RAC) indicated that a portion of the lens can also be found between the collection pond and Chartiers Creek (Figure 1).
