Joseph M. Farley Nuclear Plant Unit 2 Containment Post-Tensioning System Five-Year Inservice Inspection

Volume 1 – Report

Southern Company Services, Inc.
September 1985

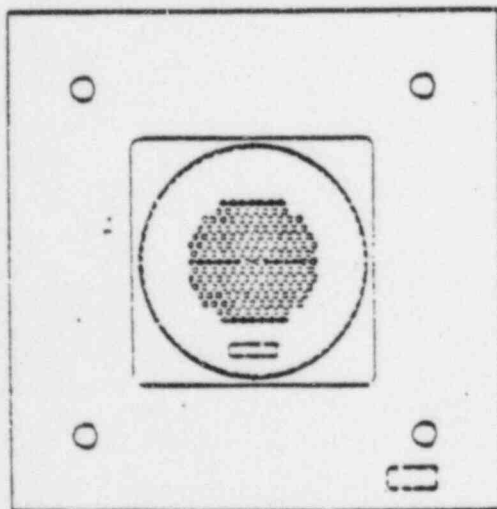
ANCHORAGE ASSEMBLY INSPECTION
SHOP END OF TENDON NO. V-4.

HAS B & C CORROSION LEVEL.

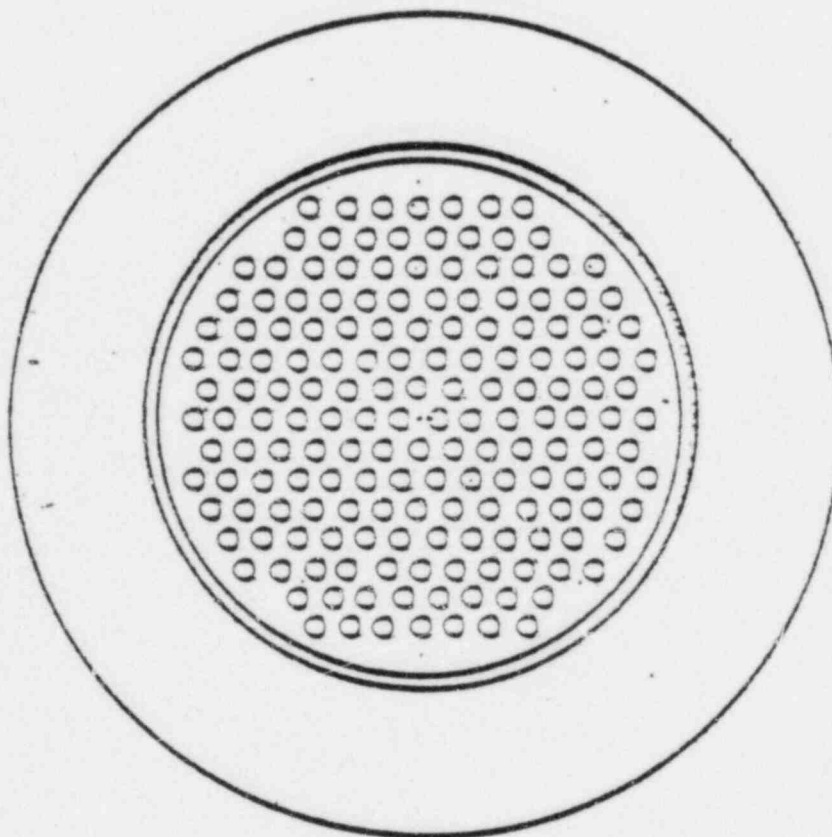
NO MISSING, UNSEATED OR MISSHAPED BUTTONHEADSNO SPLITS > 0.12"

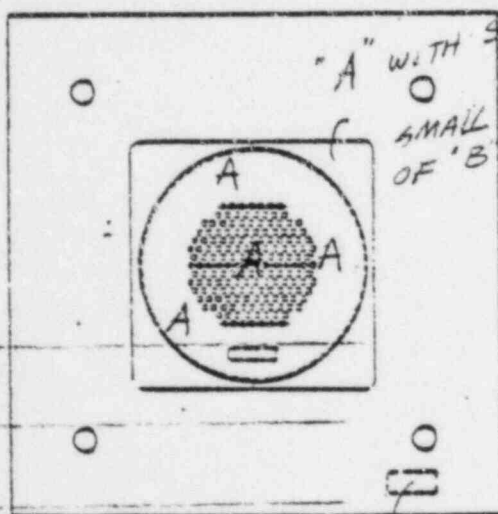
Degree of Corrosion "A" WITH "B" & "C"

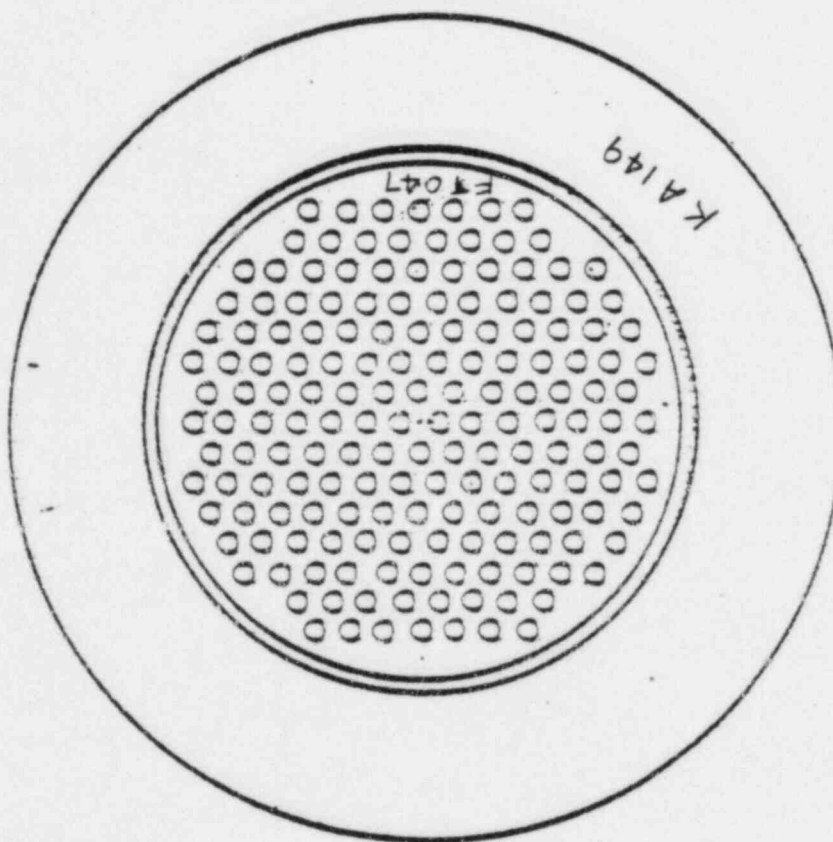
TENDON V-28

NO MISSING, UNSEATED OR IMPROPERLY FORMED

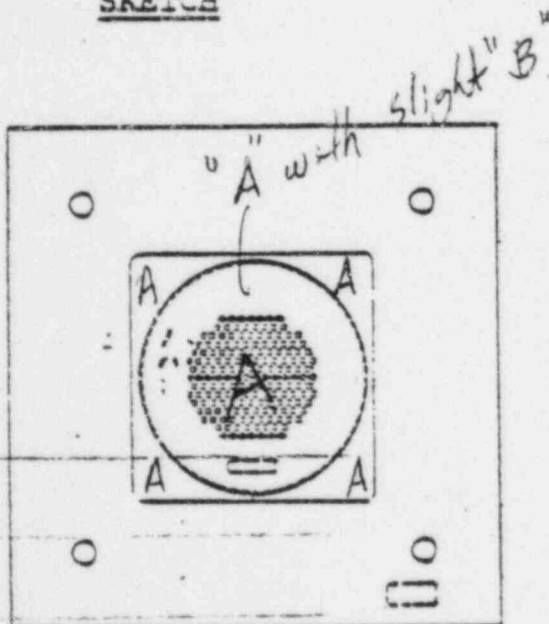
ANCHORAGE ASSEMBLY INSPECTION
FIELD END OF TENDON NO. V-28

REMARKS: ANCHORAGE LOOKS GOOD,
SHIM GAPS GOOD, "B" CORROSION
ON HEAD IS VERY SLIGHT
AND APPEARS TO HAVE BEEN
PRESENT AT INSTALLATION,
"B" CORROSION IS NOT PROGRESS
GASKET RETAINER PLATE IN
GOOD CONDITION "A" LEVEL
OF CORROSION

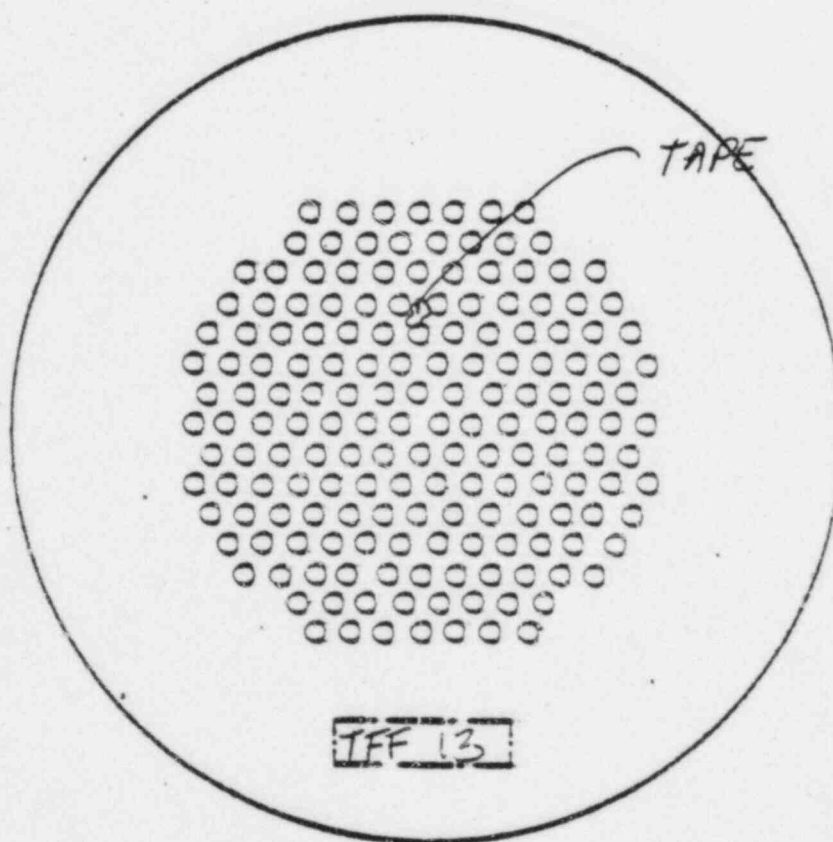
TENDON V-28

FOUND SMALL PIECE OF TAPE - REMOVED ALL
VISIBLE TAPE

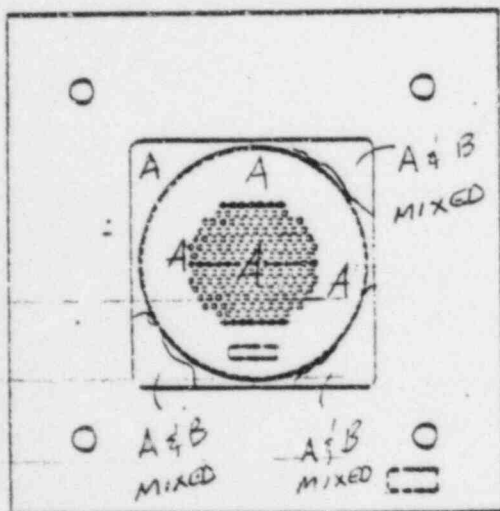
Degree of Corrosion "A", "B", "C" ^{ONE SPOT} _{OF "C"}

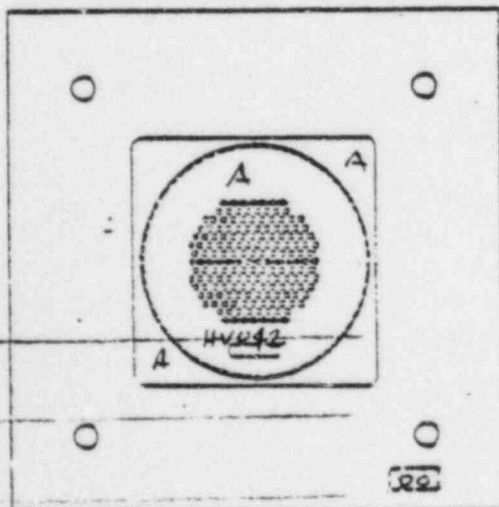
ANCHORAGE ASSEMBLY INSPECTION
FIELD END OF TENDON NO. V-52

'A' TYPE CORROSION

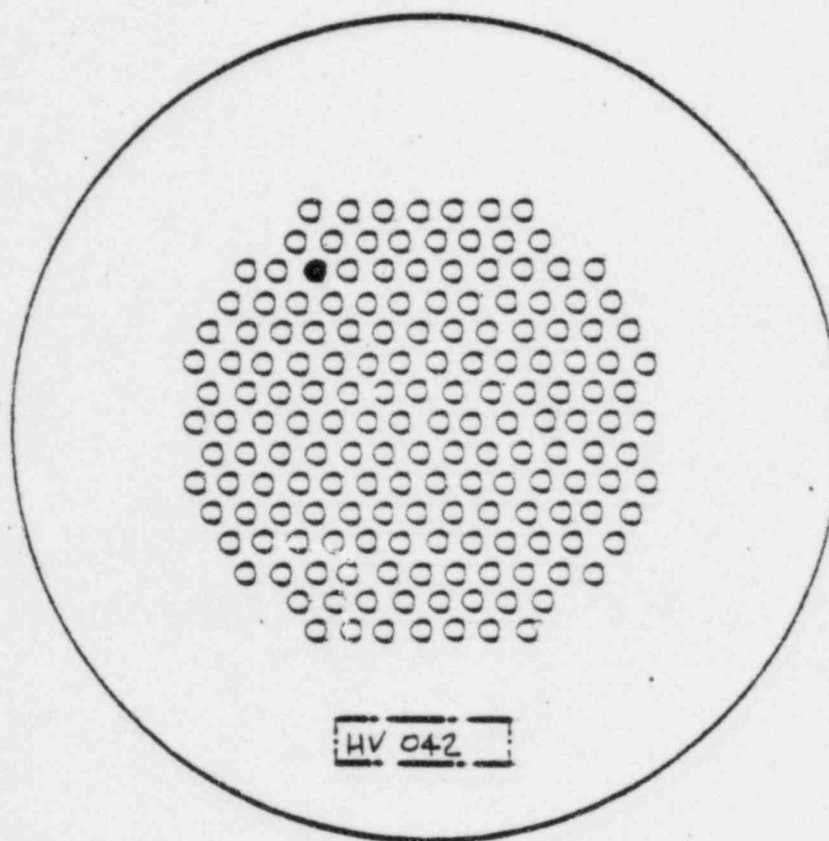
TENDON V-52

The examination of the tendon end anchorages covered 7140 buttonheads and vacant positions. The field end of V52 had one missing buttonhead. Records from the repair program show one buttonhead failed after stressing. Missing buttonheads were noted on H3EF, H26FD and D117. The buttonheads were not located in the grease cap. The original stressing cards indicate H26FD and D117 each lost an effective wire during stressing. Since the buttonhead for H3EF was not found in the end cap, it is suspected that the buttonhead failed after stressing but before the installation of the end cap. There were no indications of abnormal degradation of the buttonheads on any anchorage.

ONE MISSING BUTTONHEAD ... OVERALL BUTTONHEAD
APPEARANCE IS ABOVE AVERAGE (BRIGHT SHINY METAL)

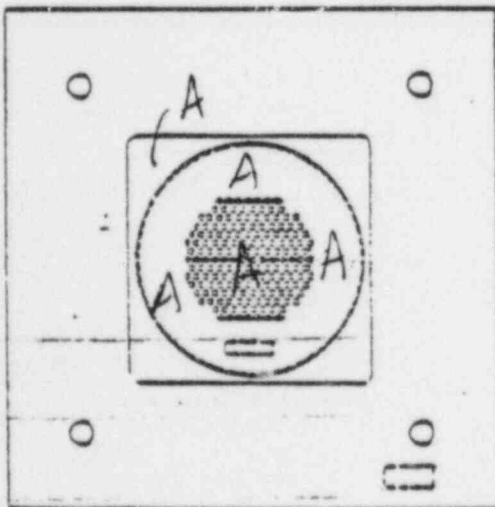
REMARKS: ANCHORAGE LOOKS
VERY GOOD, GOOD SHIM GAPS.
RETAINER PLATE IN GOOD
CONDITION HAS "A" WITH
SLIGHT "B" CORROSION

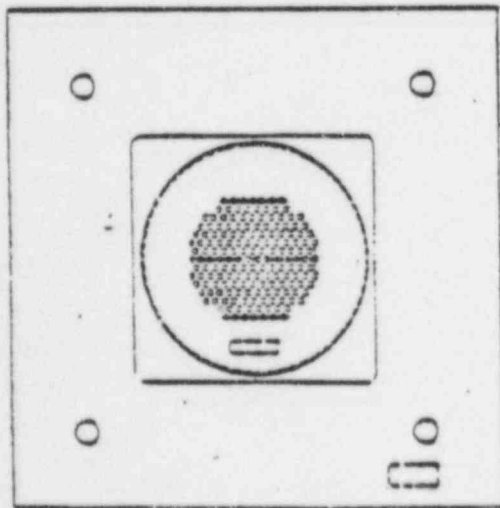
Degree of Corrosion B+C
 Cracks NONE
 ANCHORAGE AREA CONCRETE
 Cracks (width > 0.01 in.)
NONE

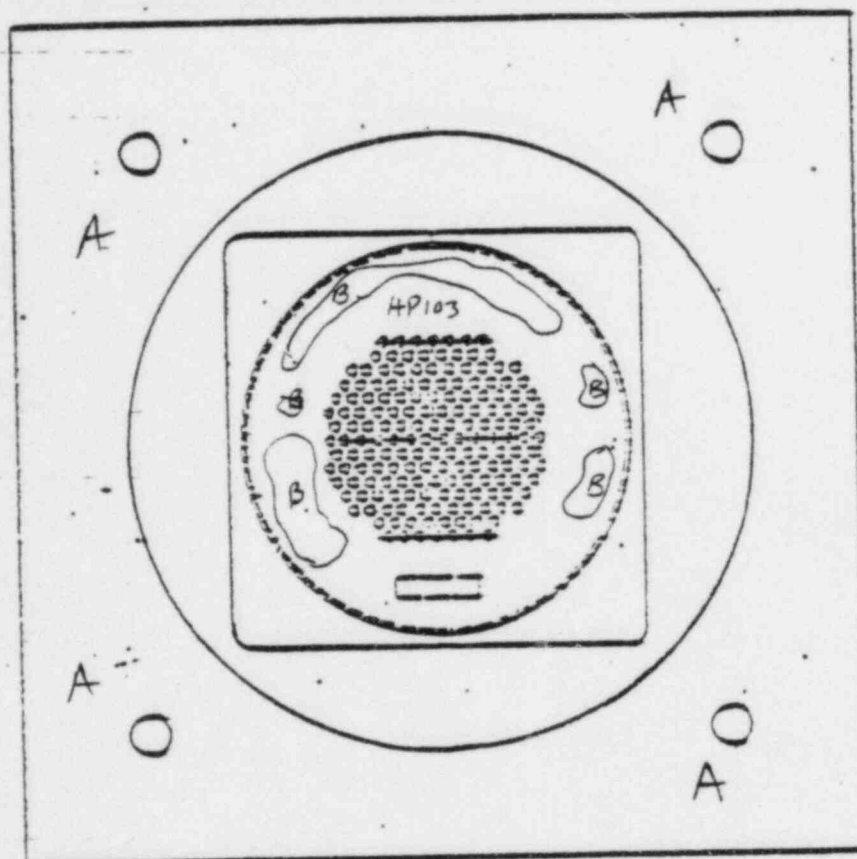
ANCHORAGE ASSEMBLY INSPECTION
FIELD END OF TENDON NO. 1 DE

LEVEL 'B' CORROSION & WATER SPOTS ON ANCHORAGE HEAD
FACE.

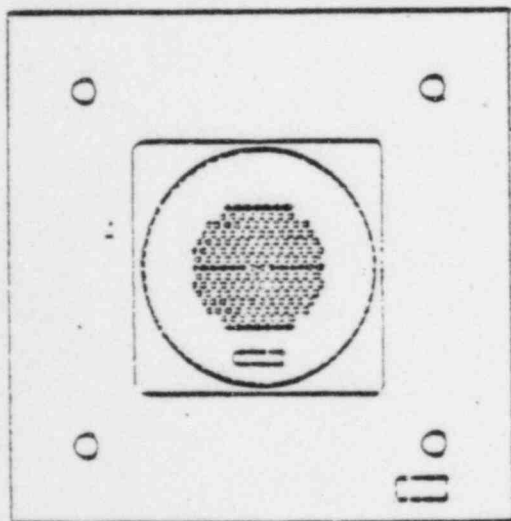
REMARKS: SOME OF CORROSION ON
BEARING plate transferred
FROM the RETAINER plate

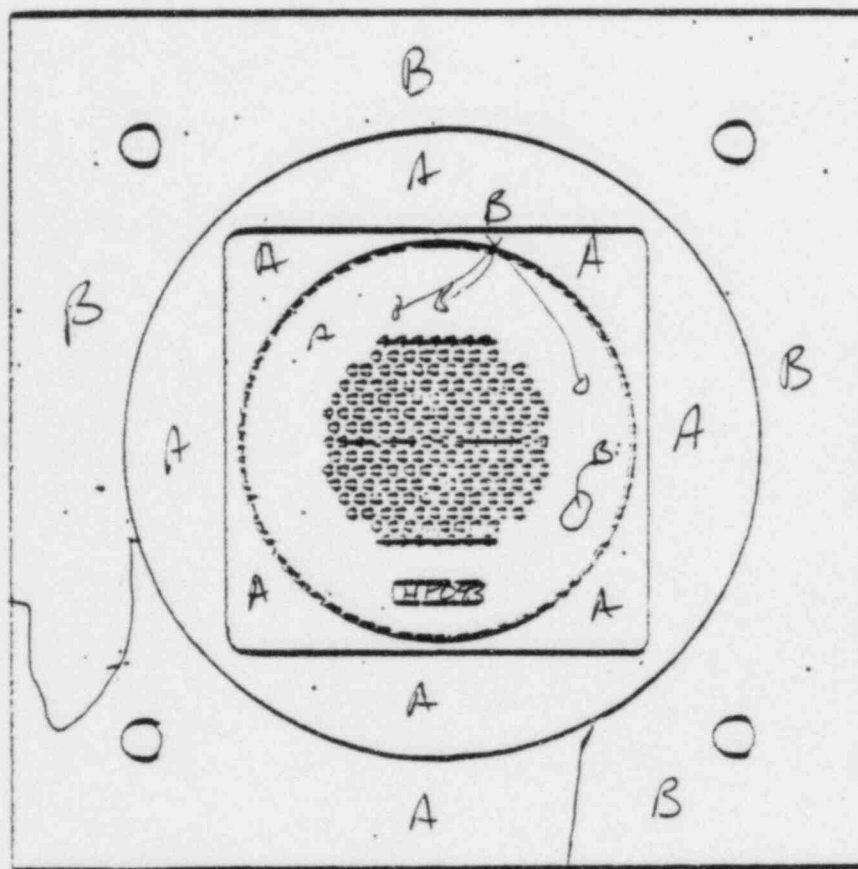
ANCHORAGE ASSEMBLY INSPECTION
FIELD END OF TENDON NO. 21 DE

SPOTTY PATCHES OF 'B' ON ANCHORHEAD FACE

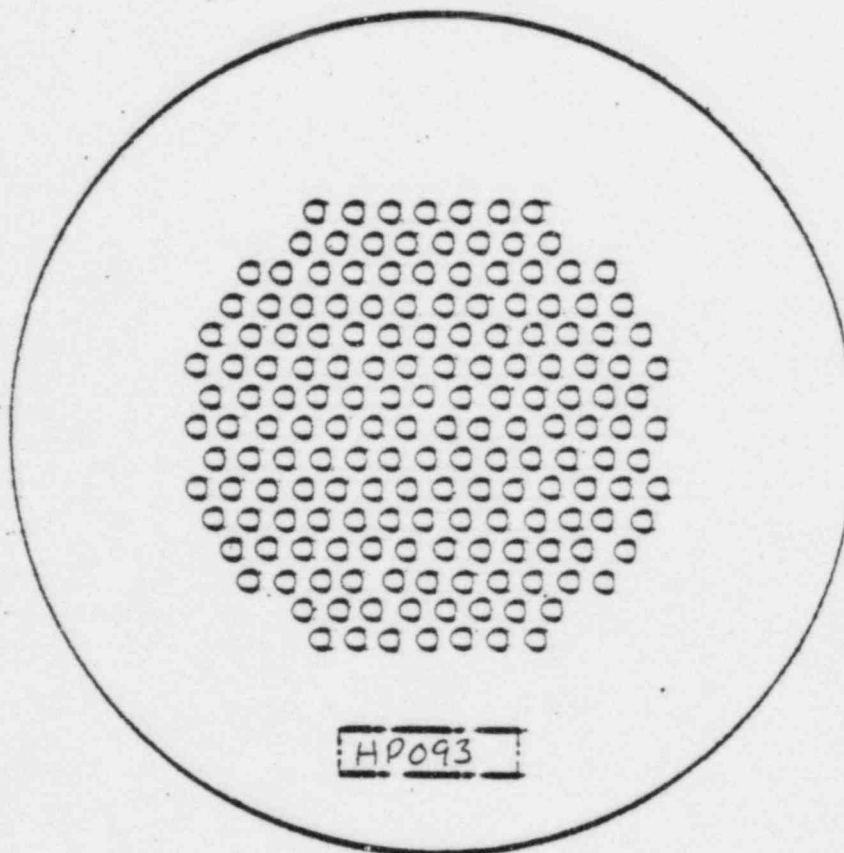
NO SPLITS OR SLIPS, MISSING OR UNSEATED

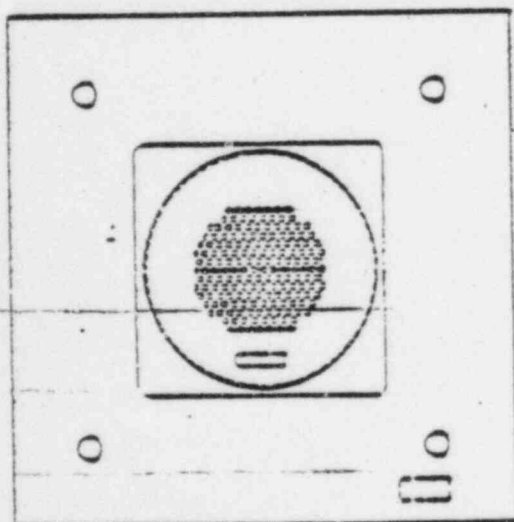
REMARKS: SOME CORROSION ON
BEARING PLATE FROM RETAINED
PLATE

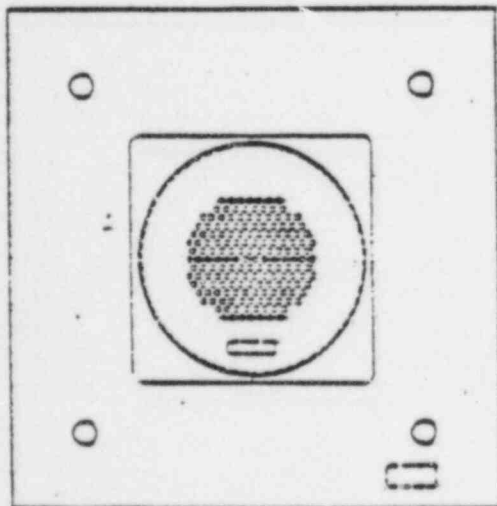
REMARKS: MUCH of CORROSION ON
BEARING PLATE APPEARS to
have been transferred from
the Retainer plate

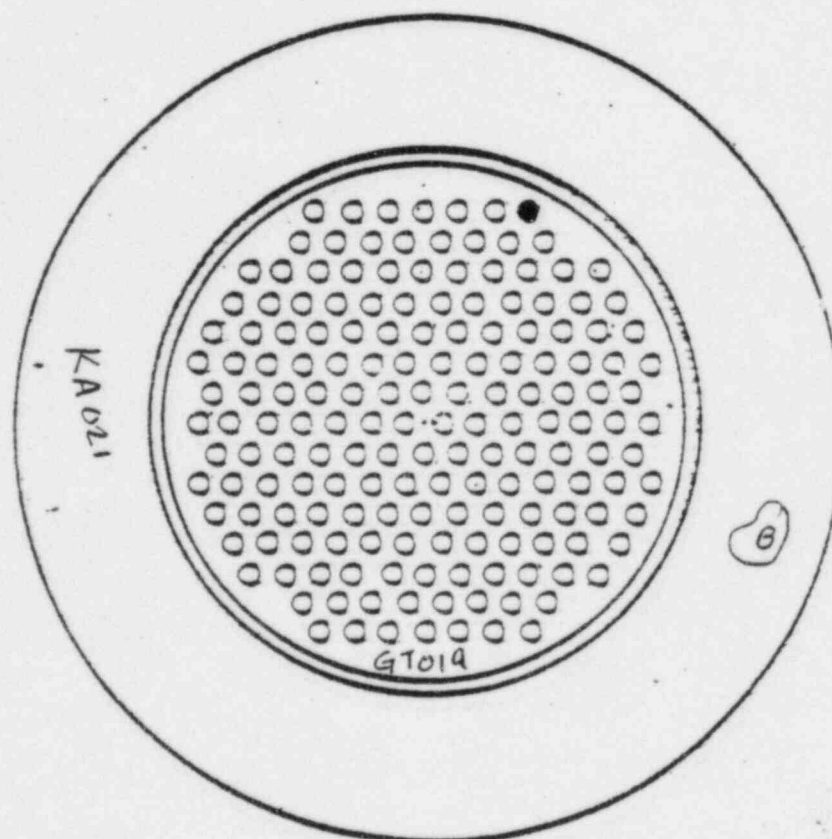
1 BUTTONHEAD MISSING. NO IMPROPERLY FORMED OR UNSEATED
 BUTTONHEADS. NO SPLITS > 0.12"

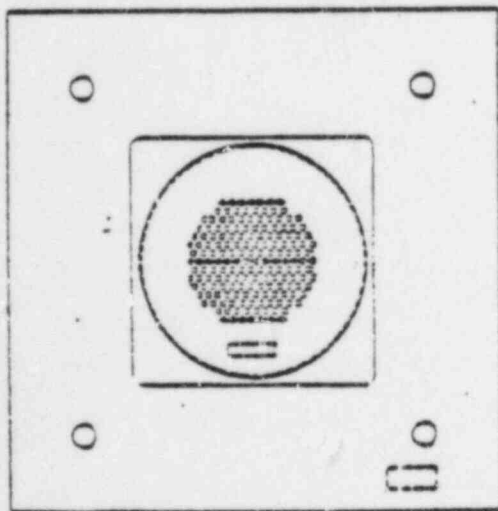
Degree of Corrosion A, B & C

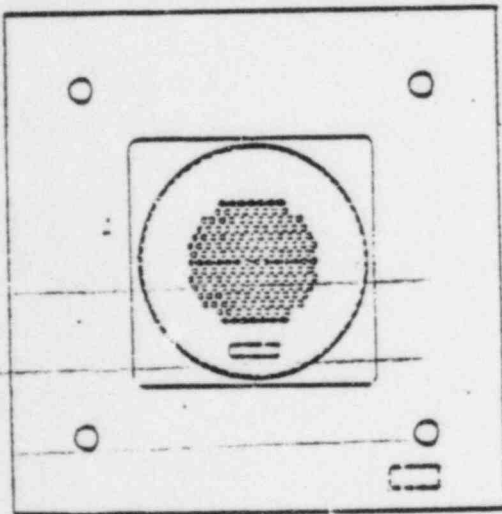
REMARKS: Some of corrosion on
Bearing ^{plate} is transferred from
the retainer plate

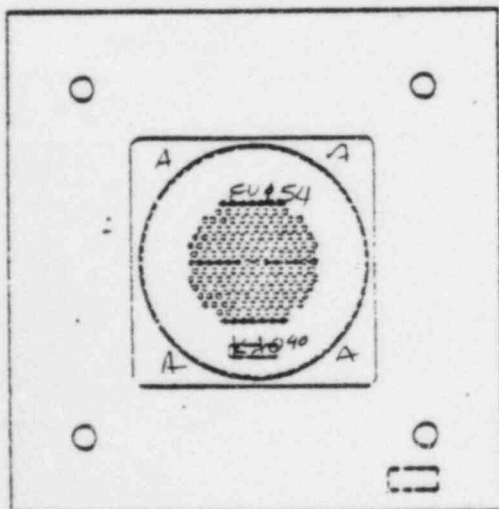
Degree of Corrosion A + HEAVY B
 Cracks NONE

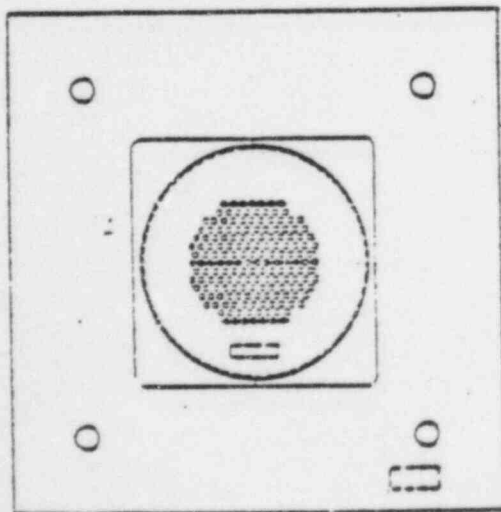
REMARKS: Much of corrosion
on bearing plate appears
to have been transferred
from the retaining plate1/2" gap between halves of
outside 4" shim on bottom
sideDate 6-1-85 Signature J. J. [Signature]

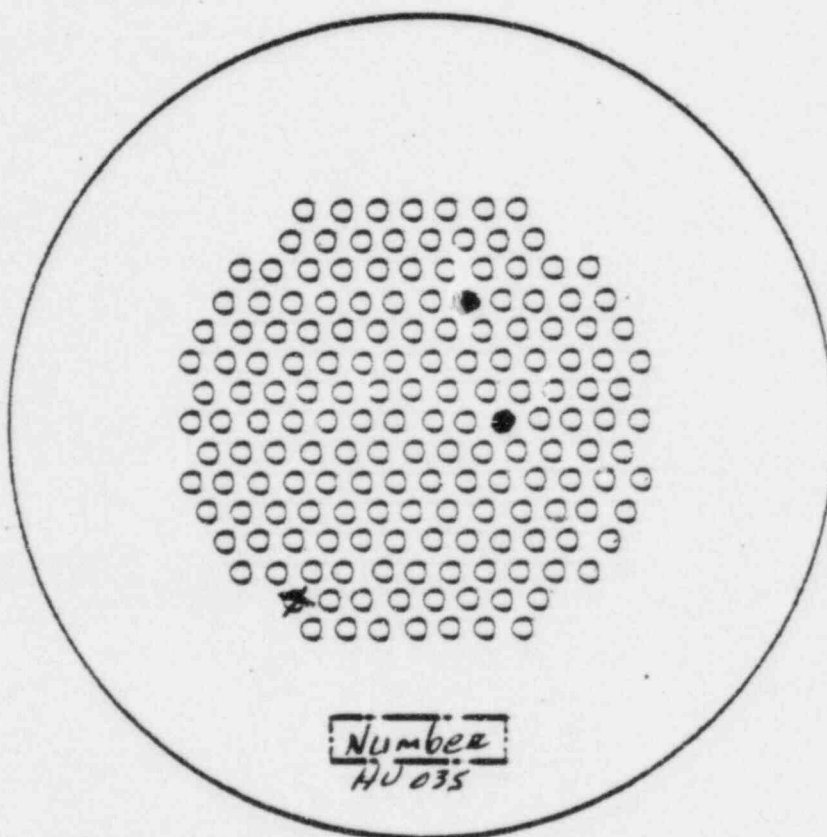
TENDON 26 DFZ. J. O'Rourke 16-1-85
SIGNATURE DATE

2 MISSING WIRES1 DOUBLE BUTTONHEAD

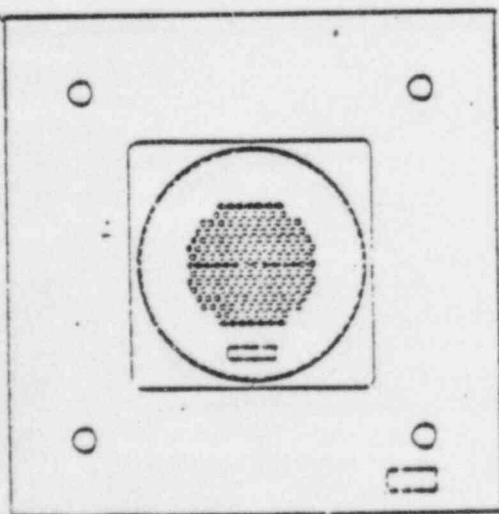
MEASURABLE
 SURFACE CRACK (NO DEPTH)

REMARKS: GASKET RETAINER

PLATE HAS B & C LEVEL OF
CORROSION. SHIM STACK STRAIGHT
WITH GAPS $\approx 1/4$ ". SHIM BUSHING
IS FULLY ENGAGED. BUSHING
HAS NEW, POLISHED APPEARANCE.
ANCHORAGE ASSEMBLY IS IN
OVERALL GOOD CONDITION.

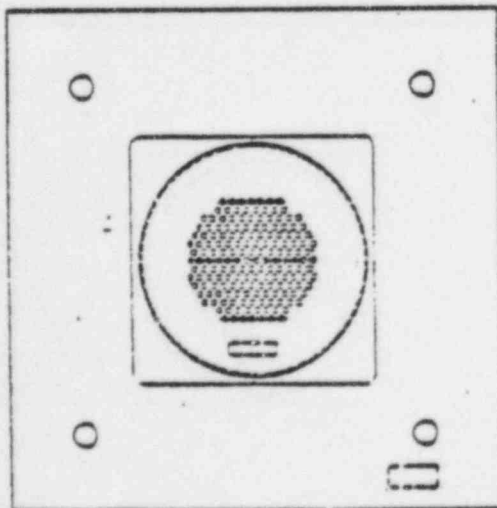
REMARKS: Much of BEARING plate
corrosion appears to have
been transferred from
retainer plate

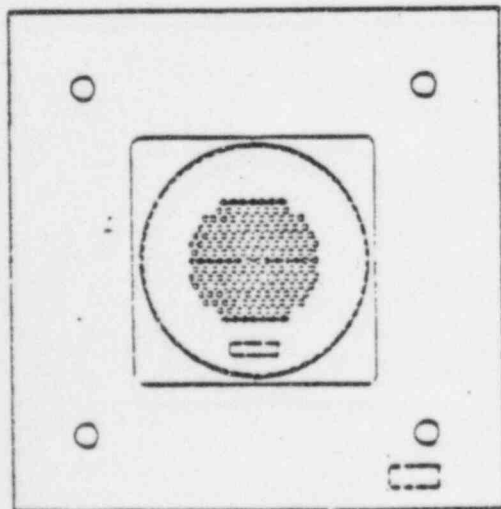
REMARKS: Much of corrosion on
the bearing plate appears
to have been transferred from
the retaining plate.

gap between outside 4" shims
halves measures 11/16", top only.
gap between halves of inside
4" shim is 7/16", top only

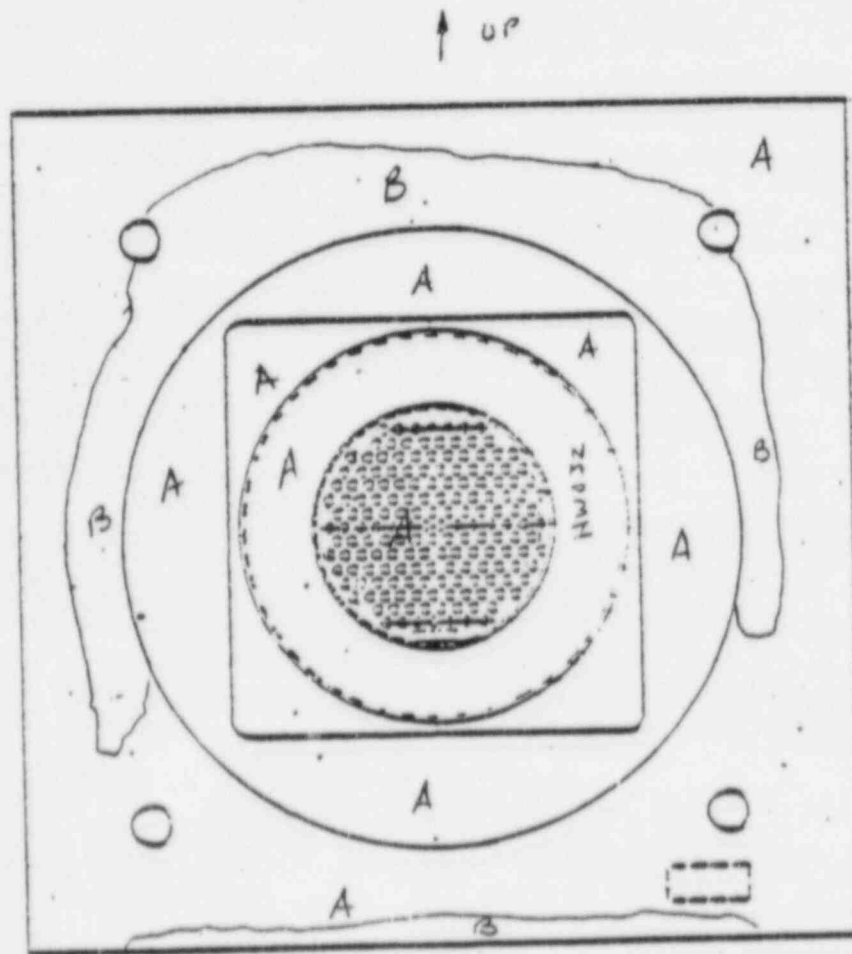
ANCHORAGE ASSEMBLY INSPECTION
 SHOP END OF TENDON NO. D-119.C

BEARING PLATE CORROSION APPEARS TO HAVE BEEN
 TRANSFERRED FROM THE GASKET RETAINER PLATE.

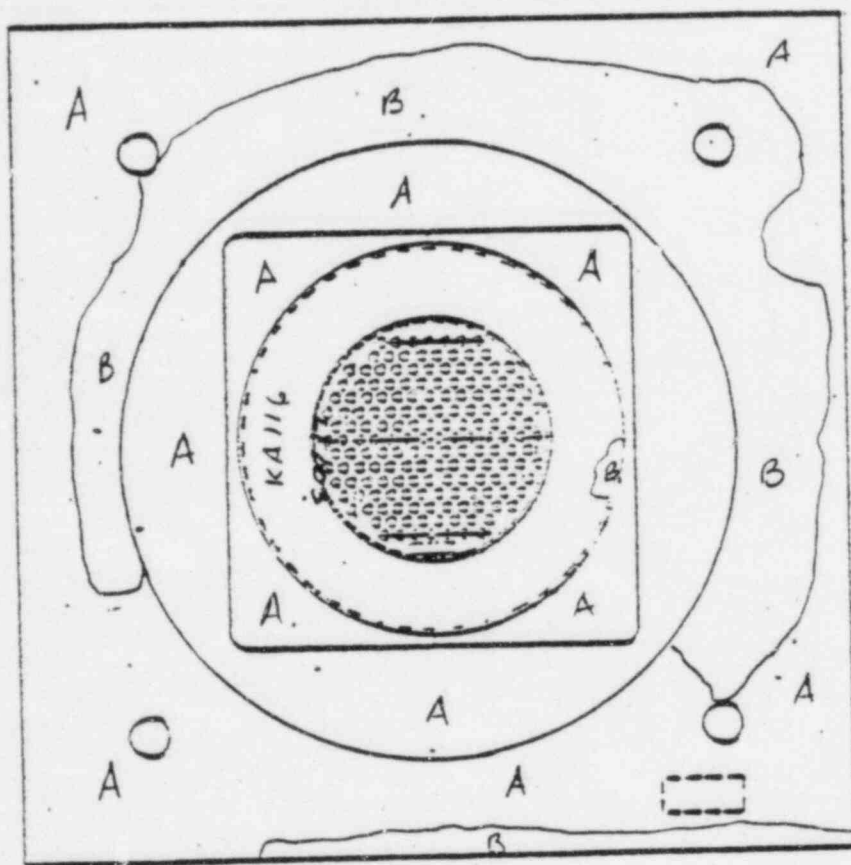
CORROSION APPEARS TO BE TRANSFERRED FROM
GASKET RETAINER PLATE.

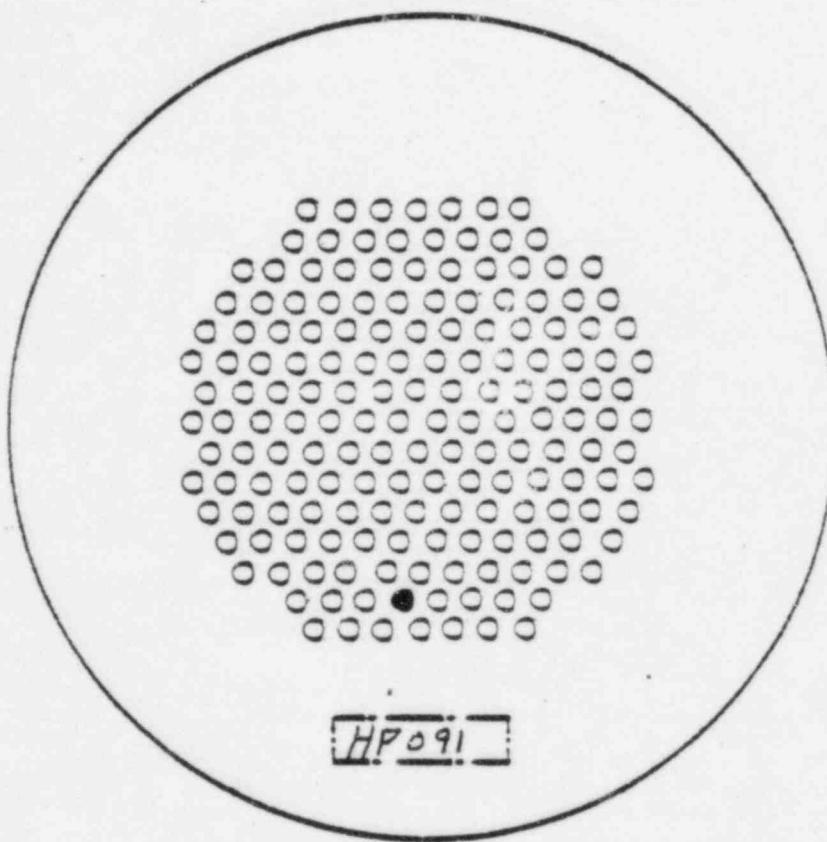
D117

one missing Buttonhead

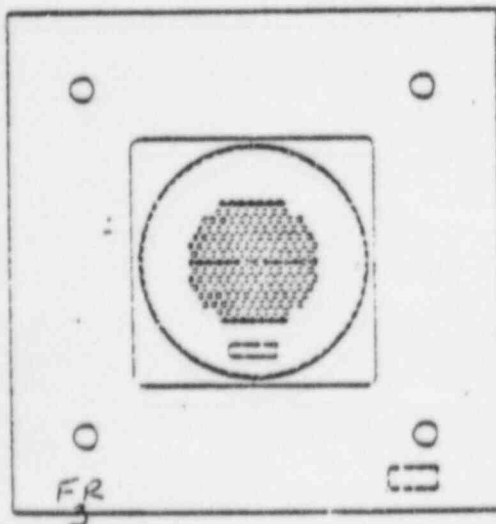
SHIM STACK GAPS < 1/4"
GOOD UNIFORM STACK, STRAIGHT
& SOUND.

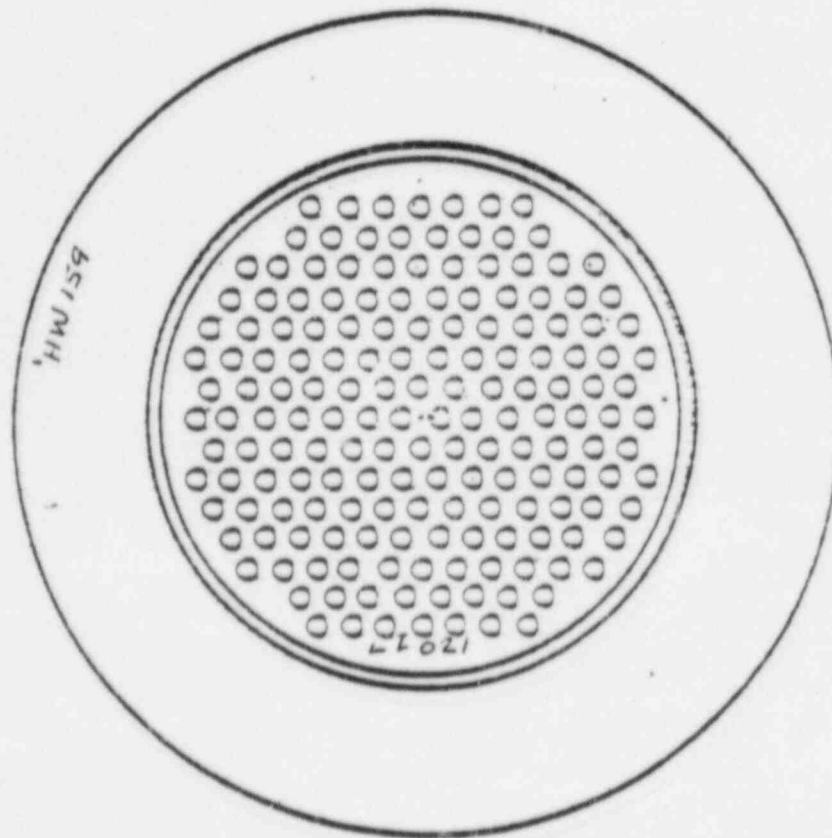
NO MISSING, UNSEATED OR IMPROPERLY FORMED BUTTONHEADSNO SPLITS GREATER THAN 0.12" WIDE. BUTTONHEADS AREWELL ROUNDED WITH FLAT TOPS. BUTTONHEADS HAVE A SHINYNEW APPEARANCE
