LICENSEE EVENT REPORT (LER)

Facility Name (1) Byron, Unit 1	Docket Number (2) 0   5   0   0   0   4   5   4	Page (3) 1   of   0   4
------------------------------------	--	----------------------------

Title (4)  
ASME INSPECTION NOT PERFORMED ON TWO SI VALVE WELDS

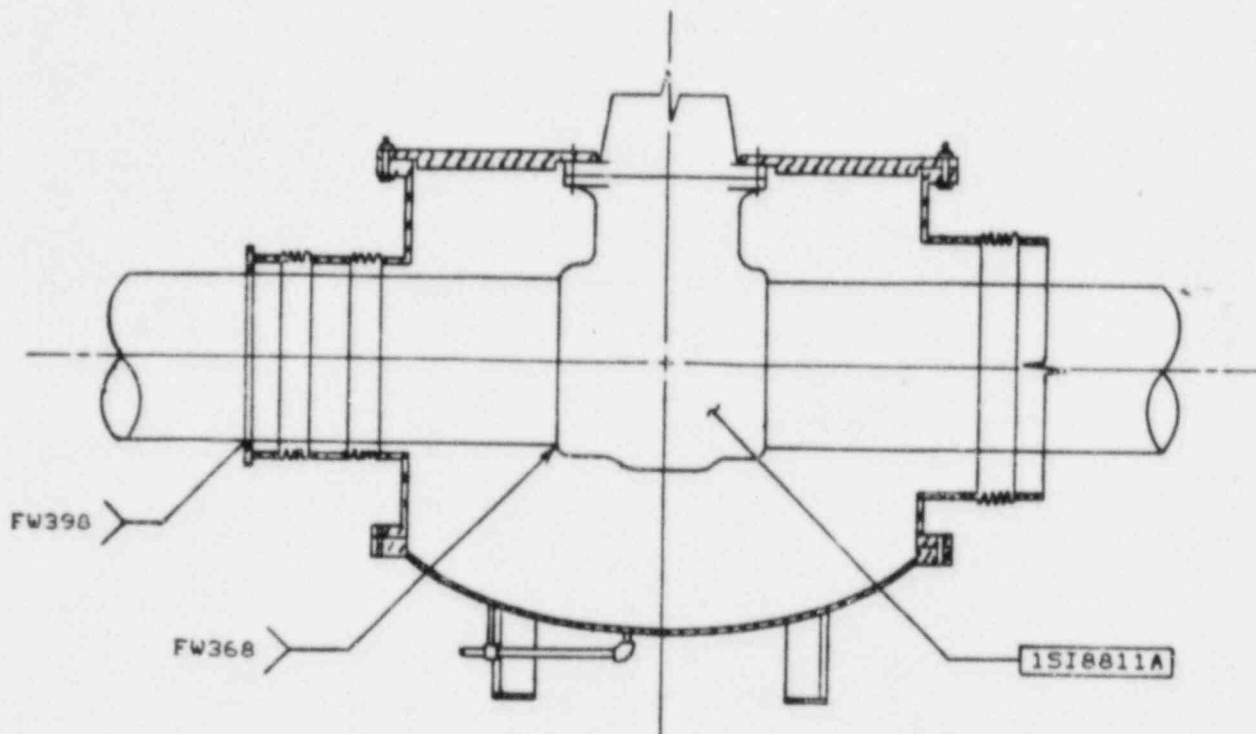
FIGURE 1

While performing the Byron Unit 2 PSI for the safety injection (SI) system, the inspection personnel realized that the valve-to-pipe welds (FW368 and FW372) on Unit 1 had been misidentified. This identification error occurred during the initial piping system walkdown by the inspection personnel who identified and stamped the valve-to-pipe welds as the pipe-to-valve containment assembly welds (FW398 and FW408). (See Figure 1 for orientation). Therefore, the pipe-to-valve containment assembly welds were examined by volumetric (ultrasonic) and surface methods, but the results were assigned to the valve-to-pipe welds. In addition, subsequent reviews of the PSI Program and data did not reveal the existence of welds FW398 and FW408, which had not been identified prior to this incident.

Train	Valve	Valve-to-Pipe Weld		Pipe-to-Valve Containment Assembly Weld *	
		Hunter #	ISI #	Hunter #	ISI #
A	1SI8811A	FW368	C-1	FW398	C-2A
B	1SI8811B	FW372	C-1	FW408	C-2A

\* Weld was identified and inspected as the Valve-to-Pipe Weld

This condition will be corrected by the performance of the required examinations during the next planned outage of greater than ten (10) day duration, as authorized by the ASME Code relief granted by the NRC. Due to the various independent reviews of the PSI Program and data, and the unique structural nature of the valve containment assemblies, this event is considered an isolated occurrence.
