U.S. NUCLEAR REGULATORY COMMISSION
REGION IV

Docket No.: 030-28641
License No.: 42-23539-01AF
Report No.: 030-28641/96-17
Licensee: Department of the Air Force
Facility: Altus Air Force Base (AFB)
Location: HQ AFMOA/SGPR
8901 18th Street
Brooks AFB, Texas
Dates: November 20-21, 1996
Inspector: Jeffrey Cruz
Radiation Specialist
Approved By: Linda L. Howell, Chief
Nuclear Materials Inspection and
Fuel Cycle/Decommissioning Branch

Department of the Air Force: Altus AFB
NRC Inspection Report 030-28641/96-17

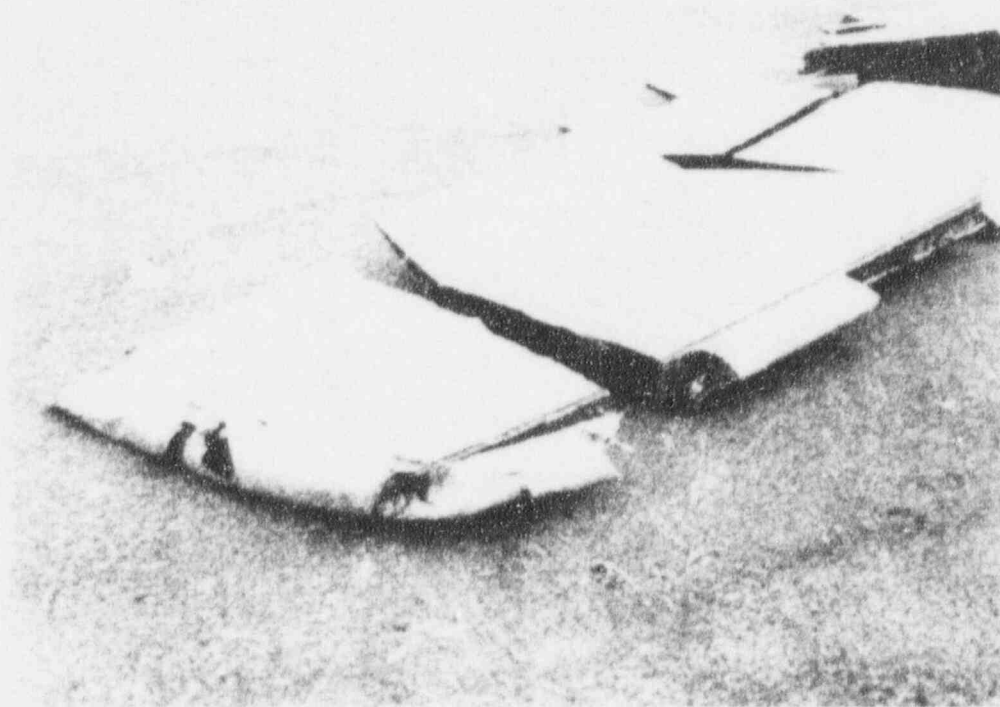
representative of the RIC. Upon arrival at the scrap yard, NCO1 located a single piece of the tail section (see Photo 1) and informed the Altus AFB RPO that one endpiece had been located and that they would continue to try to find the second piece.

endpiece containing DU counterweights weighing approximately 30 pounds. The endpiece had been cut from the tail section assembly by Air Force personnel, who, in doing so, had cut the DU. The cut resulted in approximately 1 square inch of unplated and uncovered DU surface being exposed on the endpiece. The scrap dealer then sold this load, including the endpiece containing DU, to a scrap yard located in Joplin, Missouri. On August 20, 1996, Altus AFB personnel discovered that the DU in the endpiece had been transferred. The end piece was retrieved on August 22, 1996.

Photograph 1: Tail Section Endpiece Containing Depleted Uranium Counterweights Inadvertently Transferred to a Civilian Scrap Dealer

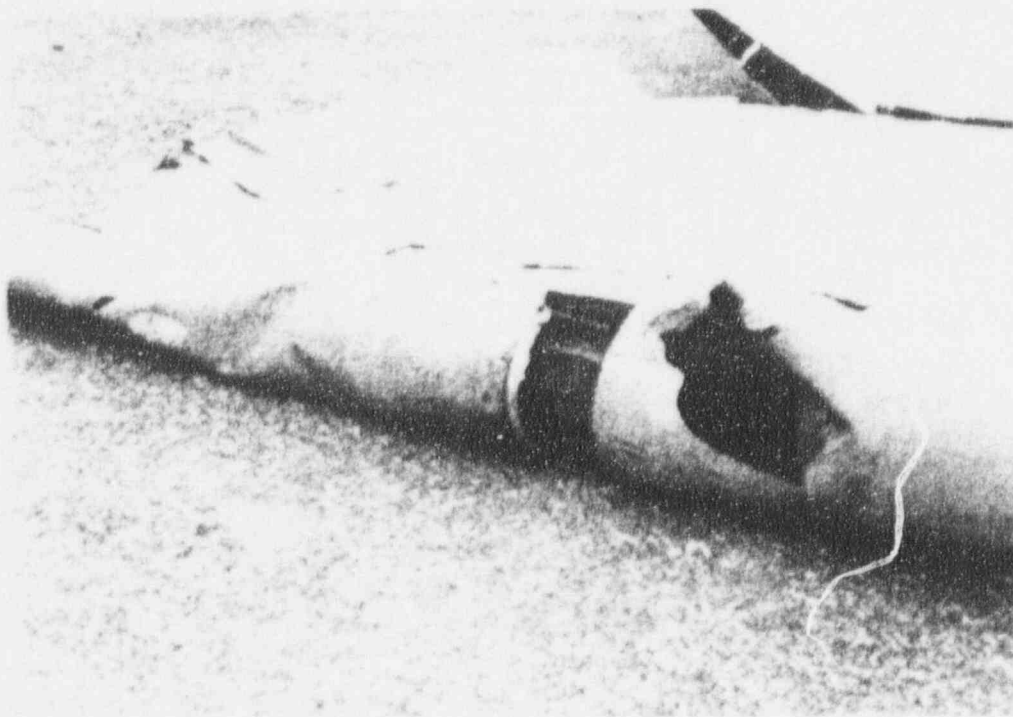
Photograph 2: Close up of Retrieved Tail Section Endpiece Containing Depleted Uranium Counterweights

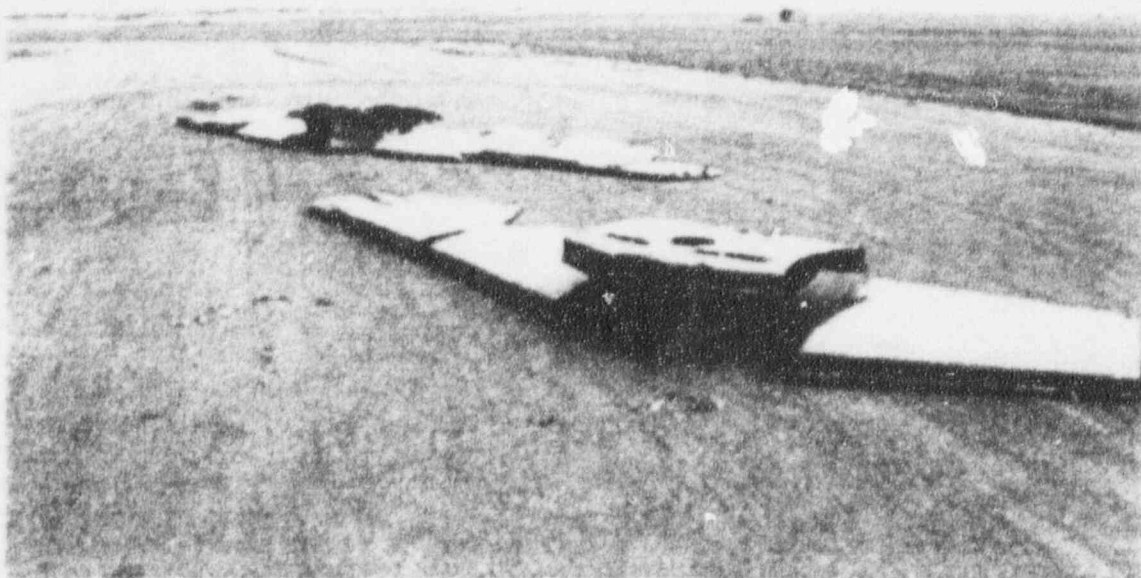
The cutting of depleted uranium counterweights contained in the tail section elevators of C-141 aircraft by Altus AFB personnel was identified as a violation of 10 CFR 40.13(c)(5)(iv) (030-28641/9617-01).

Photograph 3: Cut Tail Section Assemblies
