KG&E MANAGEMENT PLAN

MANAGEMENT PLAN FOR THE RESOLUTION OF CAR-19

STRUCTURAL STEEL WELDING
PRESENTATION

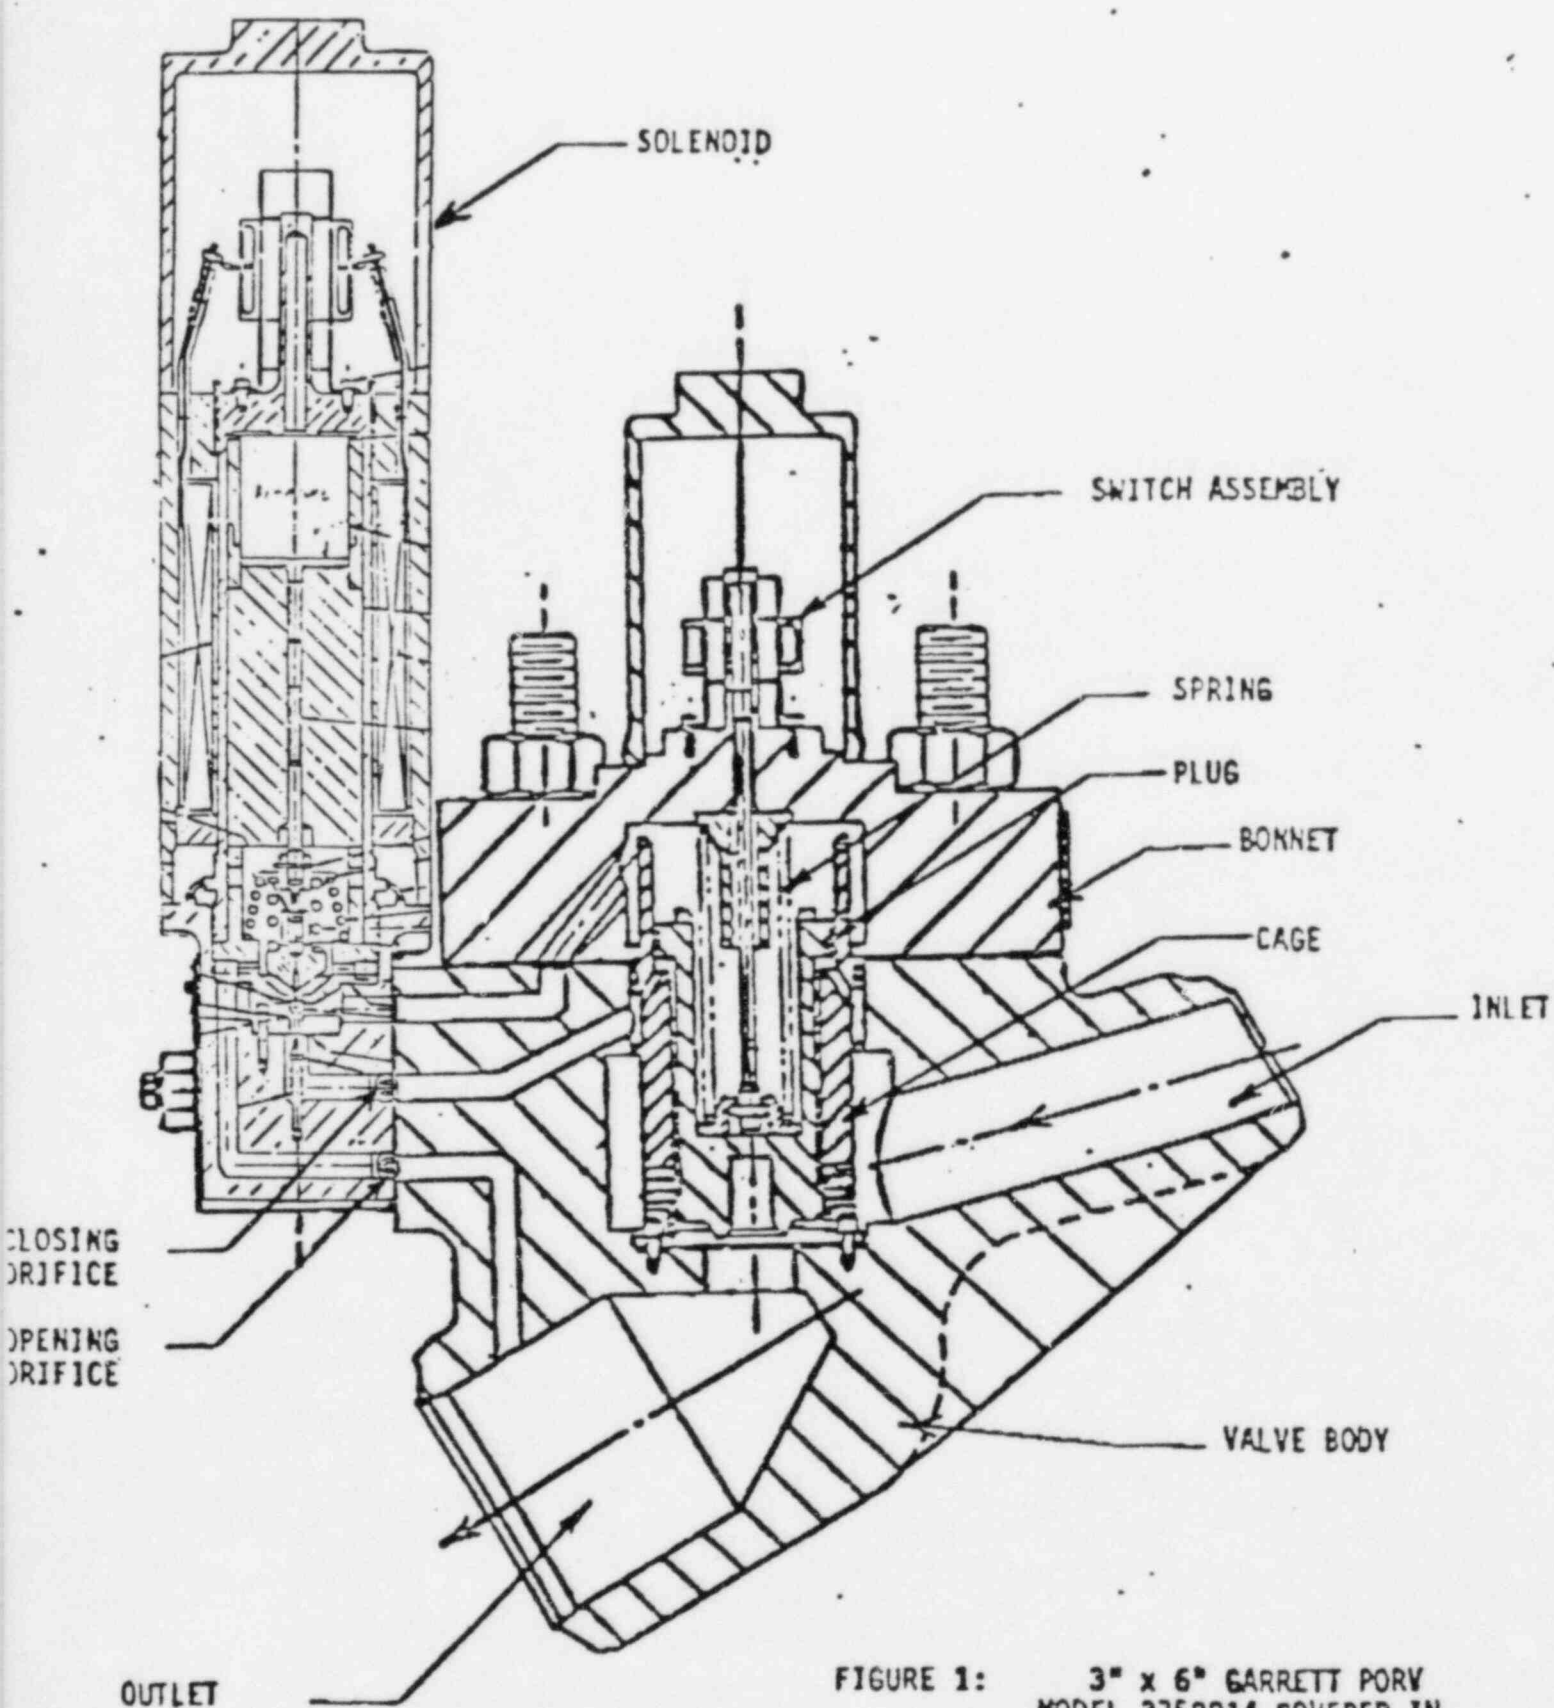
3" x 6" GARRETT PORV
 MODEL 3750014 COVERED IN
 SPECIFICATION G-955245, REV. 0

THE WOLF CREEK PRESSURIZER PROV_s FAILED TO CLOSE AFTER A DISCHARGE OF WATER FOLLOWED BY STEAM WHICH WAS CONDUCTED MANUALLY FOR AN EXTENDED PERIOD OF

TIME. THE CAUSE OF THIS MALFUNCTION WAS DETERMINED TO BE DIFFERENTIAL THERMAL EXPANSION (VALVE BODY TO CAGE) RESULTING IN A RESTRICTION OF AN ESSENTIAL FLUID FLOW PATH TO THE VALVE ACTUATOR HEAD ASSEMBLY. IDENTIFICATION OF THE CAUSE OF THE MALFUNCTION IS SUPPORTED BY TESTING IN OTHER OPERATING MODES, SUCCESSFULLY REPEATING THE FAILED TEST WITH REDUCED DIFFERENTIAL TEMPERATURES, AND A DETAILED ENGINEERING ANALYSIS.

A VALVE MODIFICATION, SPECIFIED BY WESTINGHOUSE AND CONCURRED WITH BY GARRETT (THE VALVE DESIGNER/MANUFACTURER) HAS BEEN MADE WHICH CORRECTS THE MALFUNCTION WITHOUT HAVING ANY DELETERIOUS EFFECTS ON VALVE FUNCTION.

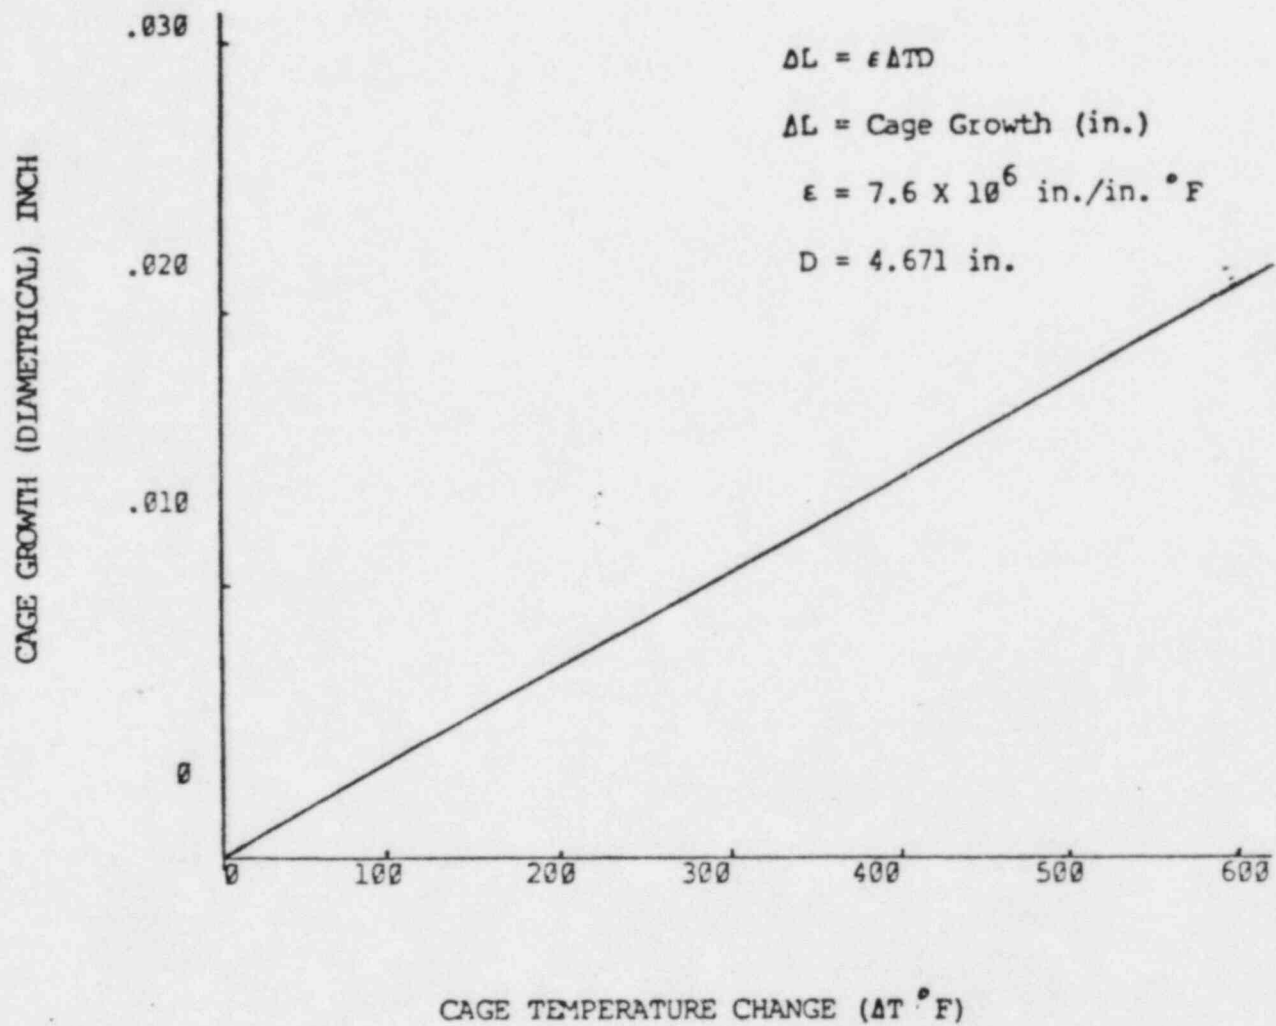
FIGURE 2

CAGE GROWTH VS. CAGE ΔT °F
