RADIOLOGIC AND ENGINEERING ASSESSMENT

DOE ID NO.: GJ-04232-RS  
ADDRESS: 1208 MAIN STREET

SEPTEMBER 1985

BENDIX FIELD ENGINEERING CORPORATION  
P.O. Box 1569  
Grand Junction, Colorado 81502

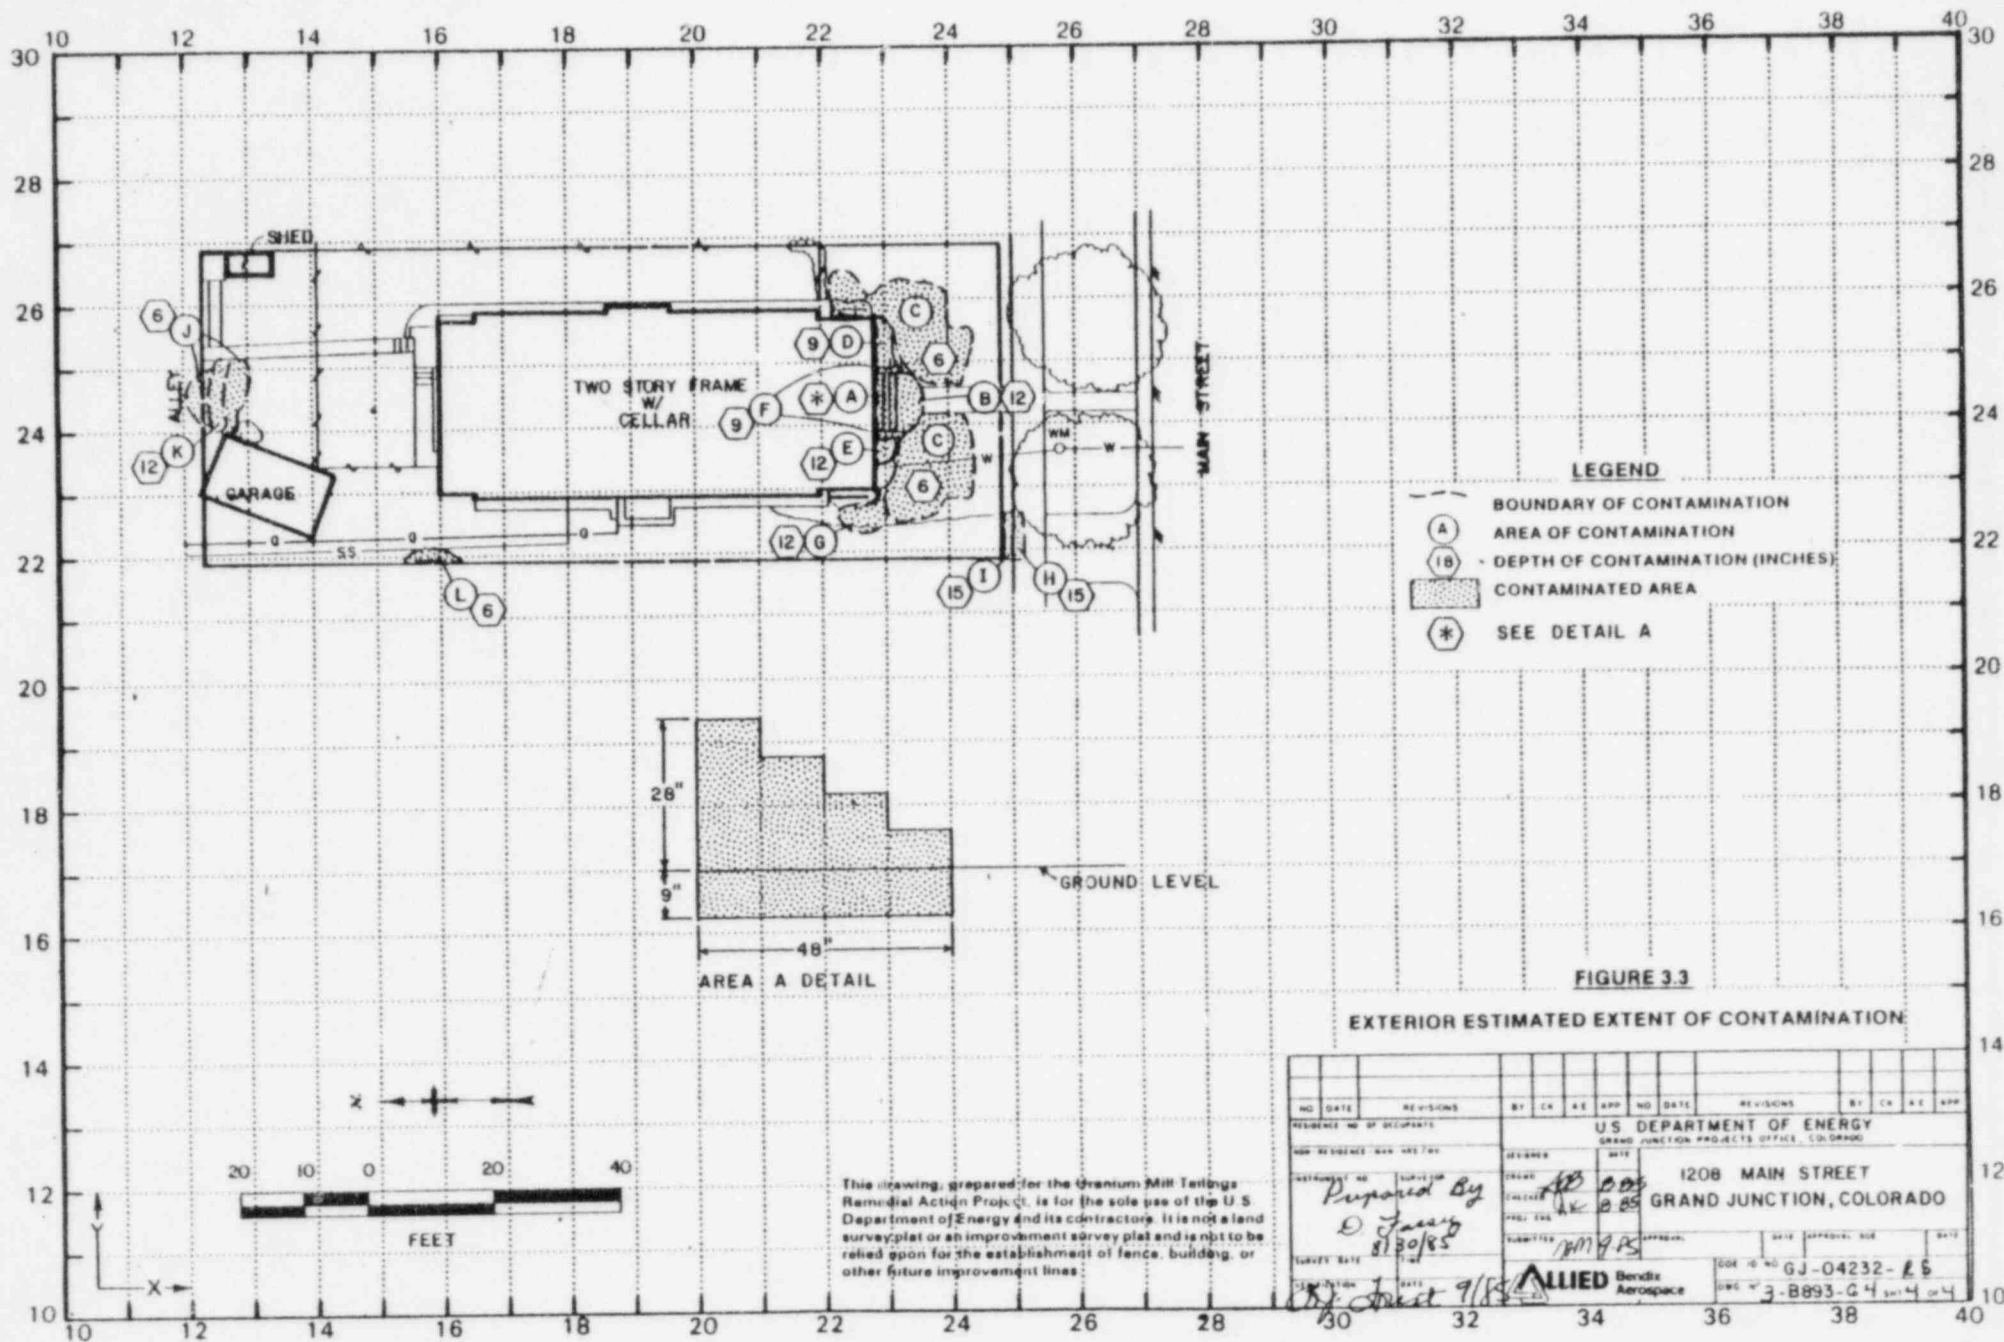
Appendix Figure 3.3 shows identified areas and estimated depths of contamination on this property, based on assessments of all measurements taken. As noted in this figure, areas recommended for remedial action that contain identified residual radioactive materials are:

- (Area A) Surface Material: Concrete  
Direction From Primary Structure: South  
Other (height or thickness): See Figure 3.3, Detail A  
Comments: This area contains a set of concrete steps. There is 9 inches of tailings beneath the steps, measured from ground level. The tailings may extend beneath the enclosed porch to the north. This should be monitored at the time of remedial action.  
Approximate Square Footage: 38

- (Area B) Surface Material: Concrete  
Direction From Primary Structure: South  
Other Directions: South of Area A  
Total Depth of Contamination: Estimated at 12 inches  
Other (height or thickness): 4-inch-thick concrete  
Comments: The depth of contamination is based on data collected in Area A.  
Approximate Square Footage: 27

- (Area C) Surface Material: Lawn  
Direction From Primary Structure: South  
Other Directions: East and west of sidewalk  
Total Depth of Contamination: 6 inches  
Comments: This area is made up of two deposits.  
Approximate Square Footage: 510

- (Area D) Surface Material: Soil  
Direction From Primary Structure: South  
Other Directions: East of Area A  
Total Depth of Contamination: 9 inches  
Approximate Square Footage: 28

- (Area E) Surface Material: Soil  
Direction From Primary Structure: South  
Other Directions: West of Area A  
Total Depth of Contamination: 12 inches  
Approximate Square Footage: 16

- (Area F) Surface Material: Wood  
Direction From Primary Structure: South  
Other Directions: East and west of Area A  
Total Depth of Contamination: Estimated at 9 inches  
Comments: These two deposits are enclosed by a wood frame along the steps. The depth of contamination is based on data collected in Area A, measured from the soil surface.  
Approximate Square Footage: 8

- (Area G) Surface Material: Lawn  
Direction From Primary Structure: West  
Other Directions: East of driveway  
Total Depth of Contamination: 12 inches  
Approximate Square Footage: 28

- (Area H) Surface Material: Concrete  
Direction From Primary Structure: Southwest  
Other Directions: Southwest property corner  
Total Depth of Contamination: Estimated at 15 inches  
Other (height or thickness): 4-inch-thick concrete  
Comments: The depth of contamination is based on data collected in Area I  
Approximate Square Footage: 16

- (Area I) Surface Material: Road base  
Direction From Primary Structure: Southwest  
Other Directions: In driveway  
Total Depth of Contamination: 15 inches  
Other (height or thickness): 3-inch-thick road base  
Approximate Square Footage: 16

- (Area J) Surface Material: Soil  
Direction From Primary Structure: North  
Other Directions: South of alley  
Total Depth of Contamination: 6 inches  
Comments: This area is made up of two deposits.  
Approximate Square Footage: 78

- (Area K) Surface Material: Soil  
Direction From Primary Structure: North  
Other Directions: South of alley  
Total Depth of Contamination: 12 inches  
Approximate Square Footage: 36

- (Area L) Surface Material: Road base  
Direction From Primary Structure: West  
Other Directions: In driveway  
Total Depth of Contamination: 6 inches  
Other (height or thickness): 3-inch-thick road base  
Approximate Square Footage: 20

The recommended remedial action for this property, DOE ID No. GJ-04232-RS includes removal of all areas identified as containing radioactive material (as discussed in Section 3.5 and shown in Appendix Figure(s) 3.3) and transport of removed material to the disposal site.

After remedial action is completed, the areas involved will be restored to original condition in accordance with the Bendix drawings, Vicinity Properties General Construction Specification (Bendix Field Engineering Corporation, 1984), and Statement of Work for Construction Subcontractor.

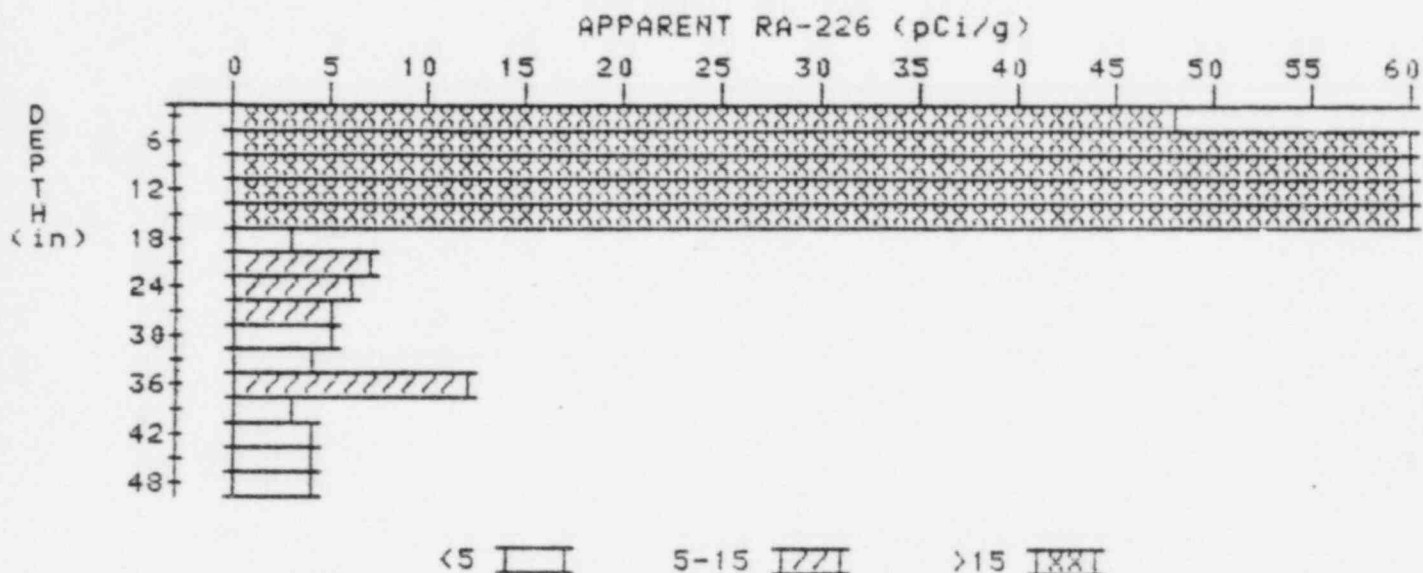
HOLE NUMBER: 18

Depth (in)	Apparent Radium-226 (pCi/g) Undeconvolved	Apparent Radium-226 (pCi/g) Deconvolved
3	48.1	48.1
6	75.4	106.2
9	85.4	111.2
12	80.9	114.5
15	57.5	64.8
18	30.0	3.0
21	17.7	7.0
24	11.4	5.9
27	8.2	5.4
30	6.6	4.6
33	6.1	3.6
36	7.0	11.8
39	5.2	3.2
42	4.5	3.8
45	4.2	3.7
48	4.2	4.2

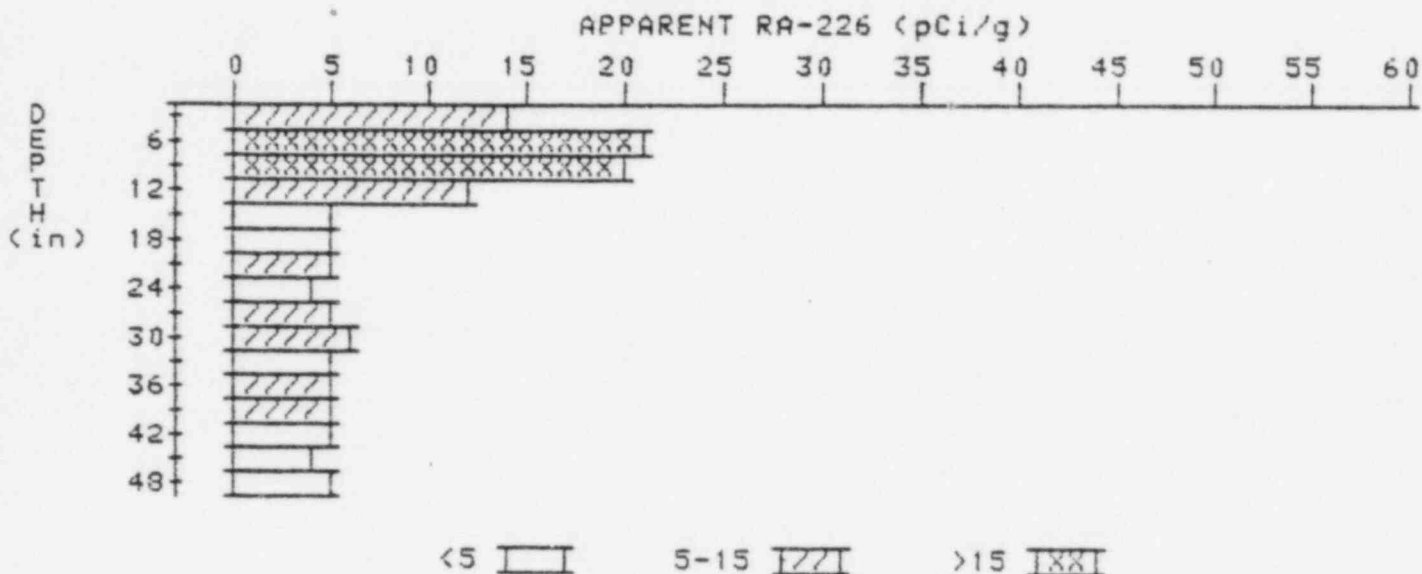
HOLE NUMBER: 29

Depth (in)	Apparent Radium-226 (pCi/g) Undeconvolved	Apparent Radium-226 (pCi/g) Deconvolved
3	13.9	13.9
6	15.9	20.9
9	15.1	19.9
12	11.6	11.6
15	8.1	4.9
18	6.4	4.6
21	5.7	5.3
24	5.2	4.3
27	5.2	5.2
30	5.2	5.6
33	5.0	4.6
36	5.0	5.0
39	5.0	5.4
42	4.8	4.8
45	4.6	4.4
48	4.5	4.5
