RADIOLOGIC AND ENGINEERING ASSESSMENT

DOE ID NO.: GJ-11183-MR
ADDRESS: 524 28 1/2 ROAD

SEPTEMBER 1985

BENDIX FIELD ENGINEERING CORPORATION
P.O. Box 1569
Grand Junction, Colorado 81502

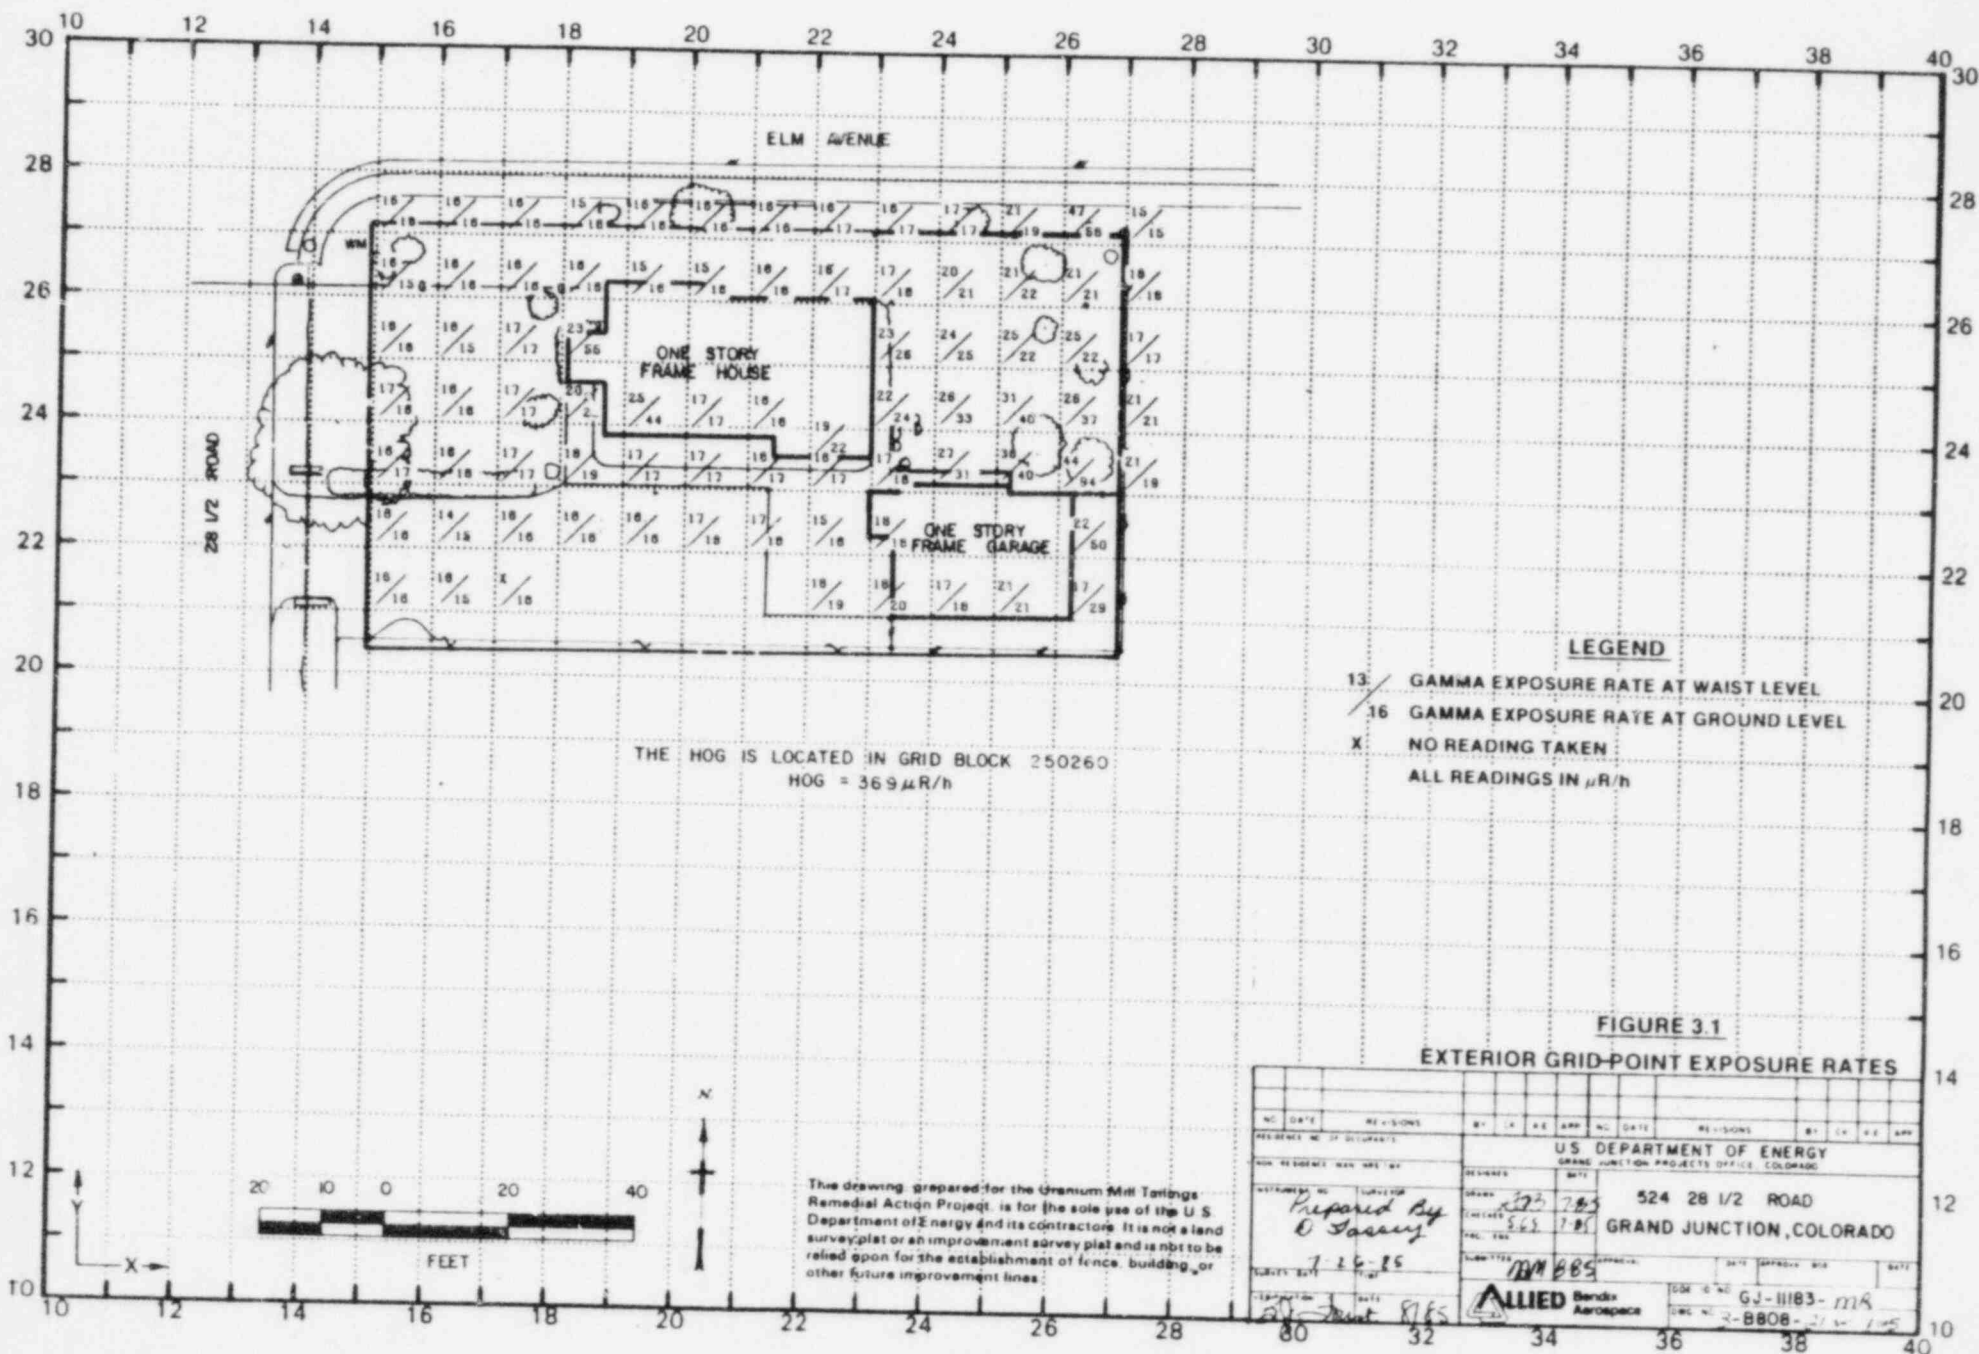
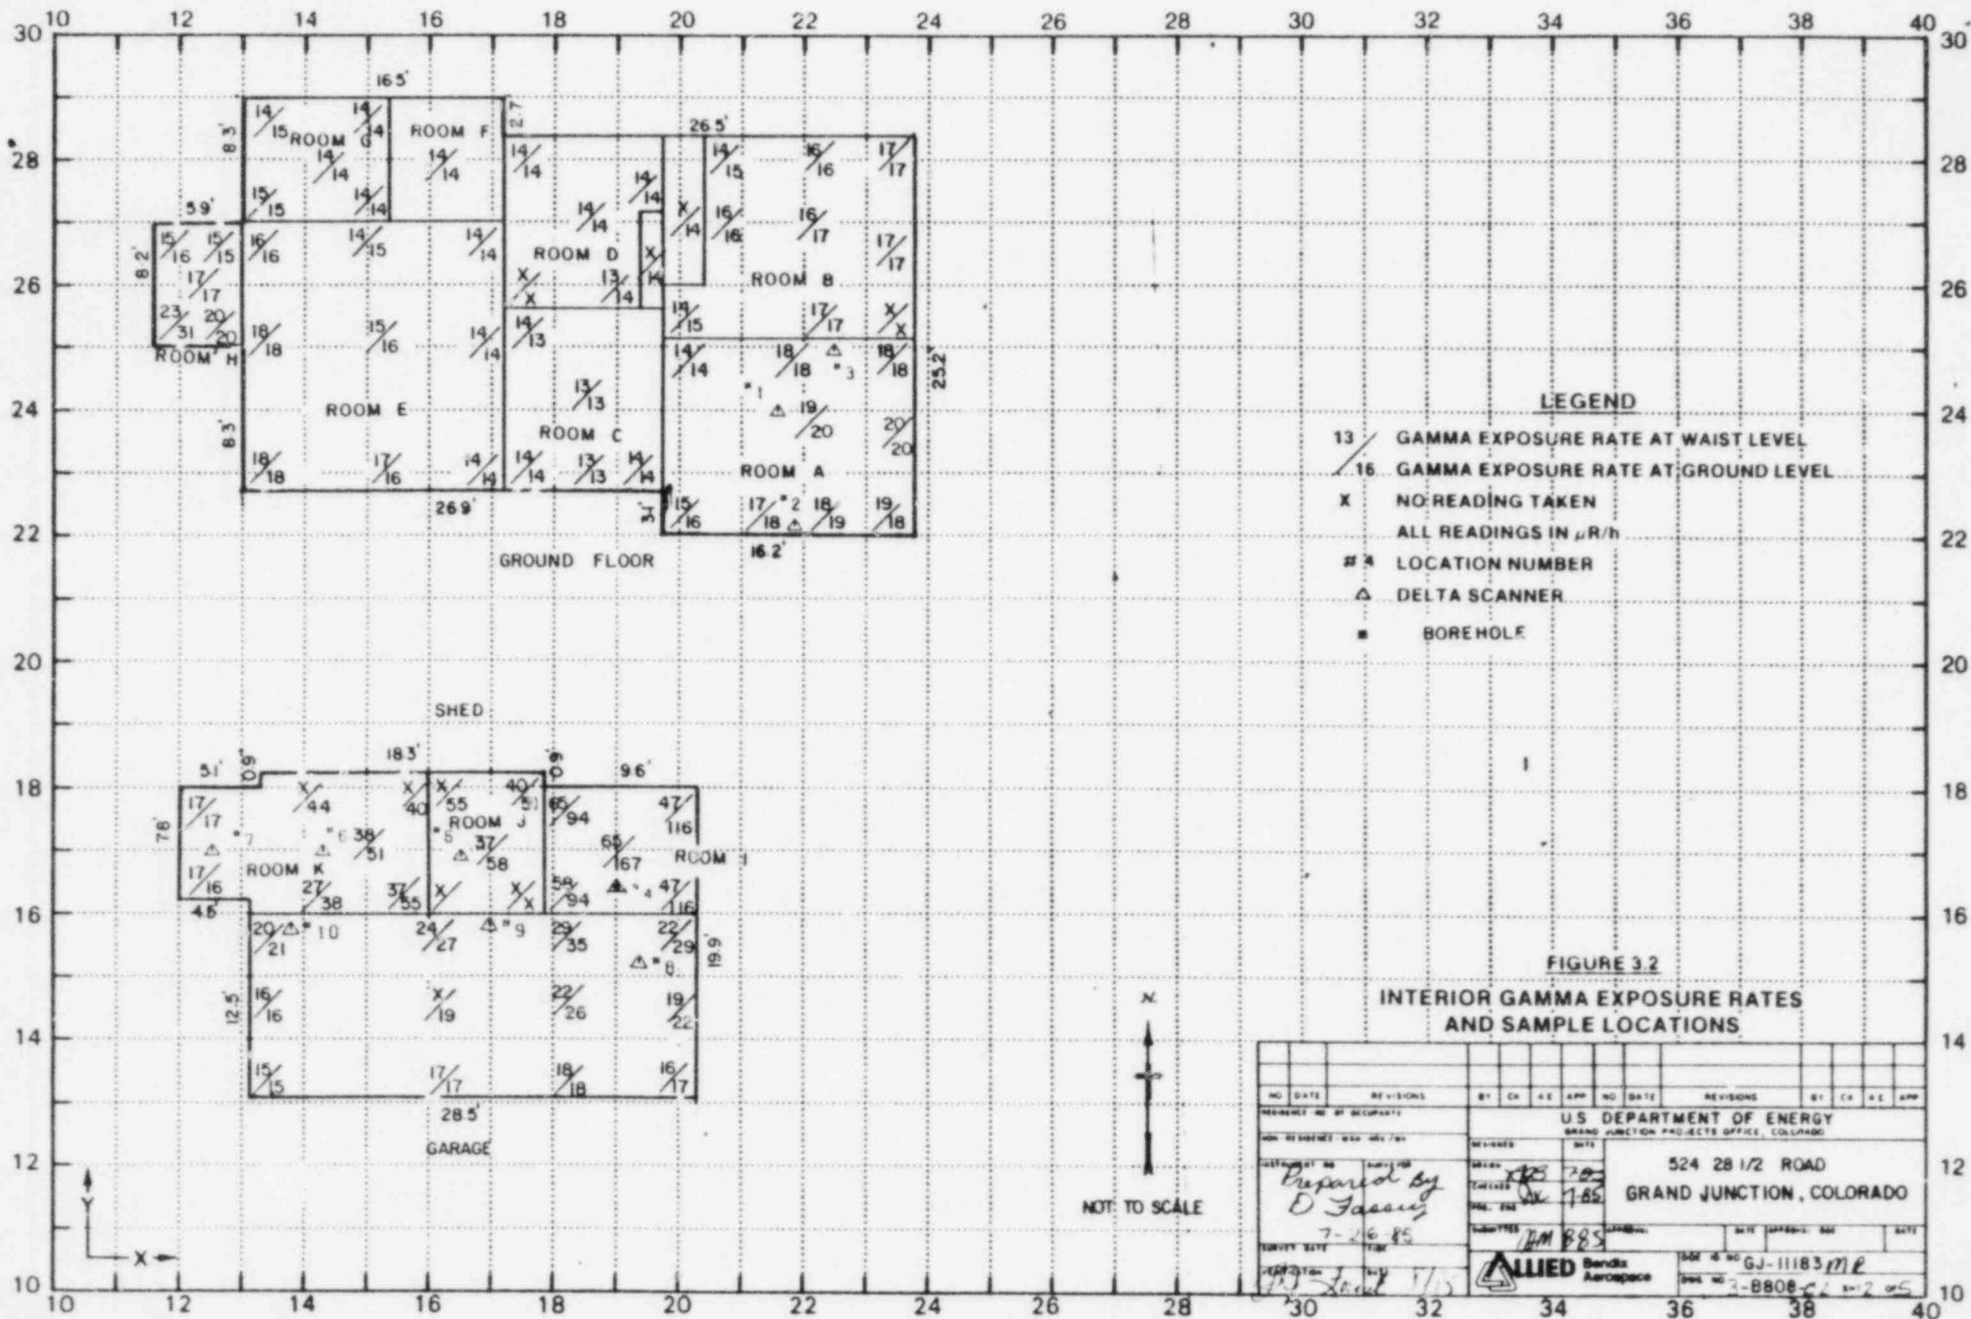
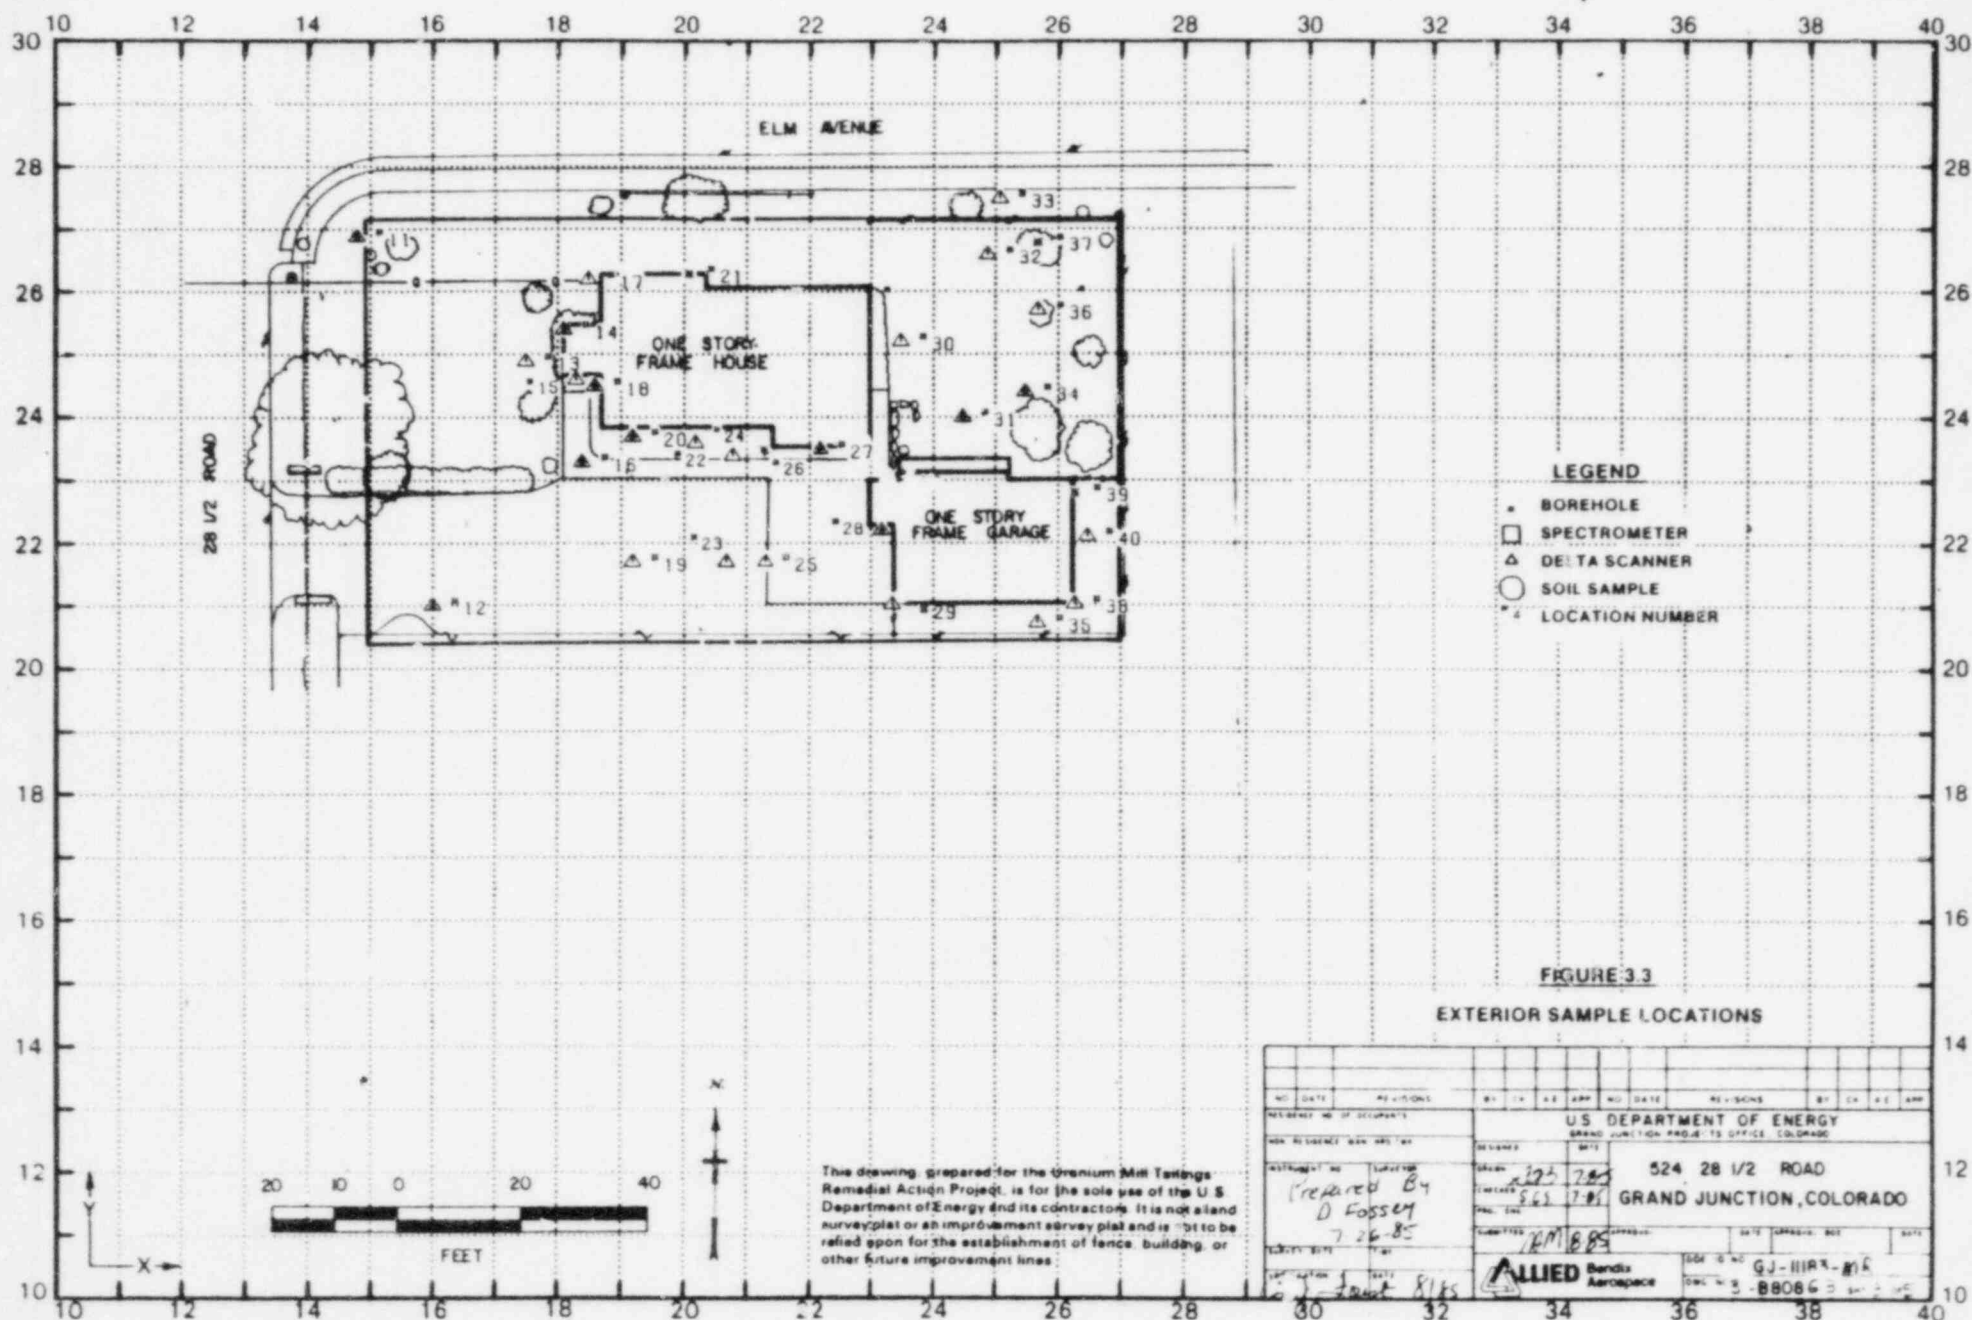
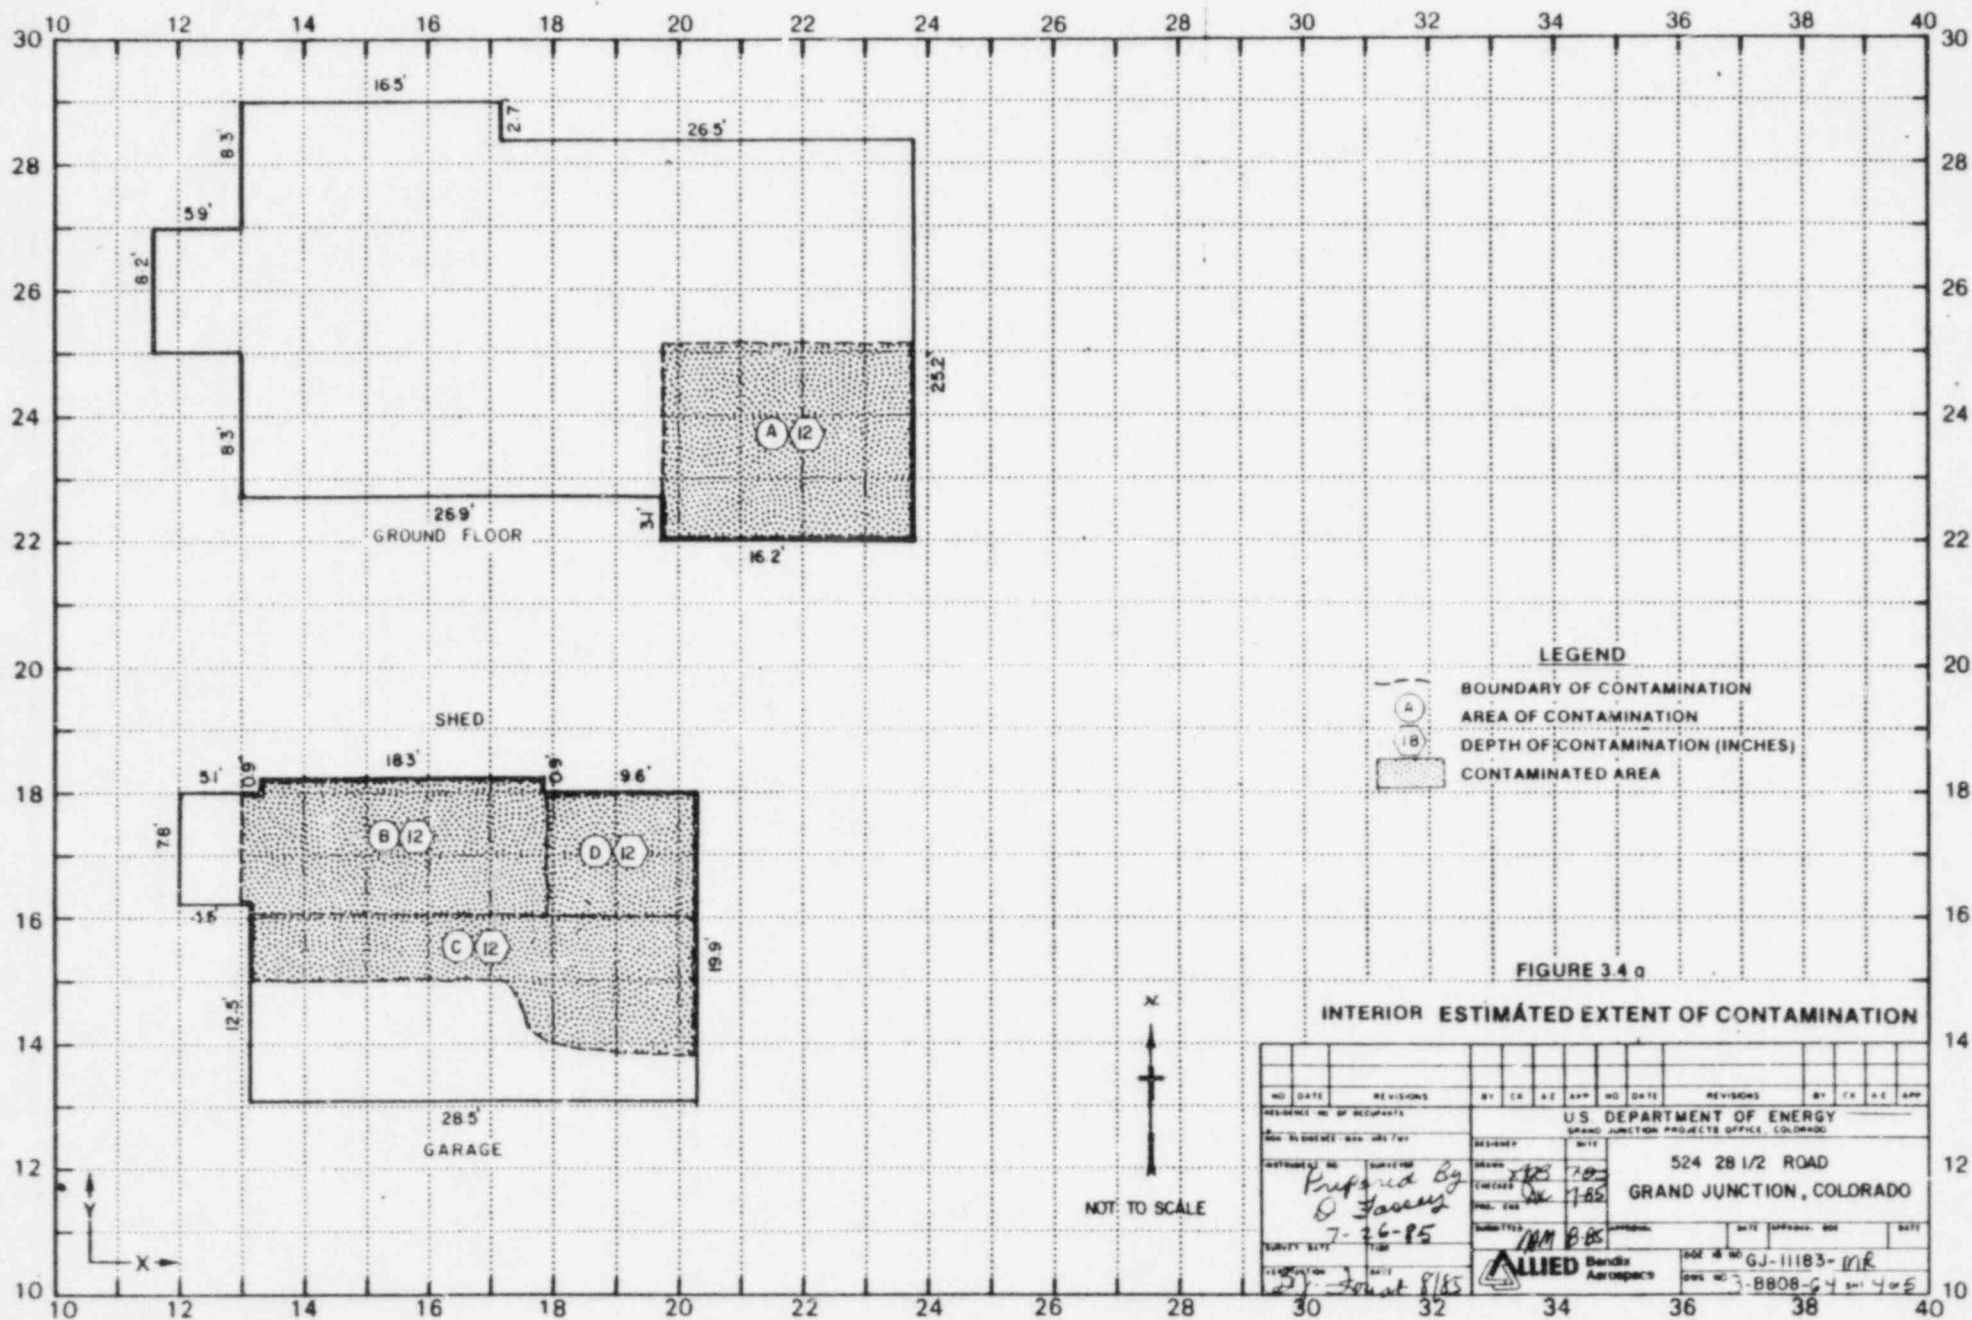
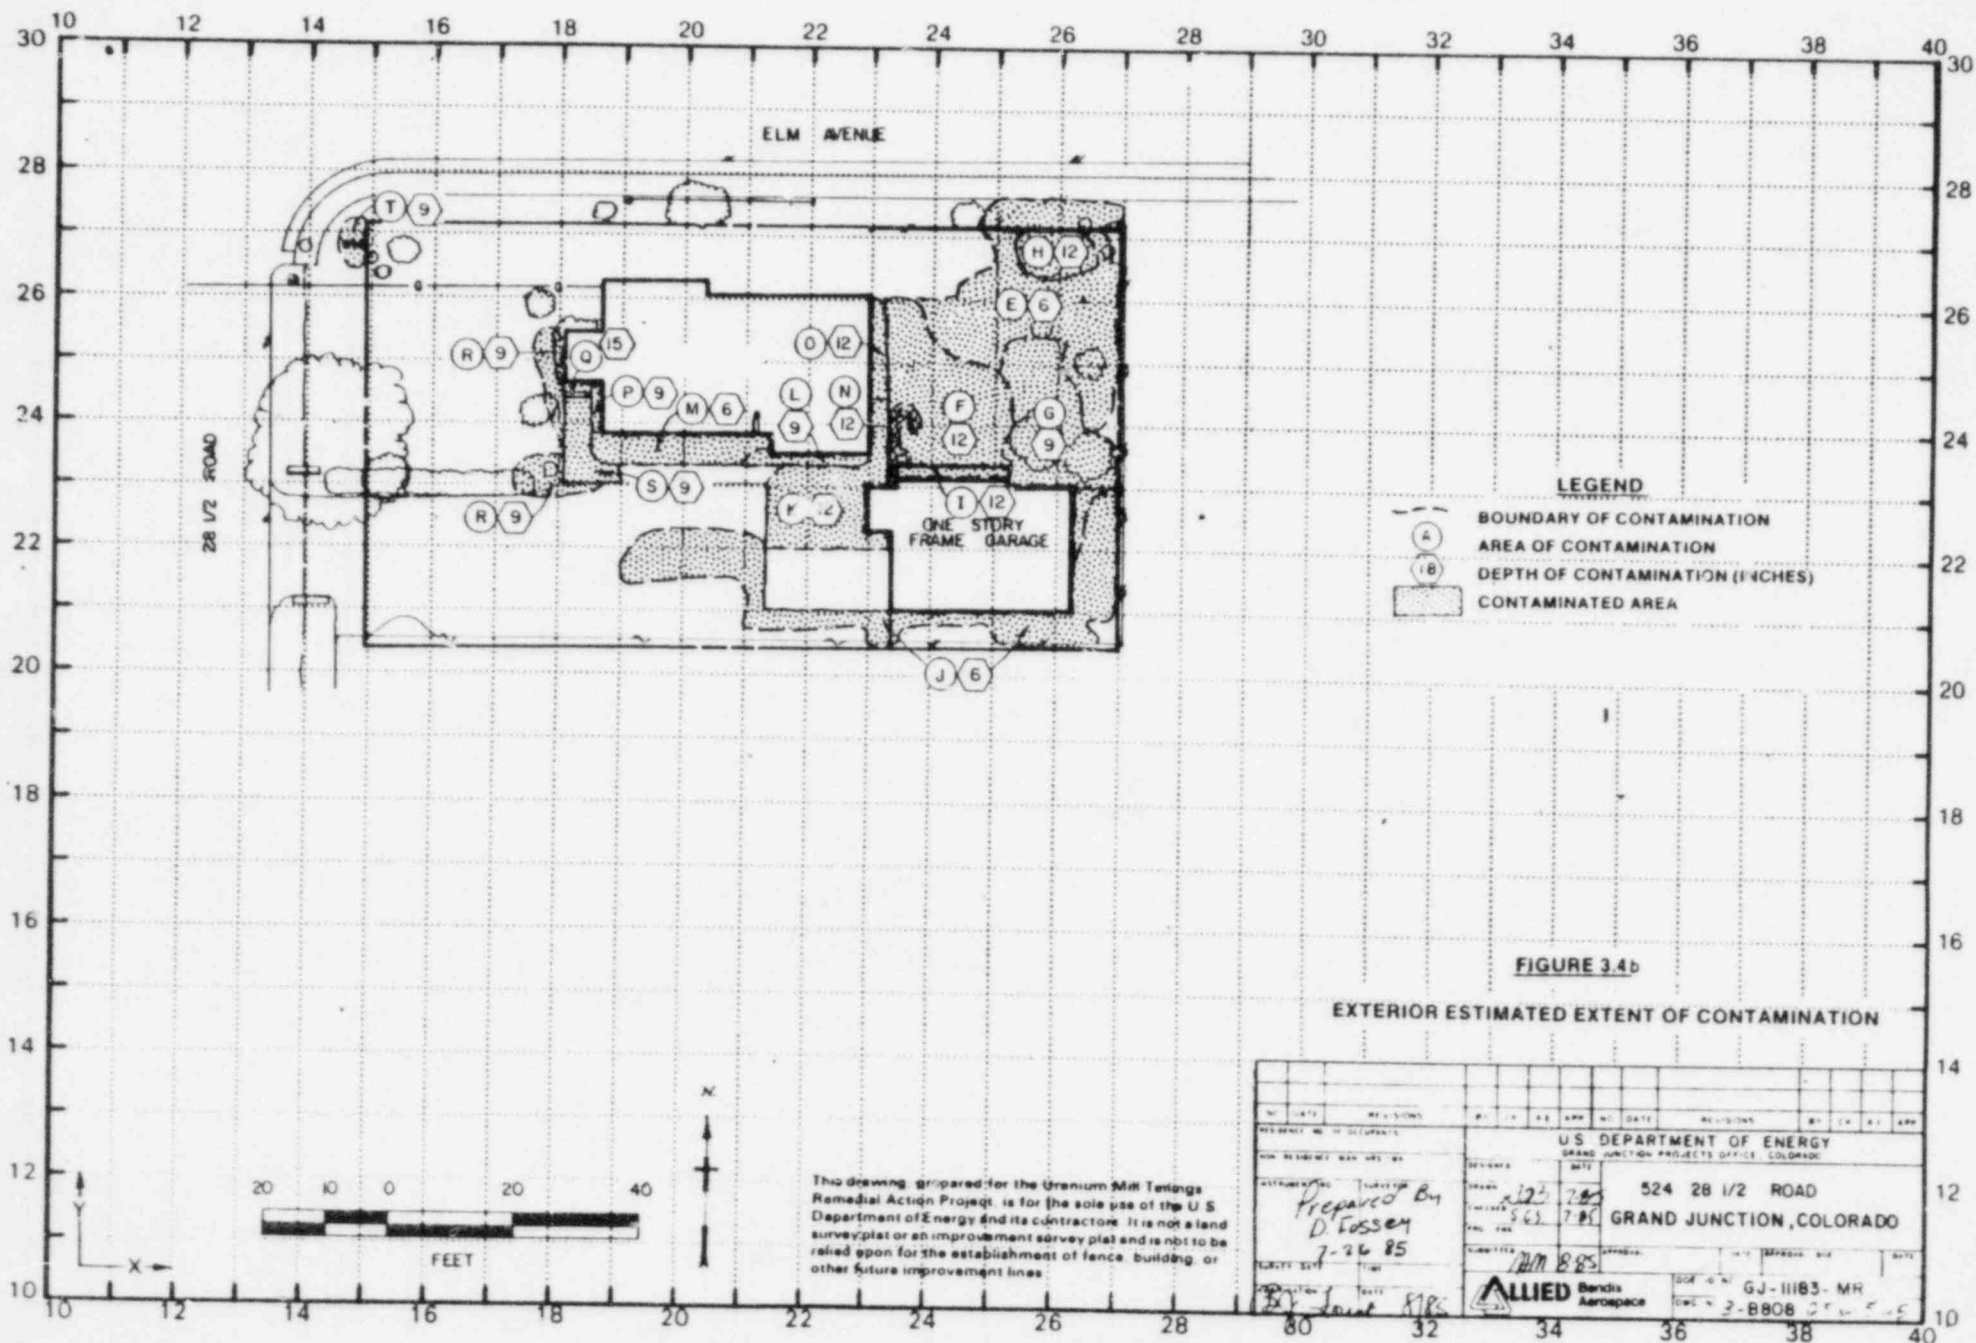
Appendix Figures 3.4a and 3.4b show identified areas and estimated depths of contamination on this property, based on assessments of all measurements taken. As noted in these figures, areas recommended for remedial action that contain identified residual radioactive materials are:

- (Area A) Surface Material: Concrete
 Direction From Primary Structure: Interior
 Other Directions: Southeast room of primary structure
 Total Depth of Contamination: Estimated at 12 inches
 Other (height or thickness): 4-inch-thick concrete
 Comments: The depth of contamination is based on data collected in adjacent exterior areas.
 Approximate Square Footage: 208; this Area is excluded from remedial action.

- (Area B) Surface Material: Concrete
 Direction From Primary Structure: Southeast
 Other Directions: Floor of shed
 Total Depth of Contamination: Estimated at 12 inches
 Other (height or thickness): 4-inch-thick concrete
 Comments: The depth of contamination is based on data collected in Area D.
 Approximate Square Footage: 170

- (Area C) Surface Material: Concrete
 Direction From Primary Structure: Southeast
 Other Directions: Garage floor
 Total Depth of Contamination: Estimated at 12 inches
 Other (height or thickness): 4-inch-thick concrete
 Comments: The depth of contamination is based on data collected in Area K. The contamination may extend further south than surface gamma readings indicate.
 Approximate Square Footage: 176

- (Area D) Surface Material: Soil
 Direction From Primary Structure: Southeast
 Other Directions: In shed
 Total Depth of Contamination: 12 inches
 Approximate Square Footage: 80

- (Area E) Surface Material: Lawn
 Direction From Primary Structure: East and northeast
 Total Depth of Contamination: 6 inches
 Approximate Square Footage: 640

- (Area F) Surface Material: Lawn
Direction From Primary Structure: East
Other Directions: North of garage
Total Depth of Contamination: 12 inches
Approximate Square Footage: 390

- (Area G) Surface Material: Lawn and gravel
Direction From Primary Structure: East
Other Directions: Adjacent to Area F
Total Depth of Contamination: 9 inches
Approximate Square Footage: 383

- (Area H) Surface Material: Lawn
Direction From Primary Structure: Northeast
Other Directions: Surrounded by Area E
Total Depth of Contamination: 12 inches
Approximate Square Footage: 104

- (Area I) Surface Material: Soil
Direction From Primary Structure: Southeast
Other Directions: North of garage
Total Depth of Contamination: Estimated at 12 inches
Comments: The depth of contamination is based on data collected in Area F.
Approximate Square Footage: 36

- (Area J) Surface Material: Gravel
Direction From Primary Structure: South and southeast
Other Directions: South, east, and west of garage
Total Depth of Contamination: 6 inches
Approximate Square Footage: 567

- (Area K) Surface Material: Concrete
Direction From Primary Structure: South
Other Directions: West and north of garage
Total Depth of Contamination: 12 inches
Other (height or thickness): 4-inch-thick concrete
Comments: The contamination may extend beneath the concrete south of this area.
Approximate Square Footage: 297

- (Area L) Surface Material: Soil
Direction From Primary Structure: South
Other Directions: Along south foundation
Total Depth of Contamination: 9 inches
Approximate Square Footage: 40

- (Area M) Surface Material: Soil
Direction From Primary Structure: South
Other Directions: Along south foundation
Total Depth of Contamination: 6 inches
Approximate Square Footage: 130

- (Area N) Surface Material: Flagstone
Direction From Primary Structure: East
Other Directions: West of Area F, along east foundation
Total Depth of Contamination: Estimated at 12 inches
Comments: The depth of contamination is based on data collected in Area F.
Approximate Square Footage: 40

- (Area O) Surface Material: Soil
Direction From Primary Structure: East
Other Directions: West of Area F, along east foundation
Total Depth of Contamination: Estimated at 12 inches
Comments: The depth of contamination is based on data collected in Area F.
Approximate Square Footage: 48

- (Area P) Surface Material: Soil
Direction From Primary Structure: West
Other Directions: East of Area S, along west foundation
Total Depth of Contamination: 9 inches
Approximate Square Footage: 16

- (Area Q) Surface Material: Concrete
Direction From Primary Structure: West
Other Directions: North of Area S, along foundation
Other (height or thickness): Estimated at 15 inches
Comments: The depth of contamination is based on data collected in Area P.
Approximate Square Footage: 12

- (Area R) Surface Material: Lawn and gravel
Direction From Primary Structure: West, along foundation
Total Depth of Contamination: Estimated at 9 inches
Comments: The depth of contamination for these two deposits is based on data collected in Area S.
Approximate Square Footage: 153

- (Area S) Surface Material: Concrete
Direction From Primary Structure: West
Other Directions: West of Area M
Total Depth of Contamination: 9 inches
Other (height or thickness): 4-inch-thick concrete
Comments: The soil beneath the concrete east of this area should be monitored during remedial action.
Approximate Square Footage: 83

- (Area T) Surface Material: Lawn
Direction From Primary Structure: Northwest
Other Directions: Northwest property corner
Total Depth of Contamination: 9 inches
Approximate Square Footage: 40

The recommended remedial action for this property, DOE ID No. GJ-11183-MR, includes removal of select areas identified as containing radioactive material (as discussed in Section 3.5 and shown in Appendix Figures 3.4a and 3.4b) and transport of removed material to the disposal site.

Remedial action will not be performed on Area A of this property because the levels of radioactivity in these areas do not exceed the EPA Standards (40 CFR 192), as described below:

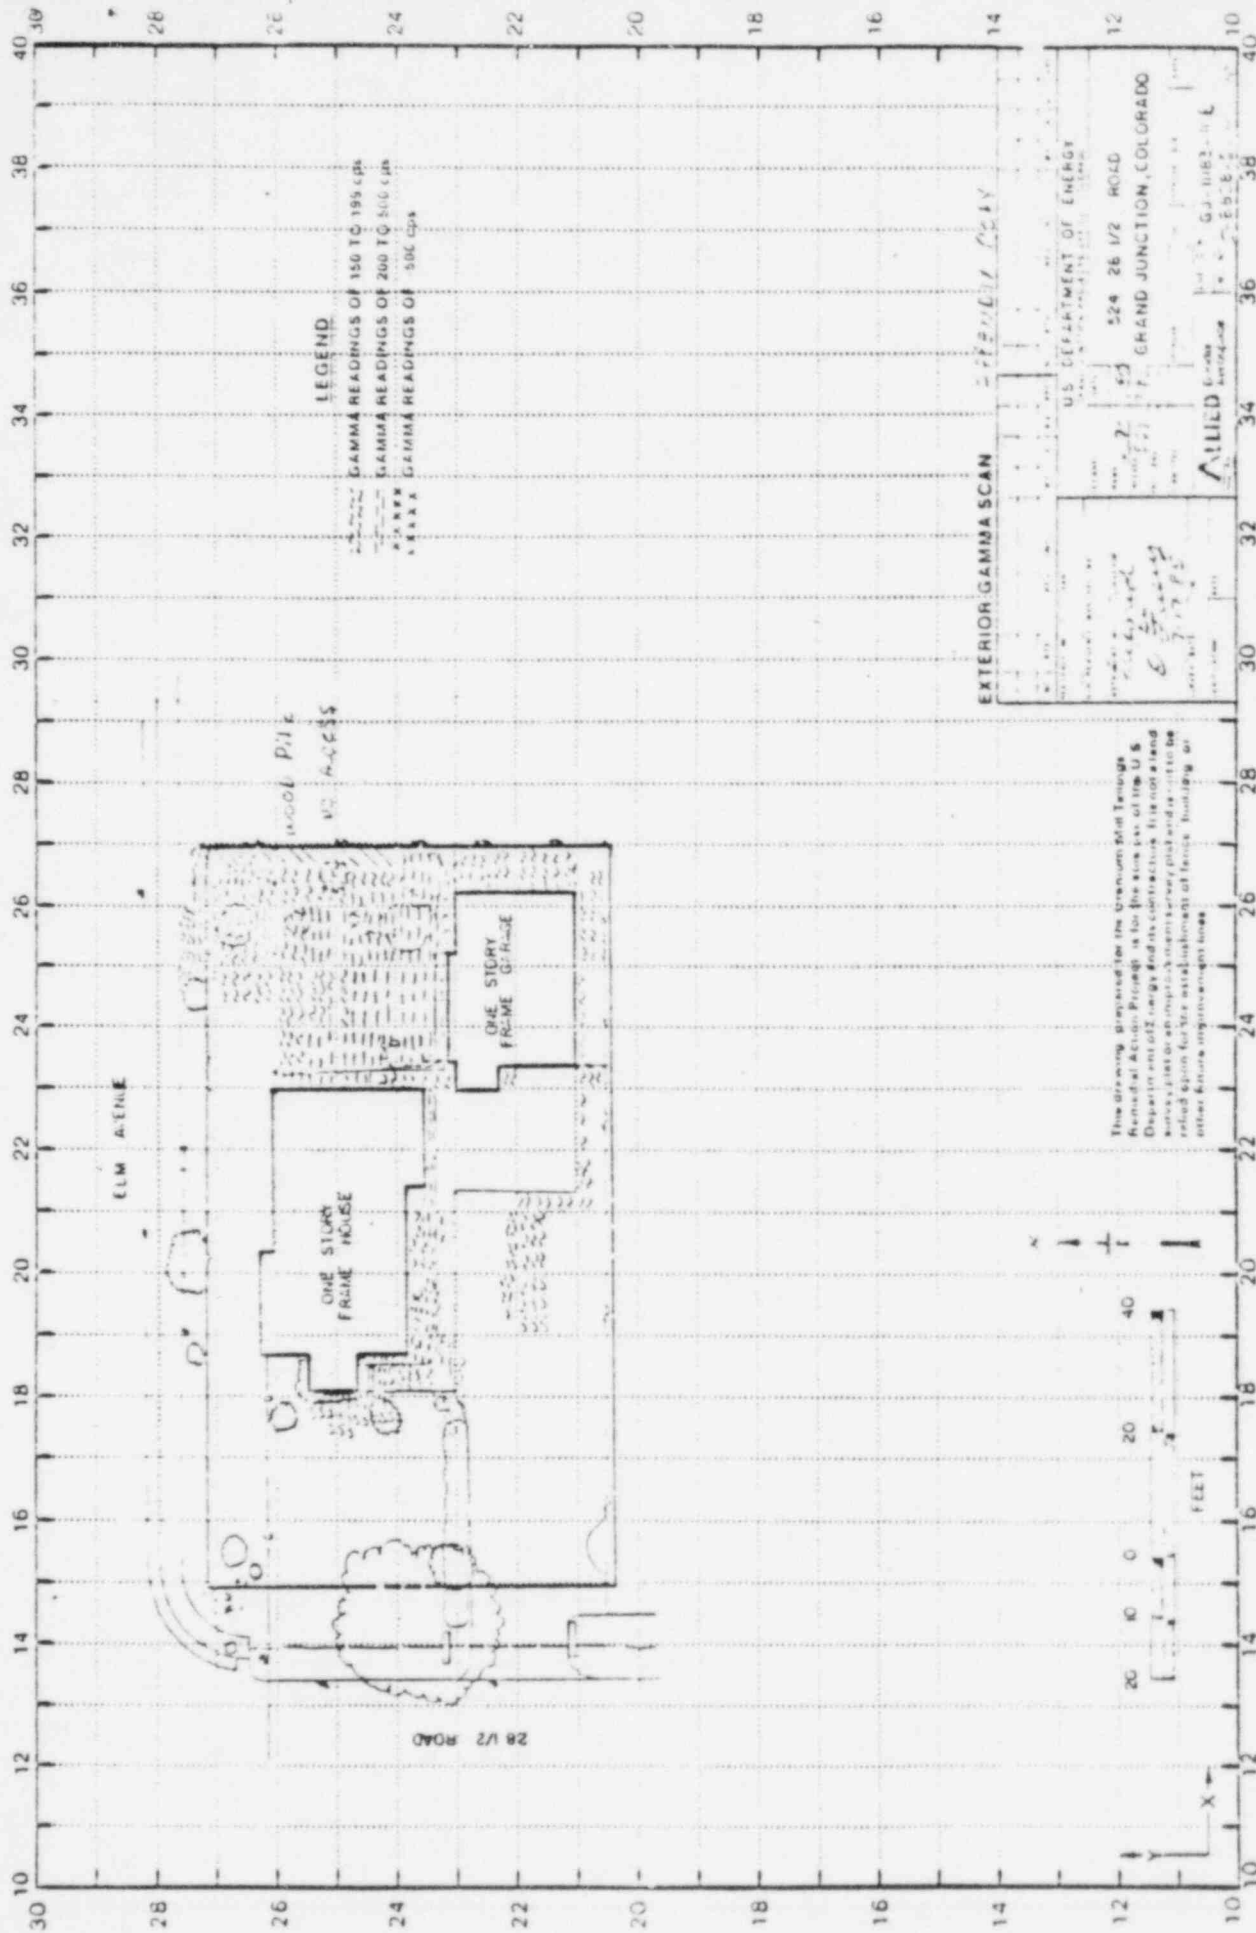
EXTERIOR GAMMA SCAN

Background Readings: 15 to 17 uR/h
Highest Outside Gamma Reading (HOG): 369 uR/h
