RADIOLOGIC AND ENGINEERING ASSESSMENT

DOE ID NO.: GJ-04676-RS
ADDRESS: 2126 TEXAS AVENUE

JULY 1985

BENDIX FIELD ENGINEERING CORPORATION
P.O. Box 1569
Grand Junction, Colorado 81502

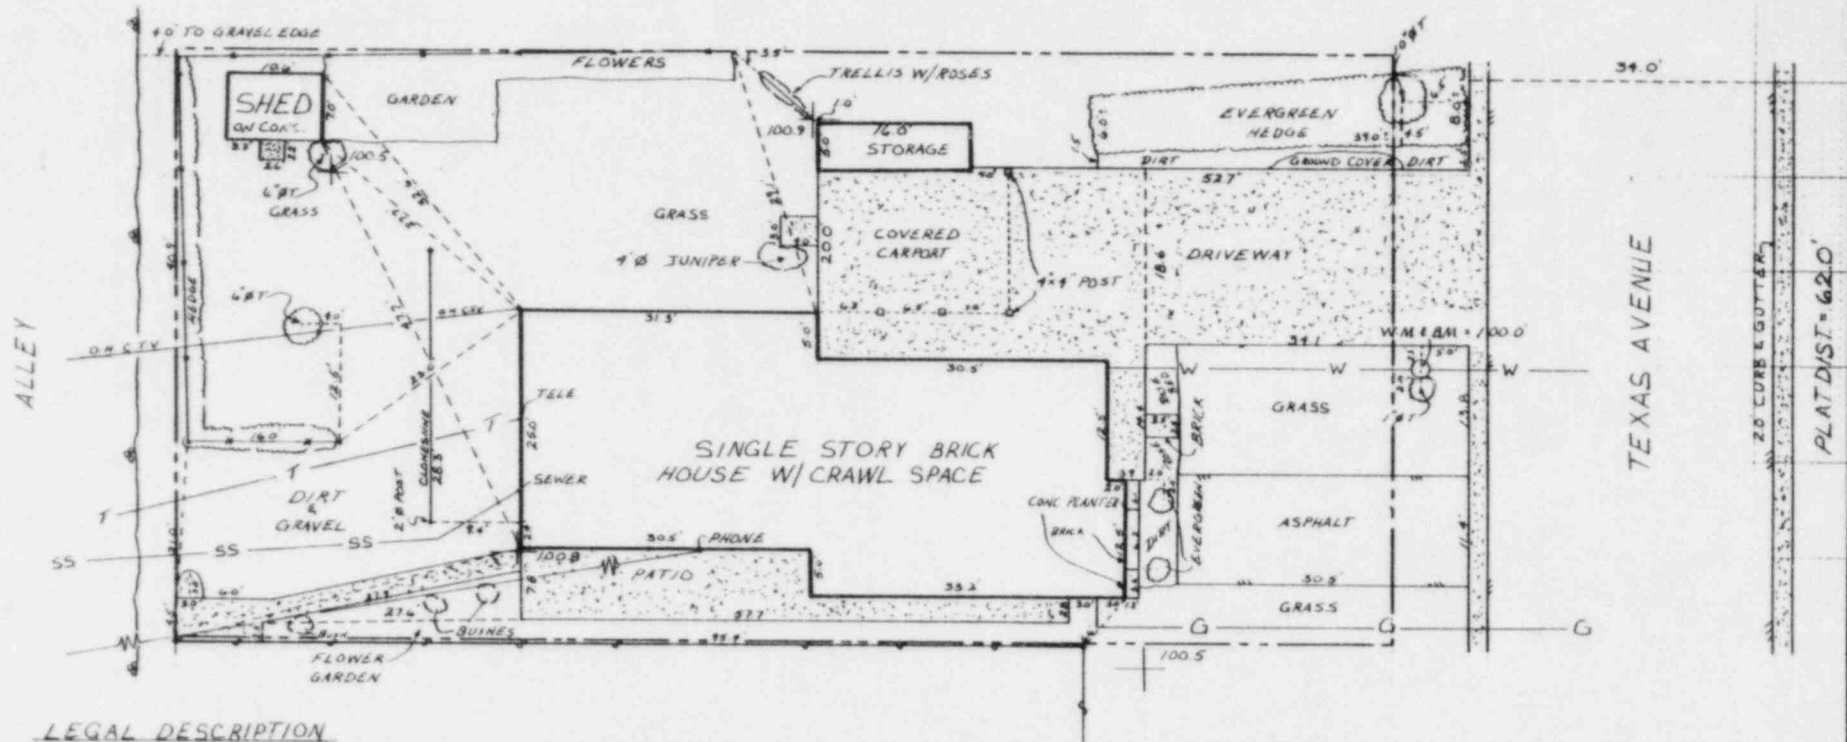
FIGURE 2.2 SITE PLAN

Structures, utilities, landscaping, and other special features of this property are included in Appendix Figure 2.2.

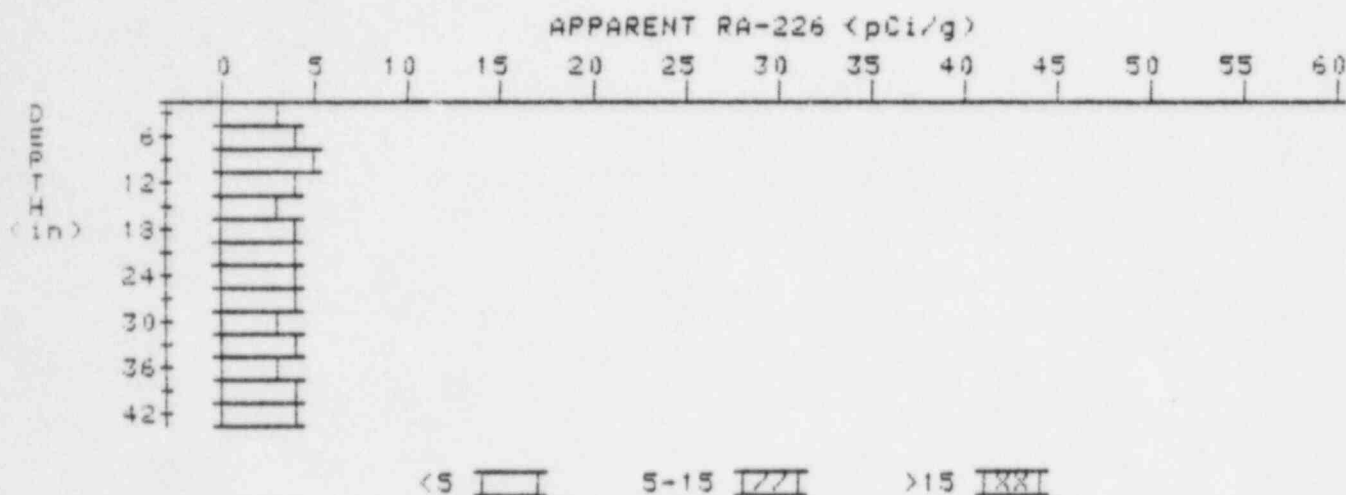
HOLE NUMBER: 4

Loc #	Grid Location	Depth (in.)	Meas. Type	In Situ Ra-226 (pCi/g)		Chem Ra-226 (pCi/g)	Comments
				Tot. Ct	Spectr.		
4	150260	00	DS	1.6		*	Background
		03	TC	3.1		*	
		06	BH	3.6	1.8	*	DC = 0 inches
		09	TC	3.9		*	
		12	BH	3.8	1.5	*	
		15	TC	3.7		*	
		18	BH	3.8	1.5	*	
		21	TC	3.8		*	
		24	BH	3.8	1.7	*	
		27	TC	3.7		*	
		30	BH	3.6	1.4	*	
		33	TC	3.6		*	
		36	TC	3.5		*	
		39	TC	3.5		*	
		42	TC	3.5		*	
5	169249	03	TC	3.3		*	Sewer line
		06	TC	3.5		*	North side of
		09	TC	3.6		*	primary structure
		12	TC	3.7		*	
		15	TC	3.7		*	DC = 0 inches
		18	TC	3.7		*	
		21	TC	3.7		*	
		24	TC	3.6		*	
		27	TC	3.7		*	
		30	TC	3.6		*	
		33	TC	3.7		*	
		36	TC	3.6		*	
		39	TC	3.6		*	
		42	TC	3.5		*	
		45	TC	3.6		*	
		48	TC	3.5		*	
		51	TC	3.6		*	
		54	TC	3.6		*	
		57	TC	3.6		*	
		60	TC	3.6		*	
6	170271	03	TC	3.0		*	Northeast side of
		06	TC	3.2		*	primary structure
		09	TC	3.3		*	
							DC = 0 inches

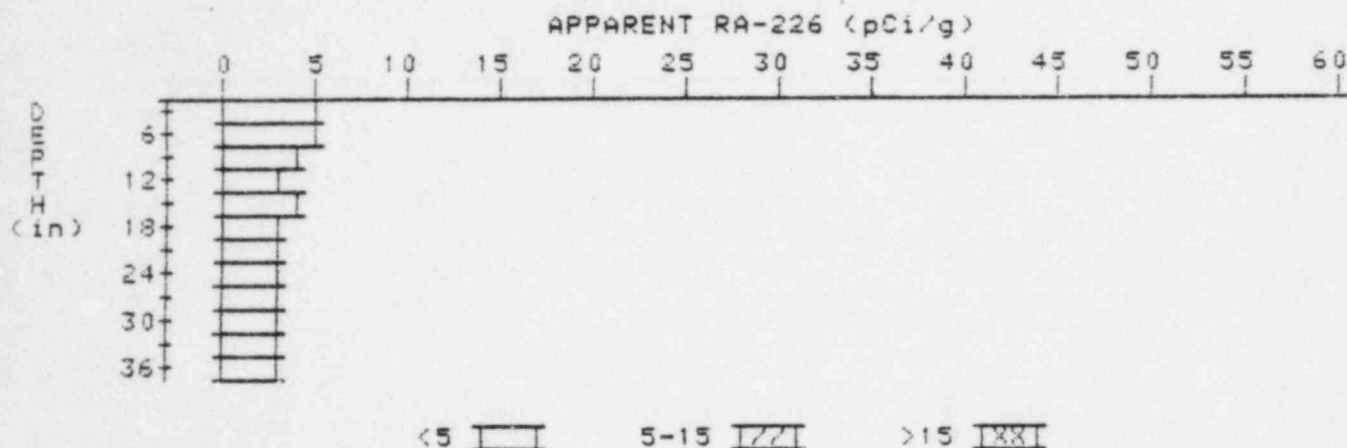
HOLE NUMBER: 1

Loc #	Grid Location	Depth (in.)	Meas. Type	In Situ Ra-226 (pCi/g)		Chem Ra-226 (pCi/g)	Comments
				Tot. Ct	Spectr.		
1		03	TC	4.5		*	Storage shed DC = 5 inches Based on all available data
		06	TC	4.3		*	
		09	TC	3.9		*	
		12	TC	3.6		*	
		15	TC	3.5		*	
		18	TC	3.4		*	
		21	TC	3.3		*	
		24	TC	3.2		*	
		27	TC	3.2		*	
		30	TC	3.2		*	
		33	TC	3.2		*	
		36	TC	3.1		*	
2		00	DS	6.4		*	Storage shed
3		00	DS	6.0		*	Storage shed

Elevated measurements were found in the storage shed, adjacent to the carport. This area was further investigated by performing grid points and a (core/auger) hole in the concrete floor, which was logged with a total count meter. The concrete core is 5-inches thick.
