RADIOLOGIC AND ENGINEERING ASSESSMENT

DOE ID NO.: GJ-14639-MR
ADDRESS: 3142 F ROAD

JULY 1985

BENDIX FIELD ENGINEERING CORPORATION
P.O. Box 1569
Grand Junction, Colorado 81502

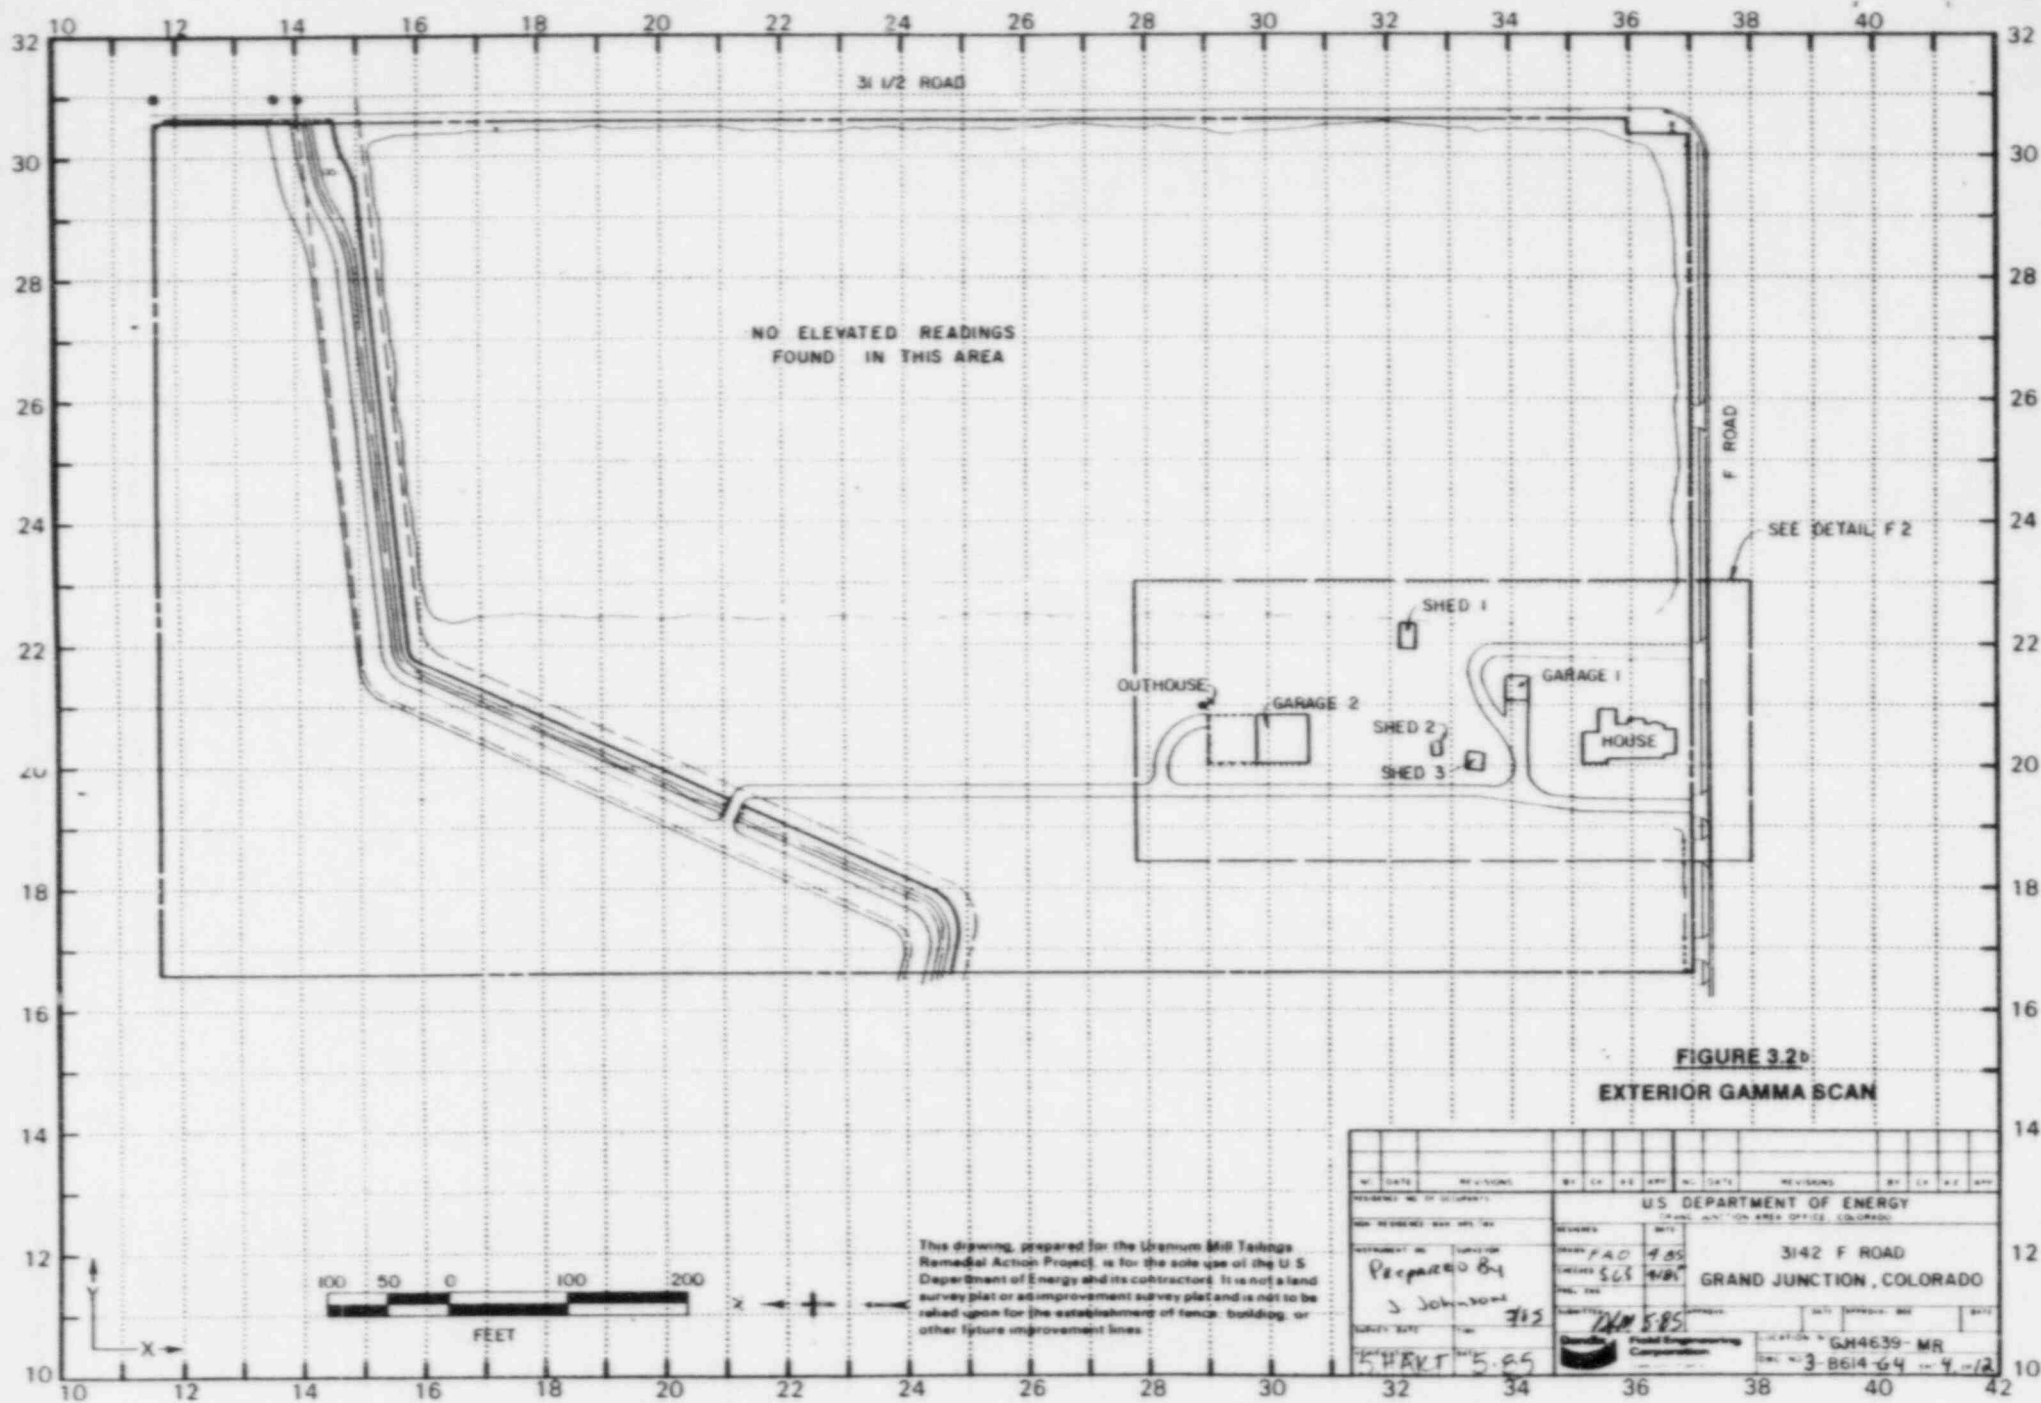
FIGURE 3.2b
EXTERIOR GAMMA SCAN

Exterior radium-concentration measurements are presented in Appendix Table 3.1. Grid-point survey results are shown in Appendix Figures 3.1a and 3.1b. Appendix Figures 3.2a and 3.2b present the ranges of elevated gamma readings and indicate areas of possible contamination.

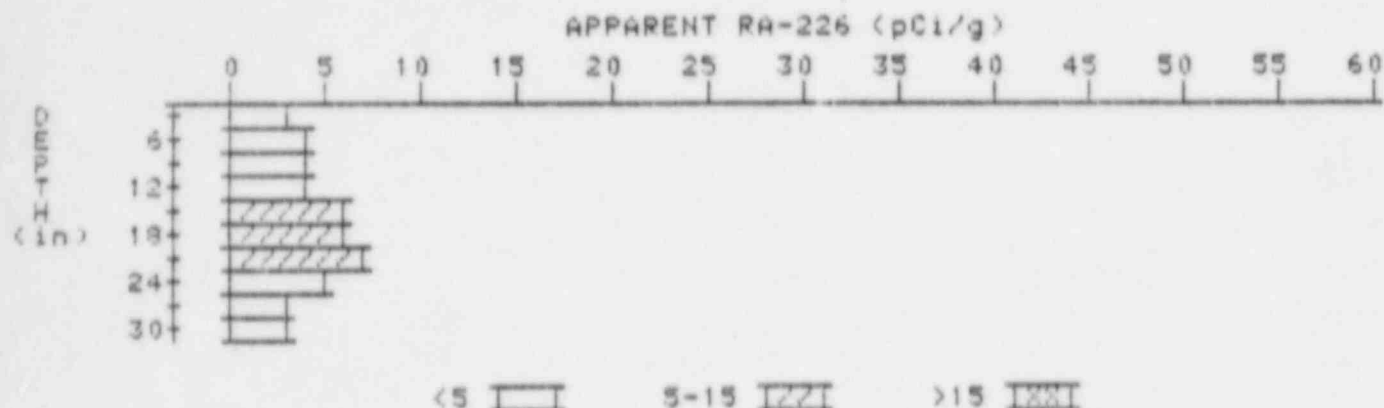
APPARENT RADIUM-226 CONCENTRATION 16 DECONVOLUTION GRAPH

Depth (in)	Apparent Radium-226 (pCi/g) Undeconvolved	Apparent Radium-226 (pCi/g) Deconvolved
3	3.3	3.3
6	3.7	3.9
9	4.0	3.9
12	4.4	3.9
15	5.1	5.8
18	5.4	5.9
21	5.5	7.1
24	4.7	4.7
27	3.9	3.4
30	3.4	3.4

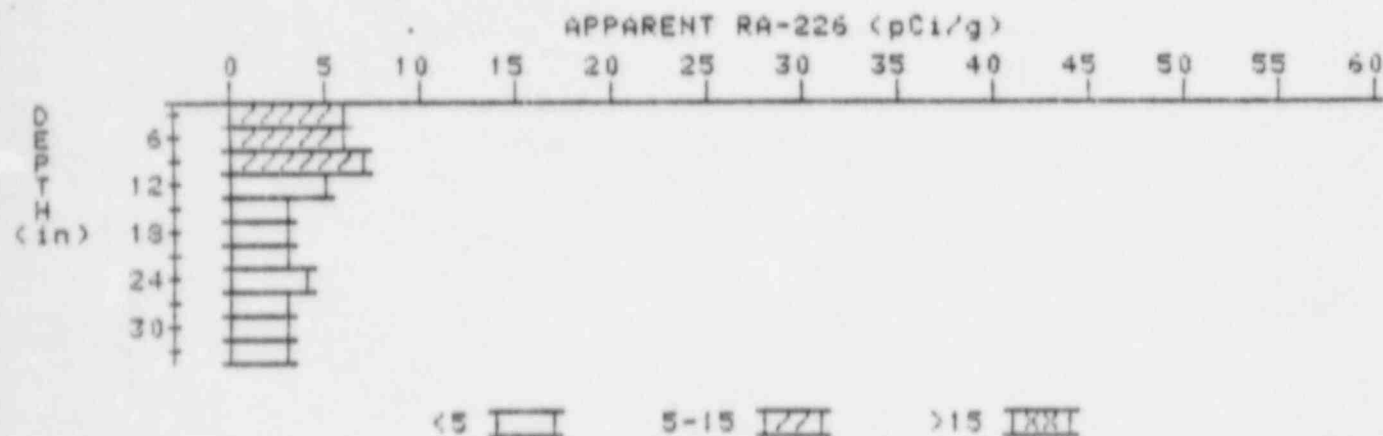
APPARENT RADIUM-226 CONCENTRATION 17 DECONVOLUTION GRAPH

Depth (in)	Apparent Radium-226 (pCi/g) Undeconvolved	Apparent Radium-226 (pCi/g) Deconvolved
3	5.7	5.7
6	5.7	6.1
9	5.5	6.6
12	4.7	4.7
15	3.9	3.0
18	3.6	3.4
21	3.4	2.9
24	3.5	3.9
27	3.4	3.4
30	3.3	3.1
33	3.3	3.3

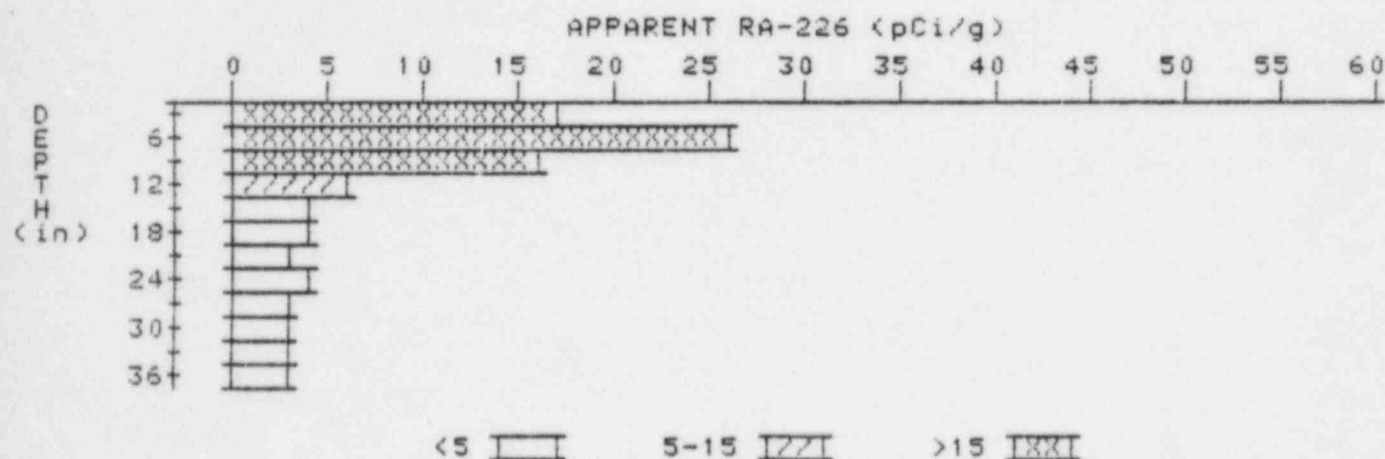
APPARENT RADIUM-226 CONCENTRATION 24 DECONVOLUTION GRAPH

Depth (in)	Apparent Radium-226 (pCi/g) Undeconvolved	Apparent Radium-226 (pCi/g) Deconvolved
3	16.8	16.8
6	17.8	26.2
9	14.1	16.1
12	9.3	5.7
15	6.5	4.2
18	5.0	3.9
21	4.1	3.2
24	3.7	3.5
27	3.4	3.4
30	3.1	2.7
33	3.0	3.0
36	2.9	2.9

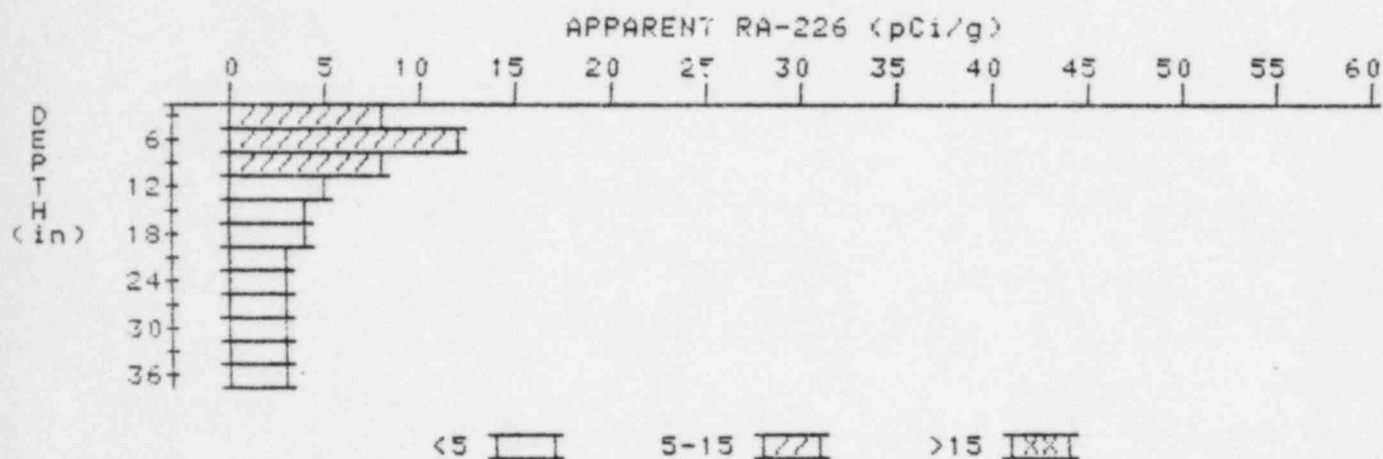
APPARENT RADIUM-226 CONCENTRATION 27 DECONVOLUTION GRAPH

Depth (in)	Apparent Radium-226 (pCi/g) Undeconvolved	Apparent Radium-226 (pCi/g) Deconvolved
3	8.1	8.1
6	8.6	12.0
9	7.2	7.6
12	5.6	4.7
15	4.5	3.6
18	3.9	3.5
21	3.5	3.3
24	3.2	3.0
27	3.0	2.6
30	3.0	3.0
33	3.0	3.0
36	3.0	3.0
