# Arizona Nuclear Power Project

Subject: Final Report - DER 85-20  
A 50.55(e) Reportable Condition Relating  
to Broken Diesel Generator Rocker Arm  
File: 85-019-026; D.4.33.2

FINAL REPORT - DER 85-20  
DEFICIENCY EVALUATION 50.55(e)  
ARIZONA NUCLEAR POWER PROJECT (ANPP)  
PVNGS UNITS 1, 2, 3

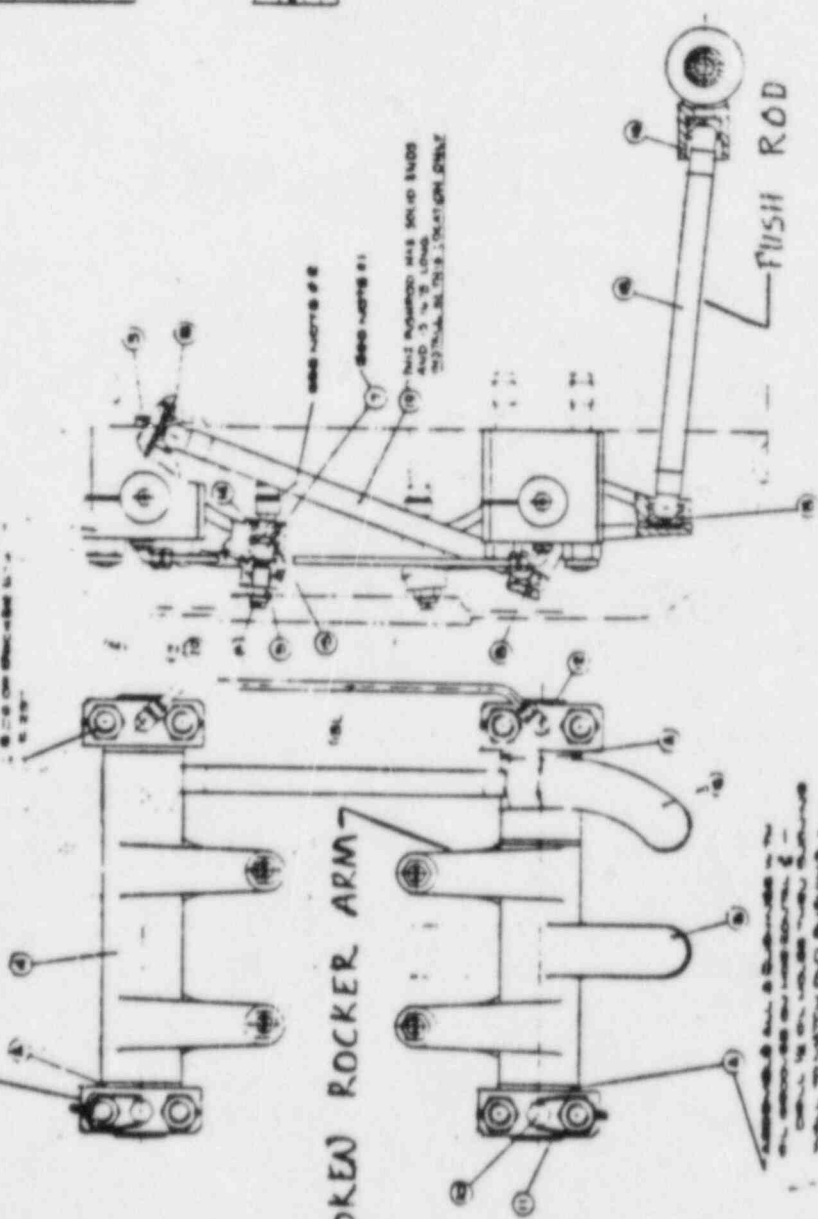
# FIGURE 1

One end of a push rod has a roller attached to it which rides on a cam of the rotating cam shaft. As the high spot on the cam (the lobe) rotates around to the push rod, the push rod rises in its guide. The other end of the push rod rests in a seat in the rocker arm (See Figure 1). The rising action forces the inlet valves seated opposite the push rod down to the open position. As the lobe passes, the push rod comes down and the valves return to the closed position.

The investigation disclosed that the rocker arm on the #5 cylinder on the right bank was split open along the entire length of the arm. NCR MC-2695 documents this finding. Continued use of the D/G with the damaged rocker arm would have initially affected performance in that the intake and exhaust valves for that cylinder would not have operated. With further use, the rocker arm may have split in two and jammed nearby components causing more extensive damage to the push rod, valves, and piston in that cylinder.

- (1) A scuffed area on the spherical push rod seat indicates that the push rod was loose and impacting on the side of the seat rather than sliding smoothly in the seat.

This concludes that the design and fabrication of the rocker arm was satisfactory. The root cause of the failure of the rocker arm was due to improper adjustment of the push rod clearances. This caused the push rod to hammer against the push rod seat eventually breaking the rocker arm. The failure is mechanical and is considered an isolated occurrence since, per Reference 2 and 3, the material and casting were not found to be deficient and proper tappet adjustment will preclude recurrence. Project records show that no clearance adjustments were made to the push rods after the D/G was delivered to the jobsite.

BROKEN ROCKER ARM

The broken rocker arm was replaced with a new rocker arm under Start-up Work Authorization No. 16632. To preclude future failures, tappet clearances will be adjusted at eighteen month intervals as required by Diesel Generator Engine Inspection Procedure No. 31ST-9DG01. Section 11 of the CES Instruction Manual (Document M018-388) details the procedure for valve tappet adjustment. The above test procedure will be performed on the Unit 2 and 3 D/G prior to entry into Mode 6 as required by the Technical Specification. Unit 1 was inspected under 31ST-9DG01 prior to
