## LICENSEE EVENT REPORT (LER)

FACILITY NAME (1) Haddam Neck										DOCKET NUMBER (2) 0 5 0 0 0 2 1 3 1 OF 0 4										PAGE (3) 1 OF 0 4	
----------------------------------	--	--	--	--	--	--	--	--	--	---	--	--	--	--	--	--	--	--	--	----------------------	--

TITLE (4) Unplanned Gaseous Release											
--	--	--	--	--	--	--	--	--	--	--	--

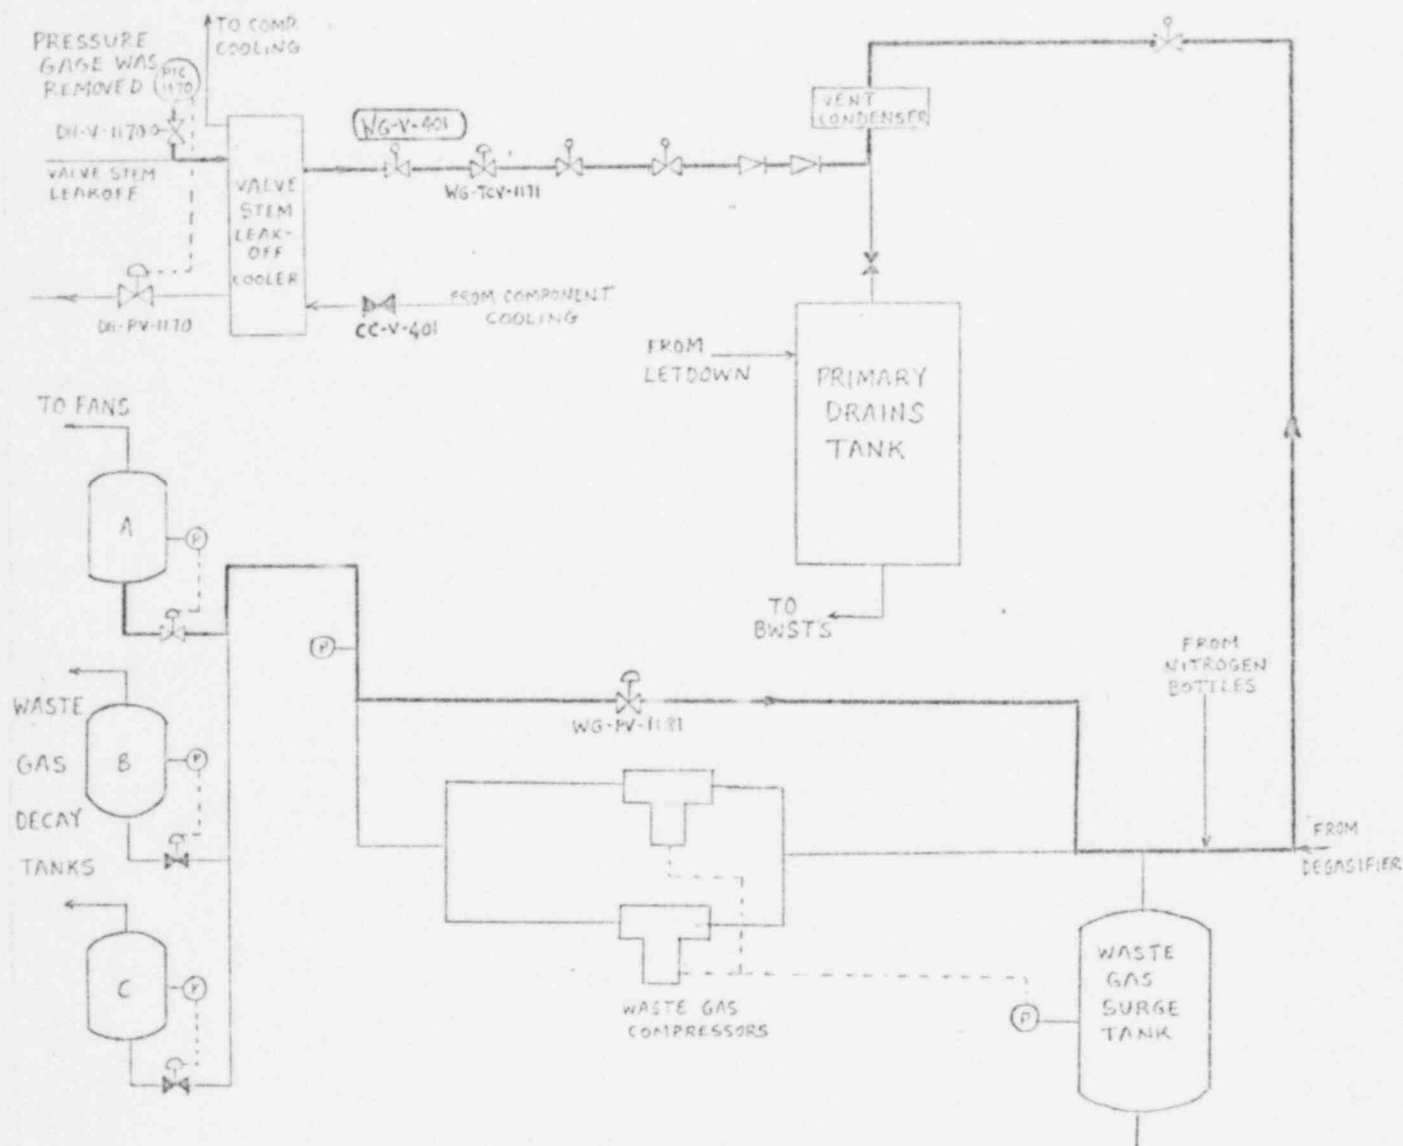
## GASEOUS WASTE SYSTEM

On September 19, 1985 at approximately 0850 hours, with the plant operating at 100% power, a reactor operator received the main stack high radiation alarm. It was quickly determined that the source of the release was due to the planned maintenance on DH-PV-1170 in the gaseous waste system (system code WE). The release was terminated when equipment operators shut WG-TCV-1171 (see system sketch).

On September 19, an equipment operator was assigned to tagout the valve stem leakoff cooler in accordance with station tagout clearance #636. Upon entering the radioactive trench, he found one of the valves labeled only as #401. He proceeded to shut #401 concluding that it was WG-V-401, the waste gas outlet valve. However, the operator was inadvertently shutting CC-V-401, the component cooling water inlet valve to the cooler.

At approximately 0830 hours, Maintenance was to begin work on DH-PV-1170. To vent the system, pressure gage PIC-1170 was removed and DH-V-1170 opened. However, instead of venting the valve stem leakoff cooler, opening DH-V-1170 vented the on-line 'A' waste gas decay tank via WG-V-401.

This occurred because normal system operation allows the waste gas decay tanks to supply the waste gas surge tank when the surge tank pressure drops. However, instead of the decay tank supplying gas to the surge tank it was able to vent through the open connection at DH-V-1170. This was later verified when it was found that the 'A' waste gas decay tank's pressure had dropped 10 psig.

Corrective action taken includes (1) discussion of the event with the operators involved, (2) alerting all equipment operators of the incident and (3) clearly labeling subject valves to prevent recurrence.
