# POWER REACTOR EVENTS

United States Nuclear Regulatory Commission

Date Published: October 1985

Period Covered: March-April 1985

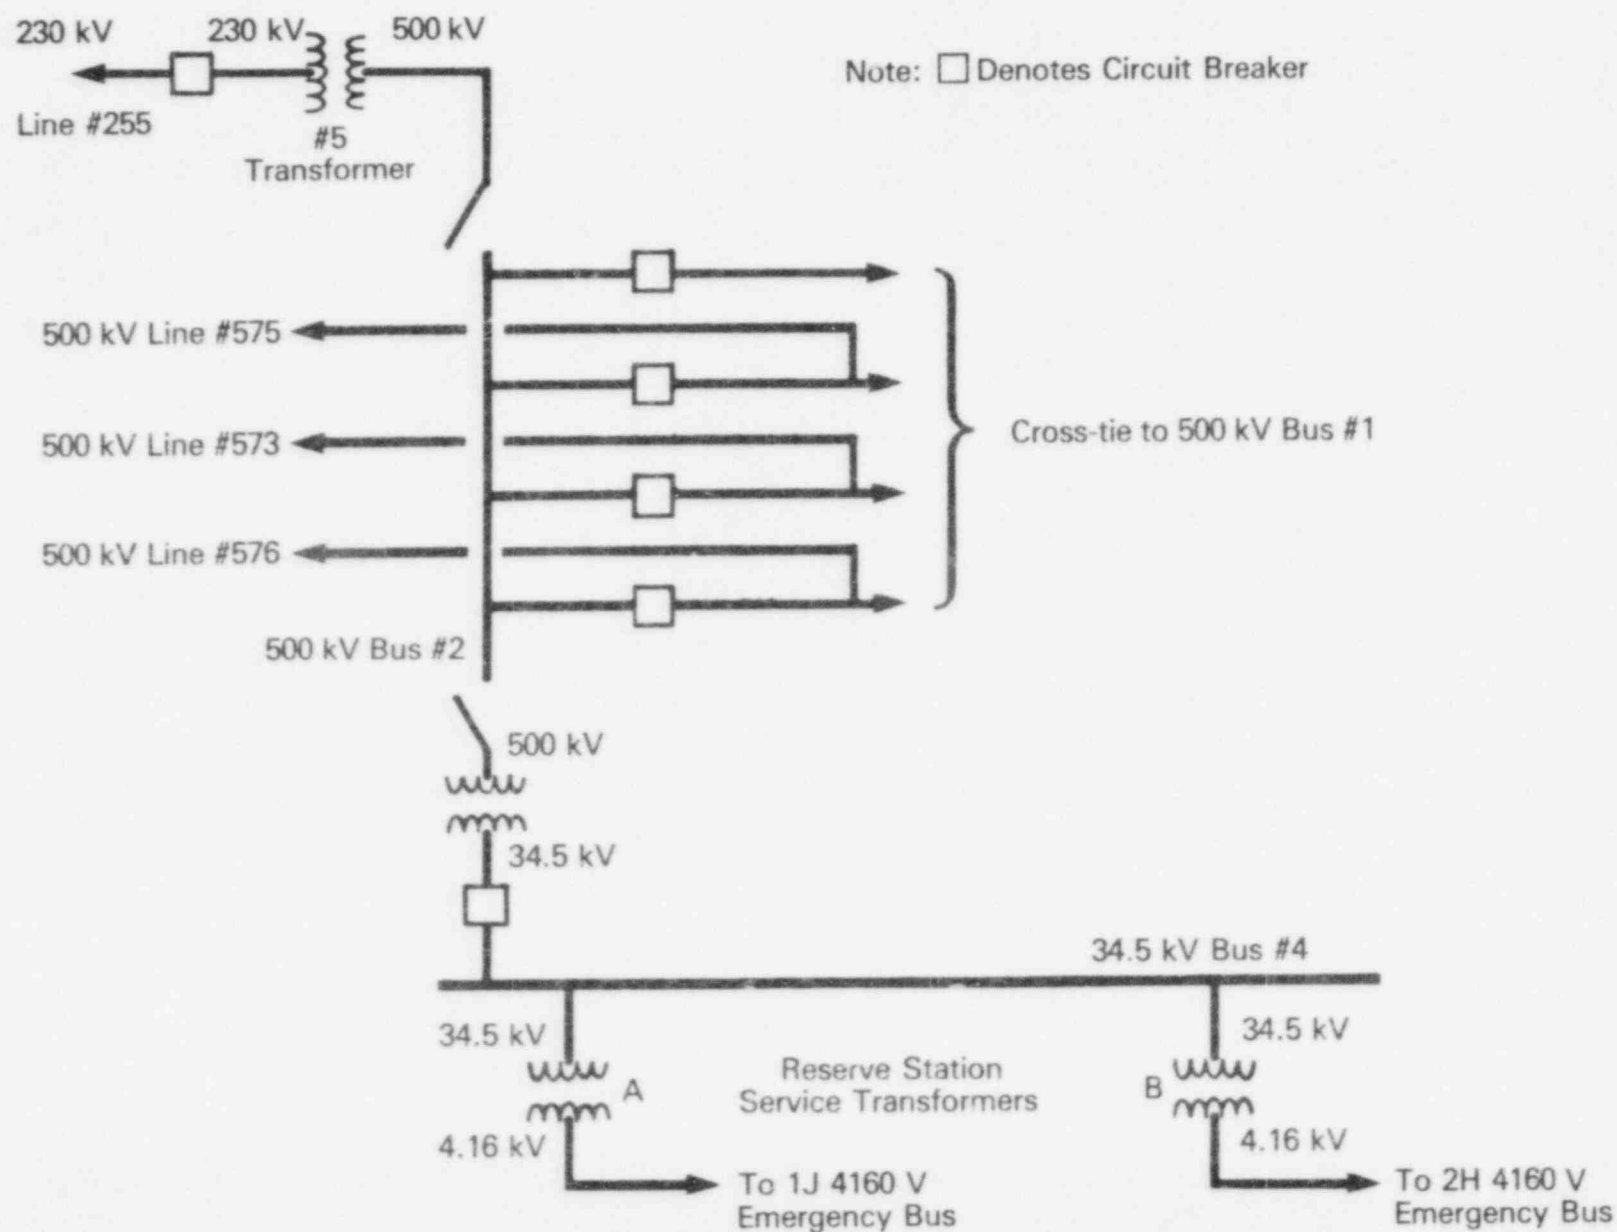
Figure 1. Simplified One-Line Diagram of 500 kV Bus #2 Feeder to 34.5 kV Bus No. 4

The licensee inspected the No. 5 transformer and found that it had not been faulted. However, they did find that one of three single differential trip (SDT) relays actuated to initiate the event. All three of the SDT relays were replaced. (A similar problem with this type of relay at a fossil power station operated by the licensee occurred earlier in 1985.) The relays that were removed are to undergo licensee testing to determine the cause of the spurious actuation.

An engineering evaluation has been requested to determine the feasibility of design modifications to the North Anna switchyard that would keep the 500 kV bus No. 2 energized in the case of a No. 5 switchyard transformer fault. The feasibility of alternate power supplies for the IRPIs is also being investigated. (Refs. 8 and 9.)

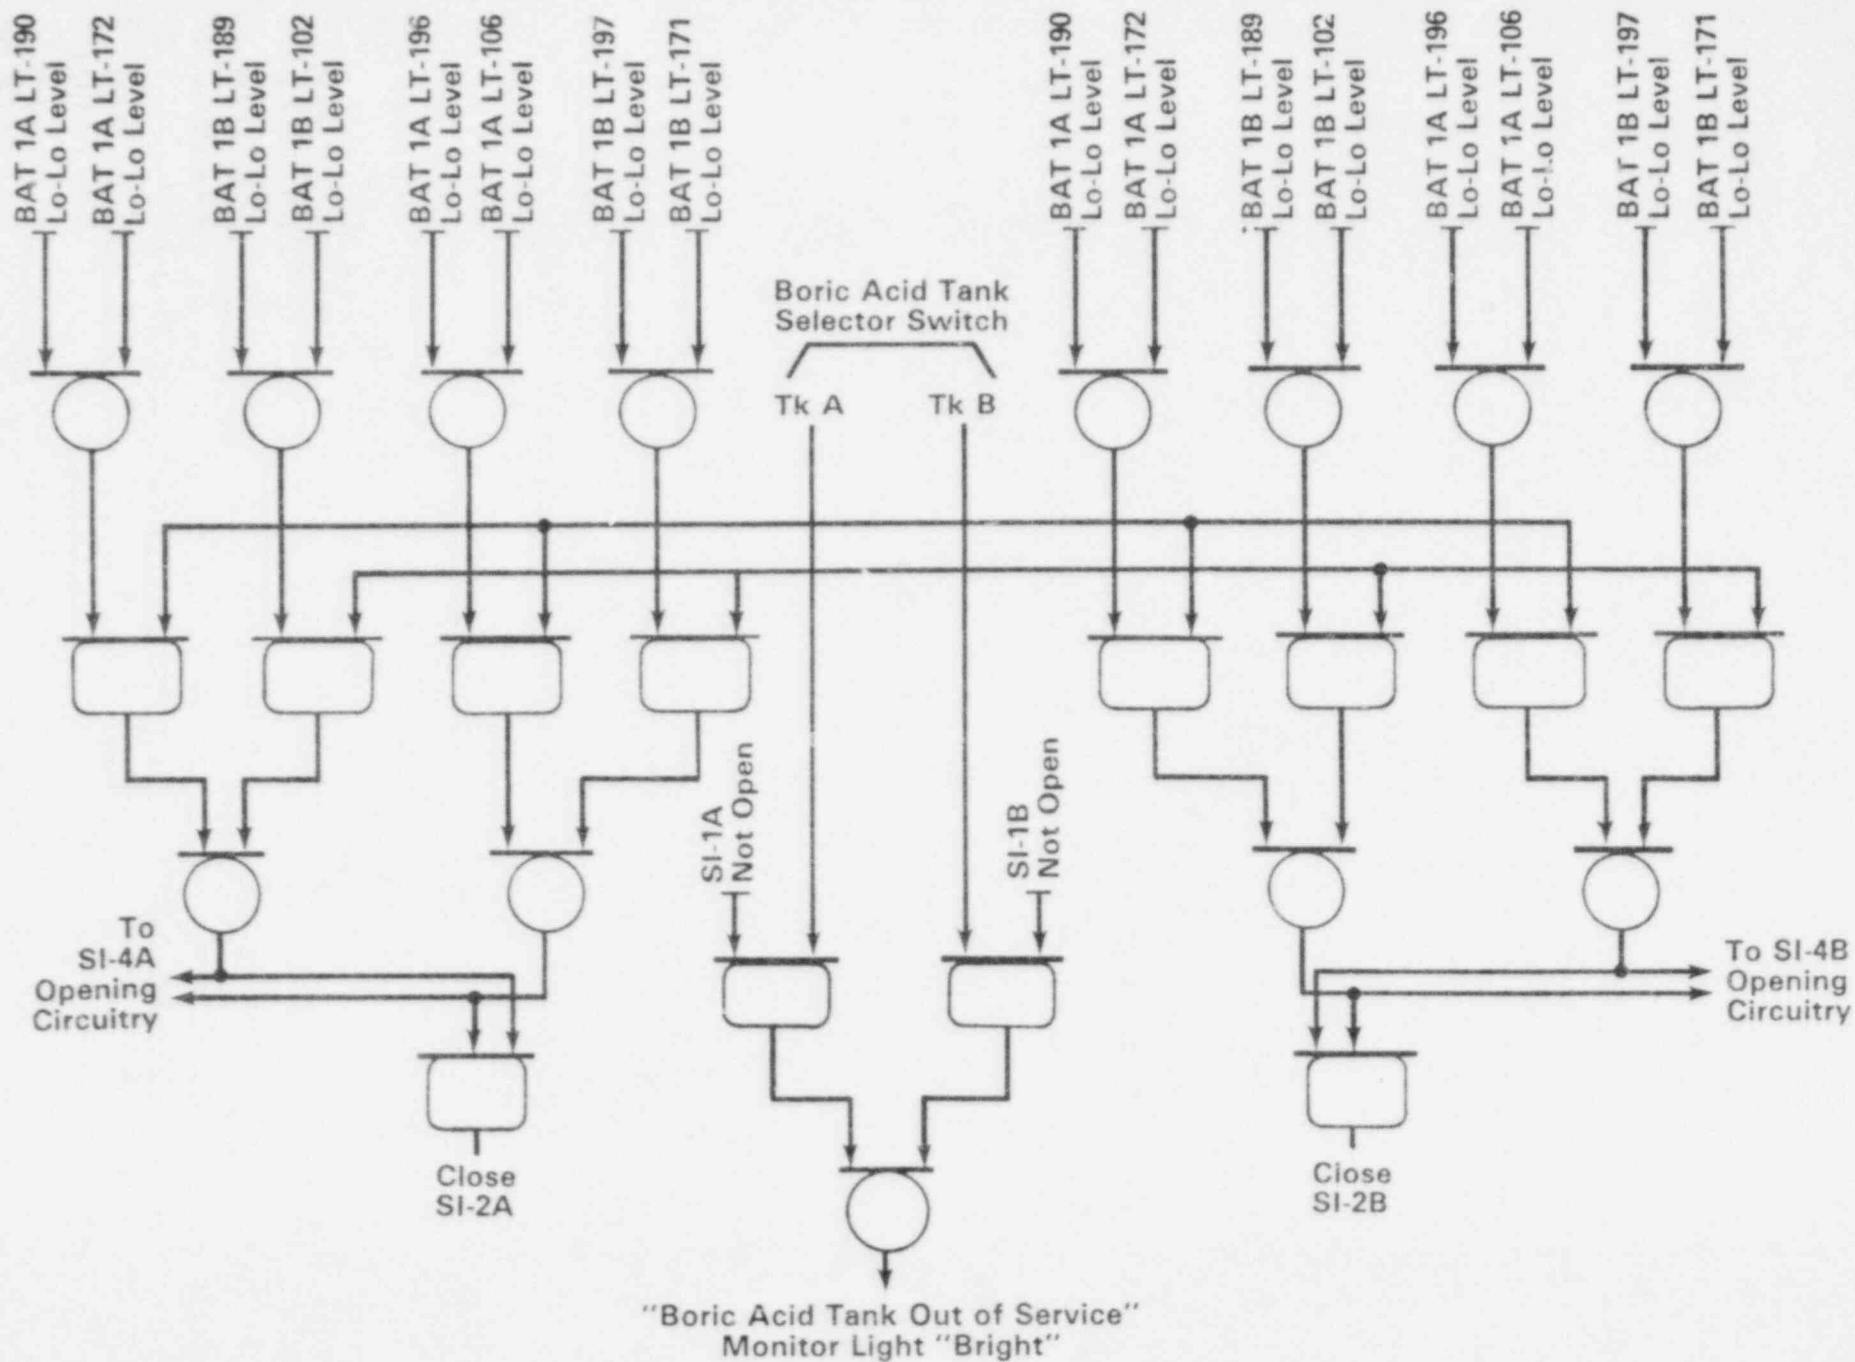
Figure 2. Simplified Logic Diagram

The switch misalignment occurred earlier the same day during the performance of surveillance procedure SP 35-147, "Boric Acid Tank Level Instrument Test." This surveillance is performed monthly by the Instrument and Control Group (I&C) as required by plant technical specifications. The purpose of the procedure is to check the setpoints of the level instruments on each BAT. During the procedure, the tank selector switch is positioned to the tank not under test.

The "Boric Acid Tank Out of Service" monitor light on the SI ready status panel is the only positive indication of proper valve and tank alignment in the control room. The Control Operator did not notice the abnormal light status. Even though the monitor light was in the "bright" condition, it is difficult to distinguish "dim" and "bright" on the ready status panel. The difficulties arise from bulb age, aging of the status windows, circuit resistor age, batch or lot of bulbs in use, and the Control Room Operator perspective of the panel.

Immediate corrective actions were taken to return the switch to the proper position, investigate the cause of the misalignment, review the safety implications of the event, and issue a plant Incident Report. On December 19, 1984, the Plant Manager conducted a meeting with the department heads on the significance of the event, and directed each of them to speak to their employees about the importance of job attentiveness. He also spoke to the personnel involved on the significance of the event and what could have been done to prevent the incident.
