DOCKET 50-312
RANCHO SECO NUCLEAR GENERATING STATION
UNIT NO. 1
MANAGEMENT REPORT CONCERNING JUNE 23, 1985
HIGH POINT VENT LEAK AT RANCHO SECO

EVALUATION OF CONCERNS
ARISING FROM THE JUNE 23, 1985
RCS HIGH POINT VENT LEAK

AT THE
RANCHO SECO
NUCLEAR GENERATING STATION

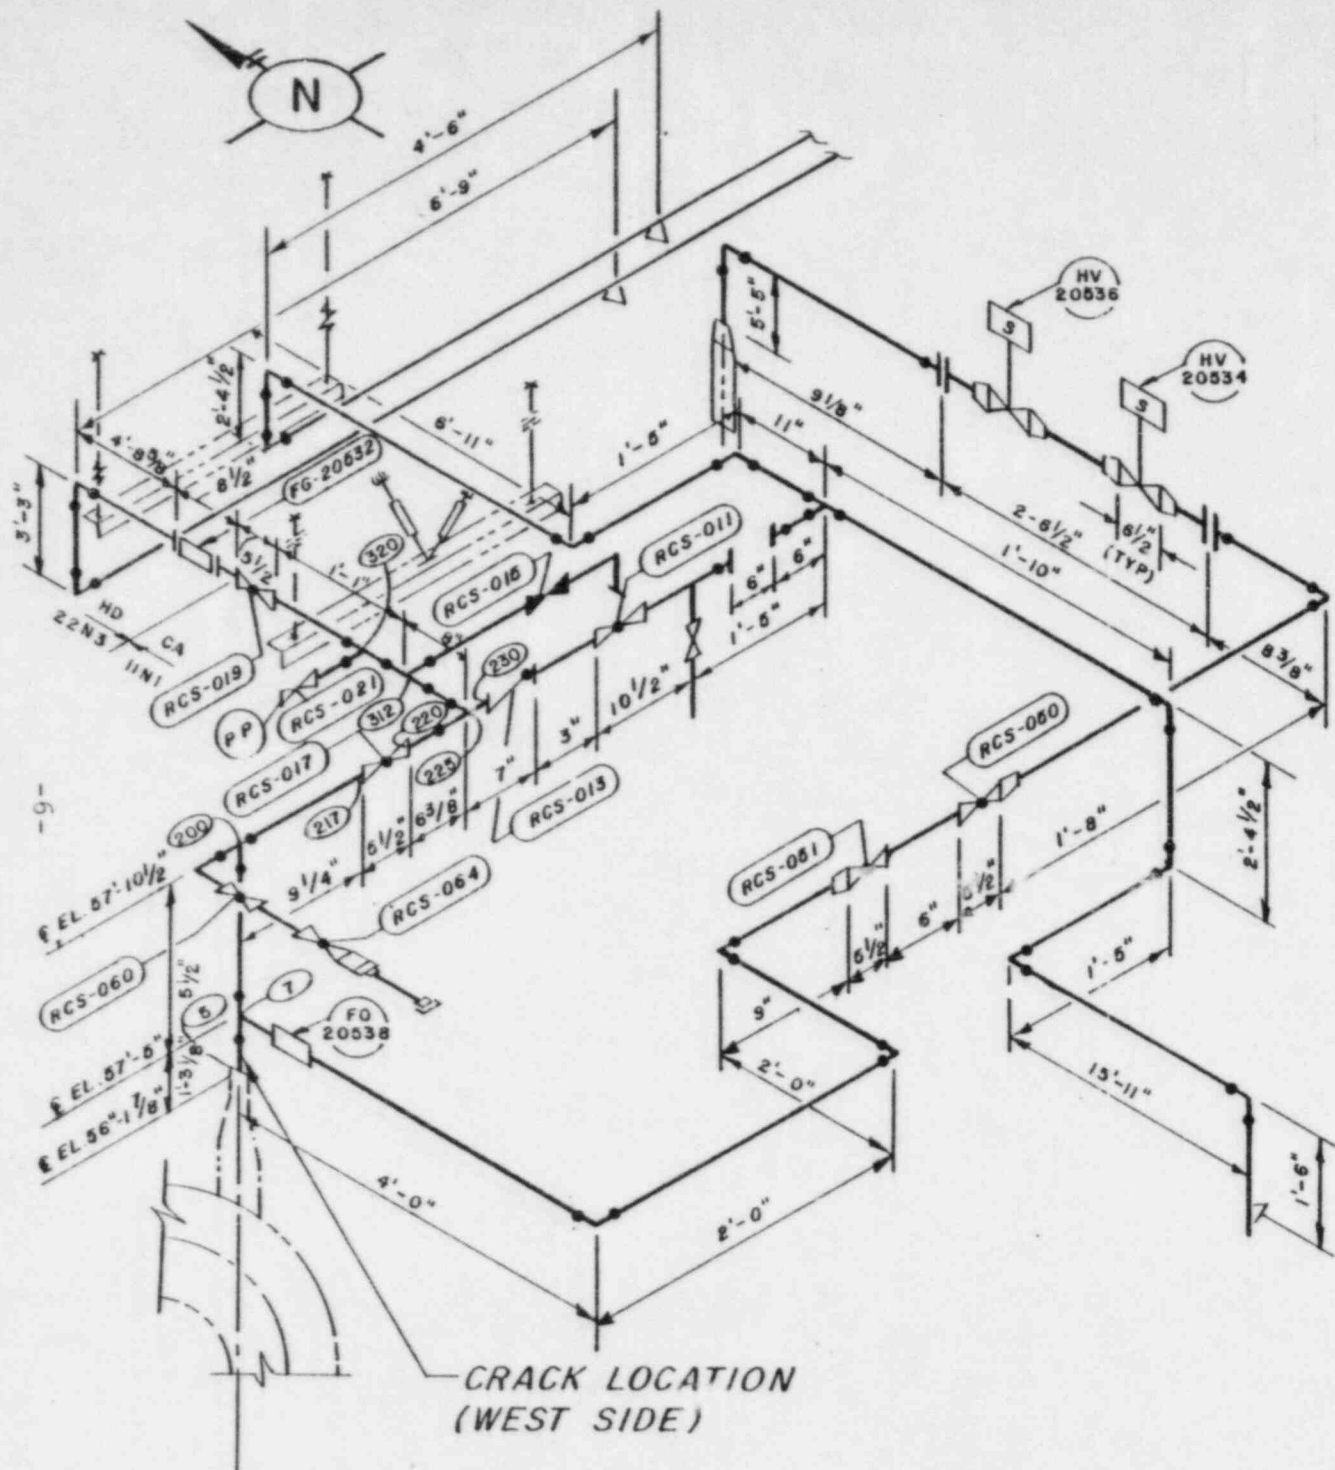
FIGURE II-1

Visual inspections by Nuclear Operations determined that a through-wall crack was located on the pipe side of a pipe to tee weld shown on Figure II-1. The crack extended approximately 120° around the pipe circumference on the west side and seemed to follow the weld fusion line. An investigation was initiated to try to determine the failure mode for the cracked pipe. The investigation included a walkdown of the "B" hot leg high point vent to document the as found piping configuration, stress analysis of the as found configurations, and removal of the segment of the pipe and tee with the crack for laboratory examination.

The District compared the as found configuration, shown on Figure II-1, with that of a 1983 drawing change notice (DCN), shown on Figure II-2, and found that three piping supports and a dummy spool piece which were considered in the design stress analysis were not installed. Nuclear Engineering then performed a stress analysis on the as found configuration. Table II-1 shows the as found piping stresses compared with the piping stress for the current design shown on Figure II-3. The data shows that under normal conditions, the combined normal primary stresses (dead weight plus pressure) in the area of the crack (data point 5) do not exceed code allowable limits. However, the seismic stresses for the as found configuration exceed the allowable limits. The dead weight analysis, however, revealed that there was an unusually large deflection (0.83 inches) at the blind flange end.

Since there had not been any seismic activity at Rancho Seco, the as found stress analysis results indicate a cyclic fatigue induced failure. To strengthen this conclusion, Nuclear Engineering performed a simplified fatigue evaluation.

Two other observations with regard to the crack location were noted. First, the crack occurred in the heat affected zone of the weld which inherently has significant residual stresses. Second, the crack occurred at a location which has high longitudinal tensile stresses compared to compressive stresses on the intact side of the pipe. Using these two factors, the results of the fatigue calculations, and the absence of conditions leading to another failure mechanism, the District concluded that a fatigue induced failure of the "B" hot leg high point vent line was the most probable cause.

AS FOUND

ISOMETRIC DIAGRAM
R.C.S. HIGH POINT VENT
STEAM GENERATOR E-205B
20564 - 1" - HD

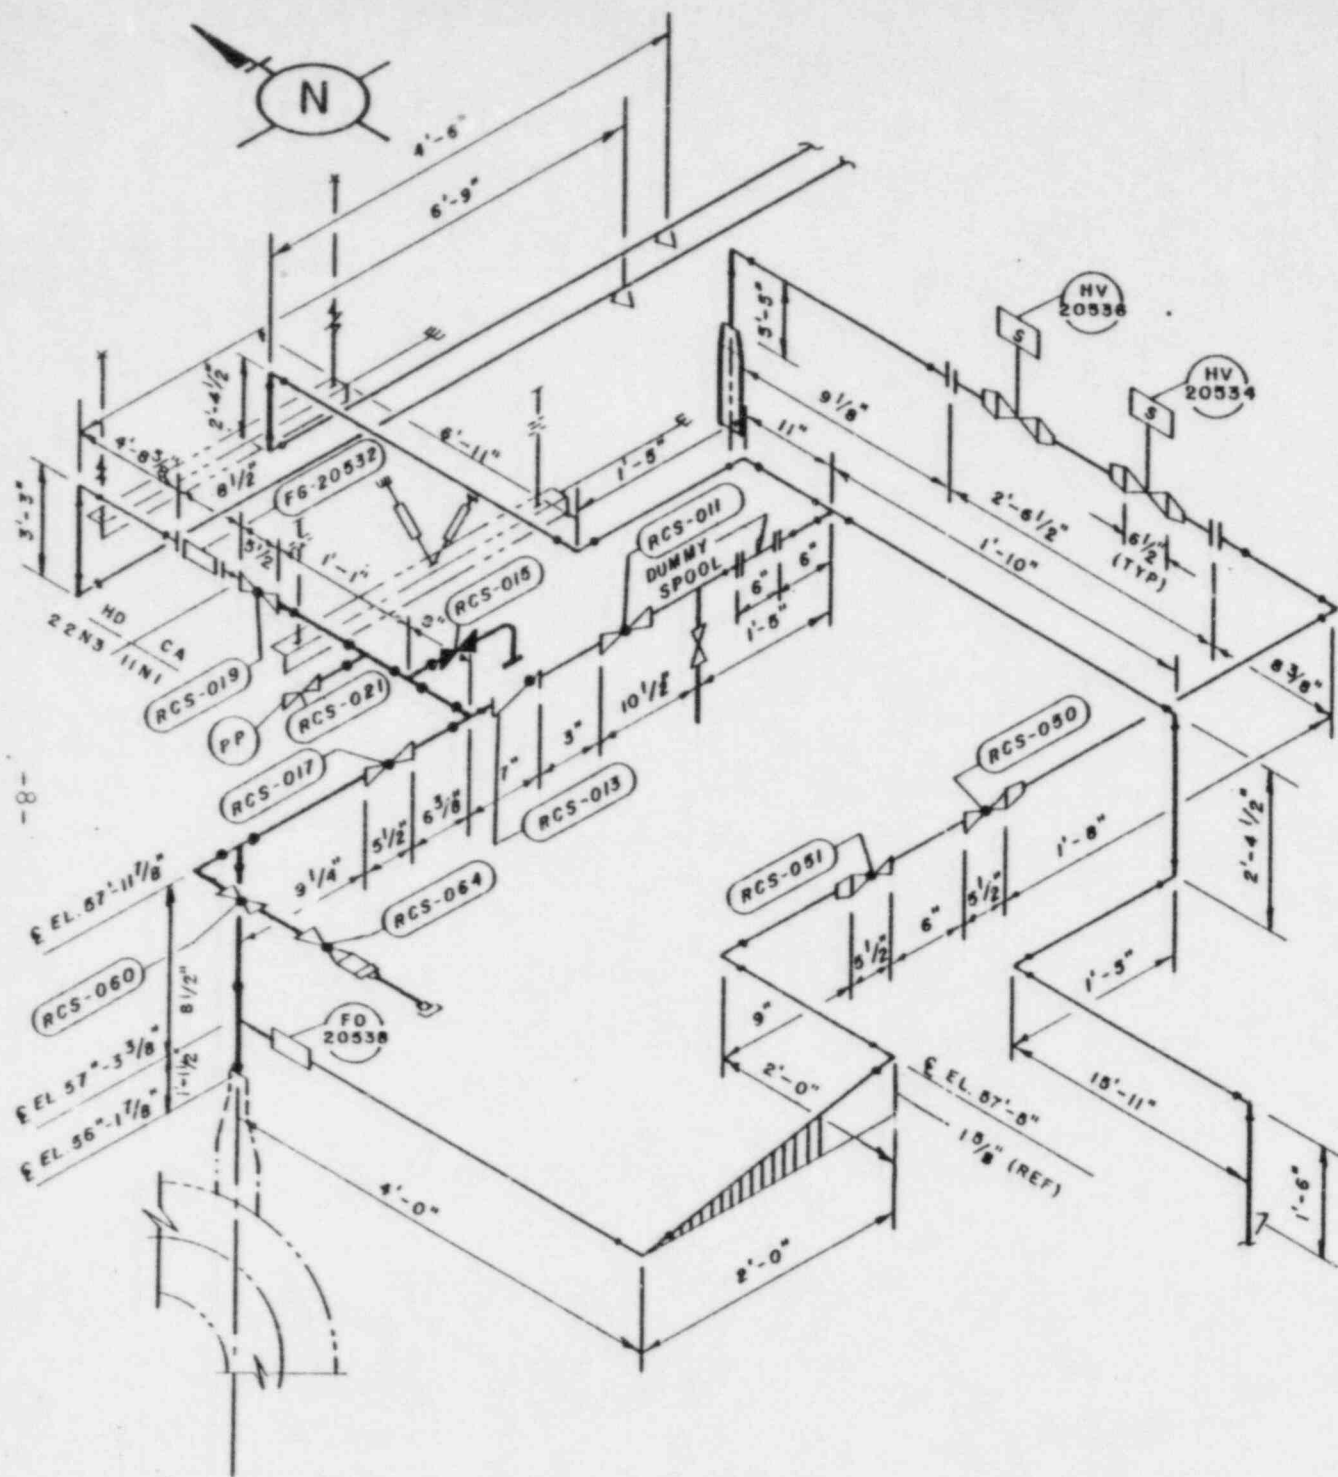
ISOMETRIC DIAGRAM
R.C.S. HIGH POINT VENT
STEAM GENERATOR E-205B
20564 - 1" - HD
FIGURE II-3

Since the District determined, as a result of investigation, that the probable failure mode was cyclic fatigue induced failure, there was a concern as to the remaining fatigue life of the rest of the highly stressed system piping. To eliminate this concern, the District replaced the piping from the "B" hot leg vent nozzle to orifice FO-20530 and valves RCS-060, RCS-L, RCS-015, and RCS-019. The District redesigned and thereby improved the piping configuration as shown in Figure II-4. The redesign eliminated the small piece of pipe between the hot leg nozzle and the tee (the segment where the crack was located) and a piece between the tee and valve RCS-015, two welds and the supports at RCS-015. The remaining modifications required by the 1983 DCN were also made since the new configuration did not significantly change from the 1983 DCN. The north support was modified to a rigid support and the south support was modified to provide rigid lateral bracing. Also, a rigid dummy spool piece was installed in the nitrogen supply piping.

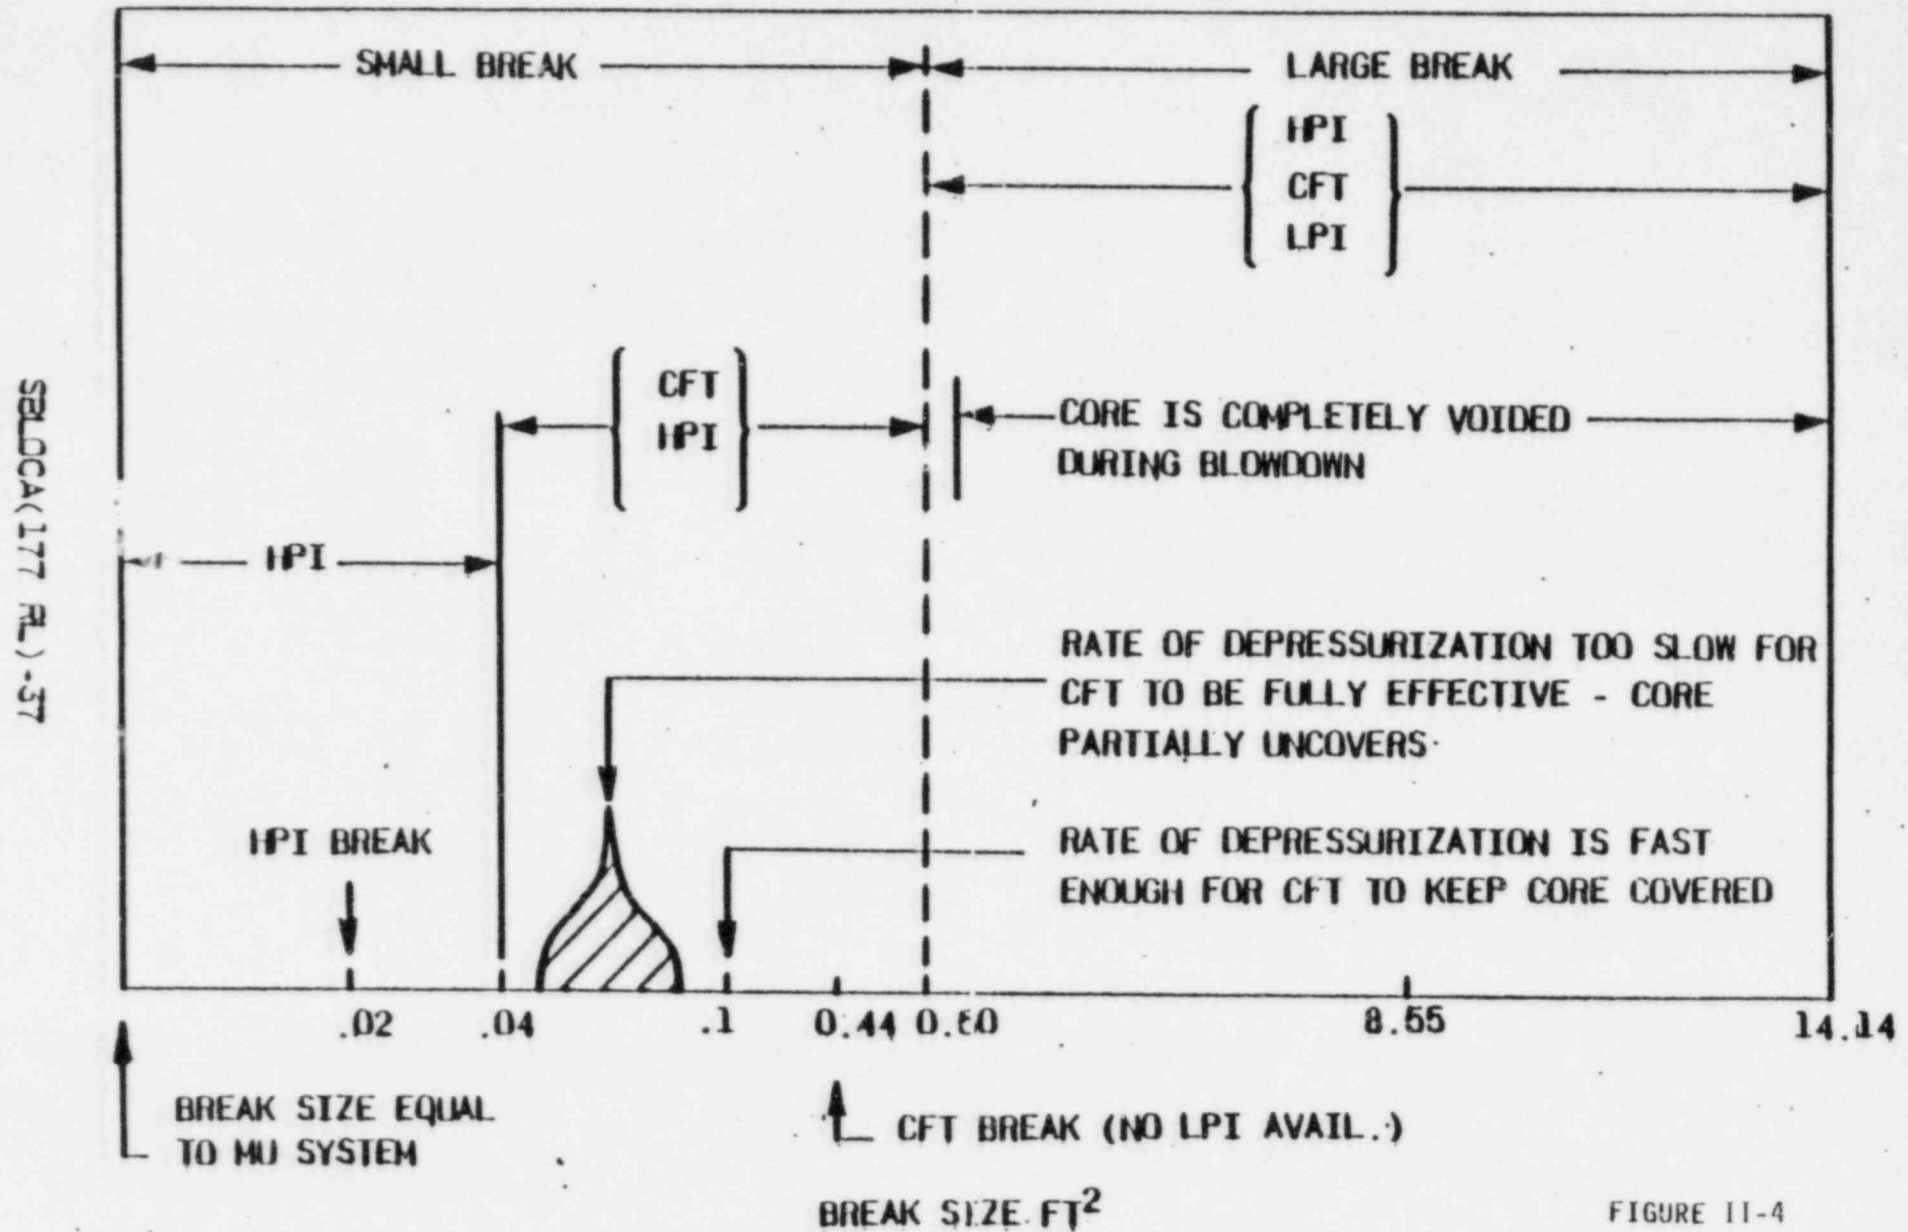
FIGURE 11-4

ECCS Vs Break Size
