RADIOACTIVE MATERIALS SERVICES  
DATA REPORT

METALLURGICAL EVALUATION OF RANCHO SECO  
STEAM GENERATOR VENT LINE CRACKING

JULY 1985

RANCHO SECOSTA TRANSIENT ASSESSMENT REPORT NO. 5

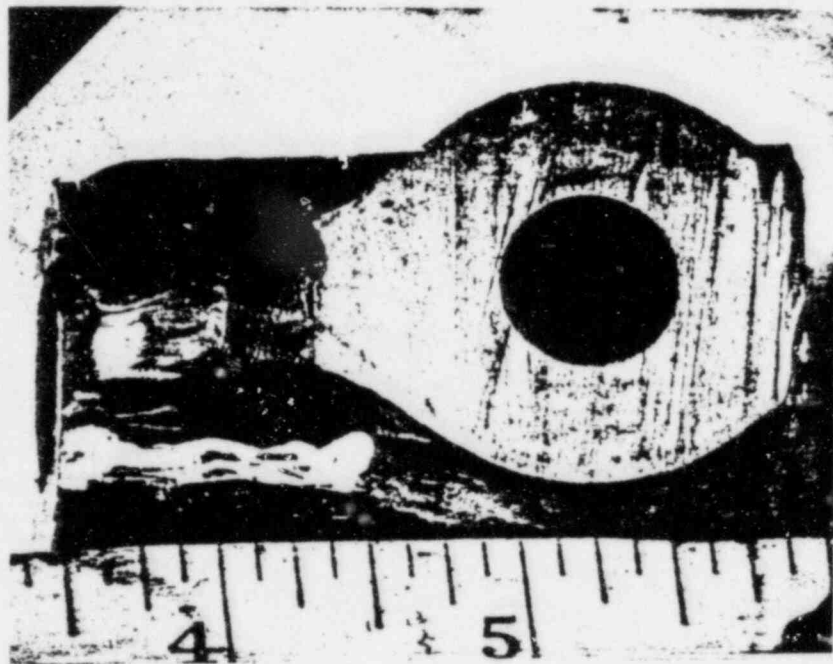
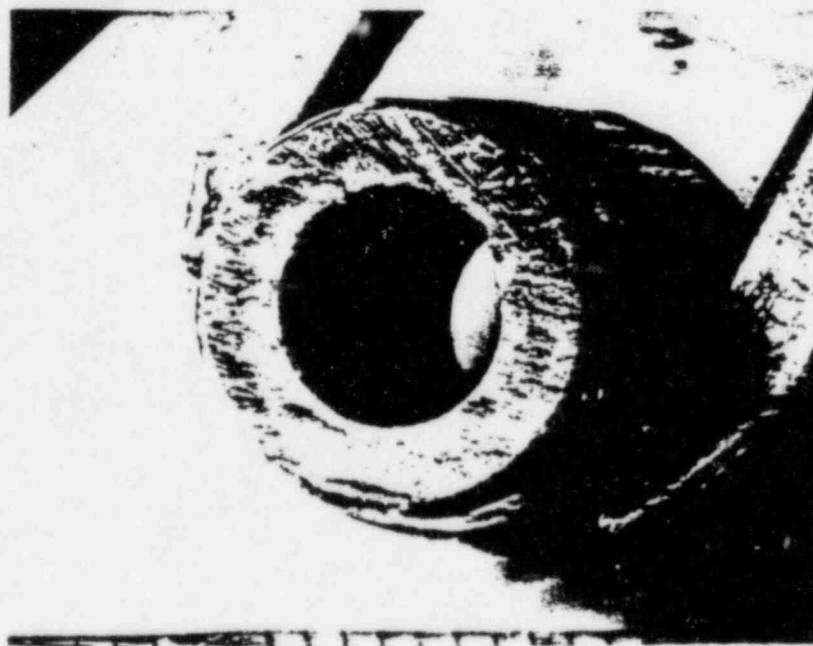
Figures 3 and 4. Top and End Views of the Pipe-to-tee Sample, Respectively.

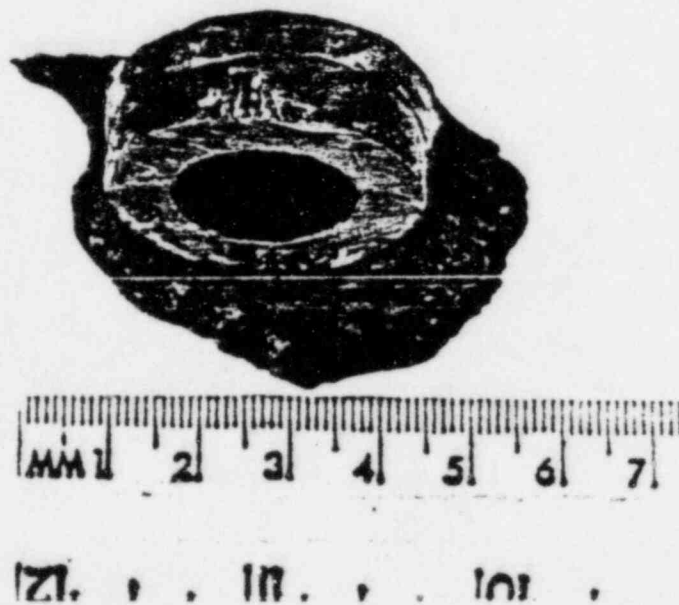
A second sample, reported to be the mating portion of the crack-containing pipe with part of the adjacent pipe-to-elbow circumferential weld, was received on Friday, June 28. This section, shown in Figure 5, was approximately 3/4 inch in length and did not contain any cracking visible to the naked eye. Excluding the weld material, the total length of the crack containing pipe appears to have have been 3/4 inch to 1 inch.

Figure 5. Photograph of 2nd Steam Generator Vent Line Sample.

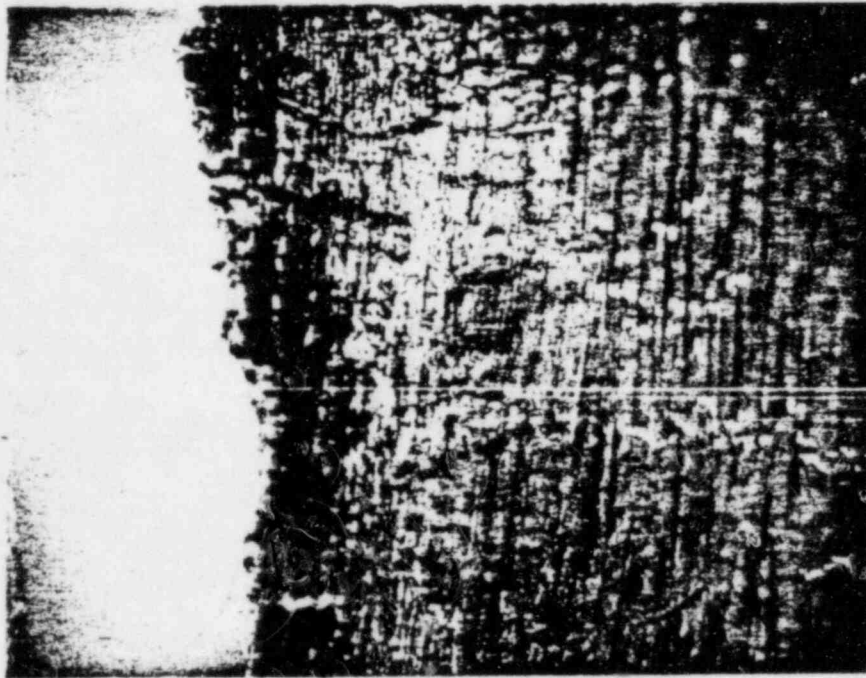
Following sectioning of the pipe-to-tee section, the ID surface was examined with a low power optical microscope at magnifications of 5-30X. A series of axial (longitudinal) cracks were found located between the ID surface weld fusion line and the end of the pipe. All of the cracks were located in the pipe base material. No cracking was discovered in the weld metal, although there does appear to be a slight lack of fusion at some locations along the weld root. The lengths of the axial cracks are on the order of 0.050 inch. A

typical area on the ID of the pipe-to-tee section is shown in Figure 6. No cracking was discovered in the tee.

Figure 6. Photograph of ID Surface Adjacent to Through Wall Crack Showing Axial Cracks, 25X Magnification.

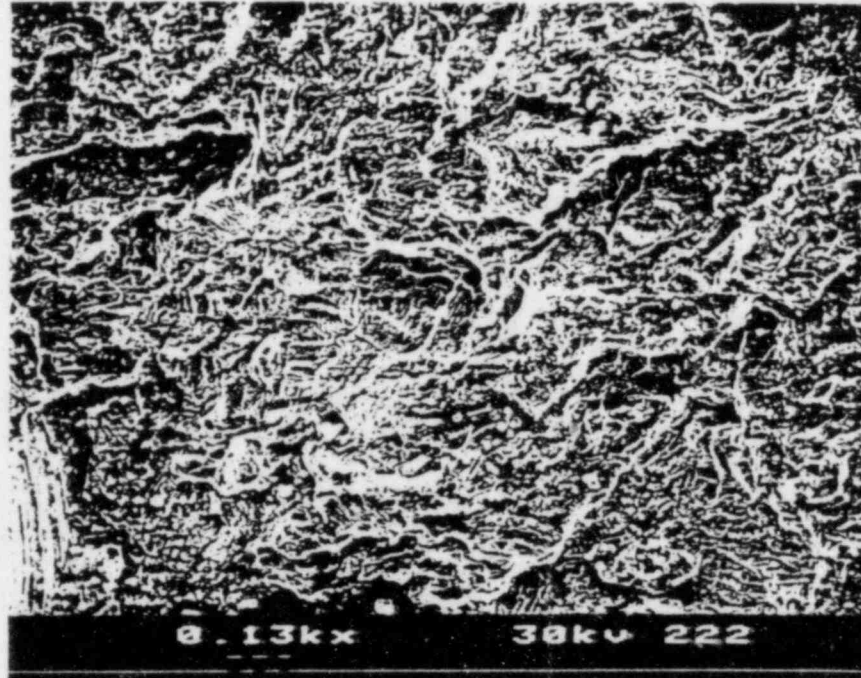
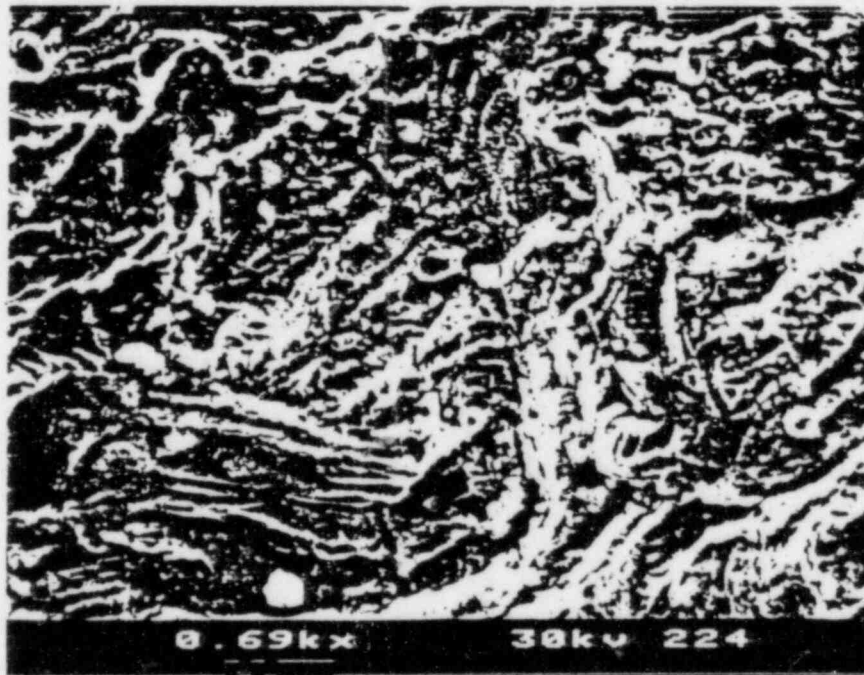
A section containing approximately 50% of the through-wall circumferential crack was removed from the pipe/tee sample using a band saw and a metallurgical cutoff machine. The fracture surface was pried open and placed in a scanning electron microscope (SEM) for examination. The SEM results reveal that the fracture surface is completely transgranular with a moderate degree of secondary cracking. The fracture surface is also heavily oxidized due to exposure to high temperature water. A thorough scan at high magnification (1000X) did not reveal any evidence of fatigue crack propagation (i.e. no fatigue striations were found). Typical SEM photomicrographs of the fracture surface are given in Figures 7 and 8.

Due to the heavy oxide layer, however, it is very possible that fatigue striations, if present, would be hidden. Unfortunately we know of no reliable technique for removing an adherent oxide layer without disturbing the underlying material. It is also possible that no striations were found because reported crack opening and closing due to a cyclic loading mechanism could have worn them away or that they could have been eroded away by the leaking high pressure steam.

Figures 7 and 8. SEM Photographs of Pipe Fracture Surface Showing Transgranular Fracture Mode, 130X and 690X Magnification, Respectively.

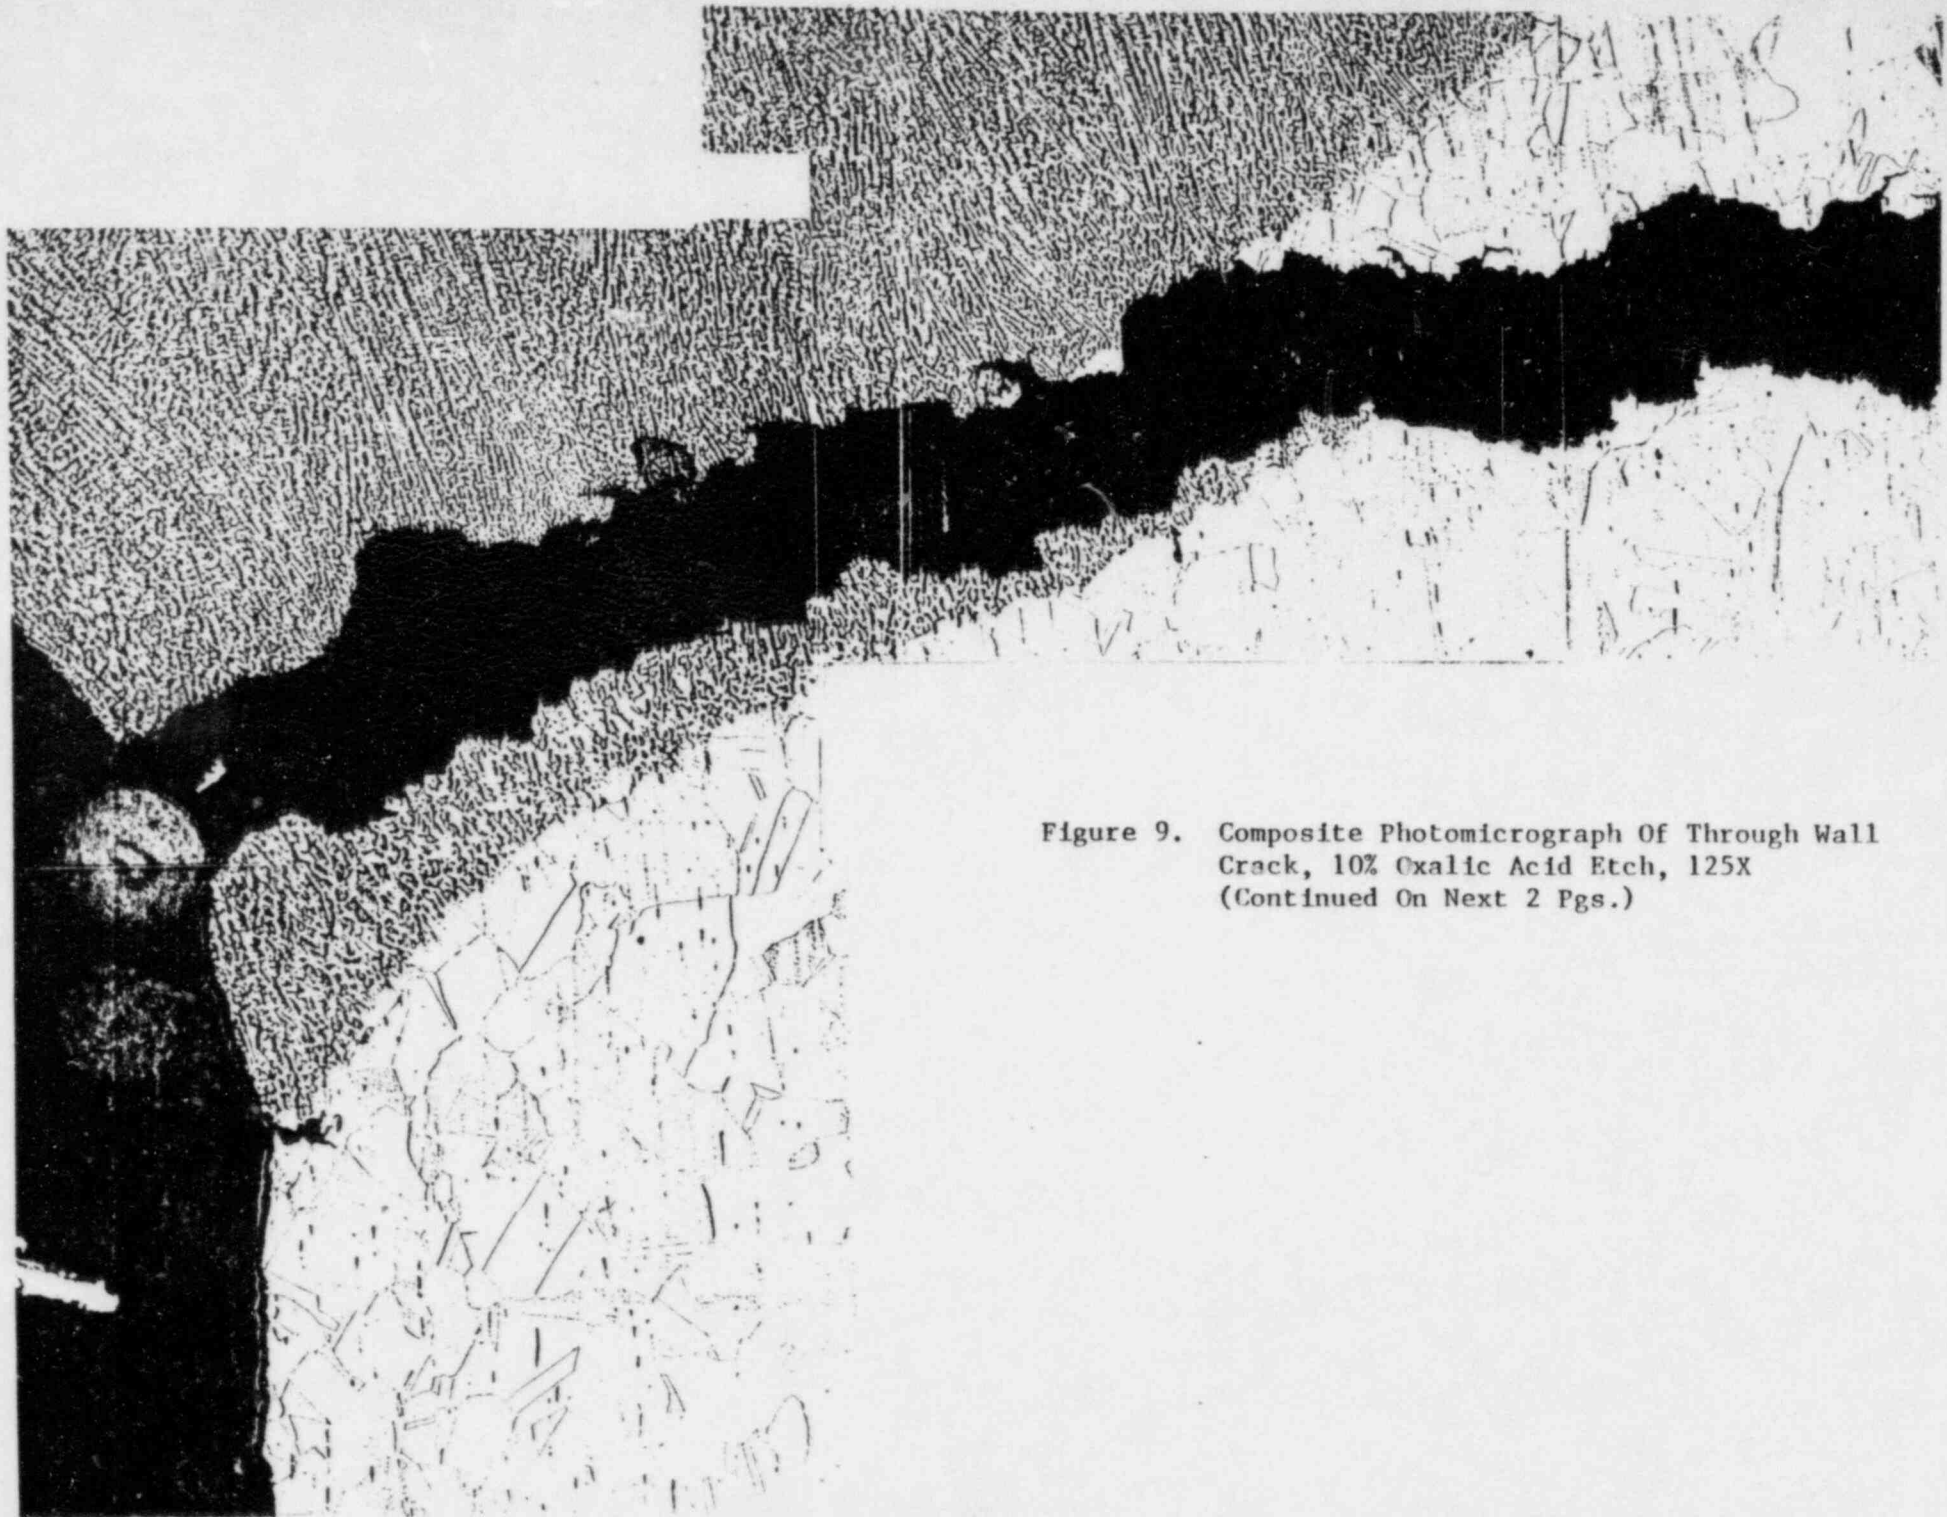
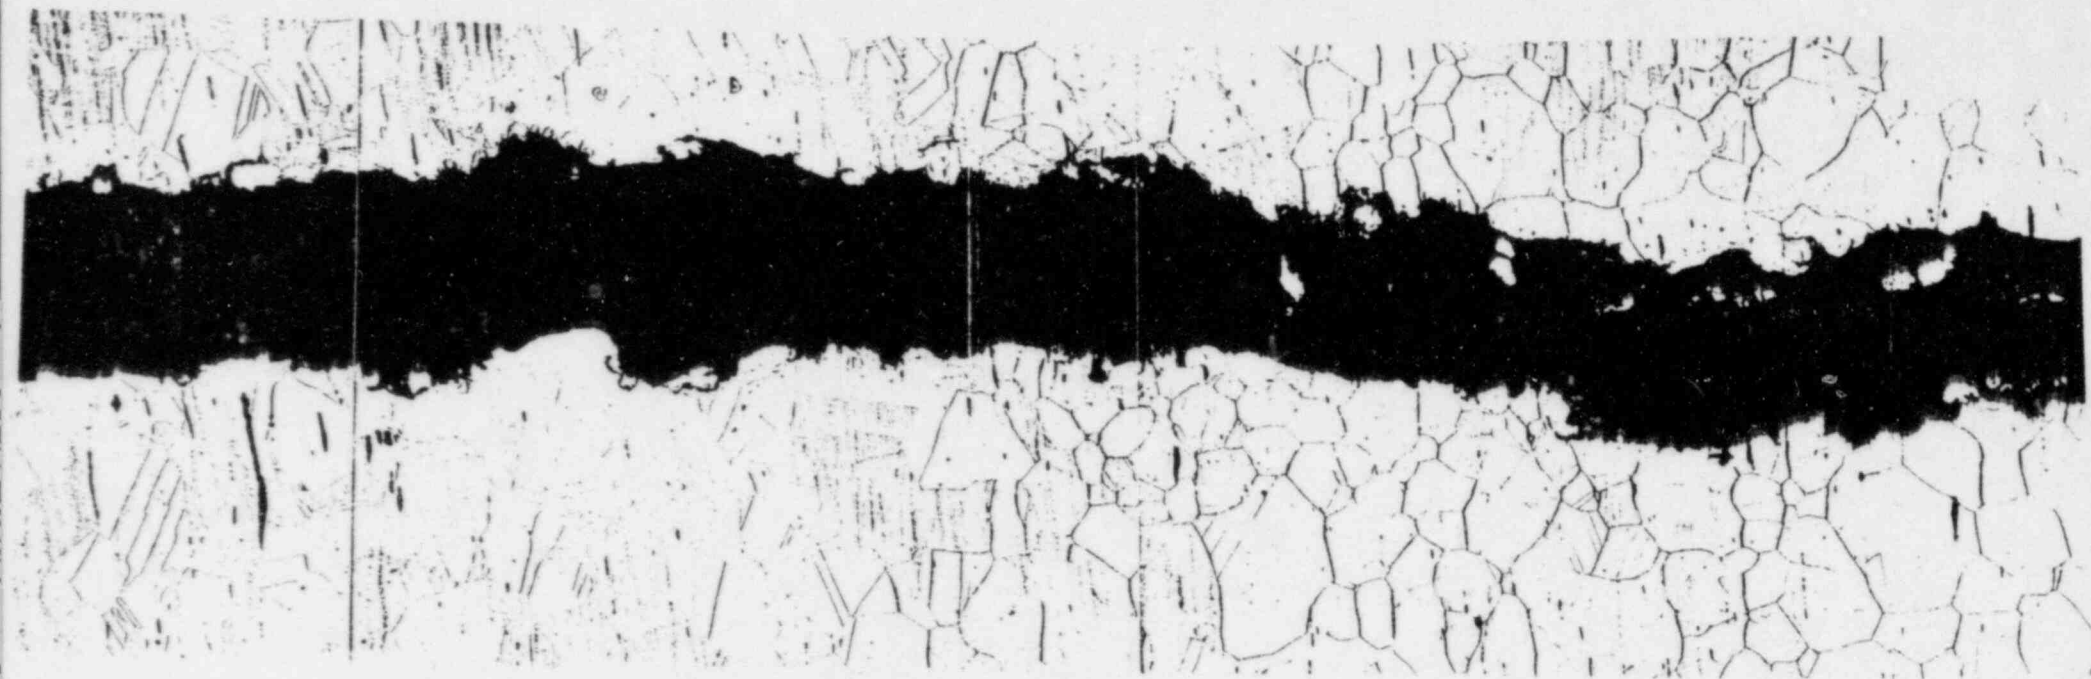
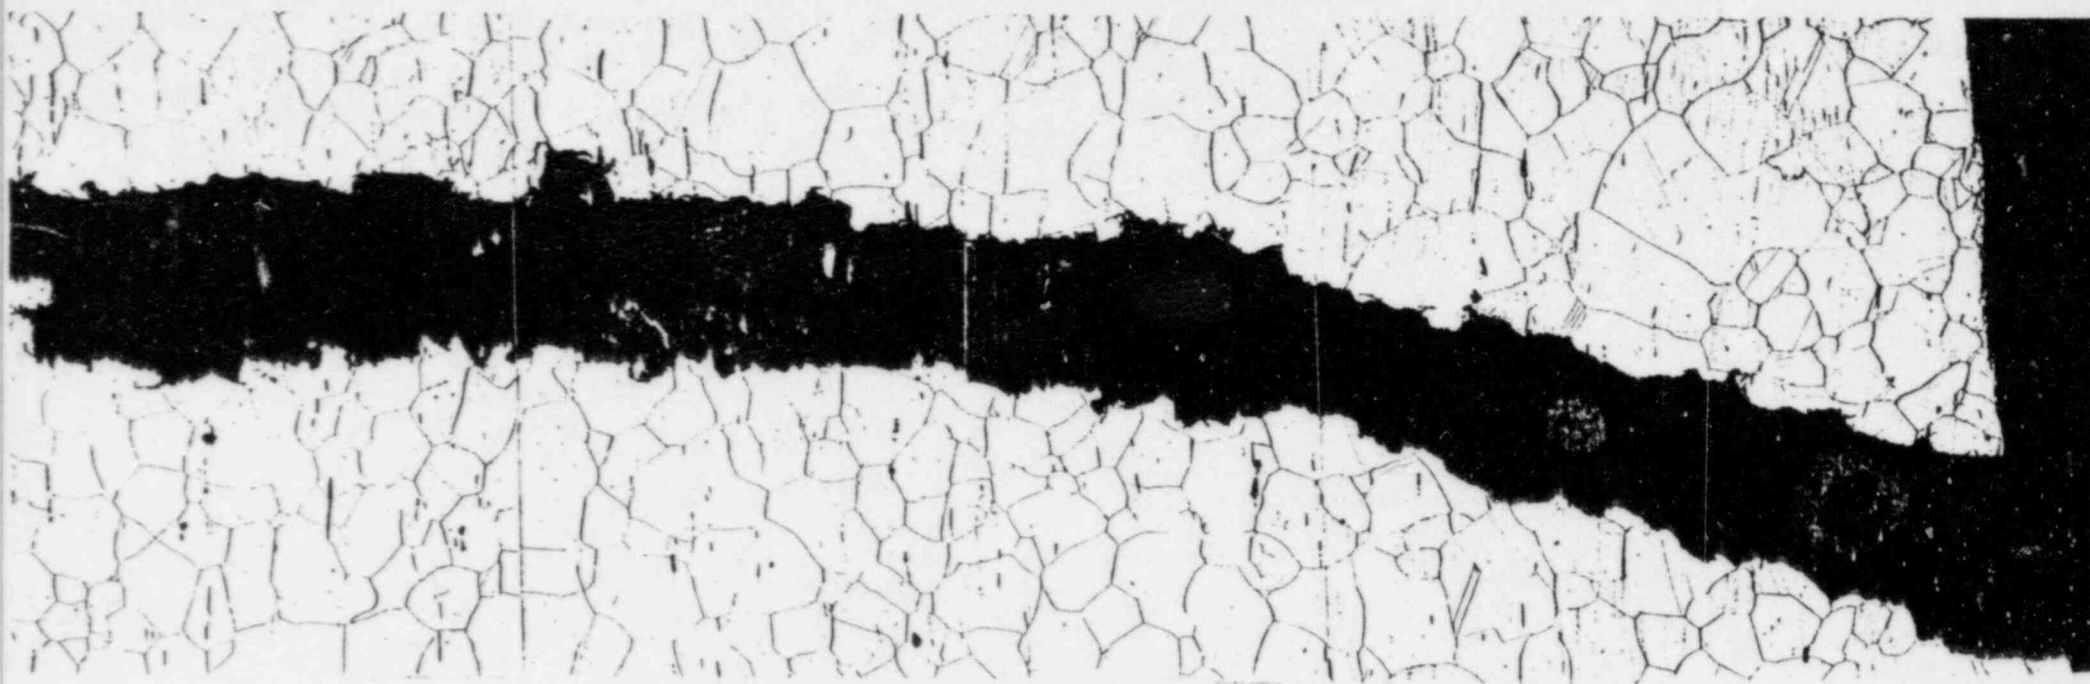
Metallographic examinations were performed on a longitudinal plane through the leaking crack, near one of the tips, and on a transverse plane located between the leaking crack and the weld, which revealed a pair of the above mentioned short axial cracks. A composite photomicrograph from ID to OD of the through-wall crack at 125X magnification is given in Figure 9. This crack is completely transgranular and located in the pipe base material, except near the OD surface where it passes through the weld cover pass. The portion of the crack located in the weld is trans-dendritic.

Figure 9. Composite Photomicrograph Of Through Wall  
Crack, 10% Oxalic Acid Etch, 125X  
(Continued On Next 2 Pgs.)

Figure 9. (Con'd) Mid-wall Portion Of Crack.

Figure 9. (Con'd) ID Surface Portion Of Crack.

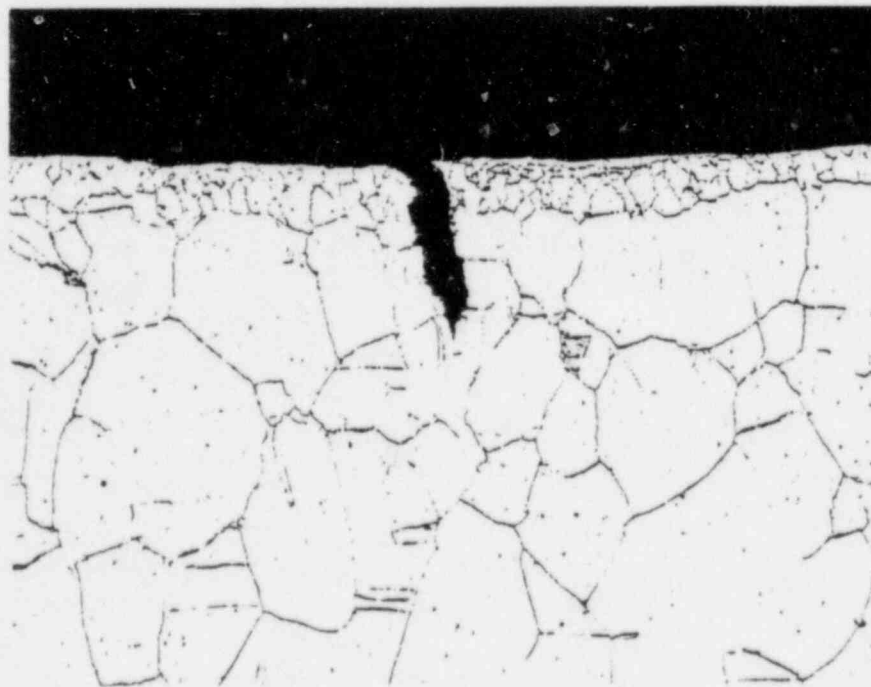
A cross-section of one of the axial cracks is shown in Figure 10. These cracks were also found to be transgranular. At this particular plane of examination the depth of the crack shown is 0.004 inch.

Figure 10. Transverse Cross Section Through Axial Crack on ID Surface of Pipe, 10% Oxalic Acid Etch, 250X.

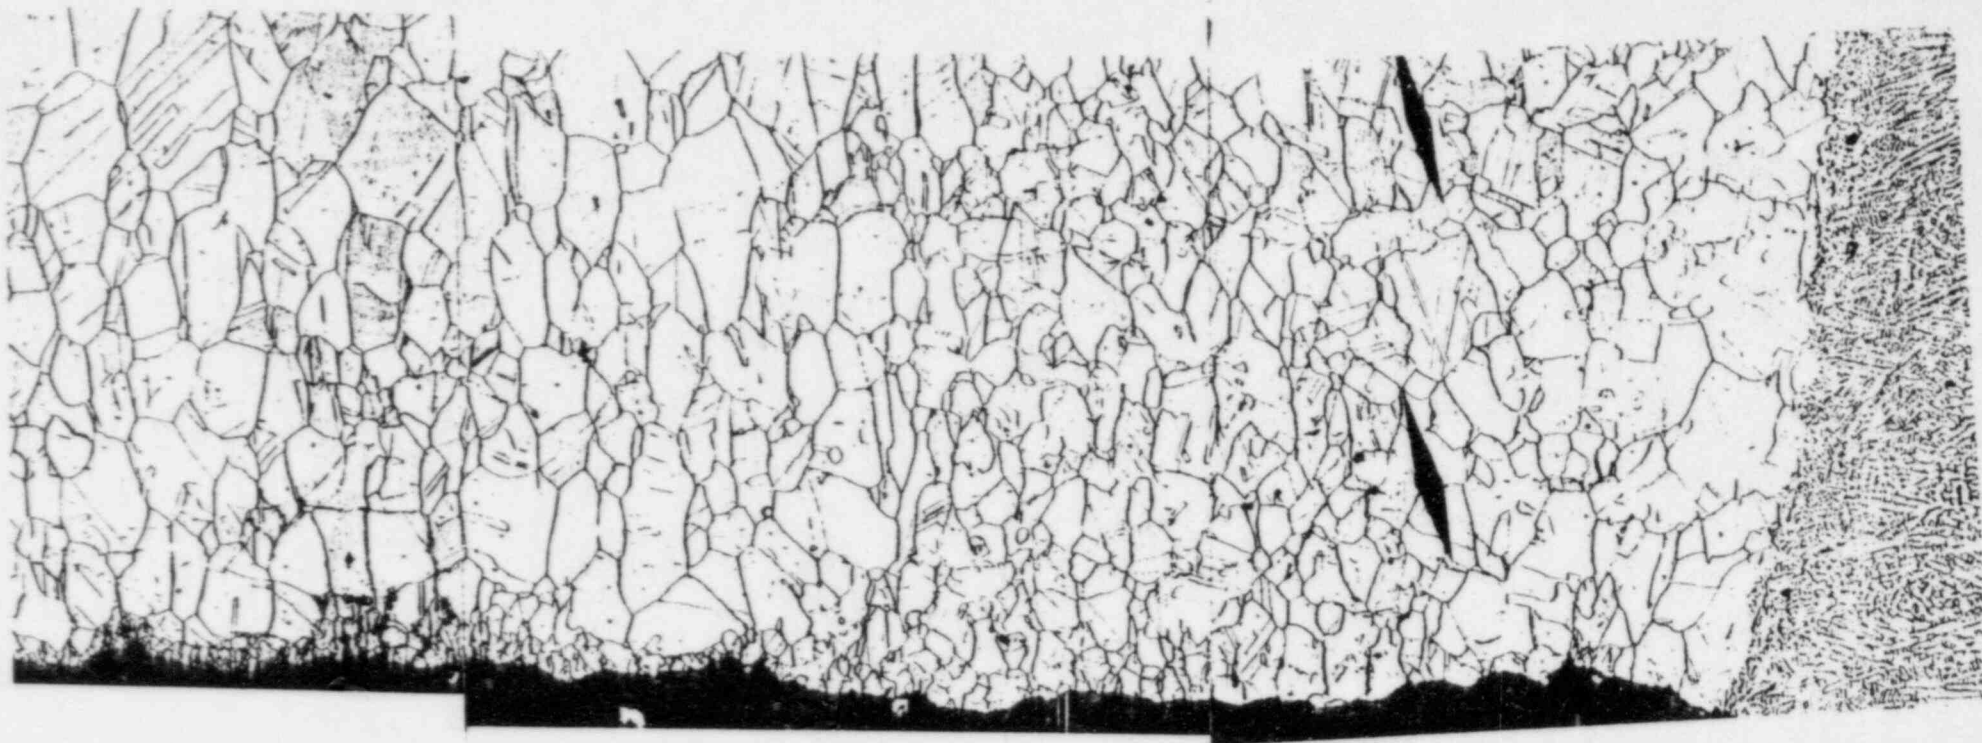
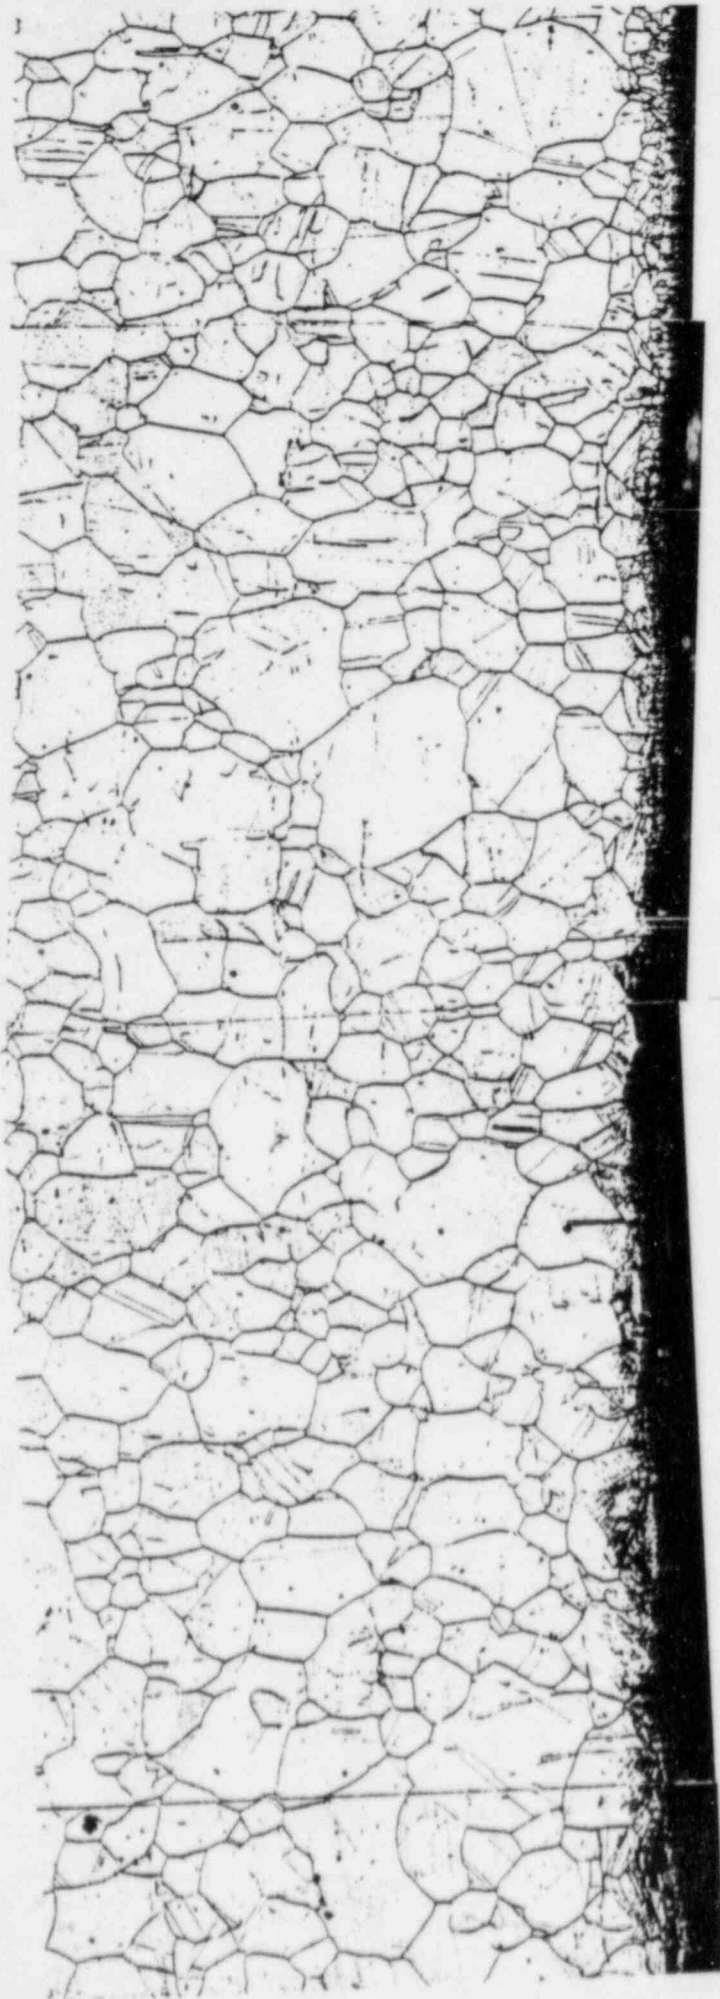
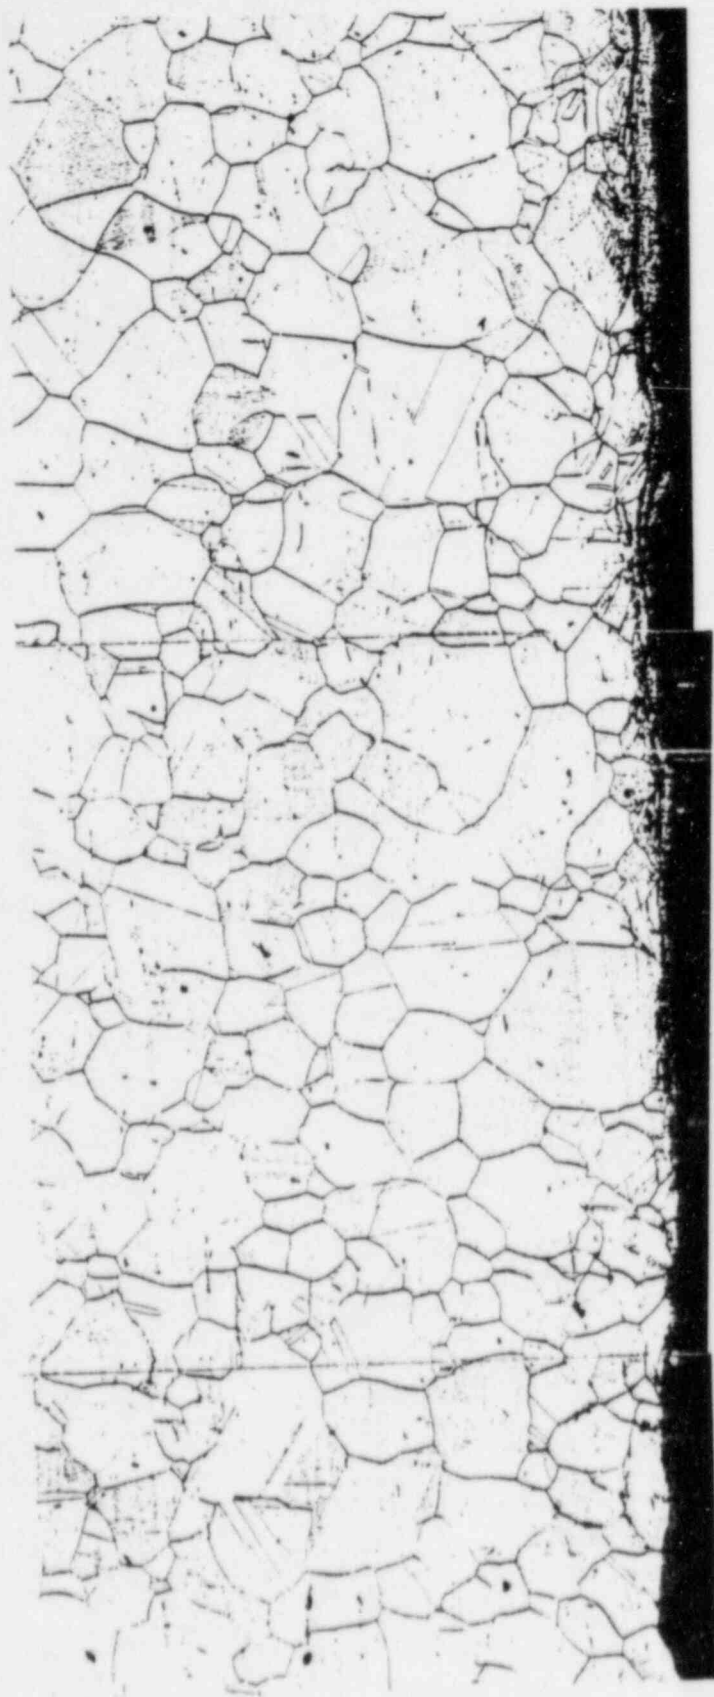
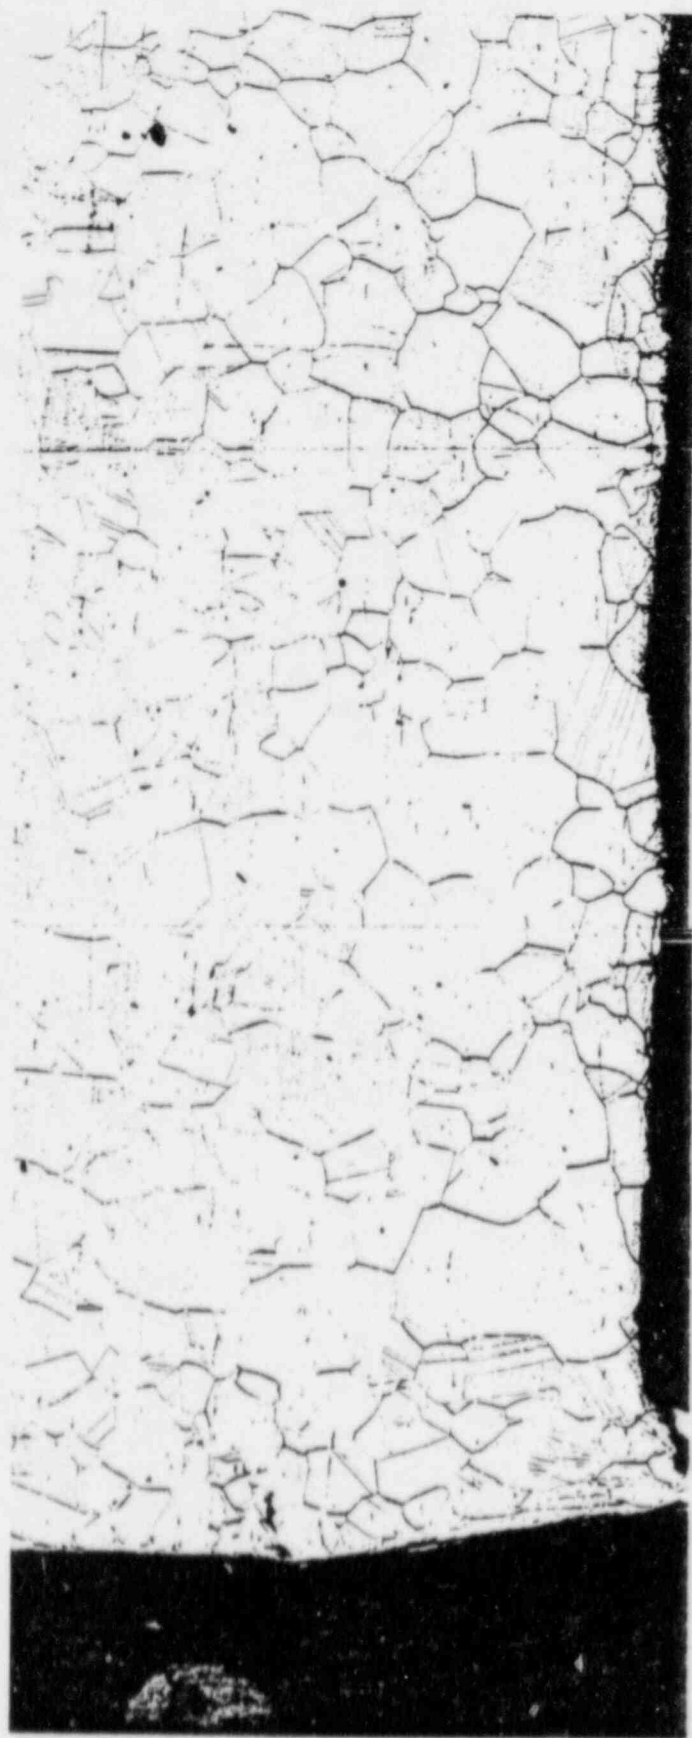
The pipe base material appears normal for welded Type 304 stainless steel and includes a rather extensive zone of sensitization in the vicinity of the weld. A third metallographic specimen prepared for the purpose of determining the extent of the sensitized weld heat affected zone (HAZ) revealed that the sensitization extends greater than 1/4 inch from the weld along the ID surface. A composite photograph of the microstructure along the ID surface HAZ is shown in Figure 11. It should be noted that the presence of sensitization is not considered relevant to the observed cracking because sensitization is a grain boundary phenomenon and the cracking is transgranular.

Figure 11. Composite Photomicrograph Of Weld HAZ Along Pipe ID Surface,  
10% Oxalic Acid Etch, 125X. (Continued On Next 3 Pgs.)
