**RADIOLOGIC AND ENGINEERING ASSESSMENT**

DOE ID NO.: GJ-43553-VL  
ADDRESS: 3011 1/2 D 1/2 ROAD

AUGUST 1985

BENDIX FIELD ENGINEERING CORPORATION  
P.O. Box 1569  
Grand Junction, Colorado 81502

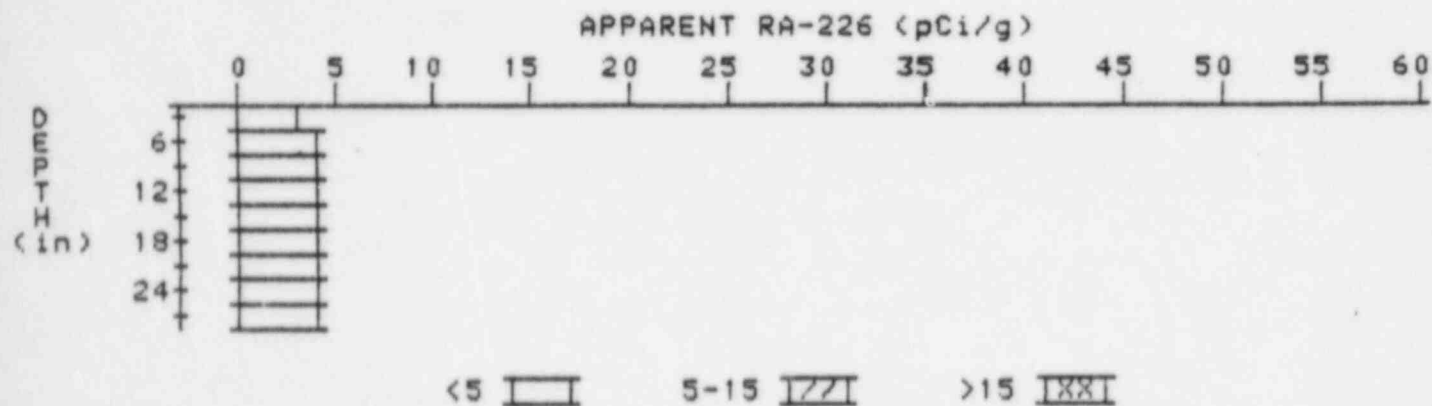
# APPARENT RADIUM-226 CONCENTRATION 10 DECONVOLUTION GRAPH

PROPERTY NUMBER: GJ-43553-VL  
HOLE NUMBER: 10  
LOCATION: 460360
