OPPD

Mid-Cycle Inspection of the
Fort Calhoun Station Steam Generators

Request for Waiver of NRC Requirement
for Mid-Cycle Steam Generator Inspections
at the Fort Calhoun Station

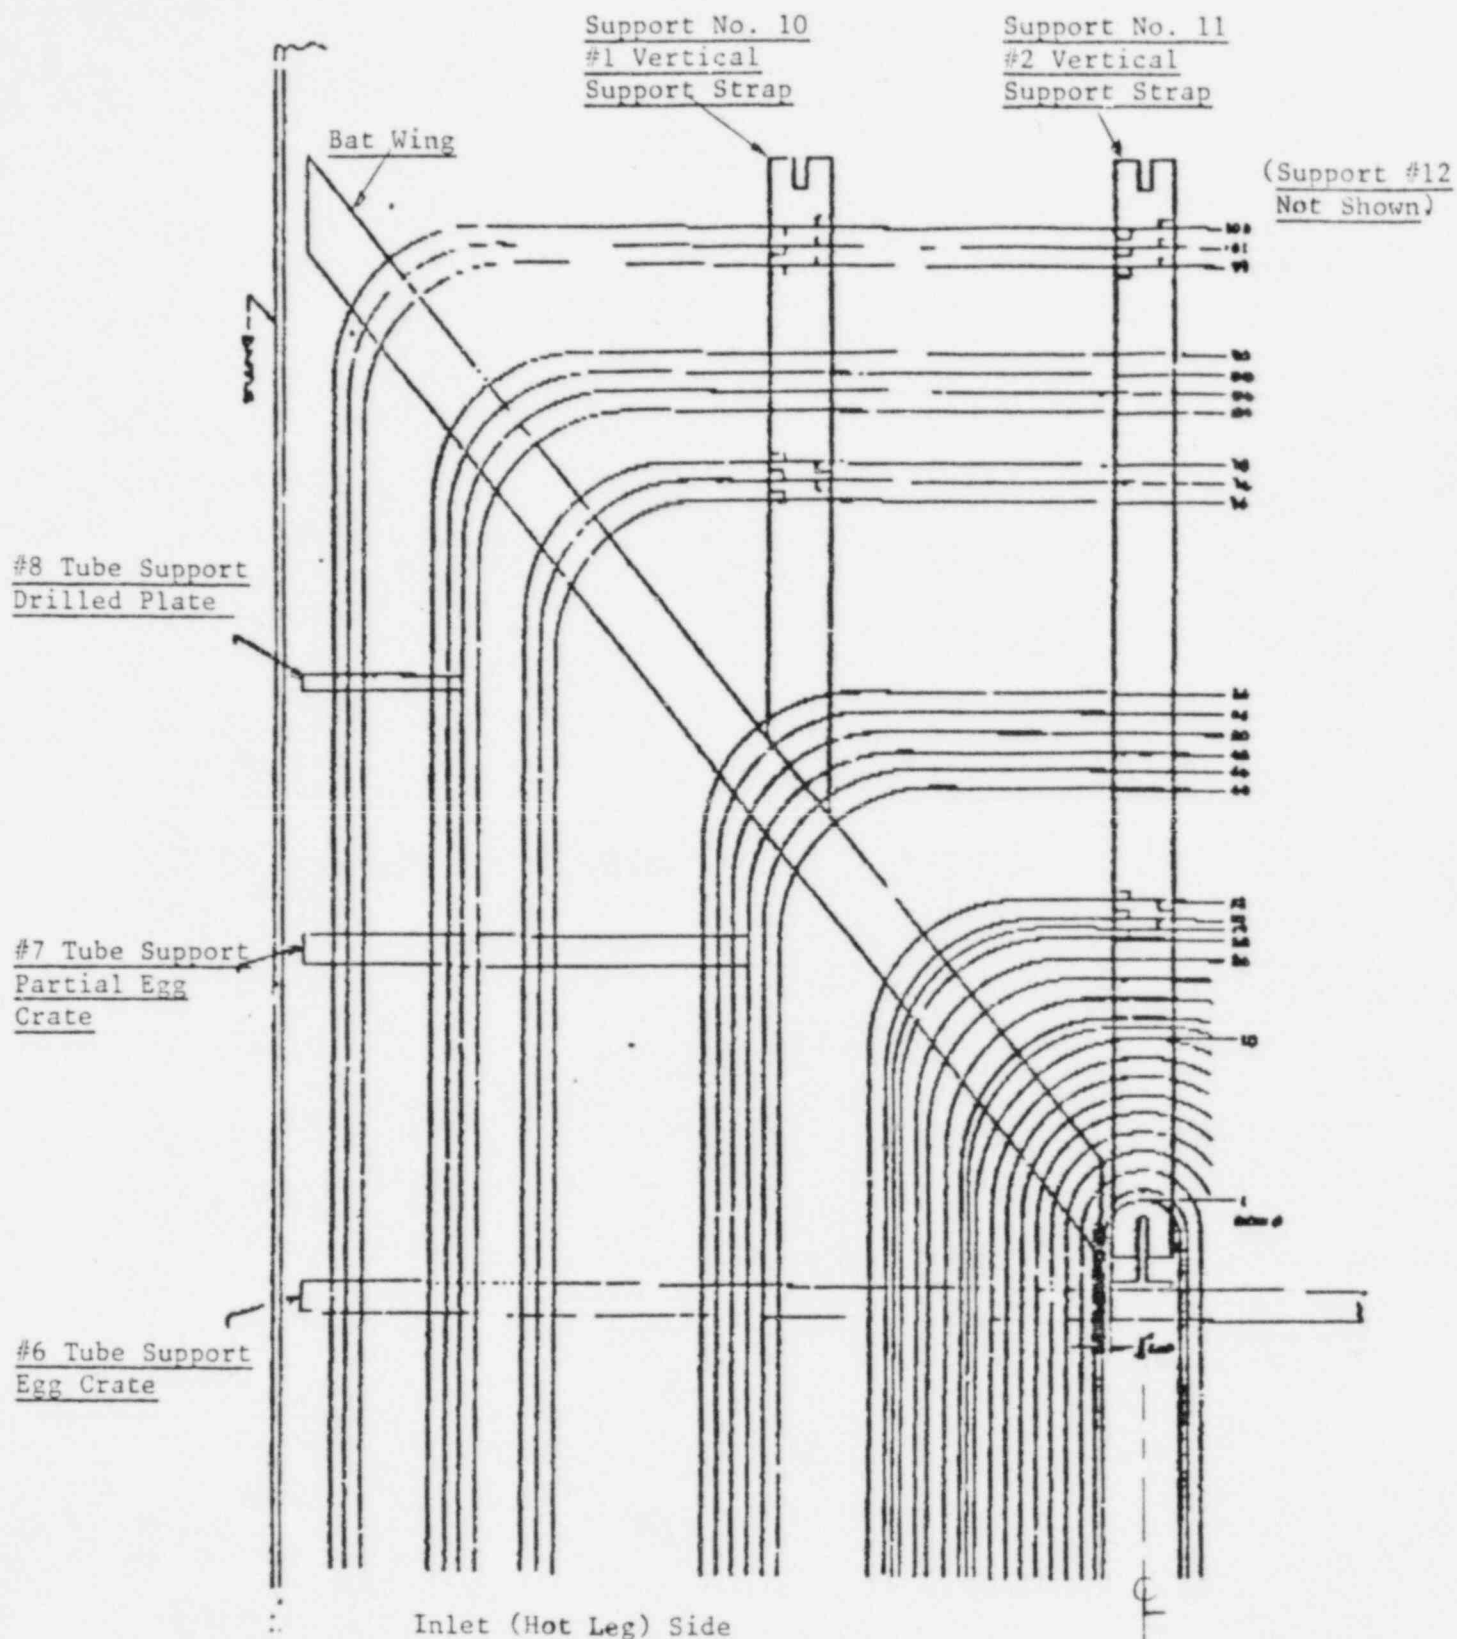
Figure No. 1 - Steam Generator Support Structure in 'U' Bend & Vertical Support Region

In the case of the tube intersections with the vertical strip/scalloped bar support system, resultant tube deformation occurred at the 3 and 9 o'clock position on the tubing, i.e., point of contact with the vertical strips, and produced a hoop tensile stress at the 6 o'clock position. The interaction of the denting induced tensile stress, the caustic environment in the crevice and the susceptible mill annealed Alloy 600 tubing produced IGSCC.

At each support elevation, including eggcrates, partial drilled hole support plates and vertical straps, denting is present to some degree. The batwing area (#9 support) which bisects the tube bends, could not be analyzed due to interference caused by the bend geometry. In the area of the horizontal run vertical strap intersections (#10-12 supports), denting appeared to be more severe than in the vertical straight run sections (those that intersect #1-7 supports). Of the examinations performed in the horizontal run, #10 support, the hot leg vertical support strap was determined to have the highest magnitude of denting. This type of behavior can be found in a caustic-induced denting environment since the highest concentration of caustic agents can be expected in this region. Of the examinations performed in the vertical section, #7 support appeared to be the most severely dented. In comparing the magnitude of denting in the #7 and #10 support regions, average values indicate that denting in the #10 support region is more severe, although the standard deviations associated with the readings overshadow any conclusions that may be drawn concerning the comparison. The attached Figure 1 shows the support elevations in the Fort Calhoun steam generators.
