OMAHA PUBLIC POWER DISTRICT
FORT CALHOUN STATION

Steam Generator Tube Rupture Incident
Final Report

June 1984

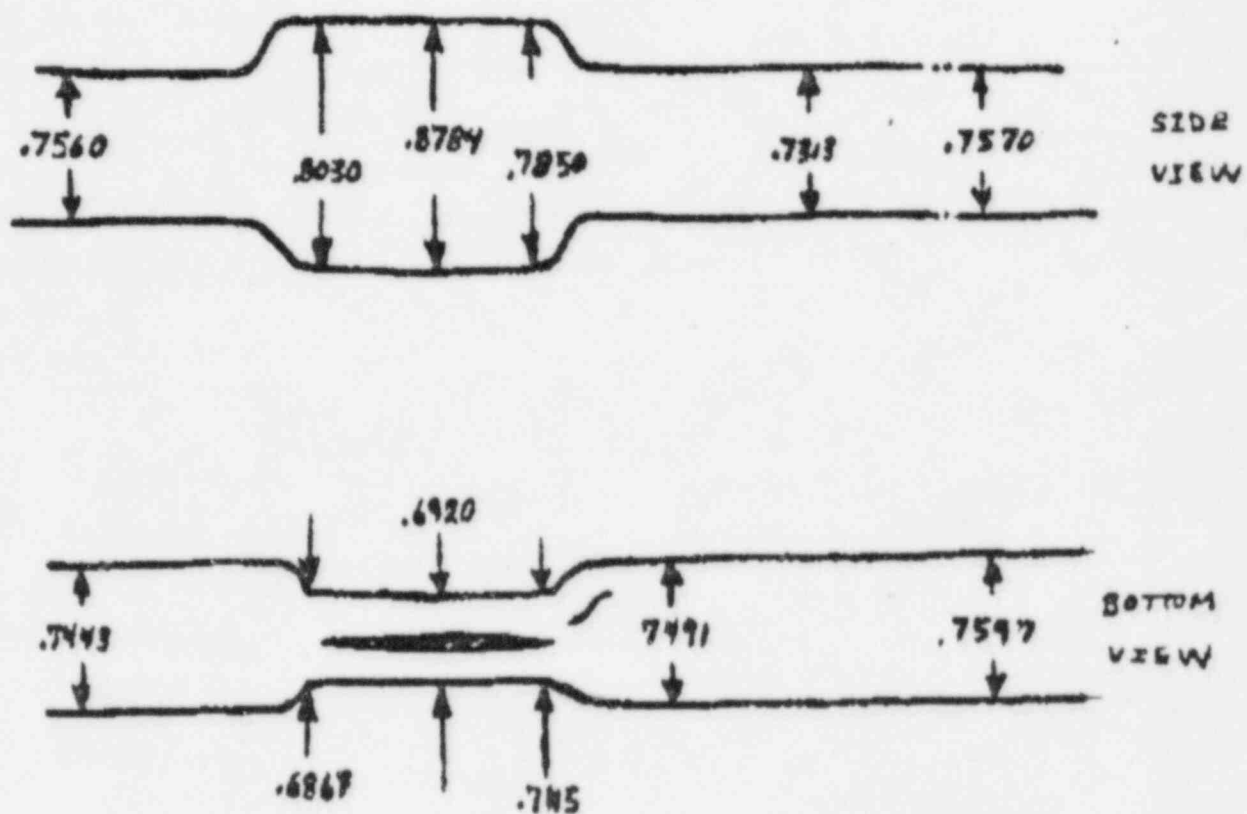
FIGURE 2. Dimensional Measurements of Tube L29R84

Figure 2 illustrates the dimensional measurements around the defect region. These measurements were taken before descaling and, as such, include the thickness of residual deposits. The measurement data indicate that the tube was ovalized. The major axis (6-12 o'clock) was elongated by 0.046-0.122 inch, while the minor axis (3-9 o'clock) was compressed by 0.045-0.070 inch diametrically.
