OMAHA PUBLIC POWER DISTRICT
FORT CALHOUN

Steam Generator Tube Rupture Incident Report

June 1984

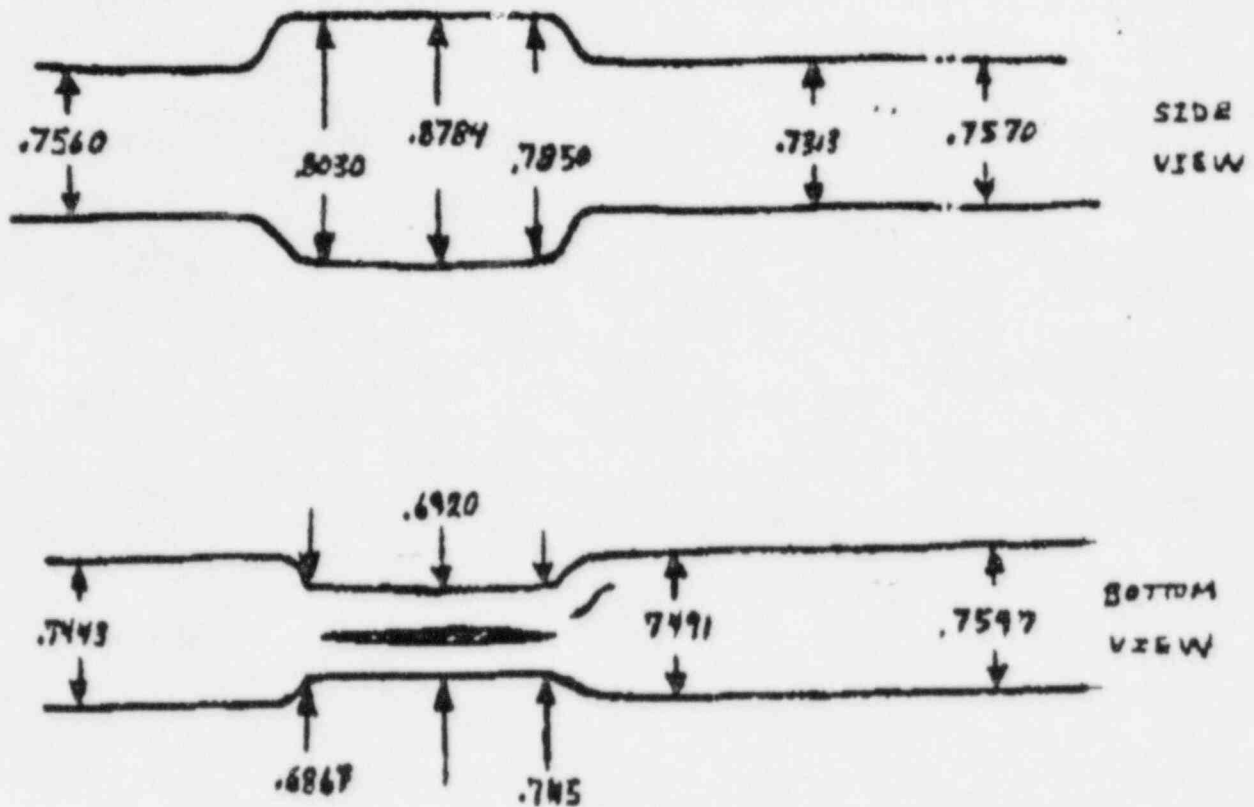
FIGURE 1. Dimensional Measurements of Tube L29R84

Figure 2 illustrates the dimensional measurements around the defect region. These measurements were taken before descaling and, as such, include the thickness of residual deposits. The measurement data indicate that the tube was ovalized. The major axis (6-12 o'clock) was elongated by 0.046-0.122 inch, while the minor axis (3-9 o'clock) was compressed by 0.045-0.070 inch diametrically.

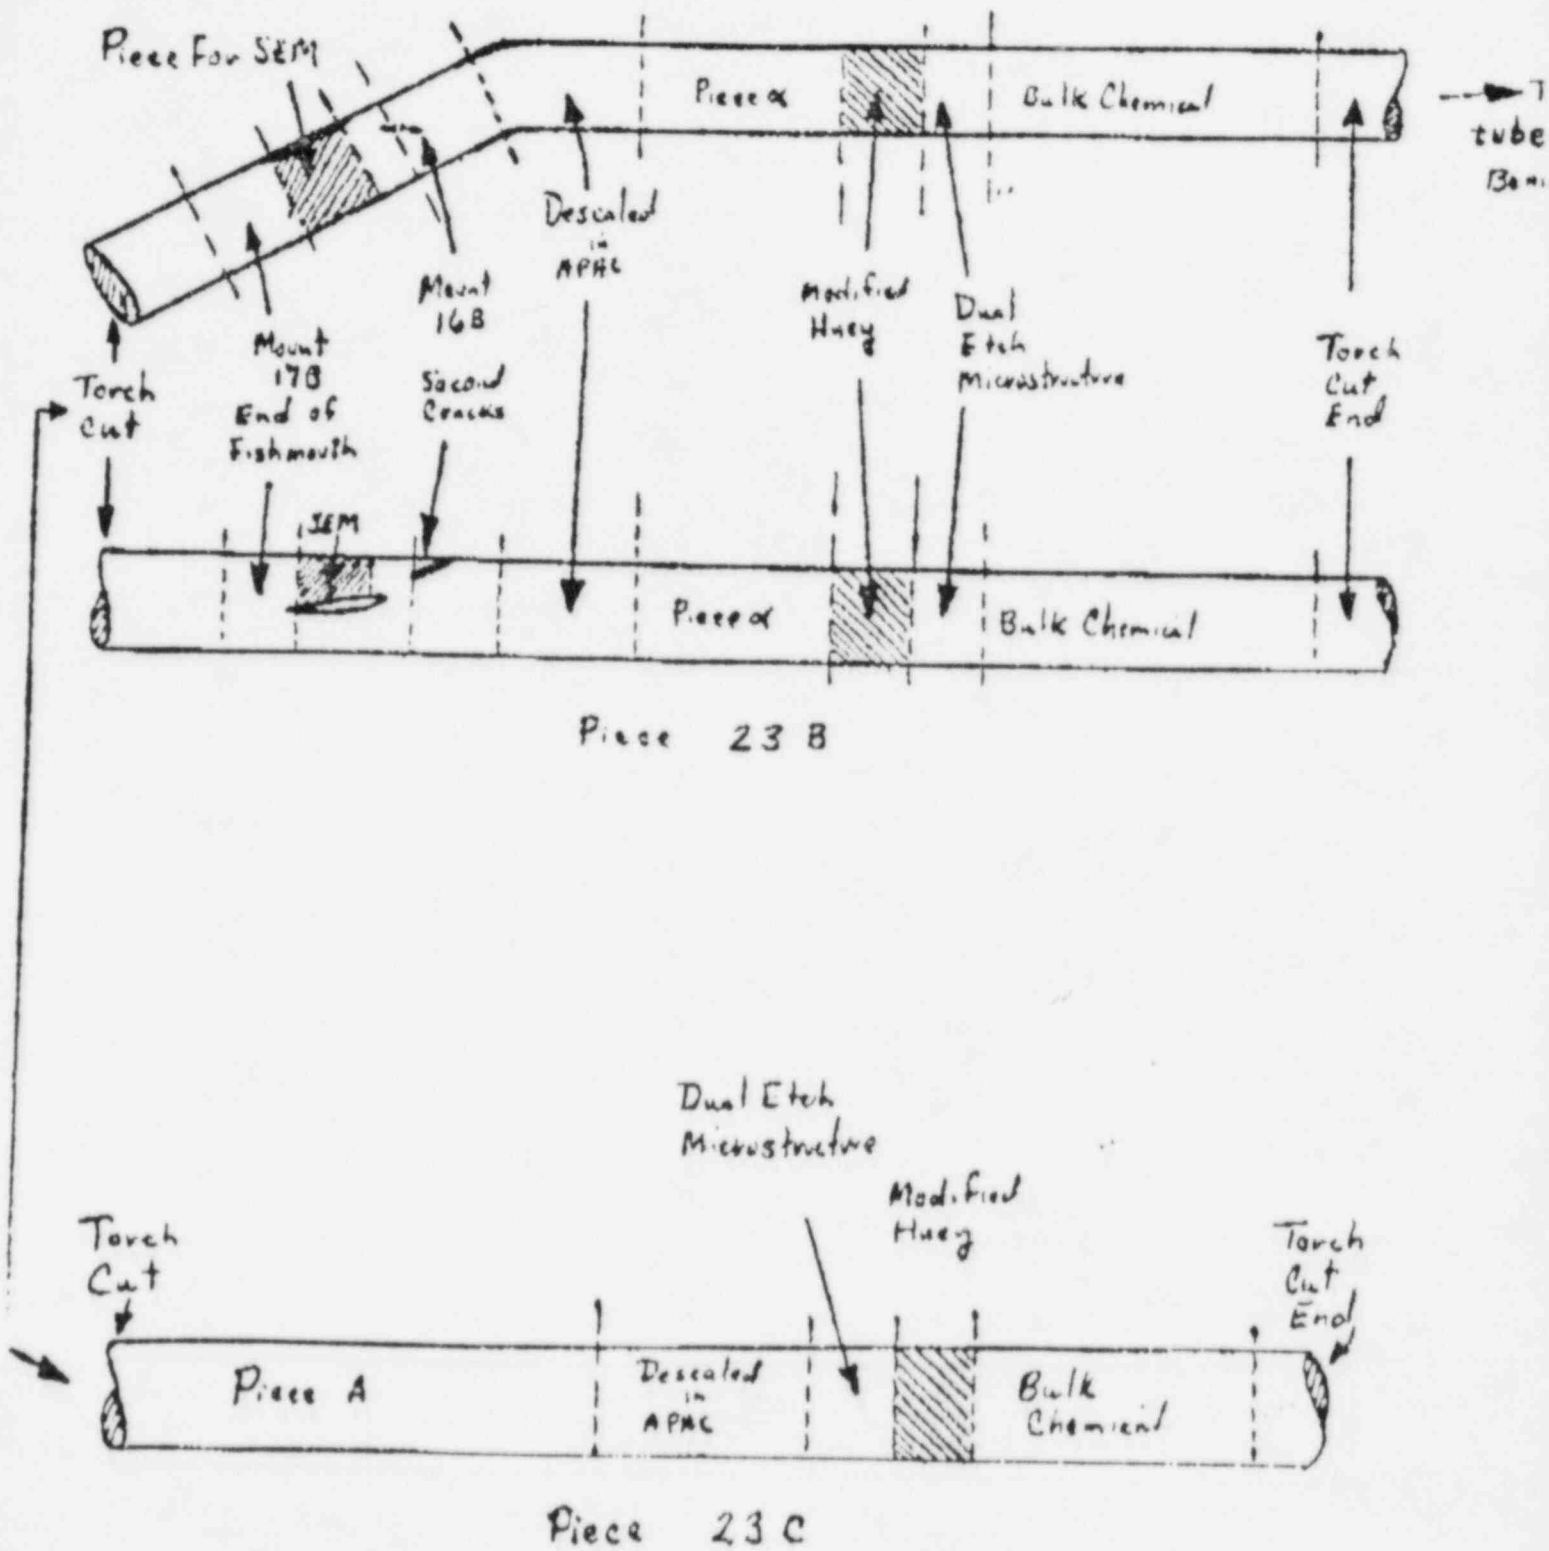
FIGURE 2. Sectioning Diagram of Tube L29R84

Upon receipt at the CE lab, the two tube specimens labeled 23B and 23C were visually inspected. Two cracks were observed on piece 23B. The first was a large, axial (1-1/4") "fishmouth" type crack, while the second was a series of small (approximately 1/4") length fissures which made an acute angle (45°) relative to the axis of the tube. One end from each tube section was removed to allow the eddy current probes to pass. Tube section 23B was the length of steam generator tube L29R84 from inboard of the first vertical tube support to outboard of the hot leg batwing tube support. The tube section labeled 23C was the length of the same tube from inboard of the first vertical tube support to outboard of the middle vertical tube support.

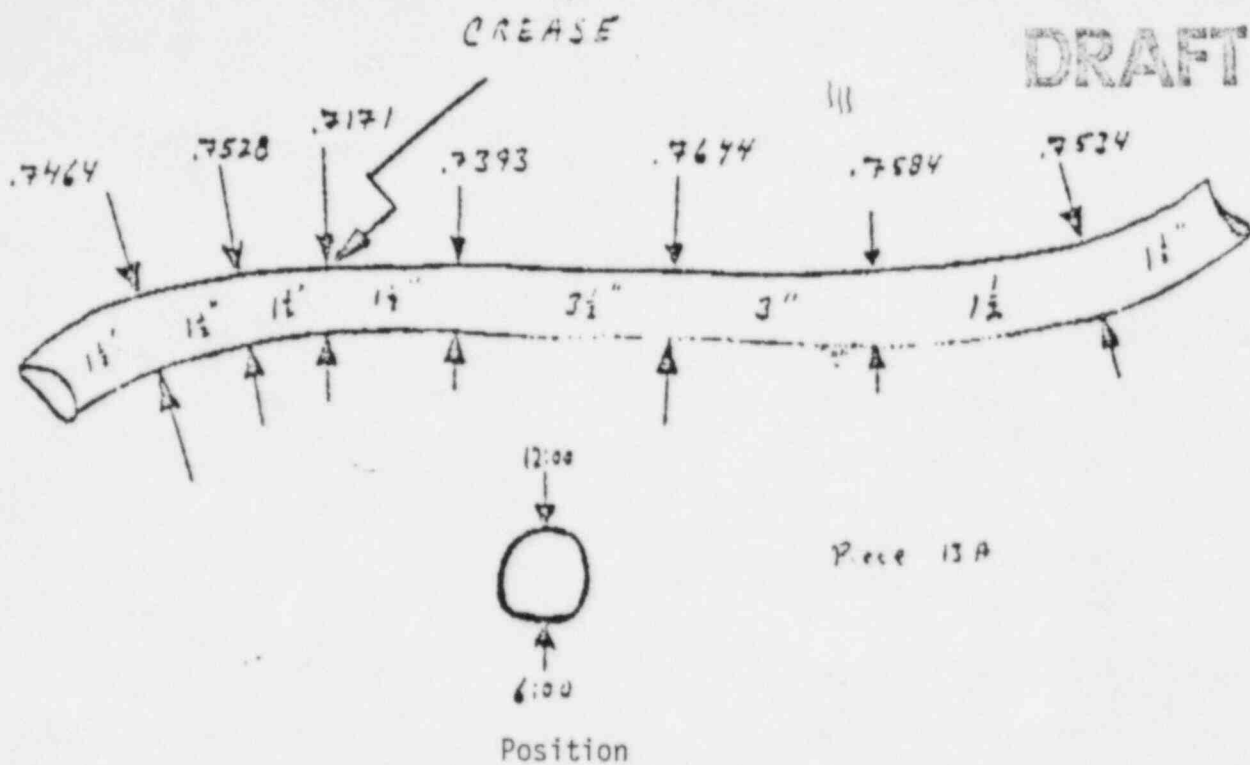
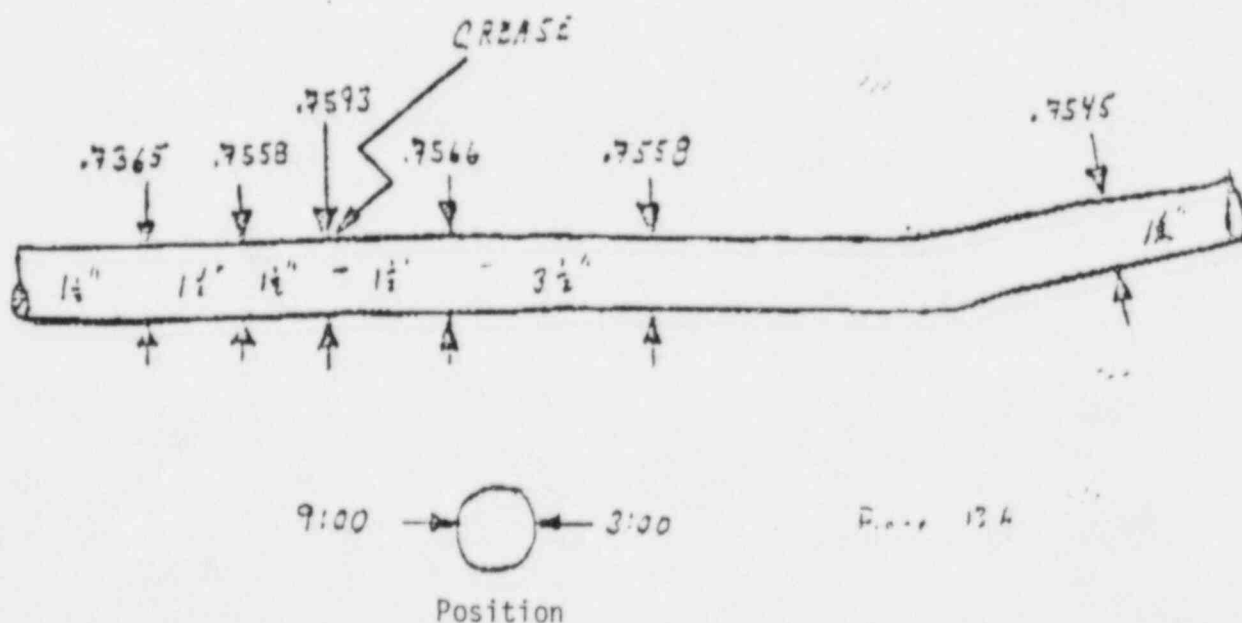
Figure 1 - Dimensional Measurements of Tube L29R86,
Section 13A

Two additional tube sections labeled 13A and 13C from tube L29R86 were visually inspected after receipt in Windsor. A kink and other marks associated with the tube removal were present on the tube sections. Deposits were more abundant and homogeneous on these sections, compared to L29R84. There was no evidence of significant corrosion attack to either tube section.

Two small defect signals were detected on section 13A during the receipt inspection. However, tube deformations from the removal operations created interferences which made it impossible to accurately assess the nature of these two defects. The best interpretation of the data was that there were one or more kinks (creases) in the tube section as a result of deformation during the removal operation. (This was subsequently confirmed during the destructive examination).
