RADIOLOGIC AND ENGINEERING ASSESSMENT

DOE ID NO.: GJ-13036-RS  
ADDRESS: 501 WEST MAIN STREET

AUGUST 1985

BENDIX FIELD ENGINEERING CORPORATION  
P.O. Box 1569  
Grand Junction, Colorado 81502

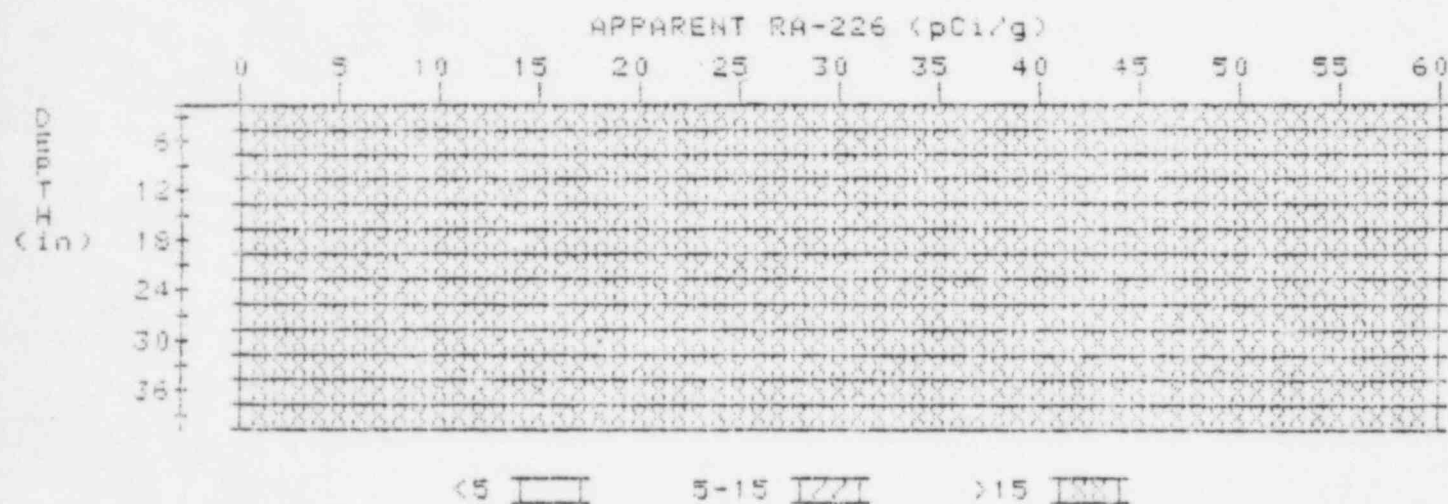
HOLE NUMBER: 2

A core was performed in the sidewalk north of the primary structure. An auger hole, 90-inches in depth, appeared to be contaminated.

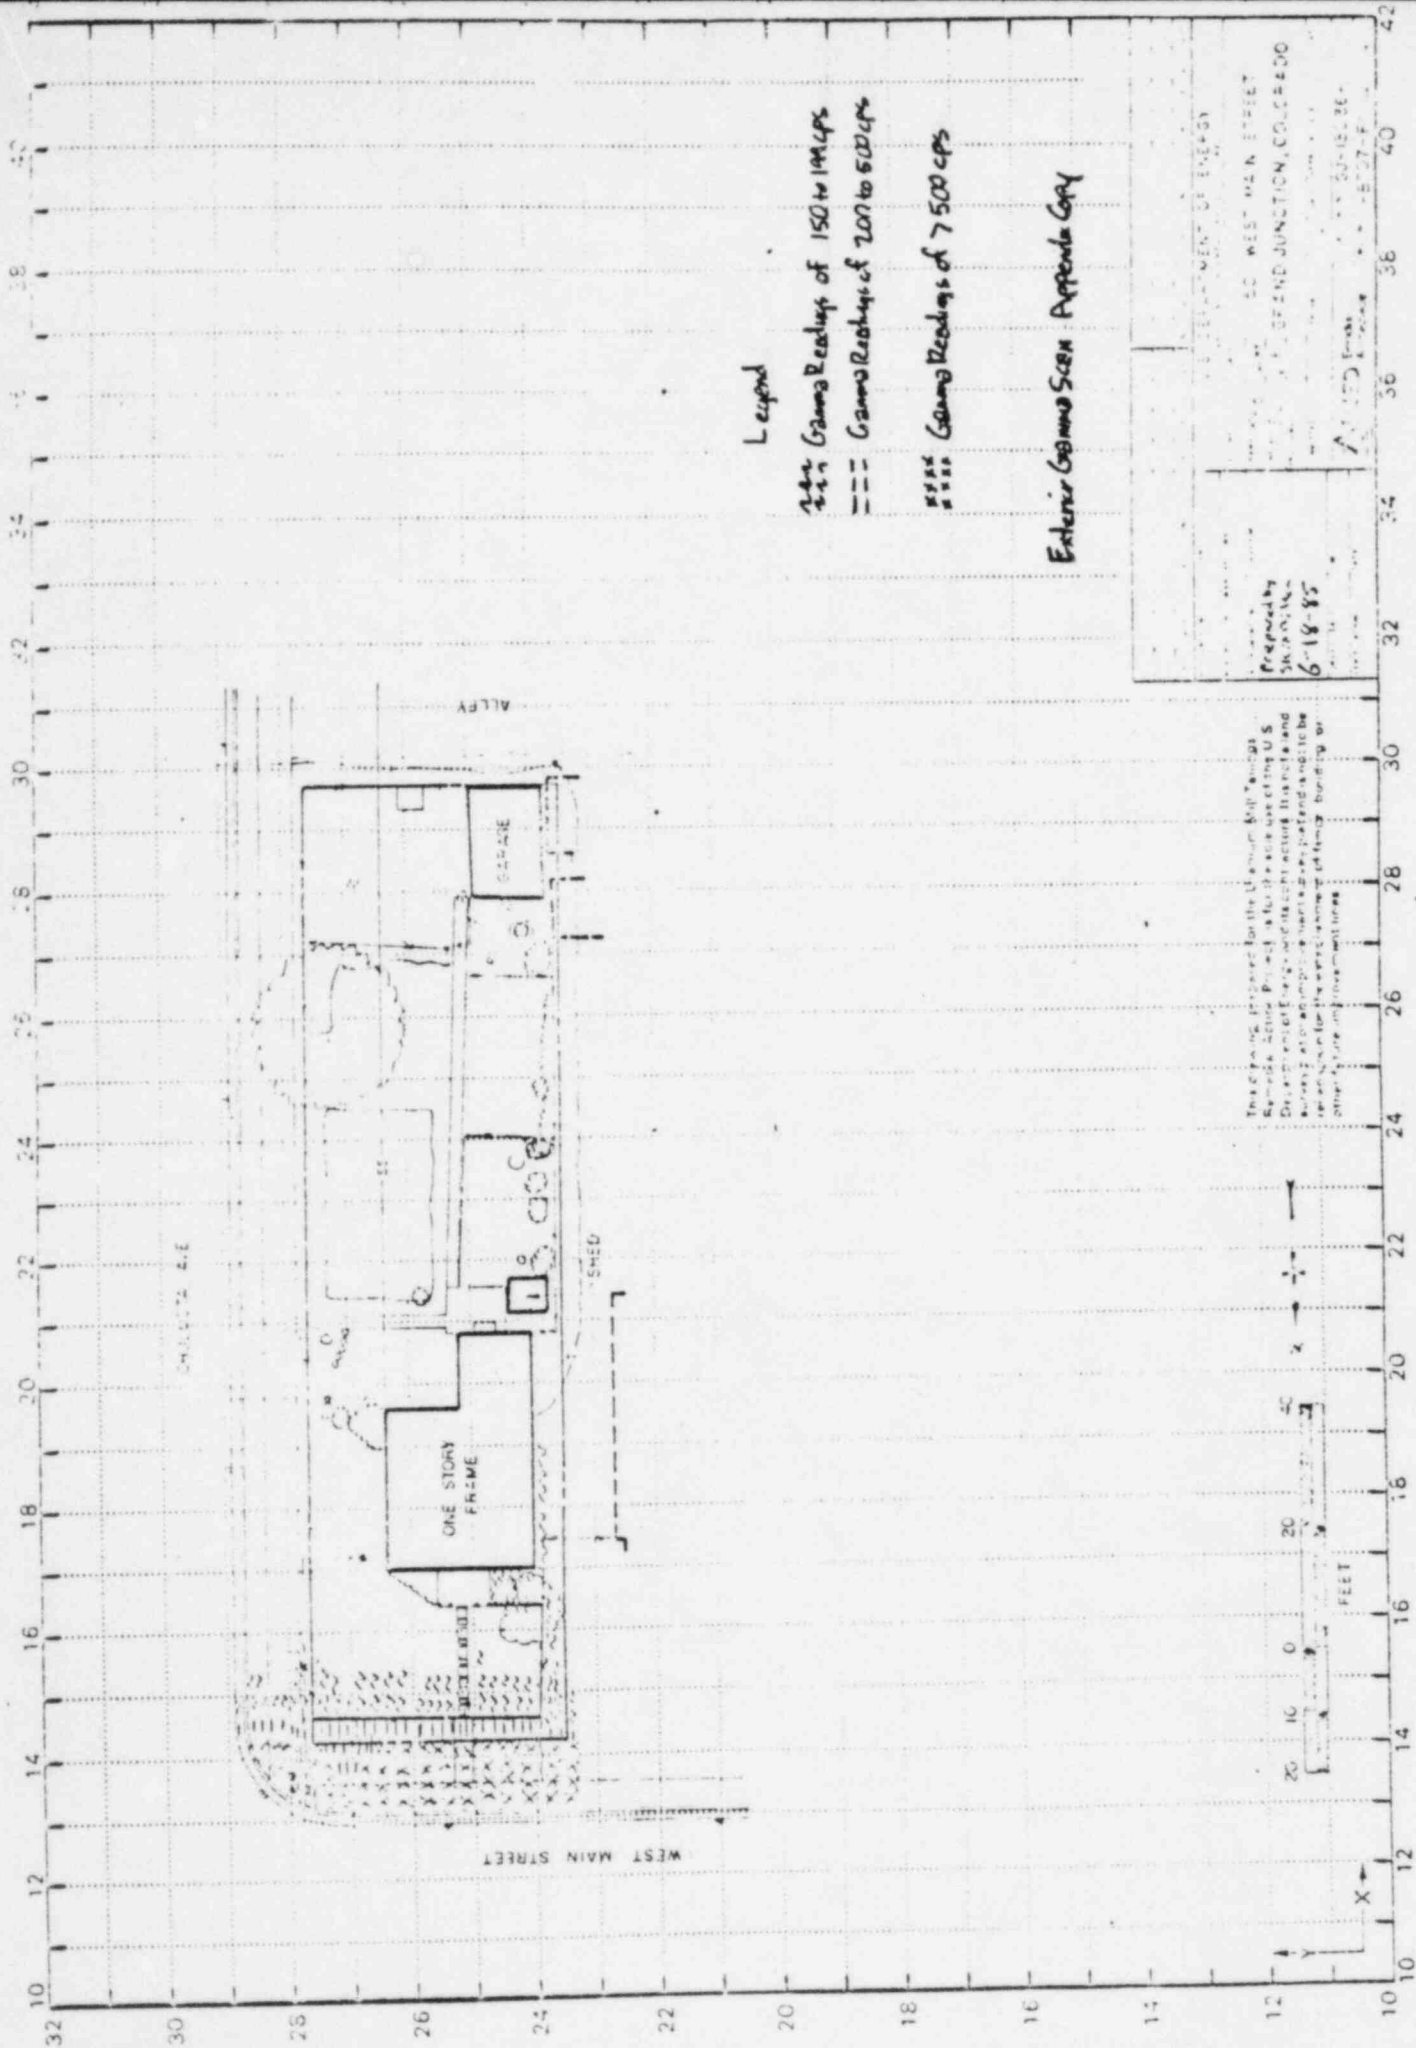
A 'storm' drain pipe is buried approximately 1-foot below the surface, and 1-foot south of the sidewalk. The pipe is backfilled with apparent tailings.
