RADIOLOGIC AND ENGINEERING ASSESSMENT

DOE ID NO.: GJ-10337-RS
ADDRESS: 635 CHIPETA AVENUE

AUGUST 1985

BENDIX FIELD ENGINEERING CORPORATION
P.O. Box 1569
Grand Junction, Colorado 81502

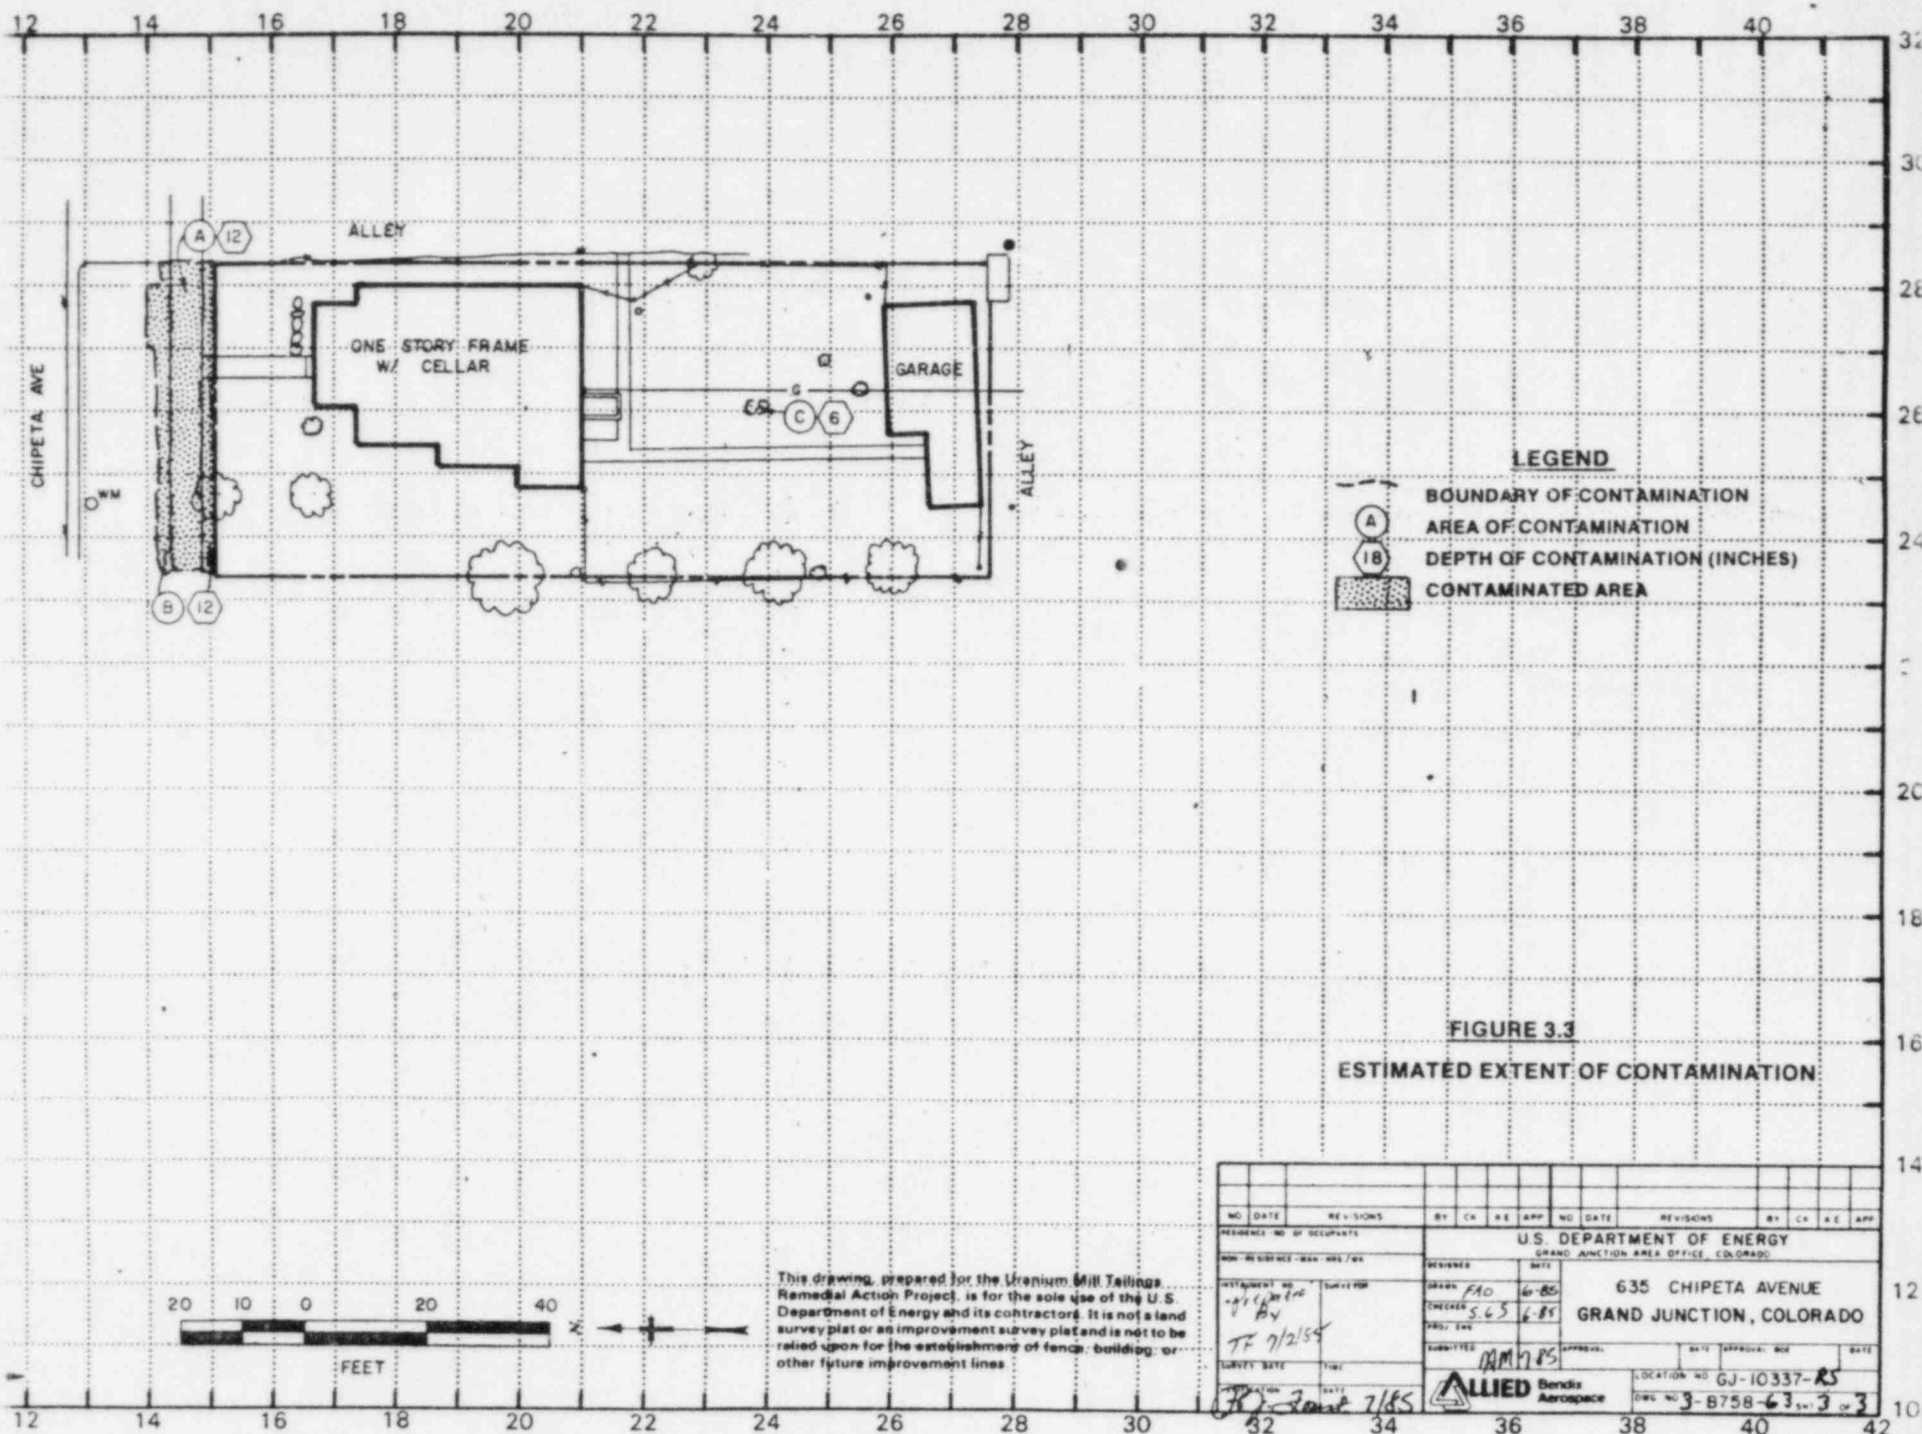
Appendix Figure 3.3 shows identified areas and estimated depths of contamination on this property, based on assessments of all measurements taken. As noted in this figure, areas recommended for remedial action that contain identified residual radioactive materials are:

- (Area A) Surface Material: Concrete
Direction From Primary Structure: North
Other Directions: South of Chipeta Avenue
Total Depth of Contamination: 12 inches
Other (height or thickness): 4-inch-thick concrete
Comments: City sidewalk
Approximate Square Footage: 250
- (Area B) Surface Material: Lawn
Direction From Primary Structure: North
Other Directions: Adjacent to city sidewalk
Total Depth of Contamination: 12 inches
Comments: A small section (6 sf) of the 4-inch-thick
north-south sidewalk is included in this area.
Approximate Square Footage: 222
- (Area C) Surface Material: Soil
Direction From Primary Structure: South
Other Directions: South yard
Total Depth of Contamination: 6 inches
Approximate Square Footage: 12

The recommended remedial action for this property, DOE ID No. GJ-10337-RS, includes removal of all areas identified as containing radioactive material (as discussed in Section 3.5 and shown in Appendix Figure 3.3) and transport of removed material to the disposal site.

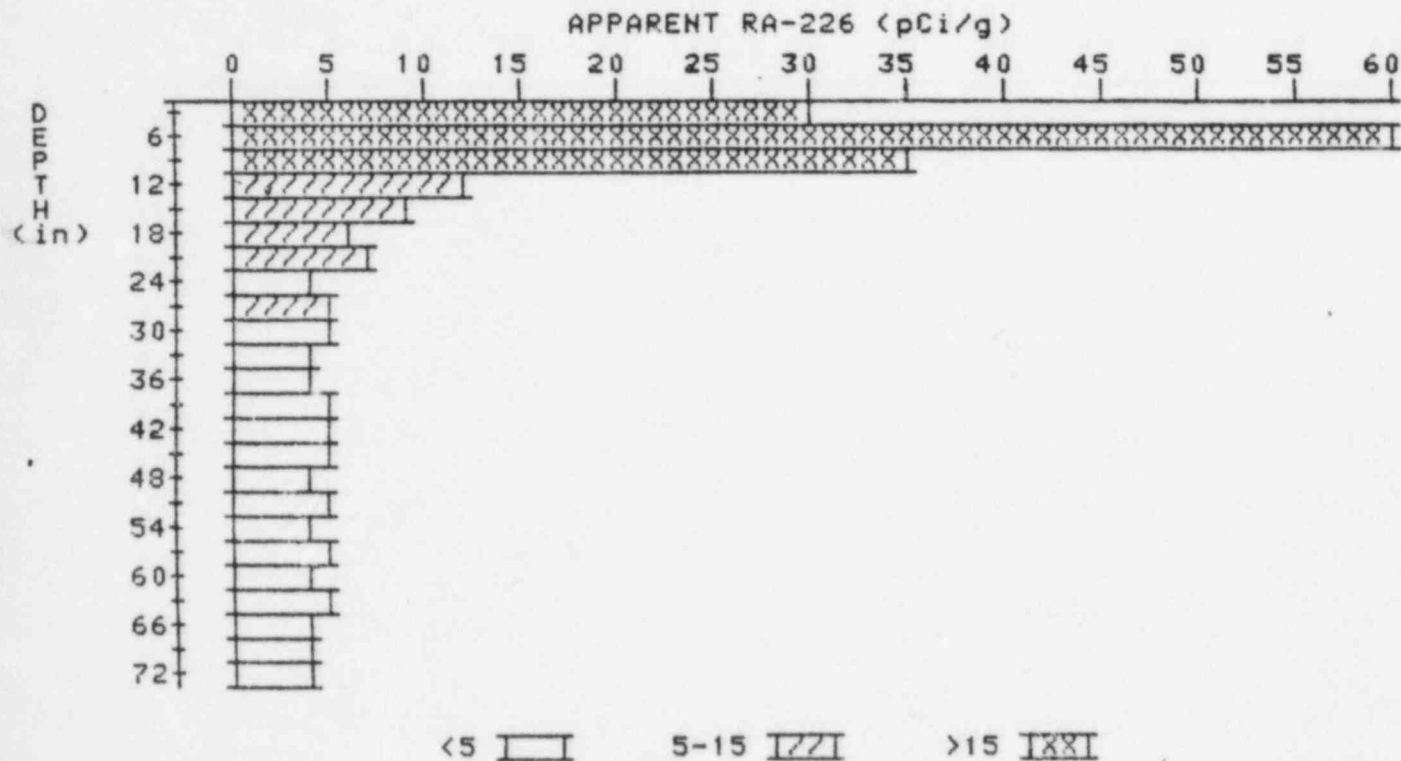
HOLE NUMBER: 3

Loc #	Grid Location	Depth (in.)	Meas. Type	In Situ Ra-226 (pCi/g)		Chem Ra-226 (pCi/g)	Comments
				Tot. Ct	Spectr.		
1	143250	00	DS	7.9		*	
		06	DS	2.6		*	
2	143271	00	DS	9.4		*	North of city sidewalk
		06	DS	7.5		*	
		12	DS	<1.0		*	
		12	DS	24.5		*	Horizontal
3	146276	00	DS	27.6		*	On city sidewalk DC = 12 inches based on all available data
		03	TC	30.2		*	
		06	TC	40.8		*	
		09	TC	31.5		*	
		12	TC	20.3		*	
		15	TC	13.7		*	
		18	TC	9.7		*	
		21	TC	7.7		*	
		24	TC	6.1		*	
		27	TC	5.5		*	
		30	TC	5.0		*	
		33	TC	4.7		*	
		36	TC	4.6		*	
		39	TC	4.6		*	
		42	TC	4.6		*	
		45	TC	4.5		*	
		48	TC	4.4		*	
		51	TC	4.4		*	
		54	TC	4.3		*	
		57	TC	4.4		*	
		60	TC	4.3		*	
		63	TC	4.4		*	
		66	TC	4.2		*	
		69	TC	4.1		*	
		72	TC	4.1		*	
4	150260	00	DS	3.4		*	
		06	DS	12.5		*	Horizontal
5	173257	03	TC	3.2		*	Water line DC = 0 inches
		06	TC	3.4		*	
		09	TC	3.5		*	
		12	TC	3.5		*	
		15	TC	3.5		*	
		18	TC	3.5		*	
		21	TC	3.6		*

Elevated readings were found on the north sidewalk. A core was drilled through the sidewalk and a borehole was augered. Deltas were taken on the sidewalk and adjacent to the sidewalk.
