LICENSEE EVENT REPORT (LER)

FACILITY NAME (1): LaSalle County Station Unit One									DOCKET NUMBER (2): 05000373		PAGE (3): 1 of 5			
TITLE (4) Potential Water Hammer Concerns of Residual Heat Removal Service Water System Division 2 Piping														
EVENT DATE (5)			LER NUMBER (6)			REPORT DATE (7)			OTHER FACILITIES INVOLVED (8)					
MONTH	DAY	YEAR	YEAR	SEQUENTIAL NUMBER	REVISION NUMBER	MONTH	DAY	YEAR	FACILITY NAME		DOCKET NUMBER			
12	17	96	96	020	00	1	16	97	LaSalle County Station Unit Two		05000374			
									FACILITY NAME		DOCKET NUMBER			
OPERATING MODE (9)		4		THIS REPORT IS SUBMITTED PURSUANT TO THE REQUIREMENTS OF 10 CFR §: (Check one or more) (11)										
POWER LEVEL (10)		000												
			<input type="checkbox"/>	20.2201(b)		<input type="checkbox"/>	20.2203(a)(3)(i)		<input type="checkbox"/>	50.73(a)(2)(iii)		<input type="checkbox"/>	73.71(b)	
			<input type="checkbox"/>	20.2203(a)(1)		<input type="checkbox"/>	20.2003(a)(3)(ii)		<input type="checkbox"/>	50.73(a)(2)(iv)		<input type="checkbox"/>	73.71(c)

During a review of the Residual Heat Removal service water system (RHRWS) for water hammer concerns, Division 2 piping supplying an RHR heat exchanger on Unit

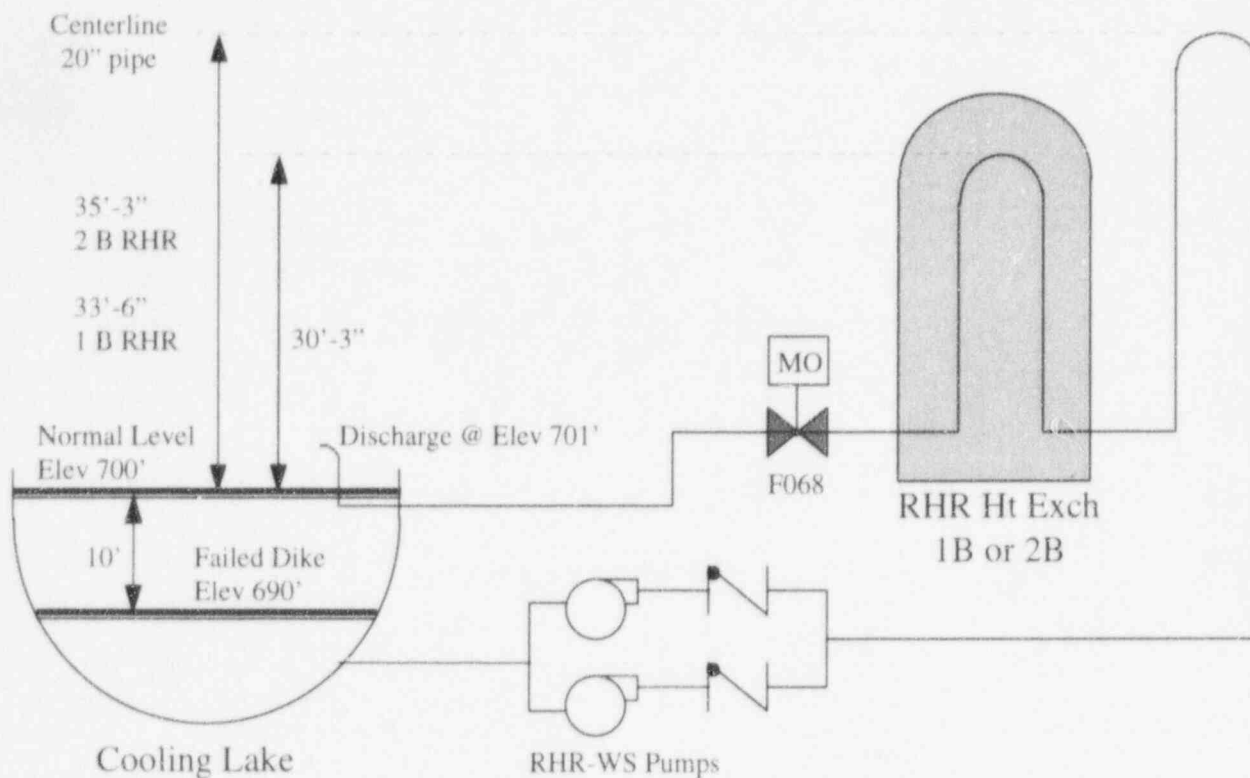
**Elevation Sketch of RHR Service Water Piping Loop
Division 2**

The original design did not address this condition. The root cause is indeterminate. The vertical piping loop in Division 2 of the RHRWS system (both units) was provided during the original design and construction phase of LaSalle Station to accommodate straight pipe length requirements associated with a flow element, and space limitations in the Division 2 RHR heat exchanger rooms. Void formation due to leakage through closed valves and/or the full impact of a piping change to provide the straight length of pipe for the flow element may not have been considered.

A contributing cause of this event is that in the past LaSalle failed to recognize that under design basis conditions the Division 2 piping system would not meet design basis requirements. Water hammer in the Unit 2 Division 2 RHRWS piping vertical loop was investigated in 1990 but did not result in identification of the subject piping being outside its design basis for the conditions described above.

- 1) During the current outages on both units, a keep fill system is being installed (an independent one for each unit) which will eliminate the potential for water hammer during design basis events in Modes 1, 2, and 3. These keep fill systems will be installed and operable prior to either Unit 1 or 2 entering Modes 1, 2, or 3.
