RADIOLOGIC AND ENGINEERING ASSESSMENT

DOE ID NO.: GJ-03077-MR  
ADDRESS: 2313 ORCHARD AVENUE

JULY 1985

BENDIX FIELD ENGINEERING CORPORATION  
P.O. Box 1569  
Grand Junction, Colorado 81502

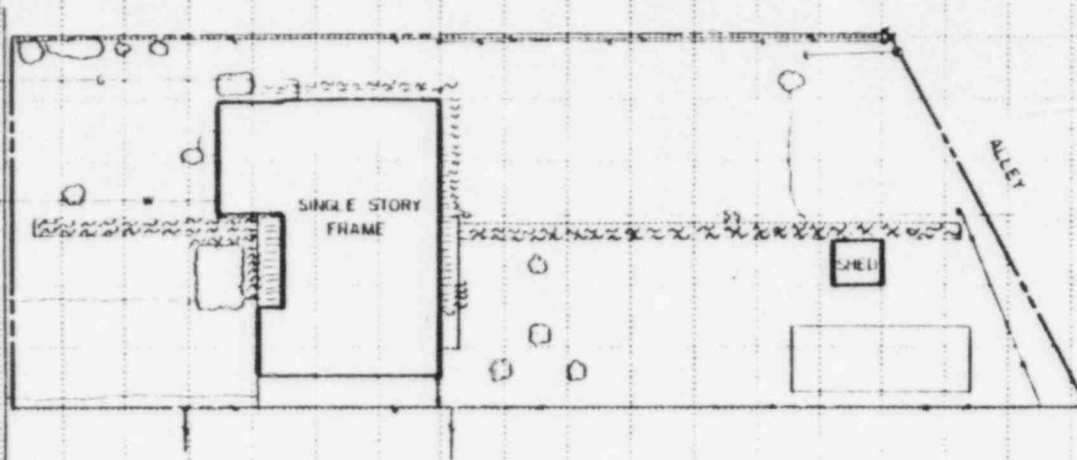
## EXTERIOR GAMMA SCAN

Elevated readings were discovered along the sidewalks north and south of the house, and in the old portion of the house. The slab the house is resting on is contaminated. A core in the back should be able to give me a depth of the concrete and the extent, if any, of contamination beneath it. Soil samples of the sidewalk and the concrete pad were collected.
