James A. FitzPatrick
Nuclear Power Plant
P.O. Box 41
Lycoming, New York 13093
315-342-3840

Subject: Docket No. 50-333
LICENSEE EVENT REPORT: LER-96-015

Design Error Allows Bypass Flow Path Around Offgas
Isolation Valve

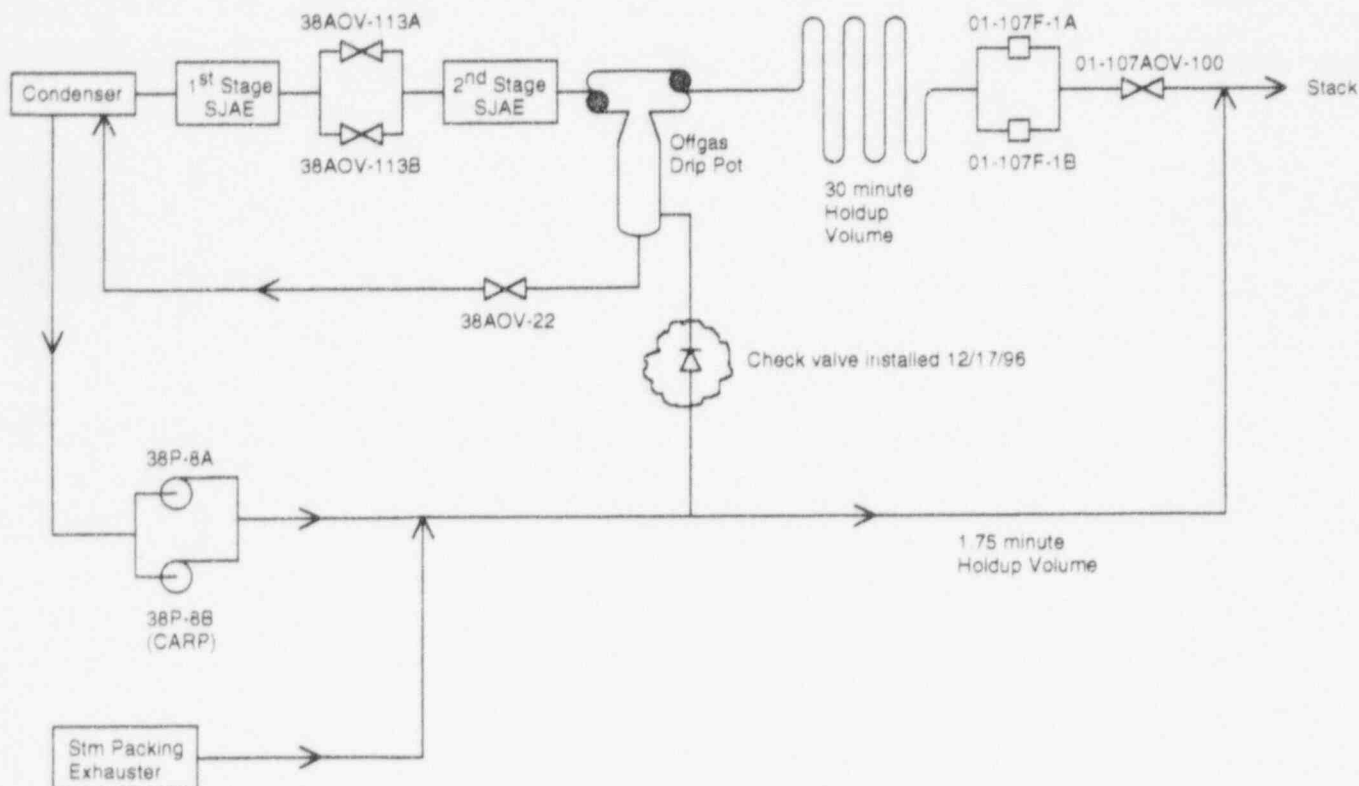
FIGURE 1

At 12:00 on December 18, 1996, it was determined that the original design of an interconnection between the condenser air removal system [SH] and the offgas system [WF] could have prevented the fulfillment of the safety function of a system required to control the release of radioactive material or mitigate the consequences of an accident. This determination was based on the observation that pressurization of the offgas 30 minute holdup volume would have cleared the water which effectively seals the condenser air removal pump / steam packing exhauster (CARP/SPE) discharge line from the offgas system by maintenance of level in the offgas drip pot and CARP/SPE discharge common drain from the drip pot and drain line, providing a flow path for offgas to bypass the offgas HEPA filters, 01-107F-1A/B, 30 minute holdup volume and offgas outlet isolation valve, 01-107AOV-100.

The offgas system is isolated by closure of 01-107AOV-100 in response to high radiation in the effluent. Closure of this valve will result in pressurization of the 30 minute holdup volume due to continued steam jet air ejector operation removing non-condensibles from the condenser [SG]. Pressurization of the 30 minute holdup volume may have resulted in offgas flow bypassing the 30 minute holdup volume and offgas HEPA filters (01-107F-1A/B) through the flowpath described above.

This condition was discovered during reactor startup from refuel outage 12 in December, 1996, when it was observed that high offgas system flow persisted in the absence of flow through the offgas HEPA filters (as indicated by filter differential pressure). It was subsequently determined that 01-107AOV-100 was inadvertently closed, and that offgas was being discharged through backflow through the CARP/SPE drain line and discharge piping.

The cause of the event was an error in the original plant design (cause code B) which created a potential discharge path from the offgas drip pot to the main stack through the common drain line from the steam packing exhauster and condenser air removal discharge pipe (1.75 minute holdup volume) to the drip pot. As designed, this line had no provision to prevent offgas backflow if the drip pot was pressurized sufficiently to clear the loop seal in the drip pot / drain line.

Simplified Offgas System Flow Diagram

1. Modification M1-96-103 was installed on December 17, 1996 and tested satisfactorily on December 18, 1996. This modification installed a check valve in the drain line from the common steam packing exhauster / condenser air removal pump discharge line to the offgas drip pot which will prevent reverse flow of the steam jet air ejector effluent in the event the thirty minute holdup volume is pressurized.
2. A calculation will be performed to evaluate the consequences of a control rod drop accident given the original configuration of the offgas system by March 19, 1997 (Corporate Radiological Engineering).
3. A revision to this LER documenting the results of corrective action 2 will be prepared, if necessary, by April 15, 1997 (Licensing).
