SACRAMENTO MUNICIPAL UTILITY DISTRICT ☐ 6201 S Street, P.O. Box 15830, Sacramento, CA 95813; (916) 452-3211
RJR 85-531 AN ELECTRIC SYSTEM SERVING THE HEART OF CALIFORNIA

October 25, 1985

DOCKET NO. 50-312
LICENSE NO. DPR-54
SUMMARY AND SUPPLEMENTAL INFORMATION FROM TRANSIENT OF OCTOBER 2, 1985

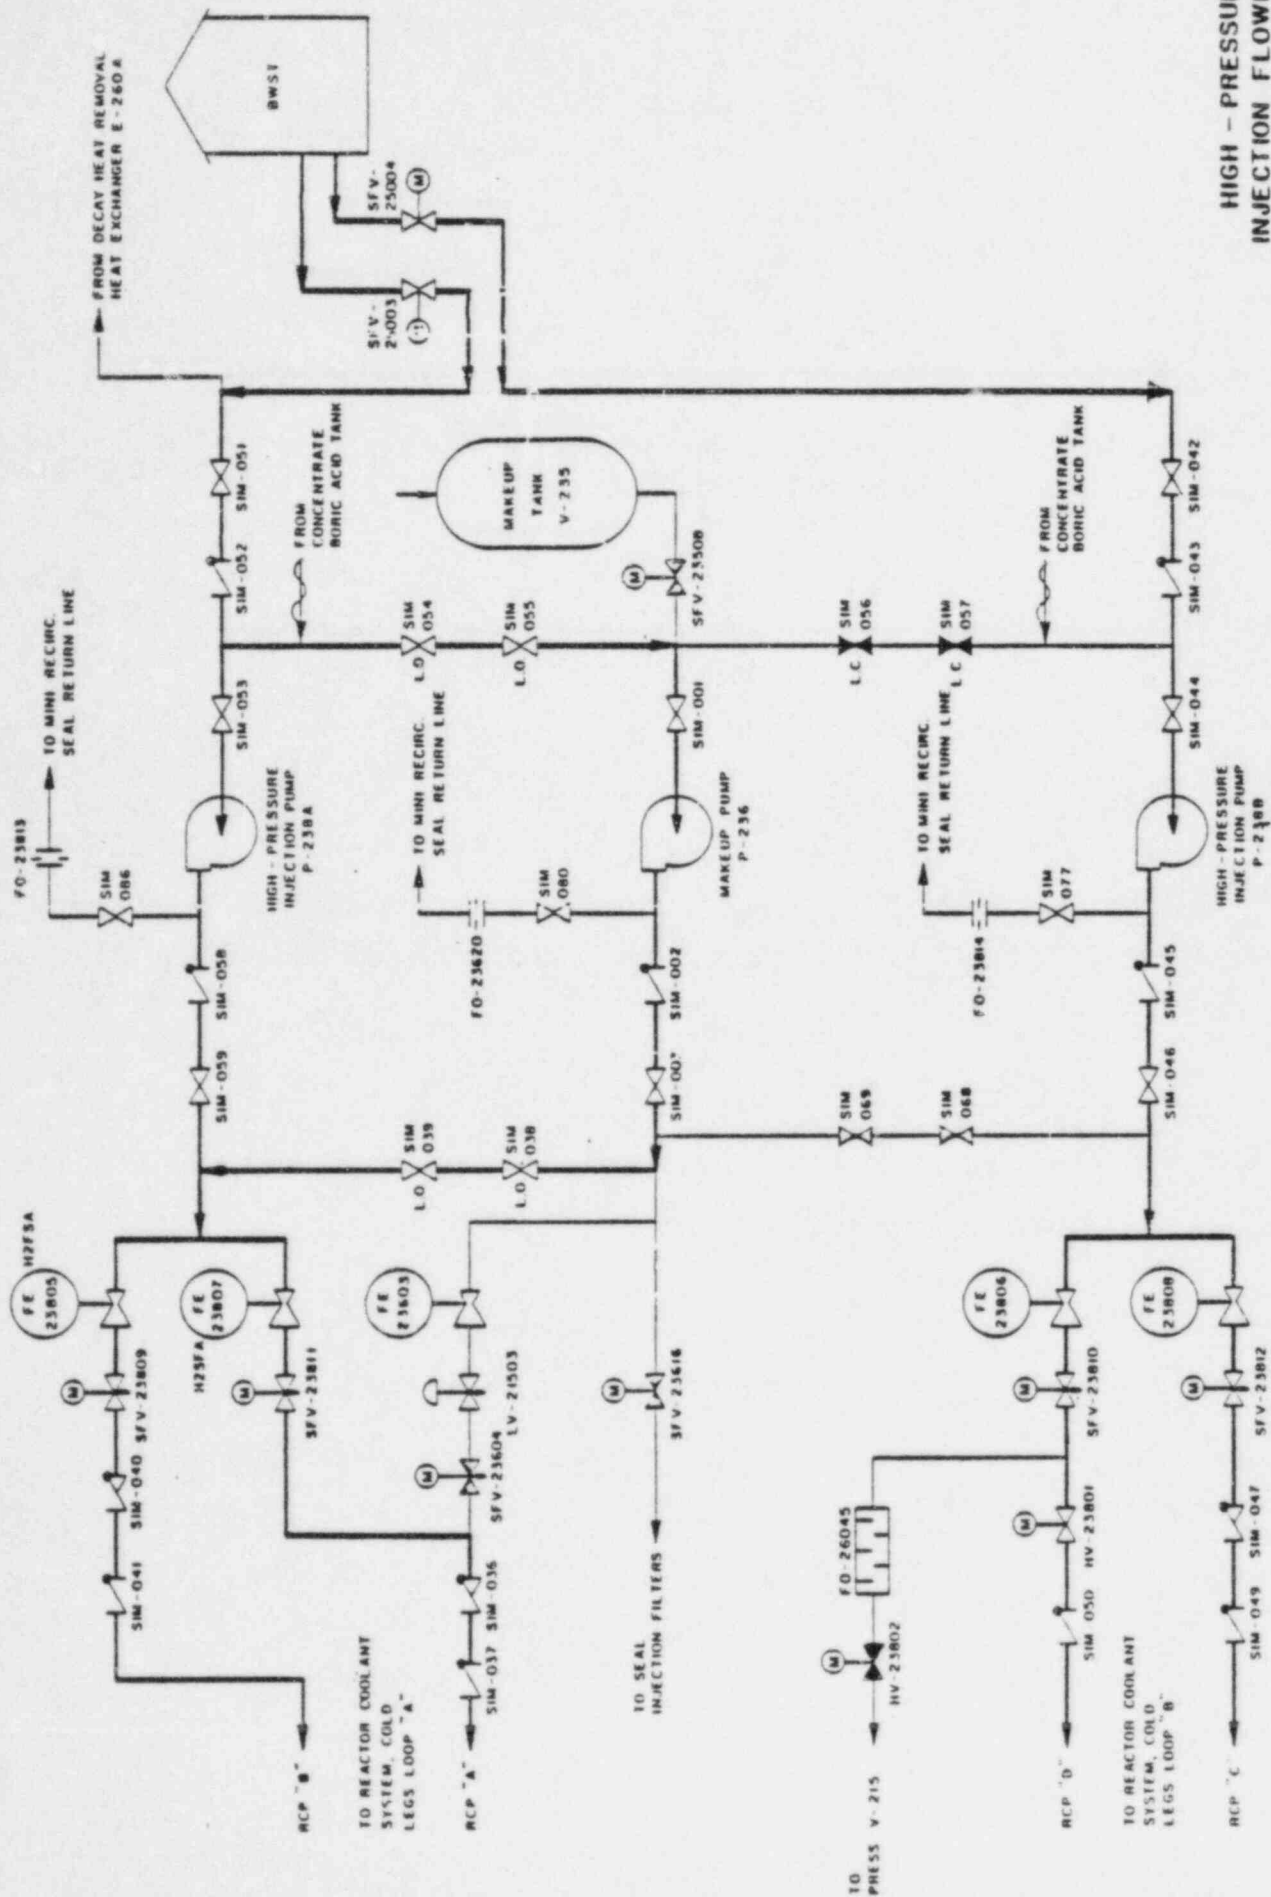
HIGH - PRESSURE
INJECTION FLOWPATH

As prescribed by plant operating procedures for pressurizer level decreasing below 100 inches, the operator started the High Pressure Injection (HPI) pump (P-238 B) lined up to the borated water storage tank and opened loop "A" HPI valve. The loop "A" nozzle is also the path for normal additions necessary to maintain pressurizer level. Although the above actions increased flow to the reactor coolant system (RCS), the pressurizer level continued to decrease. The operator opened the remaining three loop HPI valves, allowing HPI flow through all four paths to the RCS. At this point, he observed "zero" flow on the "A" HPI flow indicator. To further augment the HPI supply, he started the third HPI pump and the loop "A" HPI flow increased to about 80 gpm. Subsequent analysis of plant computer data verified this phenomenon and showed a recovery of flow indication in about 30 seconds, coincident with start of the third HPI pump.

The District has performed an exhaustive investigation consisting of system flow testing, non-destructive examination and formal analysis. This investigation led us to the root cause; a shift in the zero point of the flow transmitter. This shift occurs as the device is calibrated with the system depressurized and then brought to system operating pressure. In the case of these transmitters, this shift can result in no flow indication with as much as 75 gpm of actual flow. Note that, although this problem creates imprecise indication to the operator, it did not affect the ability of the HPI system to perform its safety function. Hydraulic calculation showed that, for the period of "zero" flow indication, the expected loop "A" HPI flow would be nearly identical to the measured zero shift.

Review of literature and discussions with the manufacturer of the transmitter has shown that this shift is not an equipment failure but inherent with the device. We are currently evaluating the implication of this finding with regard to this application and all other safety related applications of this transmitter at Rancho Seco.

Both the initial flow indication problem and the generic implications of our findings will be resolved, including an acceptance by the Plant Review Committee prior to plant restart. A followup report will be submitted to the NRC.

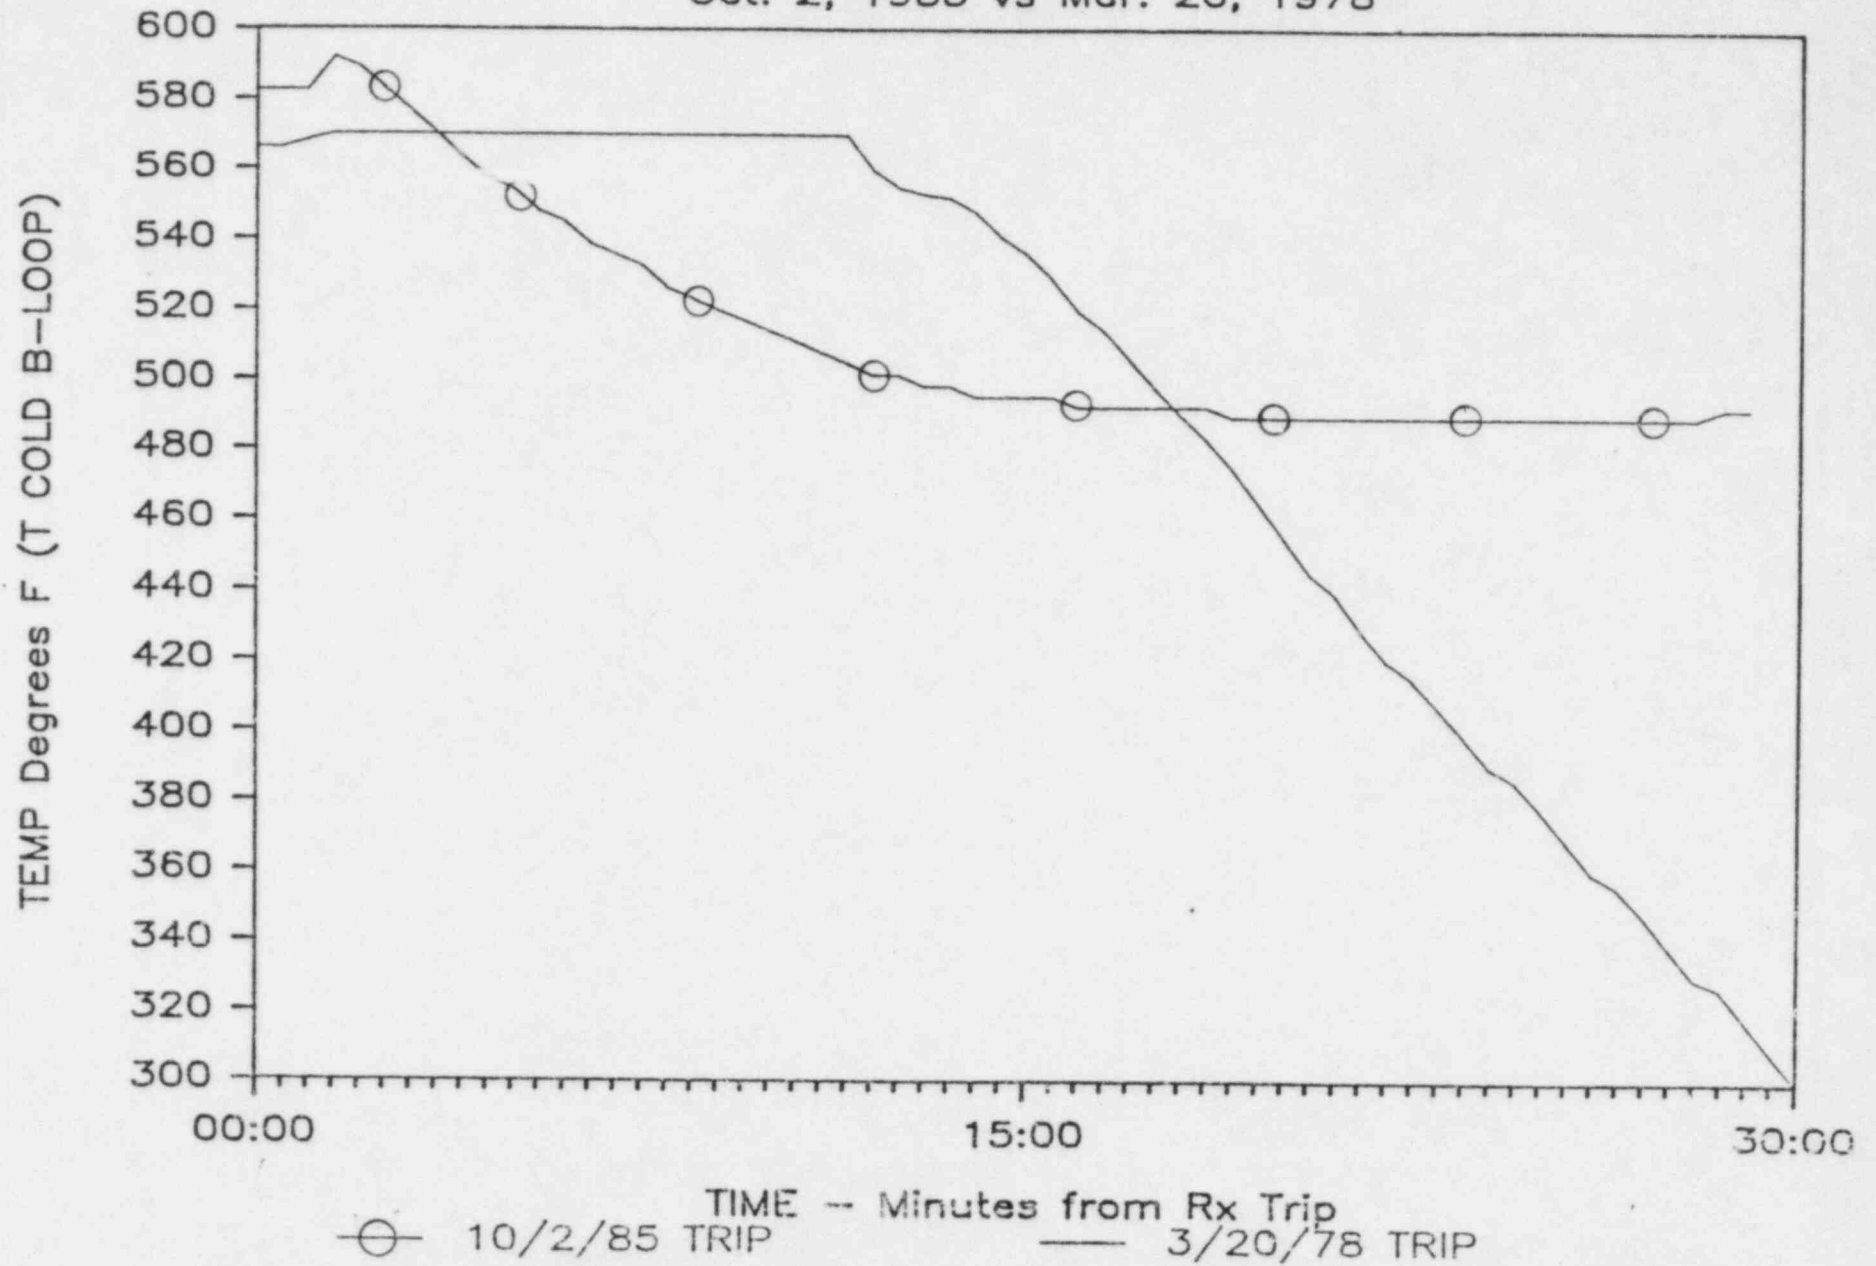
RCS TEMPERATURE

It must be understood that immediately following the transient, the Wide Range Cold Leg Temperature recorder was used for some of the analyses. This temperature recorder has since been found to be in error and recalibrated. The computer compiled data has been determined to be more accurate.

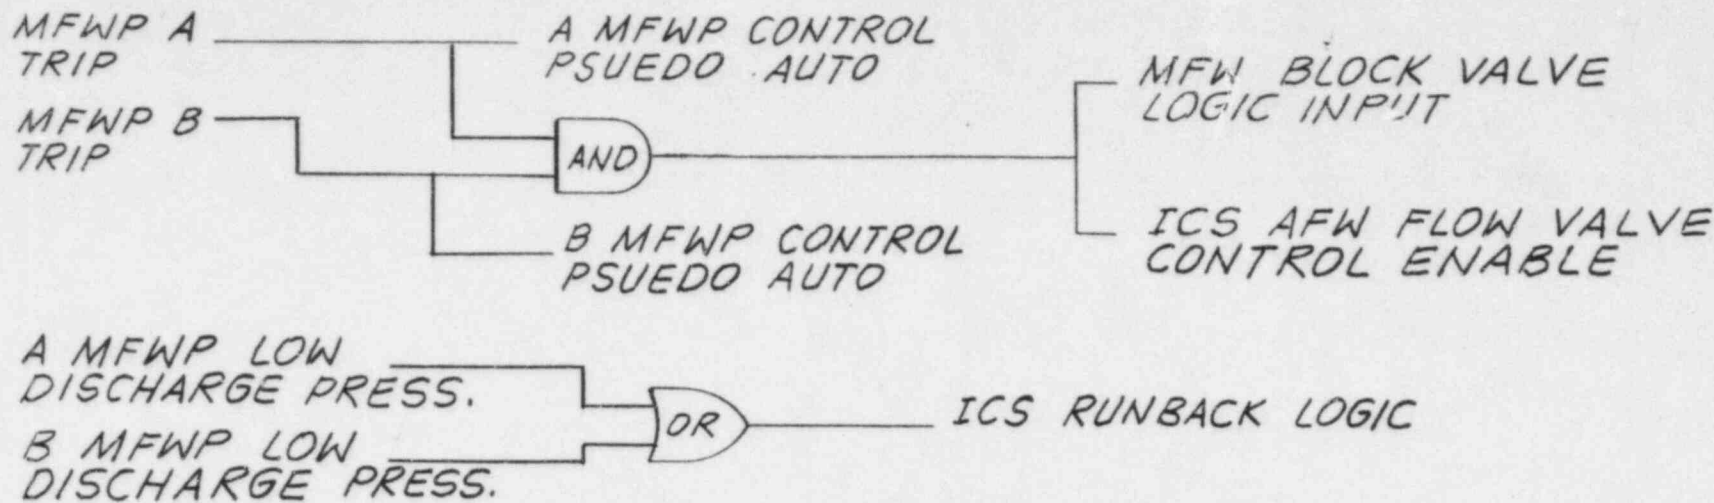
FIG. 1 - CURRENT LOGIC

MFW Block Valves - The "A&B MFW pumps tripped" signal will be replaced with the "MFW pumps discharge pressure low" signal. The remainder of the logic will remain the same (1 RCP tripped to close the block valve).

AFW Valve Control - The "A&B MFW pumps tripped" signal will be replaced with the "MFW pumps discharge pressure low" signal. This signal will allow the ICS to control the AFW valves on low OTSG level.

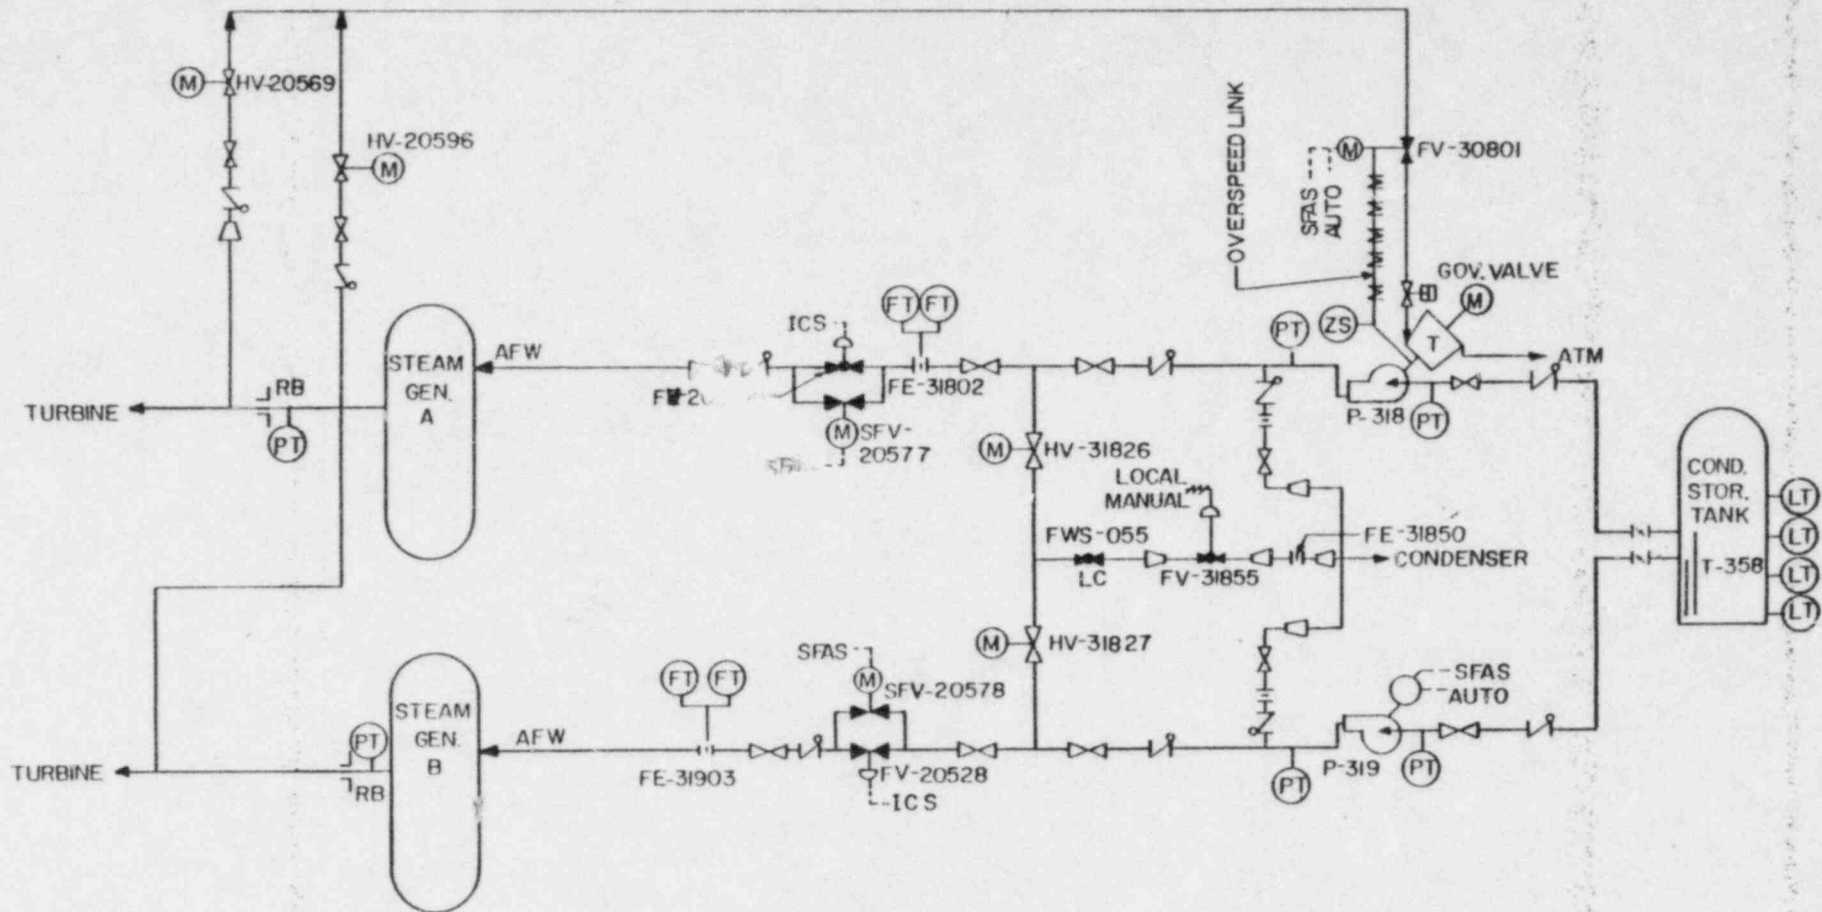
FIGURE B

The design of the AFW system was presented in detail to the NRC staff during the October 23, 1985, meeting in Bethesda. It was clearly shown that there are two separate and distinct activate/control systems and flow paths within AFW (see Figure B attached). Either system can supply AFW to the OTSG's regardless of failures in the other. The systems are briefly described below.

- 2) The second system is the Class 1 Safety Feature Activation System (SFAS). This system provides automatic AFW pump start and flow to the OTSG's when LOCA conditions are sensed. Class 1 manual start and flow control is available in the control room.

The SFAS system is completely independent of the ICS/Class 1 Pump Start System. Thus, it follows that there is no single failure which could cause loss of main feedwater flow (for example, closure of all ICS controlled main feedwater control valves), and cause the inability to provide AFW flow with the SFAS system. SFAS system AFW flow would require manual control room pump start and flow control since SFAS does not detect loss of main feedwater.

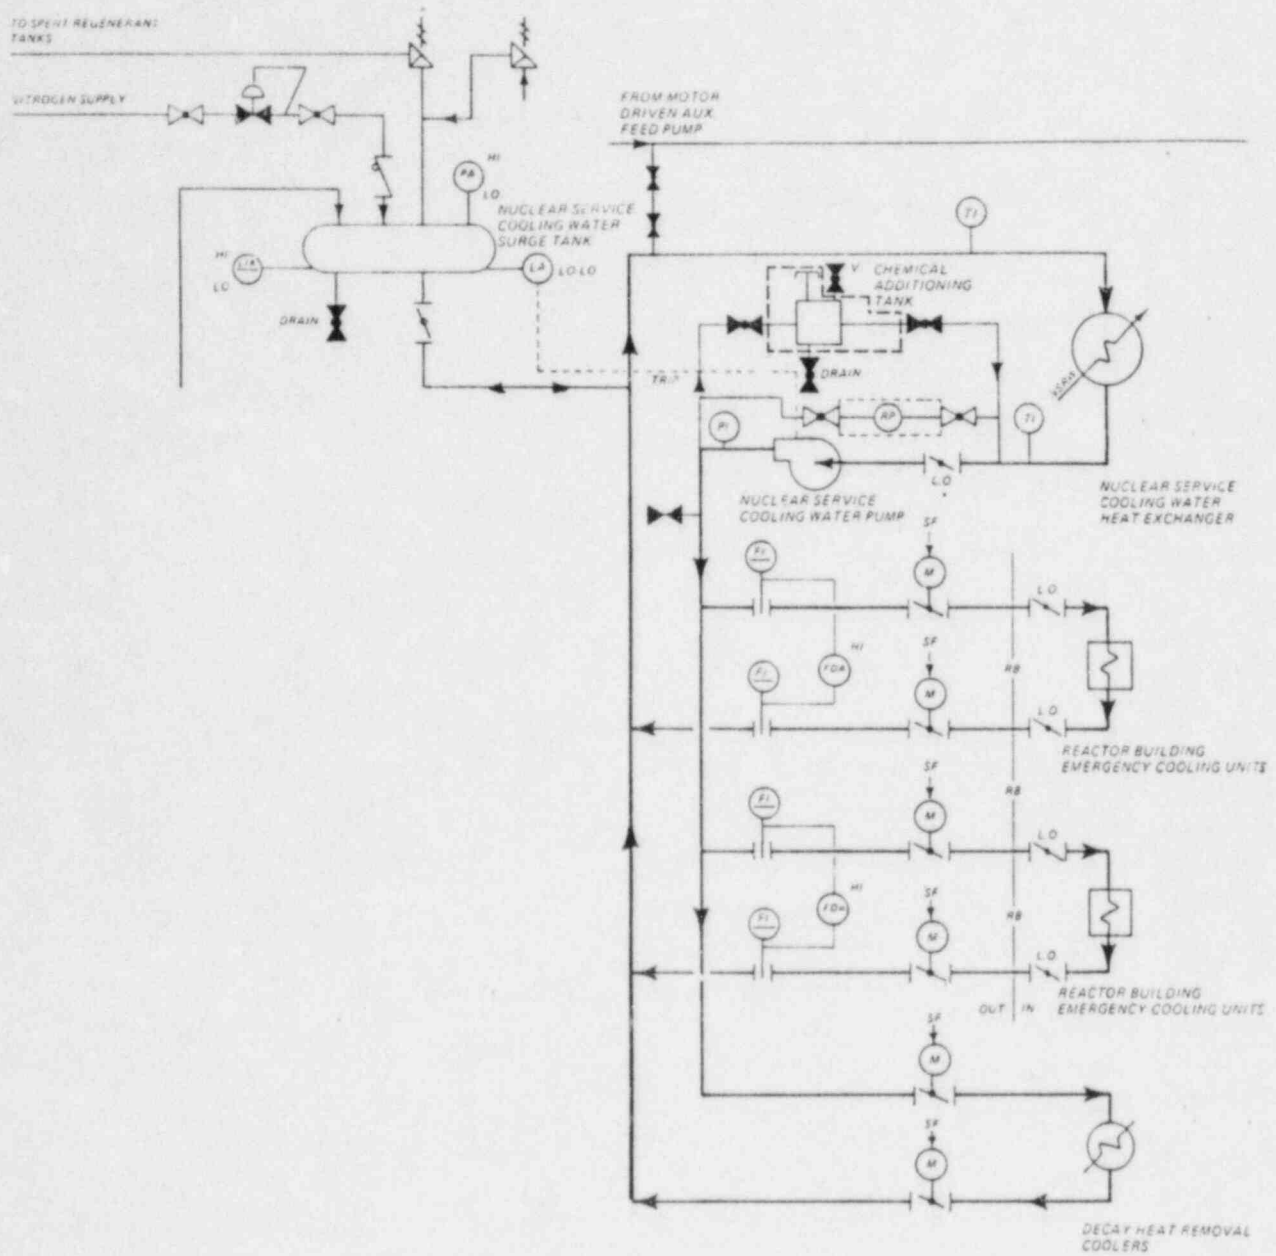
The Nuclear Service Cooling Water (NSCW) System removes heat from the decay heat removal coolers and the reactor building emergency cooling units during post-accident (LOCA) conditions. The NSCW System then transfers this heat to the Nuclear Service Raw Water (NSRW) System. During a normal plant shutdown, the NSCW System removes reactor decay heat from the decay heat removal coolers and transfers that decay heat to the NSRW System. System configuration is shown on the attached figure.

The cooler outlet valves have been adjusted to increase flow, and a successful pump surveillance test was completed on October 24th. The present flow rate of 6200 GPM is consistent with that measured prior to May and greater than the minimum design rate of 6000 GPM.
