## LICENSEE EVENT REPORT (LER) TEXT CONTINUATION

FACILITY NAME (1)  Peach Bottom Atomic Power Station - Unit 2	DOCKET NUMBER (2)  0 5 0 0 0 2 7 7 8 5 - 0 0 3 - 0 1 0 2 OF 0 6	LER NUMBER (8)			PAGE (3)		
		YEAR	SEQUENTIAL NUMBER	REVISION NUMBER

SUBJECT: Licensee Event Report  
Peach Bottom Atomic Power Station - Unit 2

This revised LER (Rev. 1) deals with the failure of the "A" loop Residual Heat Removal system outboard injection valve, M0-2-10-154A. This revision provides additional information and corrects some terminology. Revisions are indicated by a vertical bar.

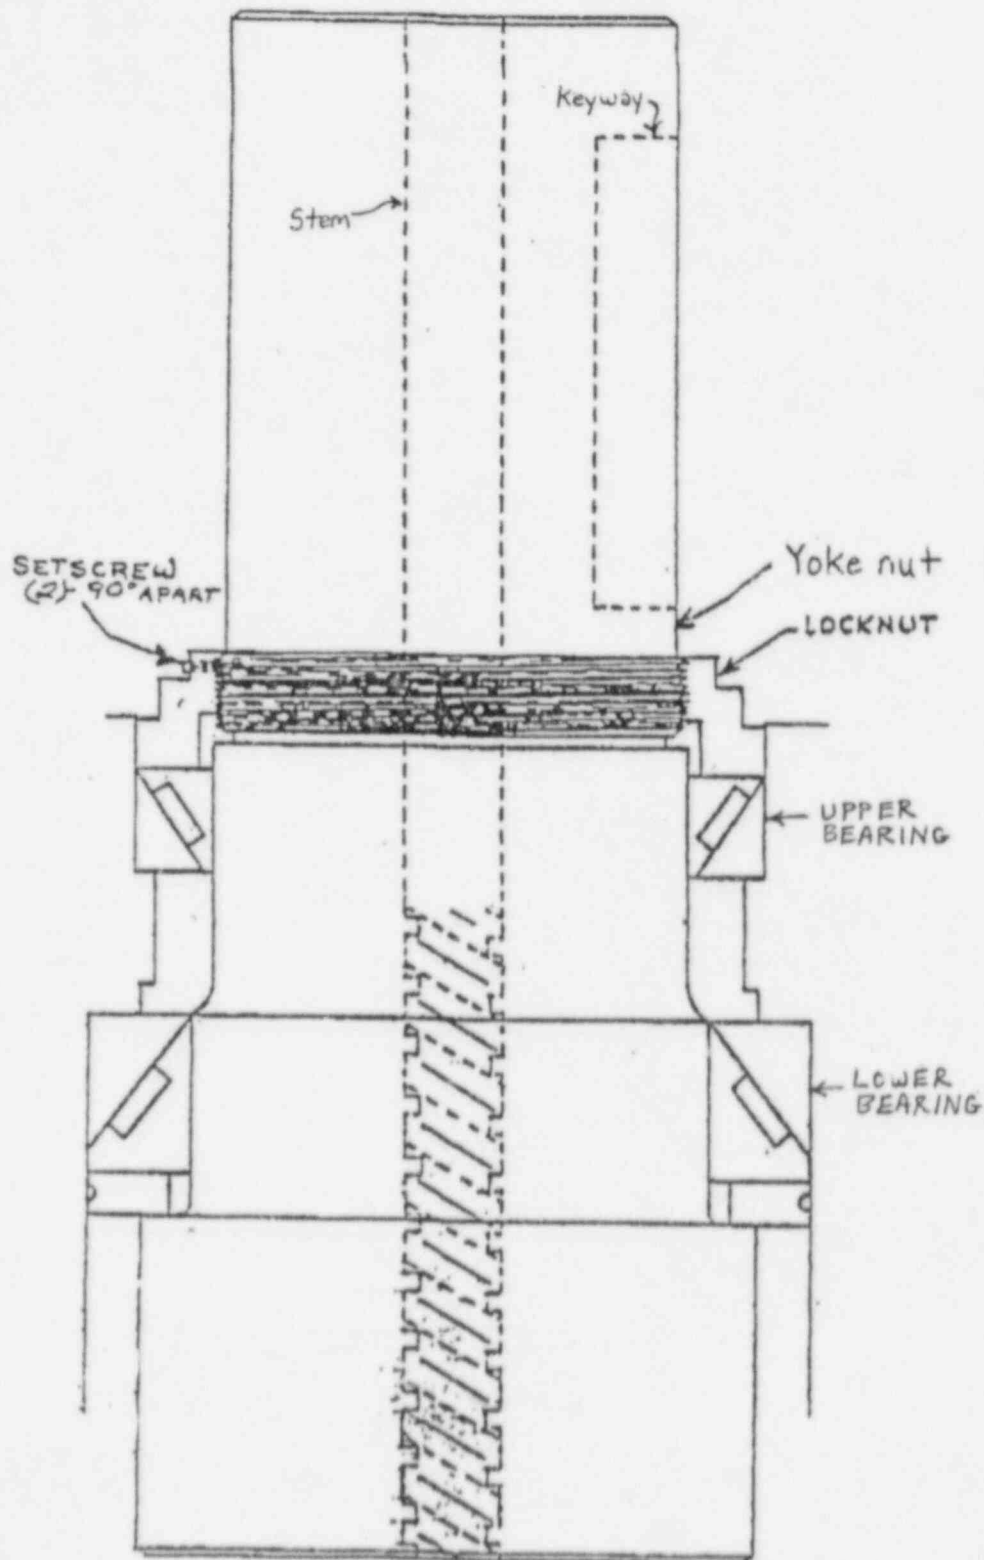
# YOKE NUT AND THRUST ASSEMBLY

The M0-2-10-154A valve is a 24" pressure seal right angle globe valve manufactured by the Walworth Company. Its Limitorque operator's torque drive sleeve is keyed to the yoke nut. The yoke nut is supported within the valve yoke between two sets of tapered roller thrust bearings (upper and lower). The yoke nut, upper and lower thrust bearings, and a locknut constitute the thrust assembly, which is supplied by Walworth as part of the valve (see attachment). With the locknut in place above the upper thrust bearing, downward motion of the yoke nut during valve opening is prevented. The locknut is threaded onto external threads on the yoke nut and is equipped with two setscrews 90 degrees apart. The locknut rotates with the yoke nut during operation.

After removing the Limitorque operator from the valve yoke, it was observed that the locknut had been forced completely off of the yoke nut. The external threads of the yoke nut and the mating threads of the locknut were damaged. With the locknut off, the yoke nut was free to travel down the valve stem until the yoke nut key became jammed between the top of its slot in the yoke nut and the top surface of loose locknut. This resulted in the mechanical binding of the yoke nut to the extent that the valve could not be stroked. The excessive thrust as a result of attempting to open this valve against a differential pressure much greater than the design pressure, 350 psi, caused the locknut and external yoke nut threads to fail. In addition to the damaged yoke nut and locknut, the upper thrust bearing cone was cracked and rollers were out of their cage. Rollers were also out of their cage on the lower thrust bearing. No damage occurred to the valve's Limitorque operator.

The reactor mode switch was changed from the "Refuel" to the "Shutdown" position at 8:50 p.m. The valve thrust assembly was rebuilt with new parts from the storeroom which were purchased from the manufacturer. The yoke nut, locknut, upper and lower thrust bearings and yoke nut key were replaced. The valve was verified as operable and returned to service and the reactor mode switch was returned to the "Refuel" position at 10:00 p.m. on June 6, 1985.
