RADIOLOGIC AND ENGINEERING ASSESSMENT

DOE ID NO.: GJ-03936-RS  
ADDRESS: 2414 HALL AVENUE

AUGUST 1985

URANIUM MILL TAILINGS REMEDIAL ACTION PROJECT OFFICE

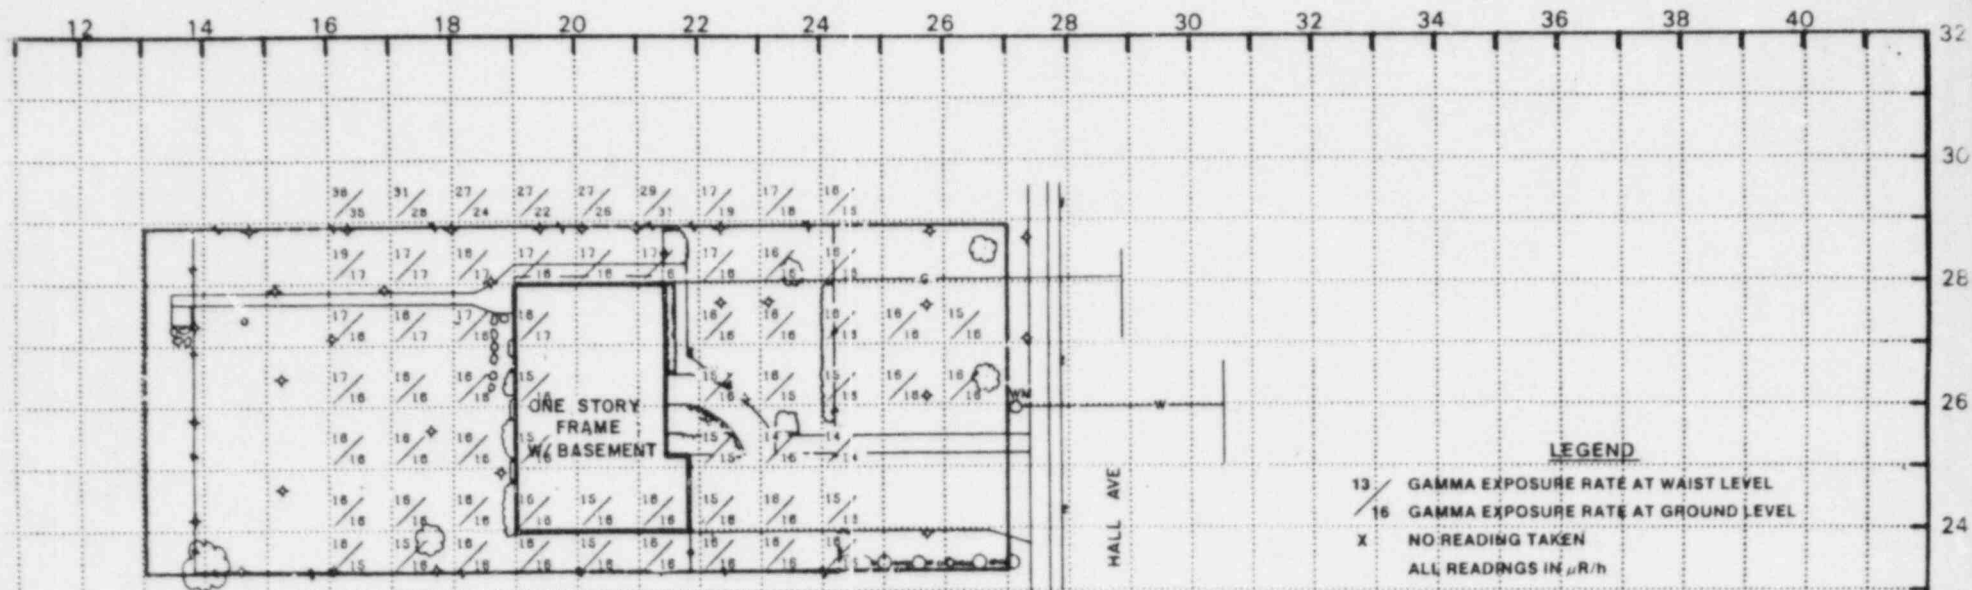
FIGURE 3.1  
 EXTERIOR GRID-POINT EXPOSURE RATES

Background Readings: 15 to 16 uR/h  
Highest Outside Gamma Reading (HOG): 94 uR/h

THE HOG IS LOCATED IN GRID BLOCK 140280  
 HOG =  $94 \mu R/h$

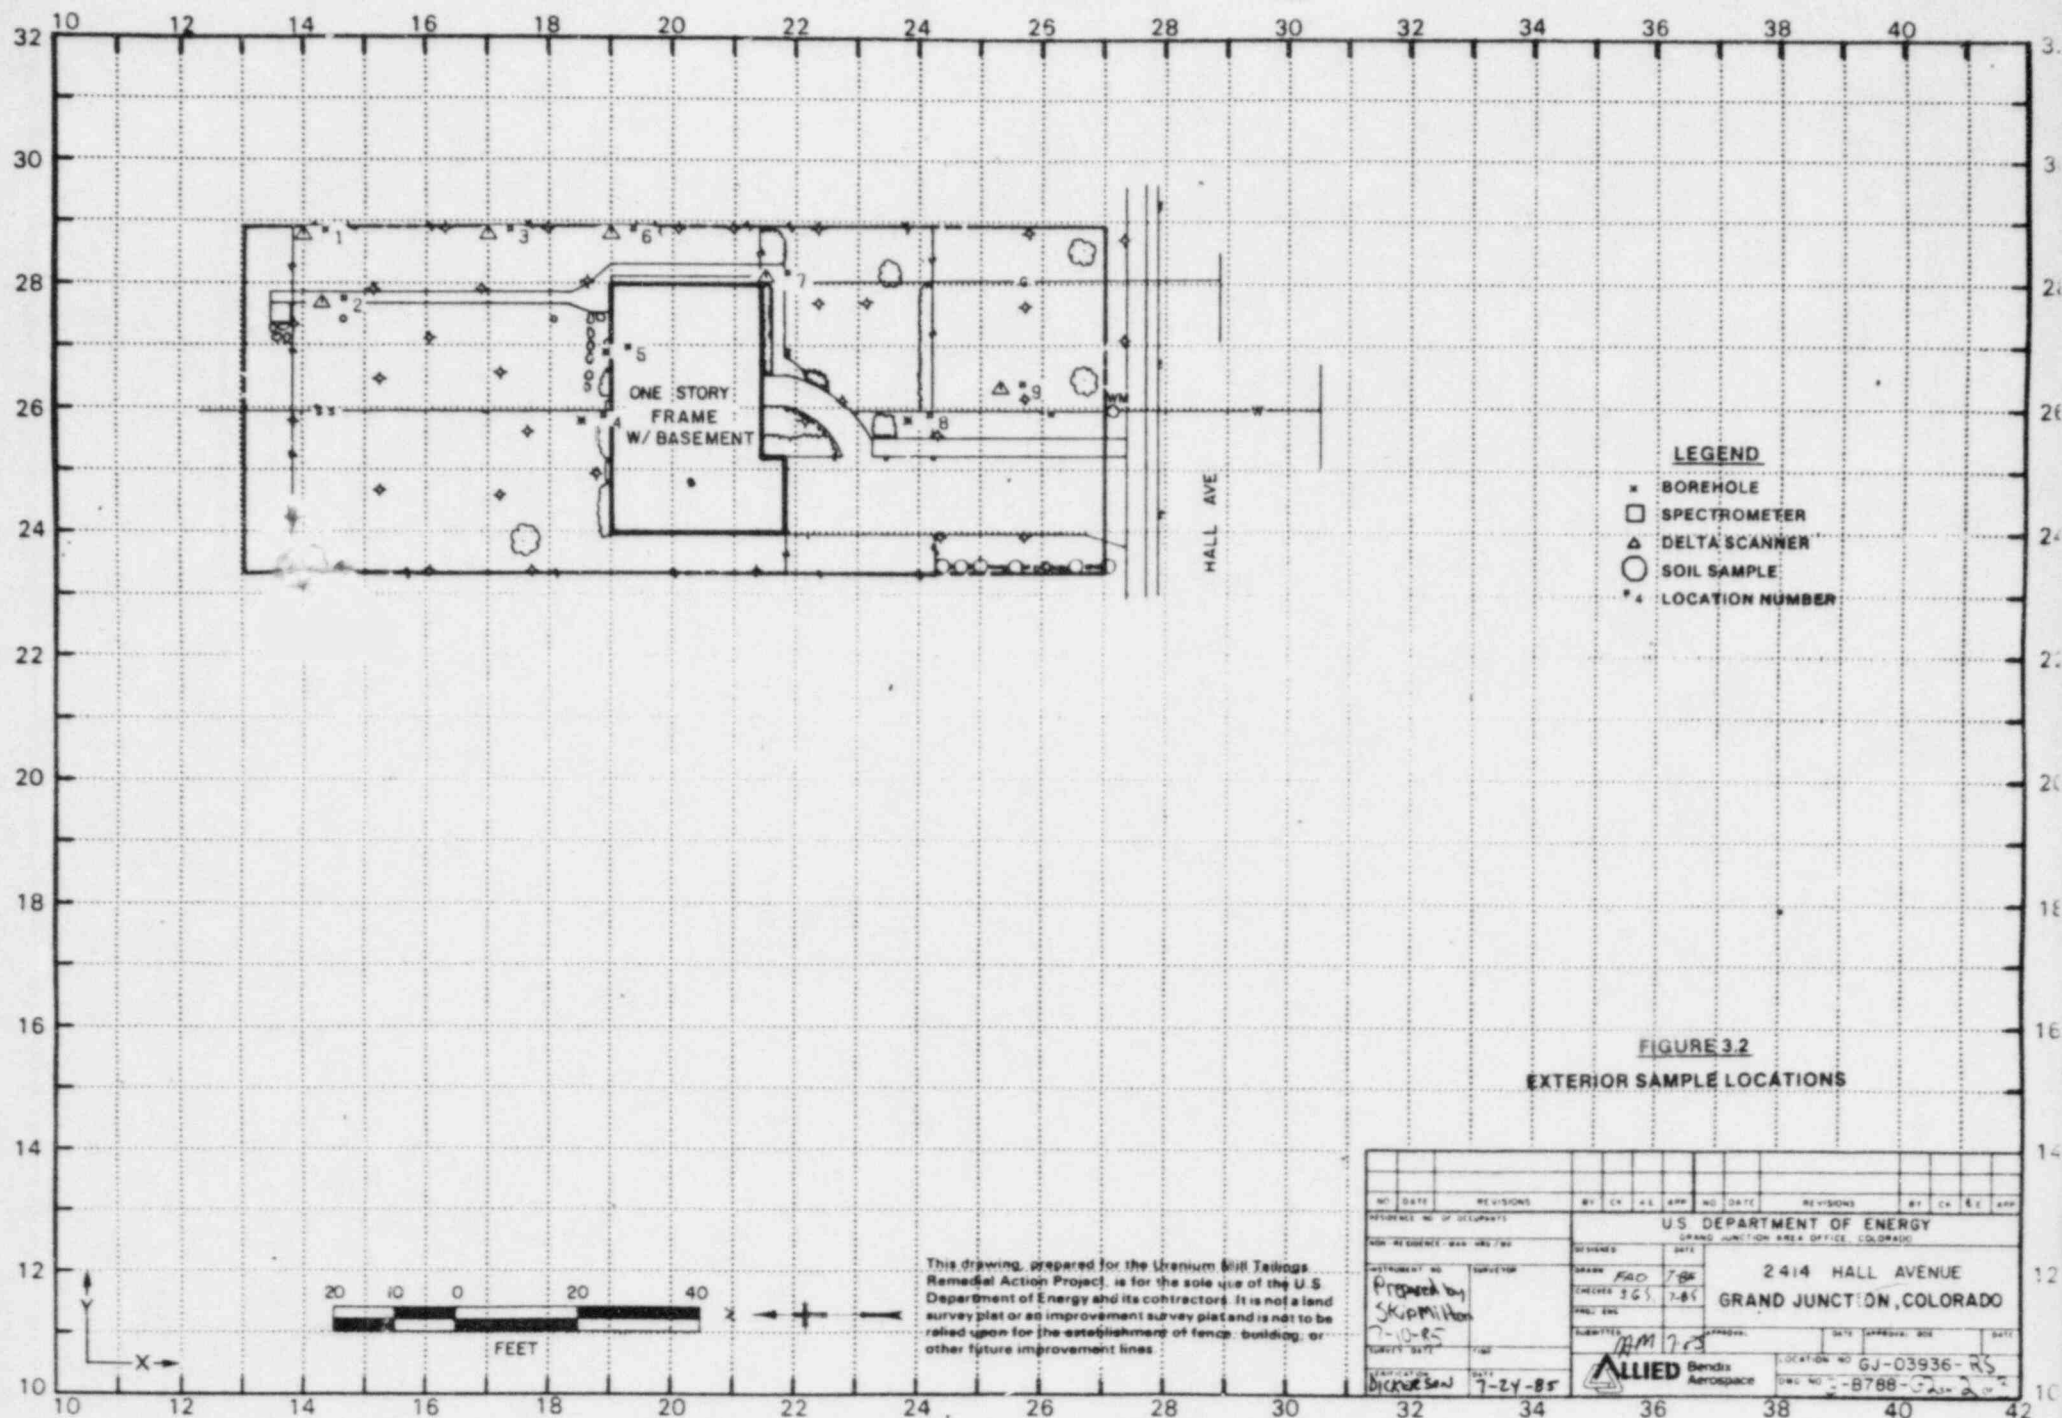
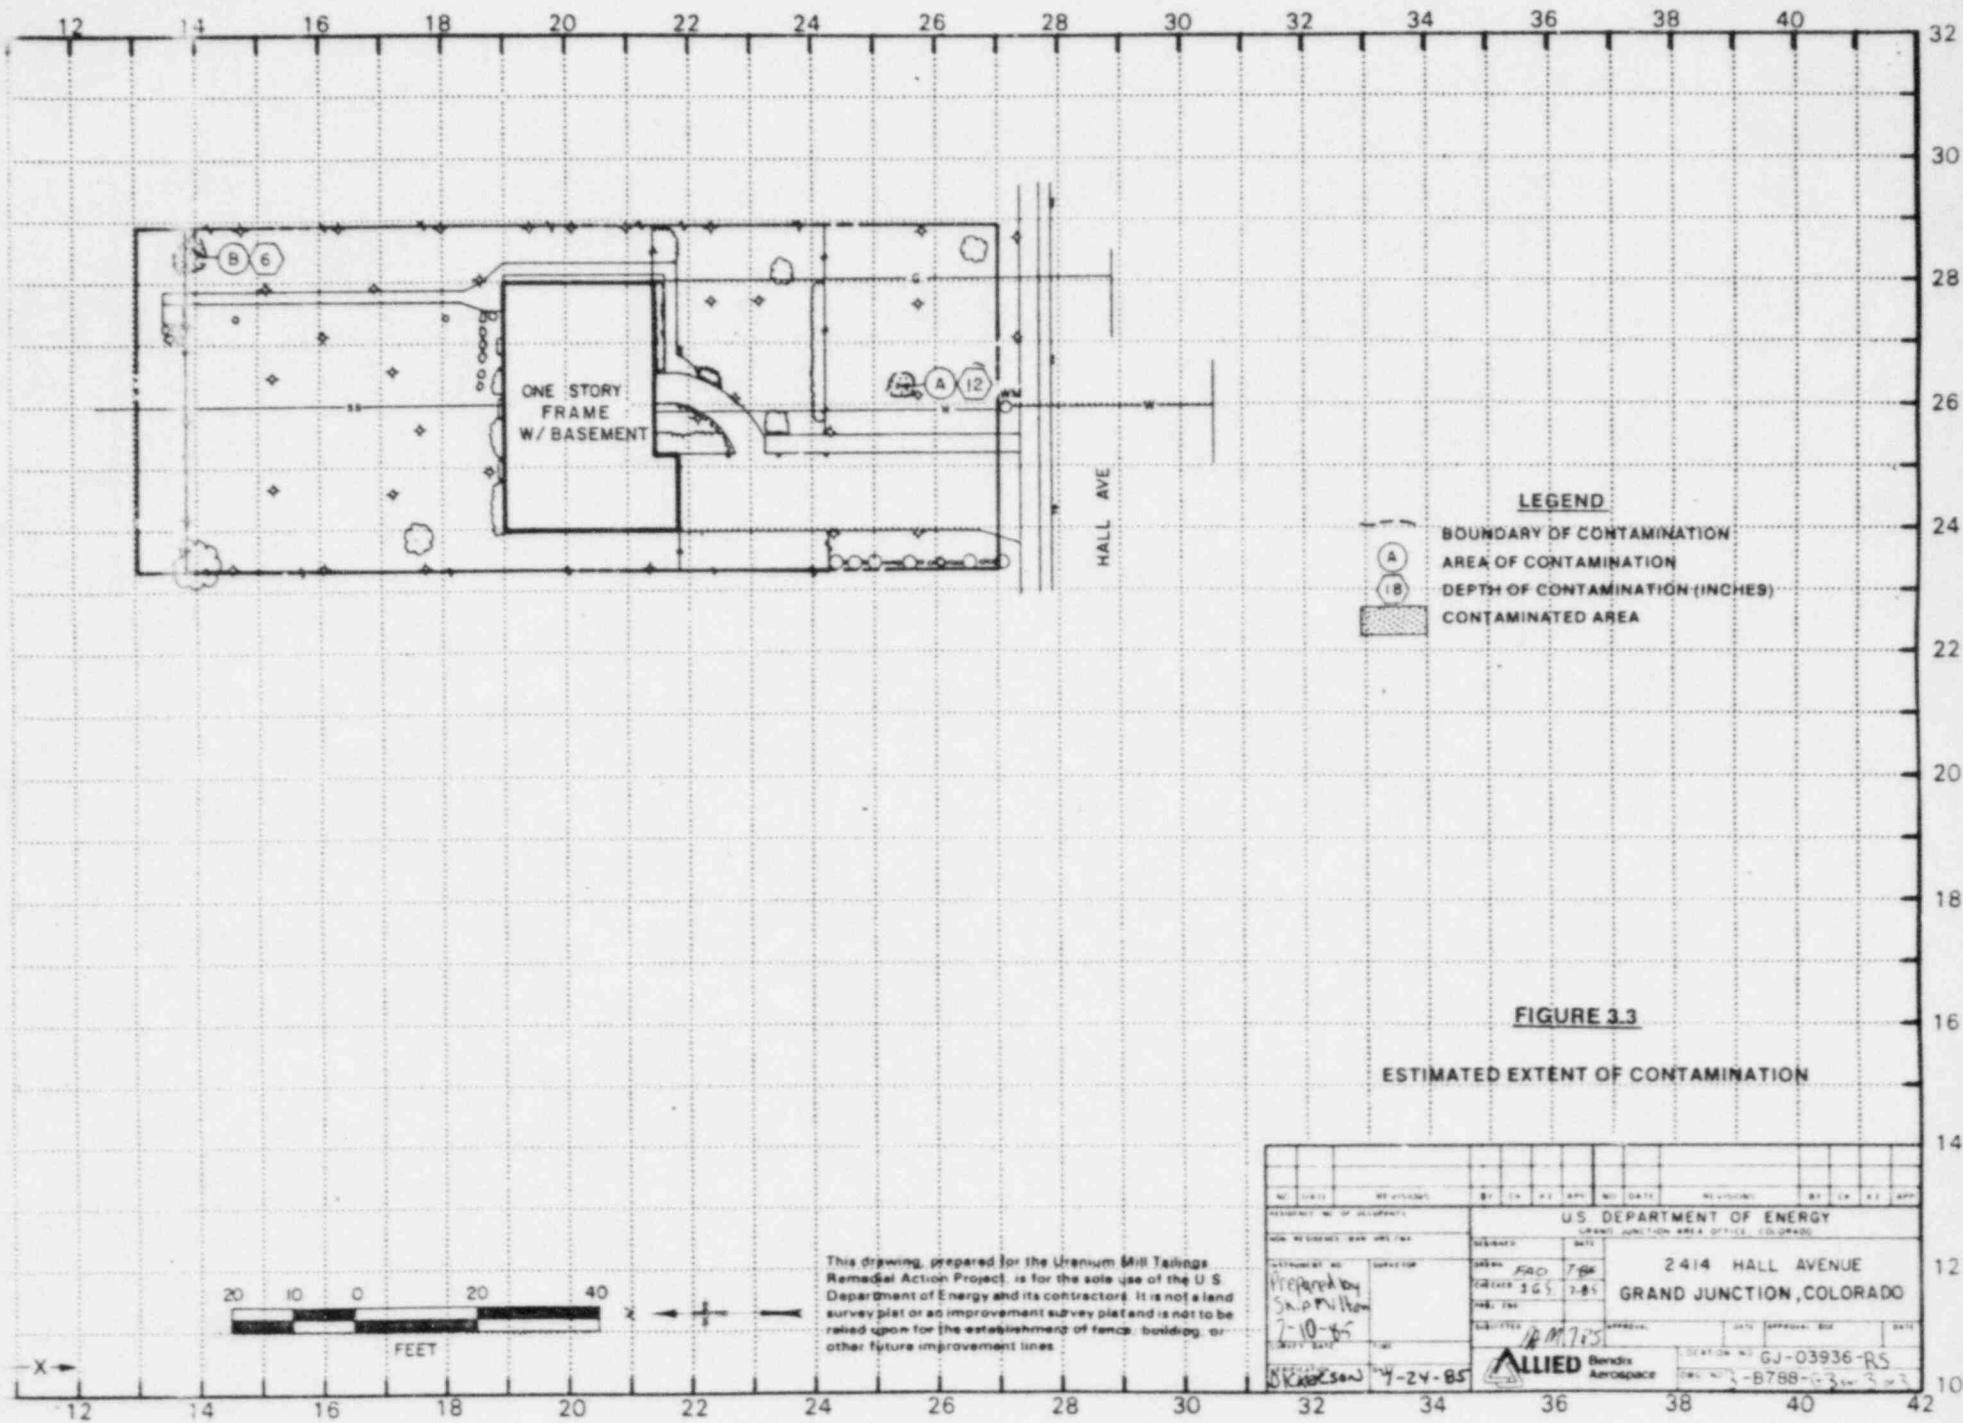
Appendix Figure 3.3 shows identified areas and estimated depths of contamination on this property, based on assessments of all measurements taken. As noted in this figure, areas that contain identified residual radioactive materials are:

- (Area A) Surface Material: Lawn  
Direction From Primary Structure: South  
Total Depth of Contamination: 12 inches  
Approximate Square Footage: 20
- (Area B) Surface Material: Lawn  
Direction From Primary Structure: North  
Total Depth of Contamination: 6 inches  
Approximate Square Footage: 30

We do not recommend decontamination and restoration of this property. It is recommended that no remedial action be performed and that a brief Property Completion Report be prepared for use in the DOE certification process.

The recommendation that no remedial action be performed on this property is made because the levels of radioactivity on this property fall below the EPA Standards (40 CFR 192) when averaged over 100 m<sup>2</sup>.

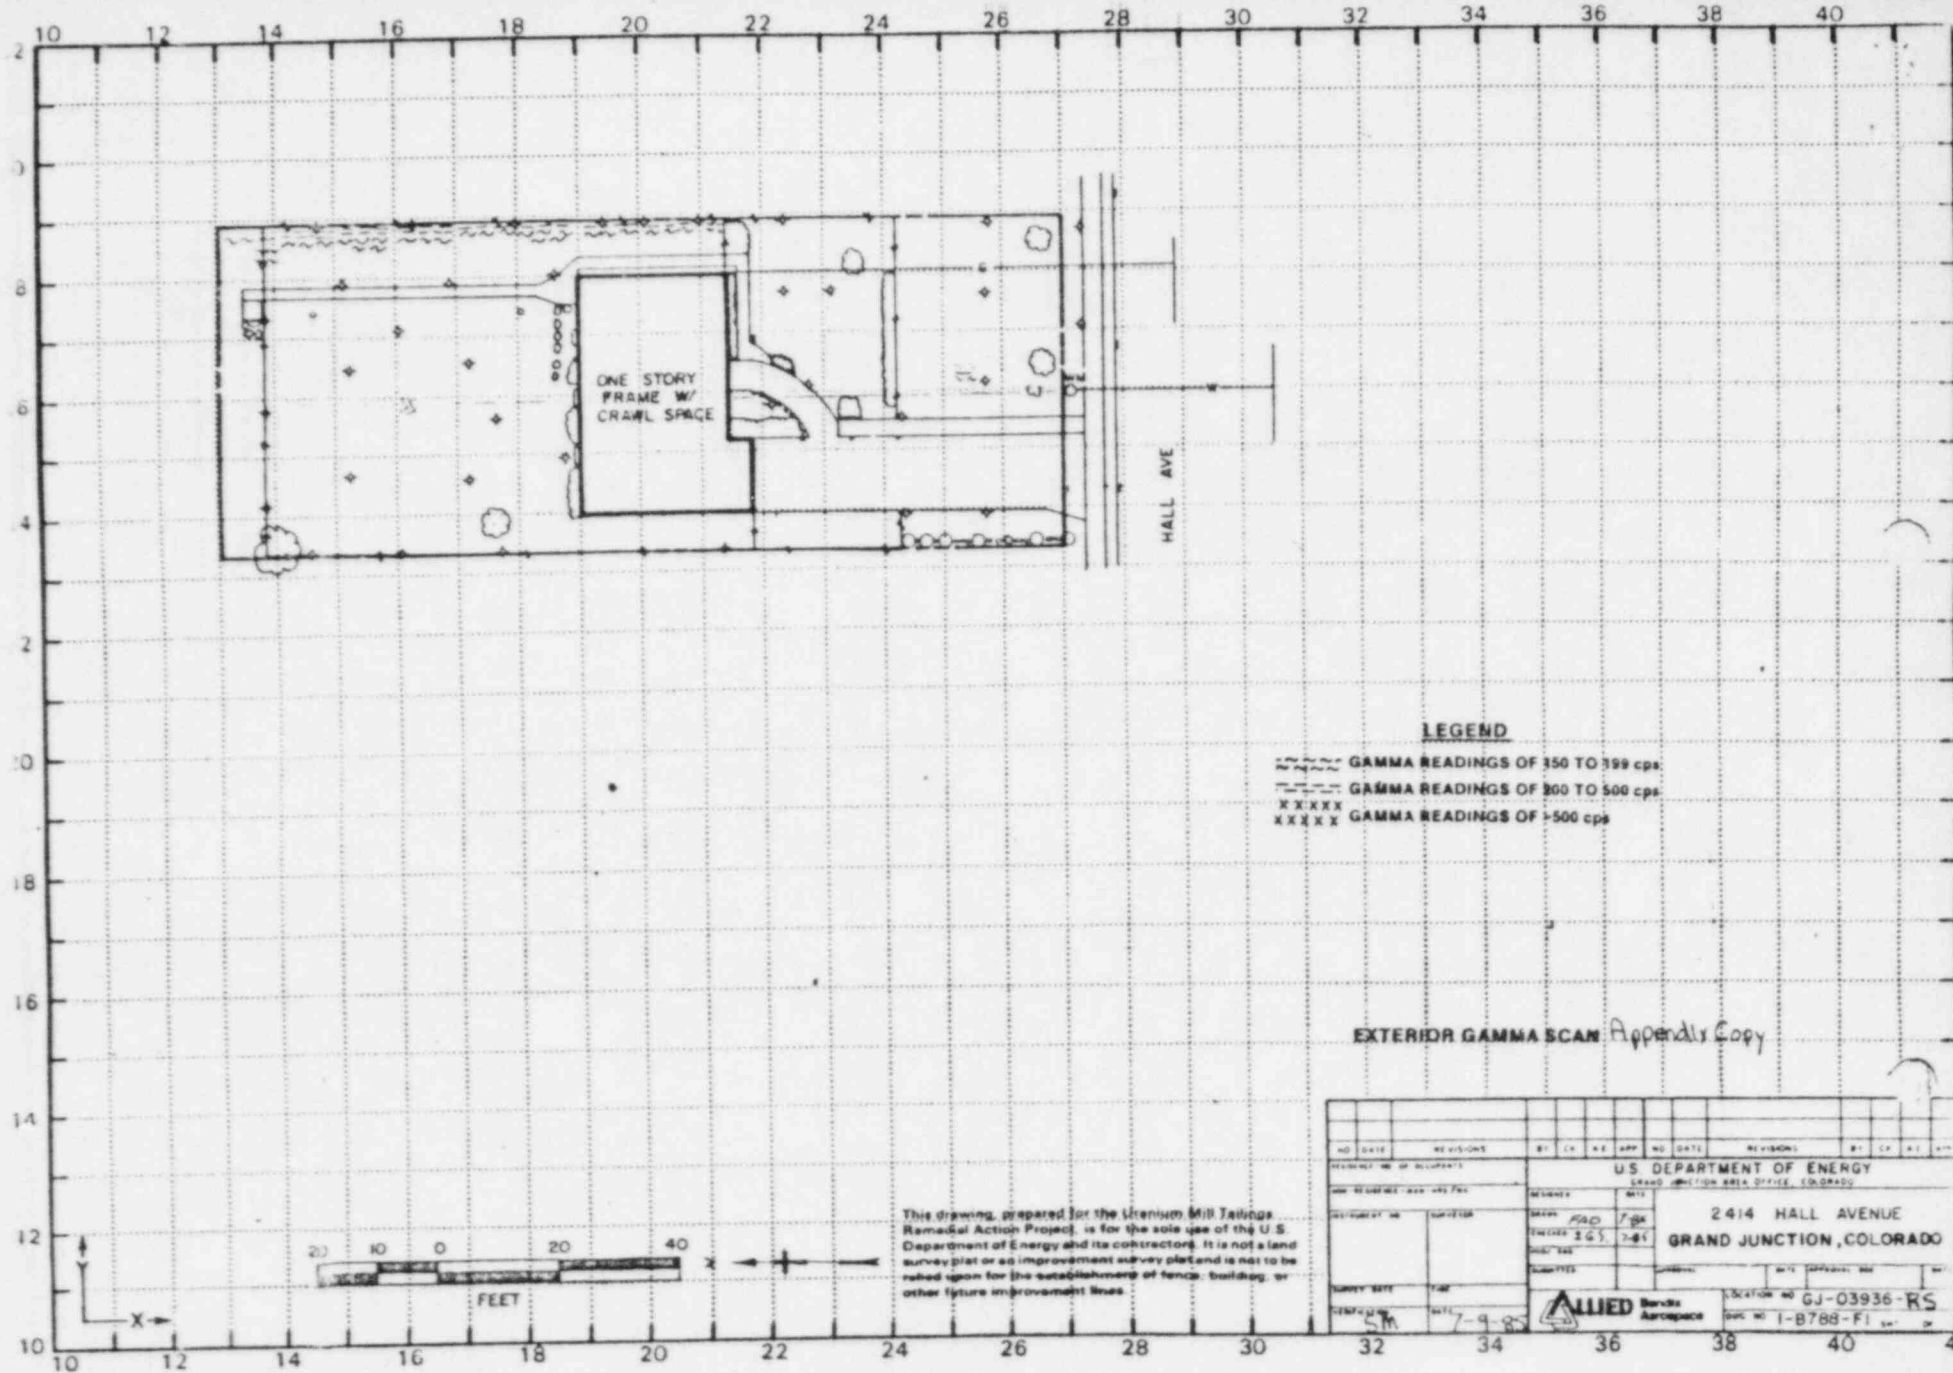
Exterior Gamma Scan Map

The exterior gamma scan showed elevated readings along the east property line. Deltas were performed in this area at 0- to 6-inches in depth. This proved that the elevated scan taken along the property line was probably due to "shine" from the adjacent property.
