**RADIOLOGIC AND ENGINEERING ASSESSMENT**

DOE ID NO.: GJ-03629-RM  
ADDRESS: 211 BELFORD AVENUE

AUGUST 1985

BENDIX FIELD ENGINEERING CORPORATION  
P.O. Box 1569  
Grand Junction, Colorado 81502

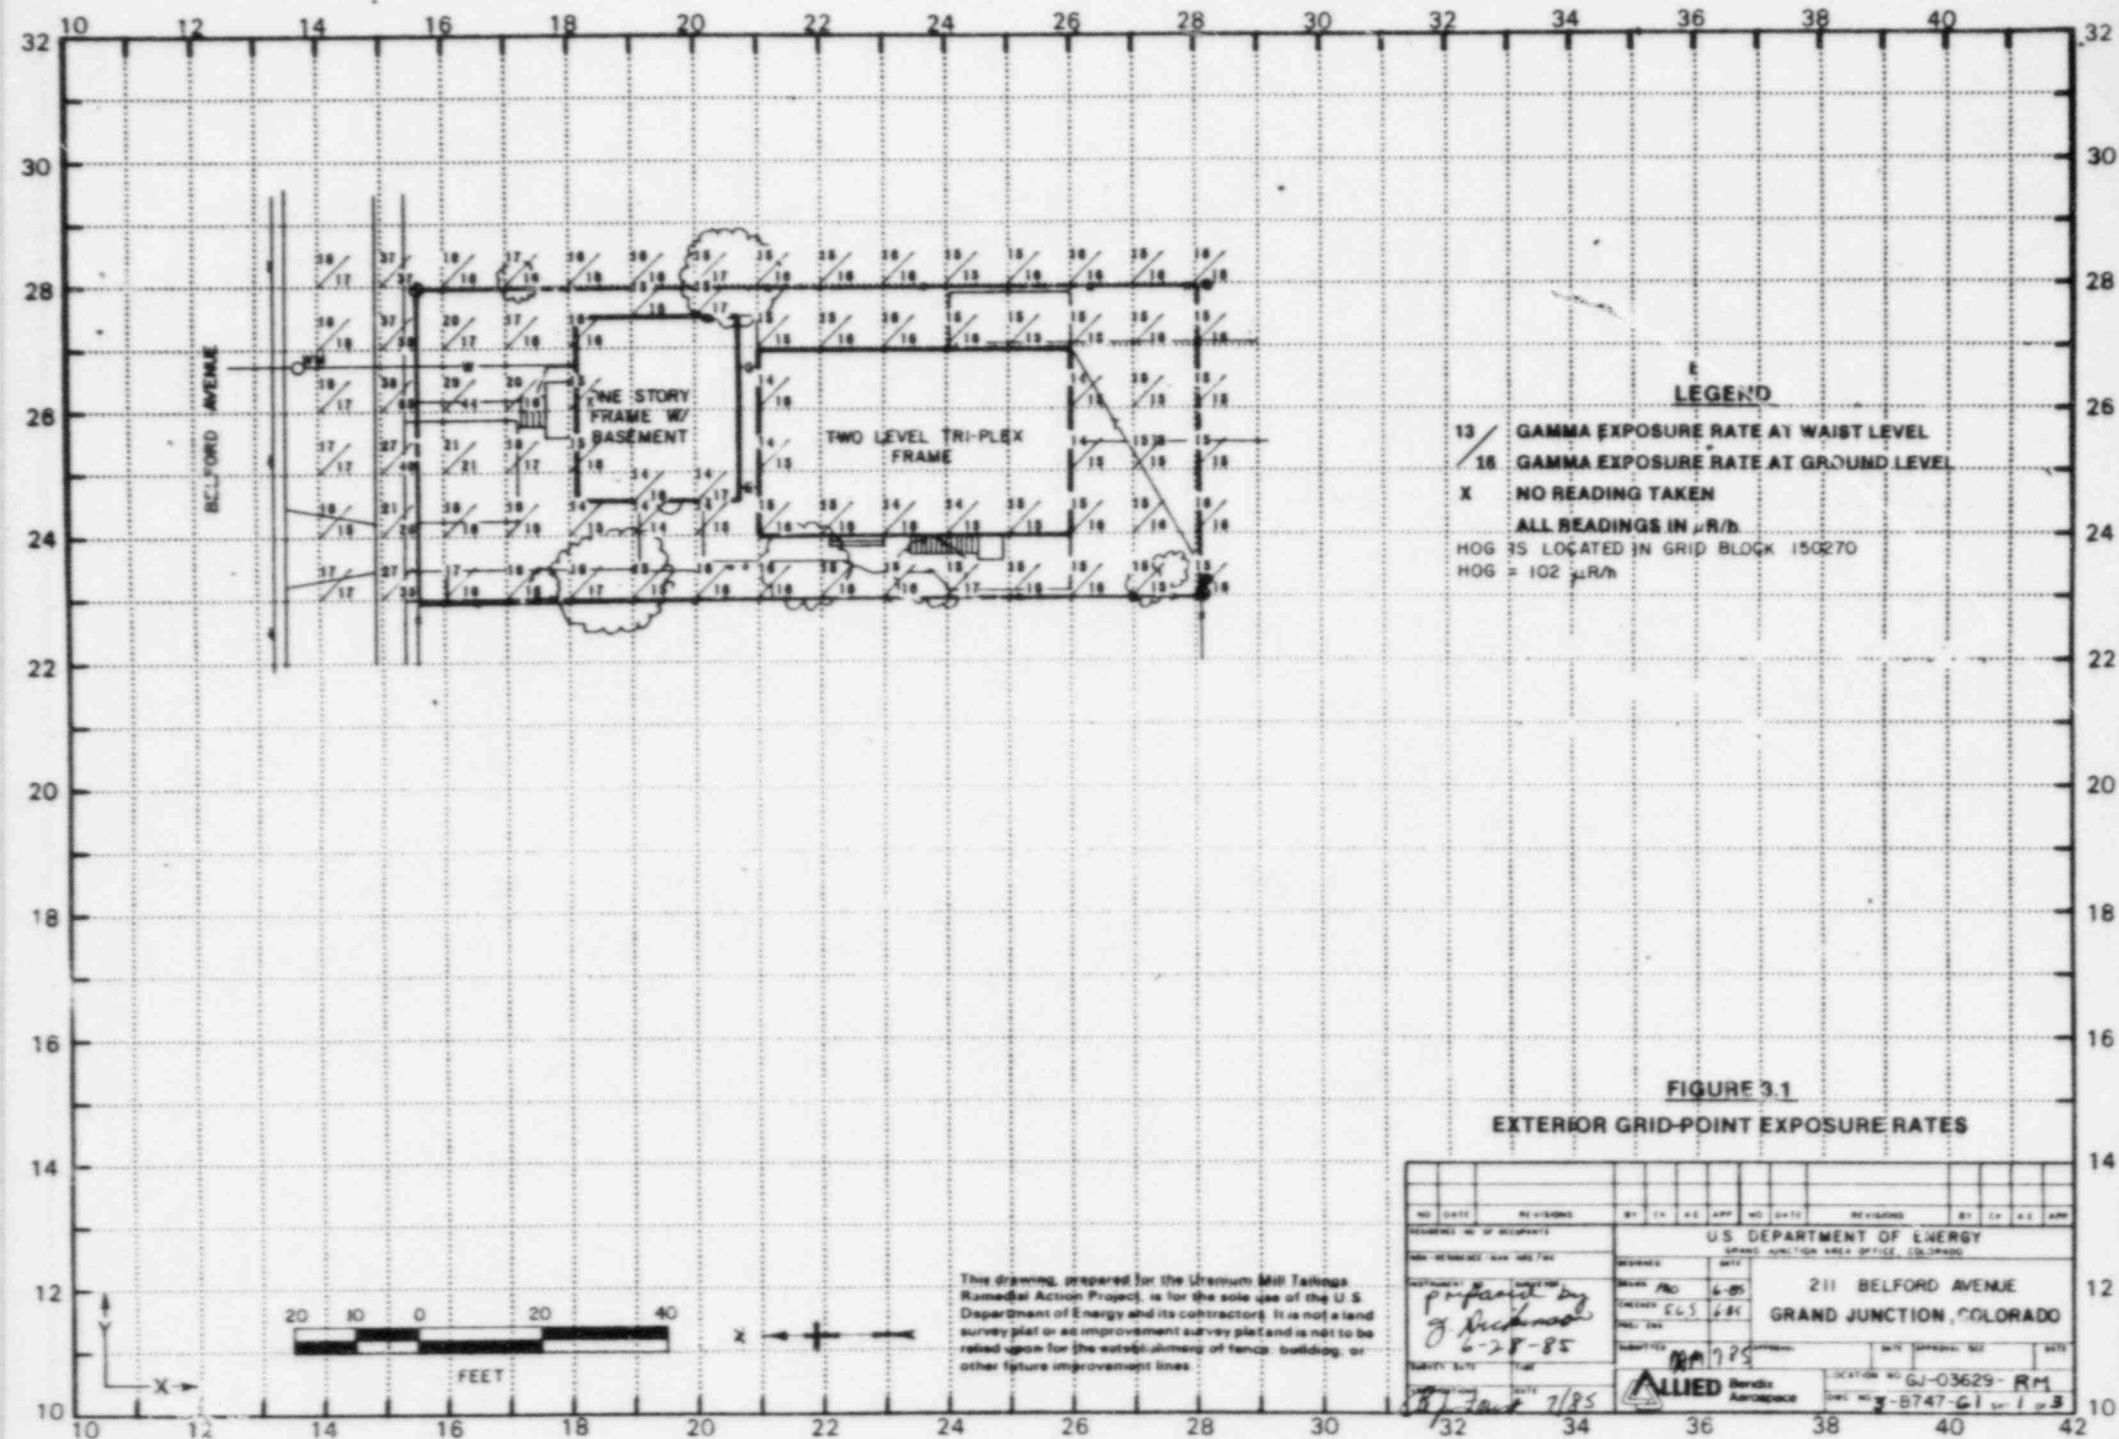
Exterior radium-concentration measurements are presented in Appendix Table 3.1. Grid-point survey results are shown in Appendix Figure 3.1.

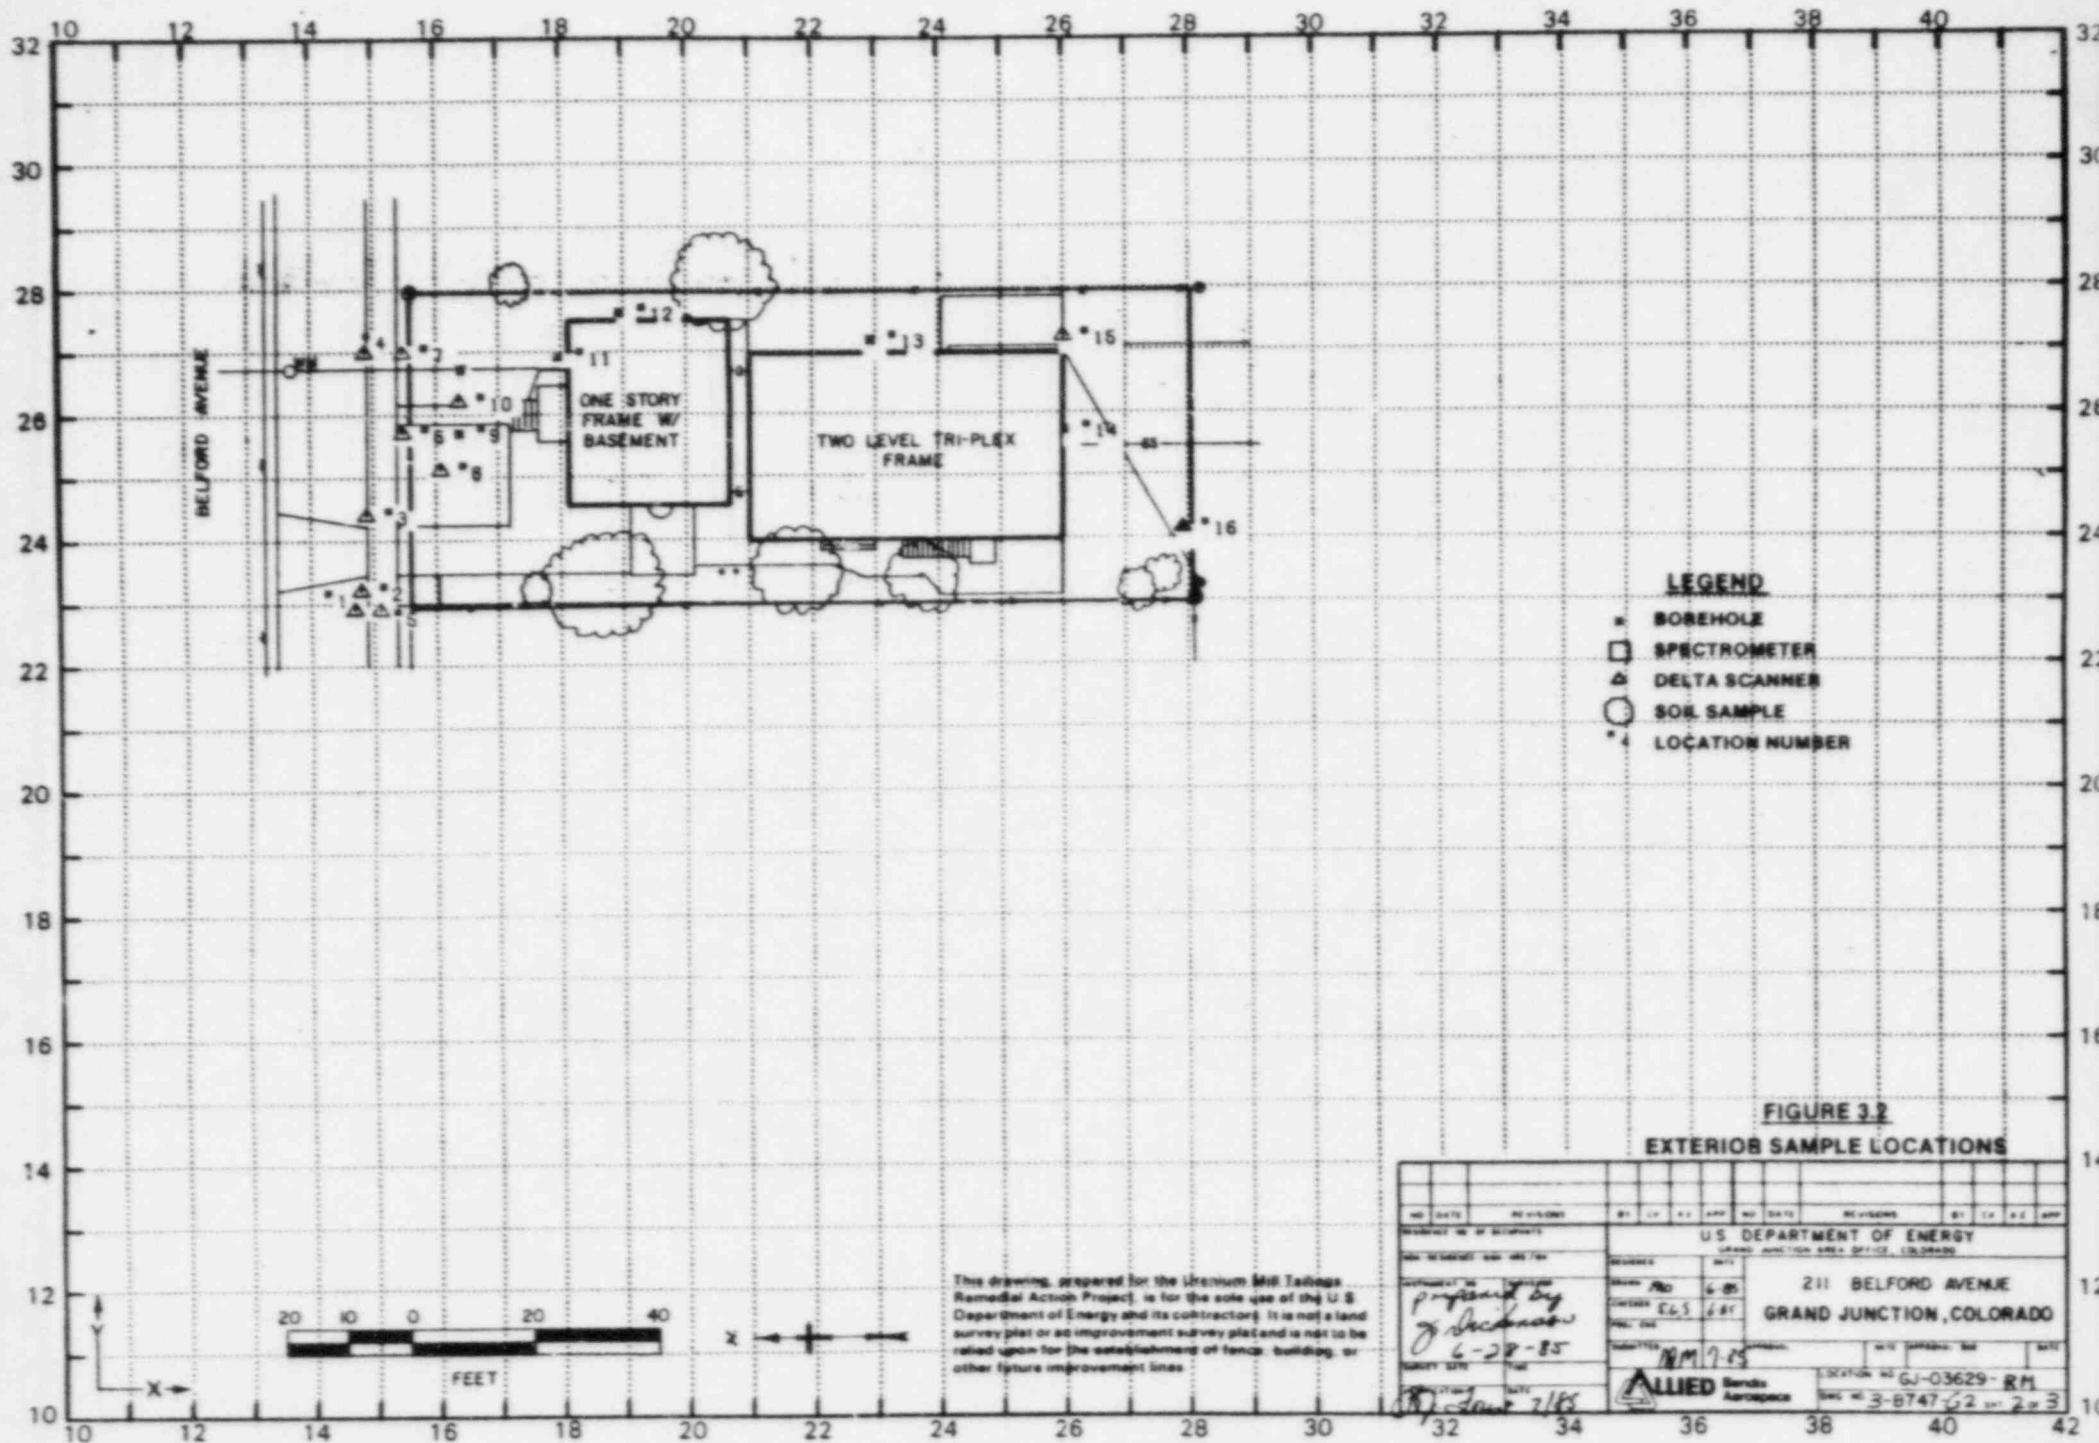
Areas which displayed elevated gamma levels were further investigated; these areas are shown in Appendix Figure 3.2. Data from these investigations are included in Appendix Table 3.1.

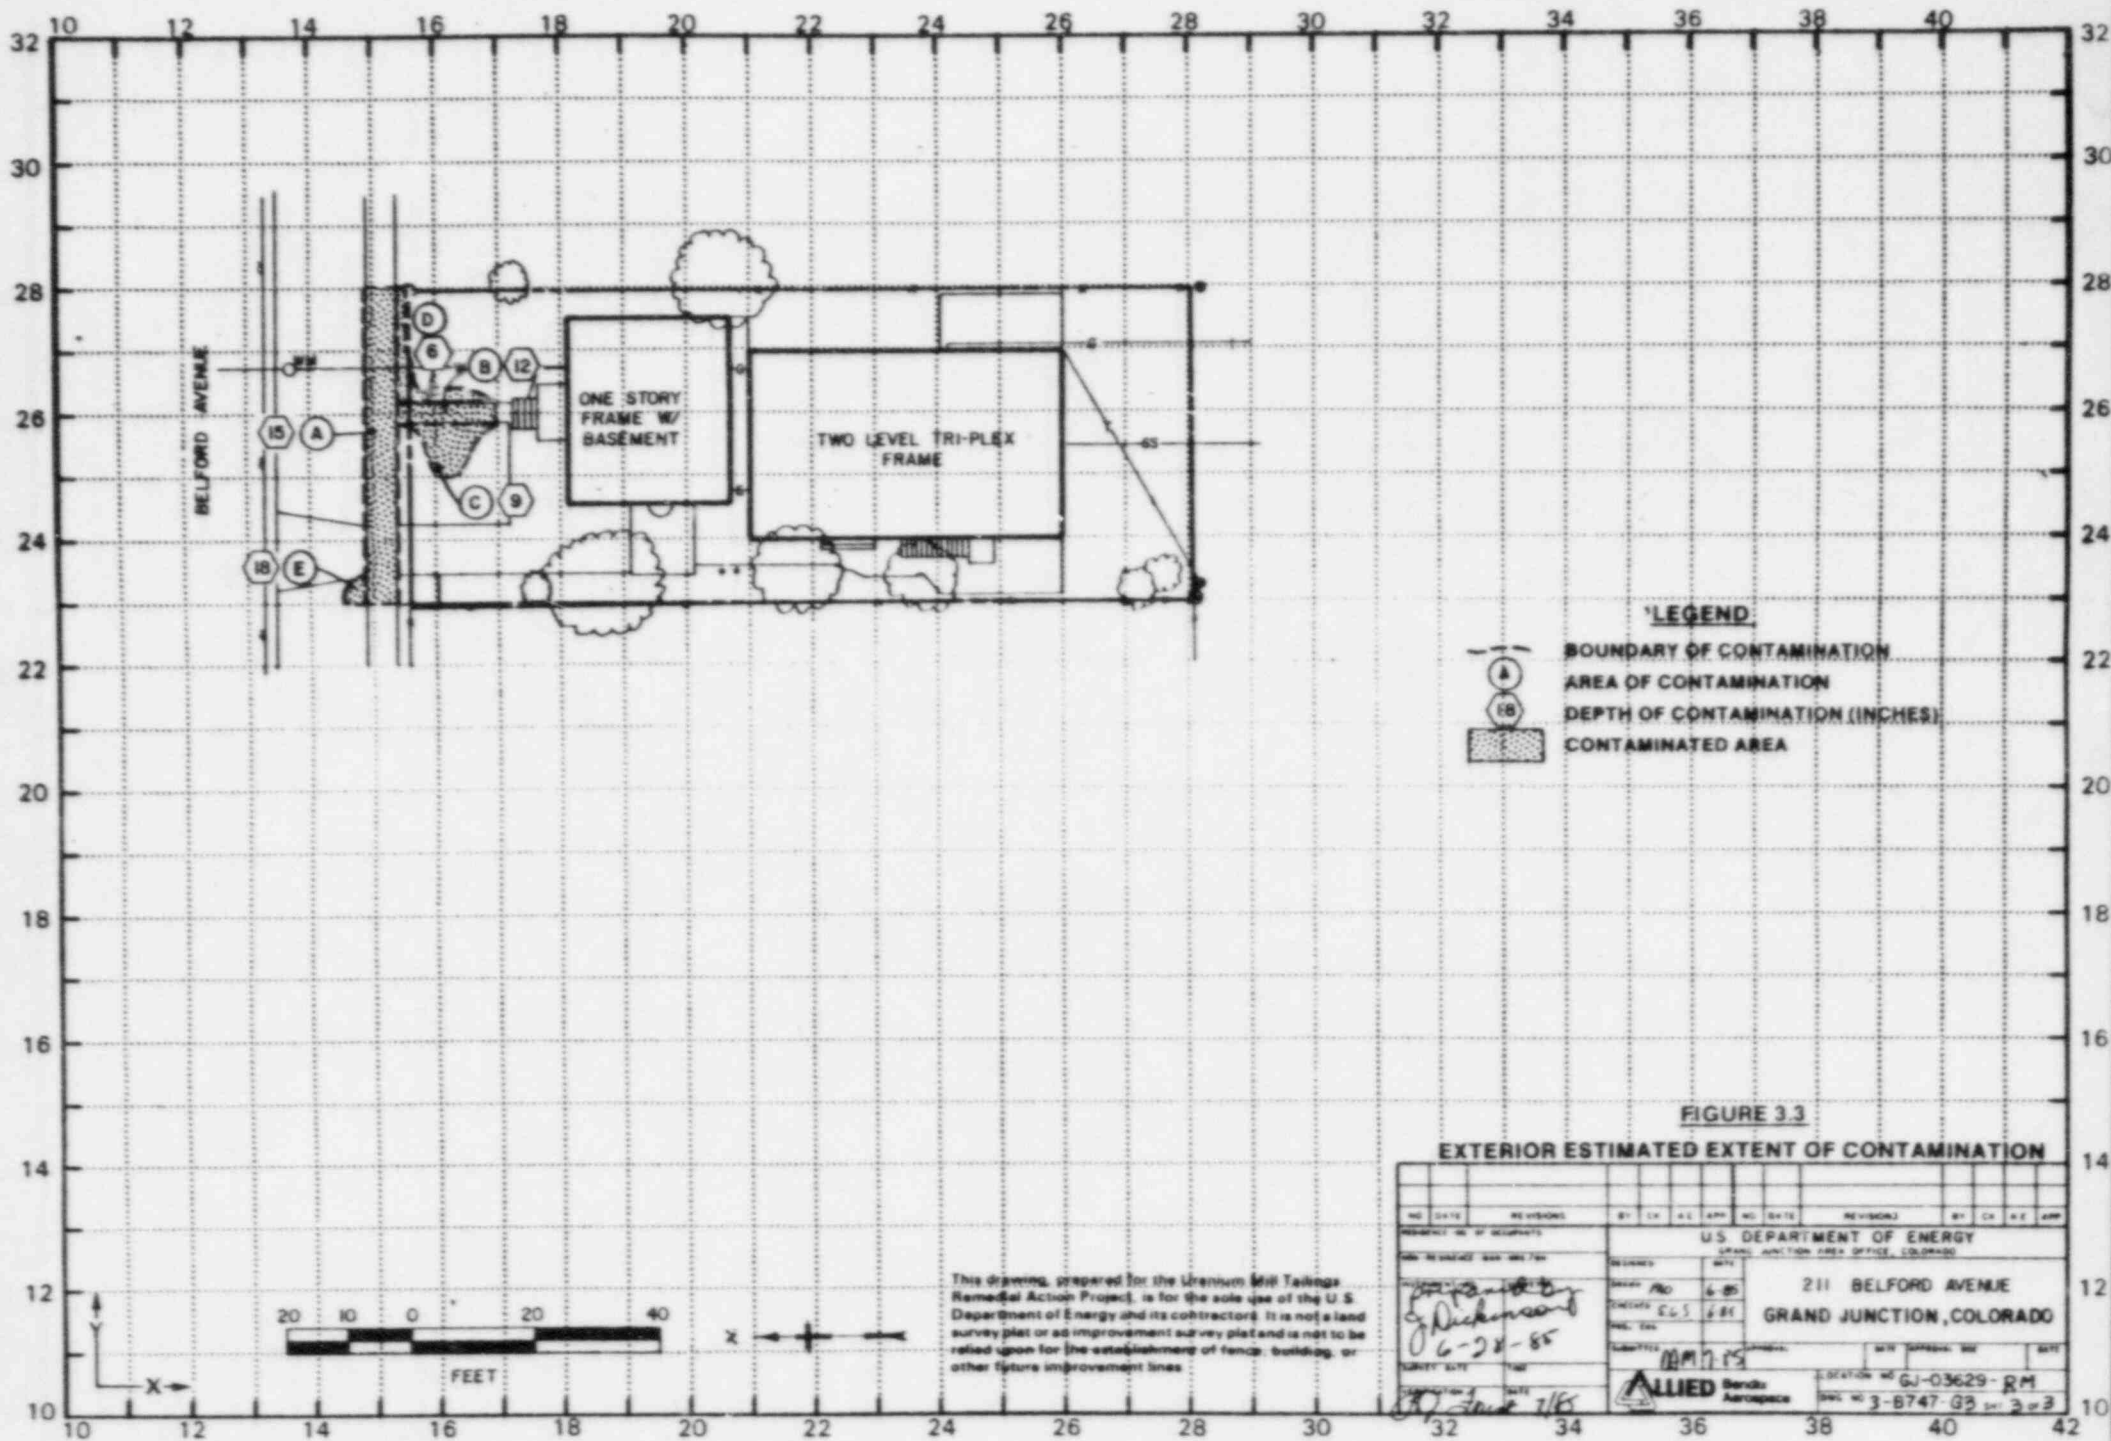
Appendix Figure 3.3 shows identified areas and estimated depths of contamination on this property, based on assessments of all measurements taken. As noted in this figure, areas recommended for remedial action that contain identified residual radioactive materials are:

- (Area A) Surface Material: Concrete  
Direction From Primary Structure: North  
Other Directions: On Belford Avenue easement  
Total Depth of Contamination: 15 inches  
Other (height or thickness): 4-inch-thick concrete  
Approximate Square Footage: 250

- (Area B) Surface Material: Concrete  
Direction From Primary Structure: North  
Total Depth of Contamination: 12 inches  
Other (height or thickness): 4-inch-thick concrete  
Approximate Square Footage: 48

- (Area C) Surface Material: Soil  
Direction From Primary Structure: North  
Other Directions: West of Area B  
Total Depth of Contamination: 9 inches  
Approximate Square Footage: 72

- (Area D) Surface Material: Weeds  
Direction From Primary Structure: North  
Other Directions: East of Area B  
Total Depth of Contamination: 6 inches  
Approximate Square Footage: 70

- (Area E) Surface Material: Weeds  
Direction From Primary Structure: Northwest  
Other Directions: North of Area A  
Total Depth of Contamination: 18 inches  
Approximate Square Footage: 9

The recommended remedial action for this property, DOE ID No. GJ-03629-RM, includes removal of all areas identified as containing radioactive material (as discussed in Section 3.5 and shown in Appendix Figure 3.3) and transport of removed material to the disposal site.

After remedial action is completed, the areas involved will be restored to original condition in accordance with the Bendix drawings, Vicinity Properties General Construction Specification (Bendix Field Engineering Corporation, 1984), and Statement of Work for Construction Subcontractor.

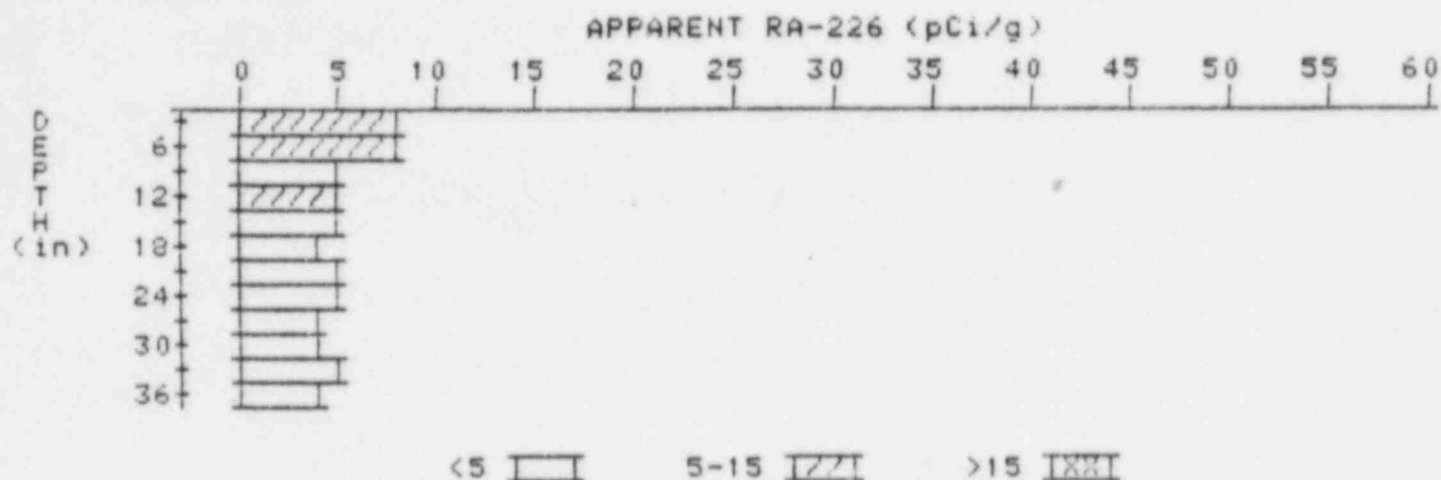
HOLE NUMBER: 9

Depth (in)	Apparent Radium-226 (pCi/g) Undeconvolved	Apparent Radium-226 (pCi/g) Deconvolved
3	8.1	8.1
6	7.2	7.7
9	6.0	4.9
12	5.4	5.0
15	5.0	4.8
18	4.7	4.3
21	4.6	4.6
24	4.5	4.5
27	4.4	4.4
30	4.3	4.1
33	4.3	4.7
36	4.1	4.1

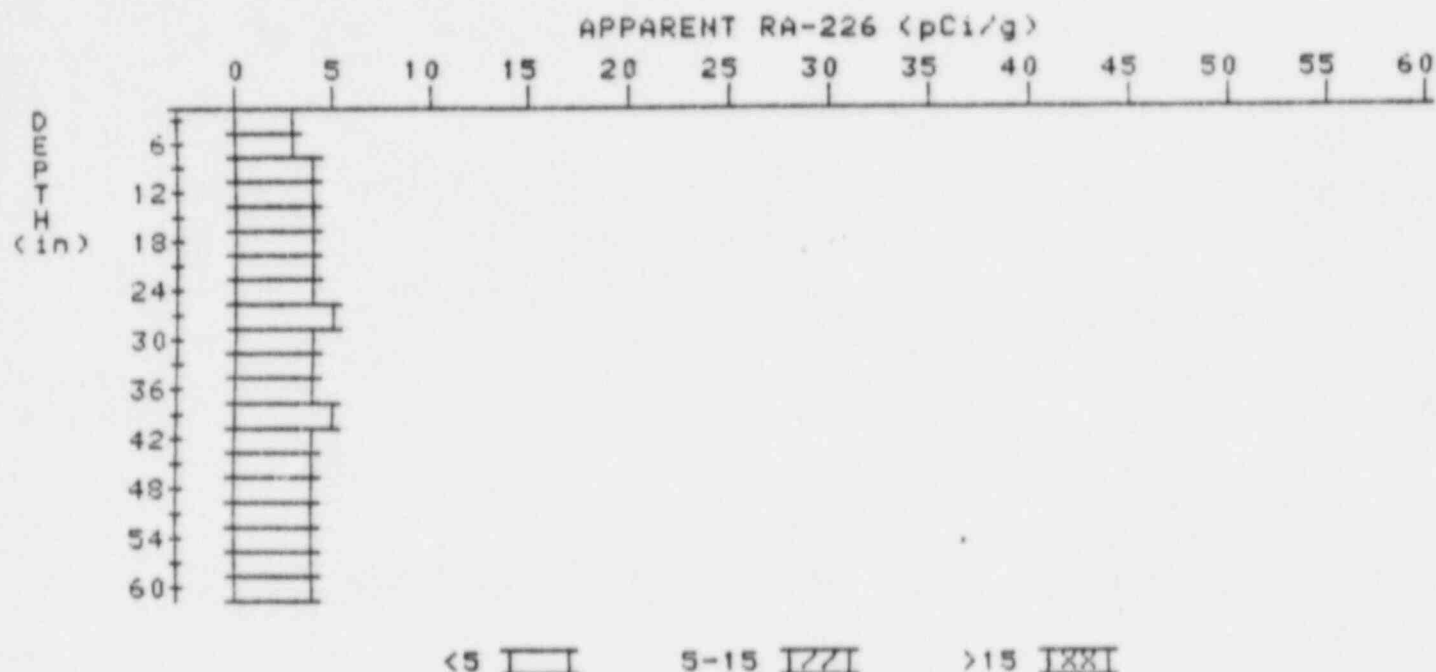
HOLE NUMBER: 11

Depth (in)	Apparent Radium-226 (pCi/g) Undeconvolved	Apparent Radium-226 (pCi/g) Deconvolved
3	3.4	3.4
6	3.6	3.4
9	3.9	4.3
12	4.0	4.2
15	4.0	4.0
18	4.0	4.0
21	4.0	3.8
24	4.1	4.1
27	4.2	4.6
30	4.1	3.7
33	4.2	4.4
36	4.2	4.2
39	4.2	4.6
42	4.0	3.6
45	4.0	4.2
48	3.9	3.7
51	3.9	4.1
54	3.8	3.6

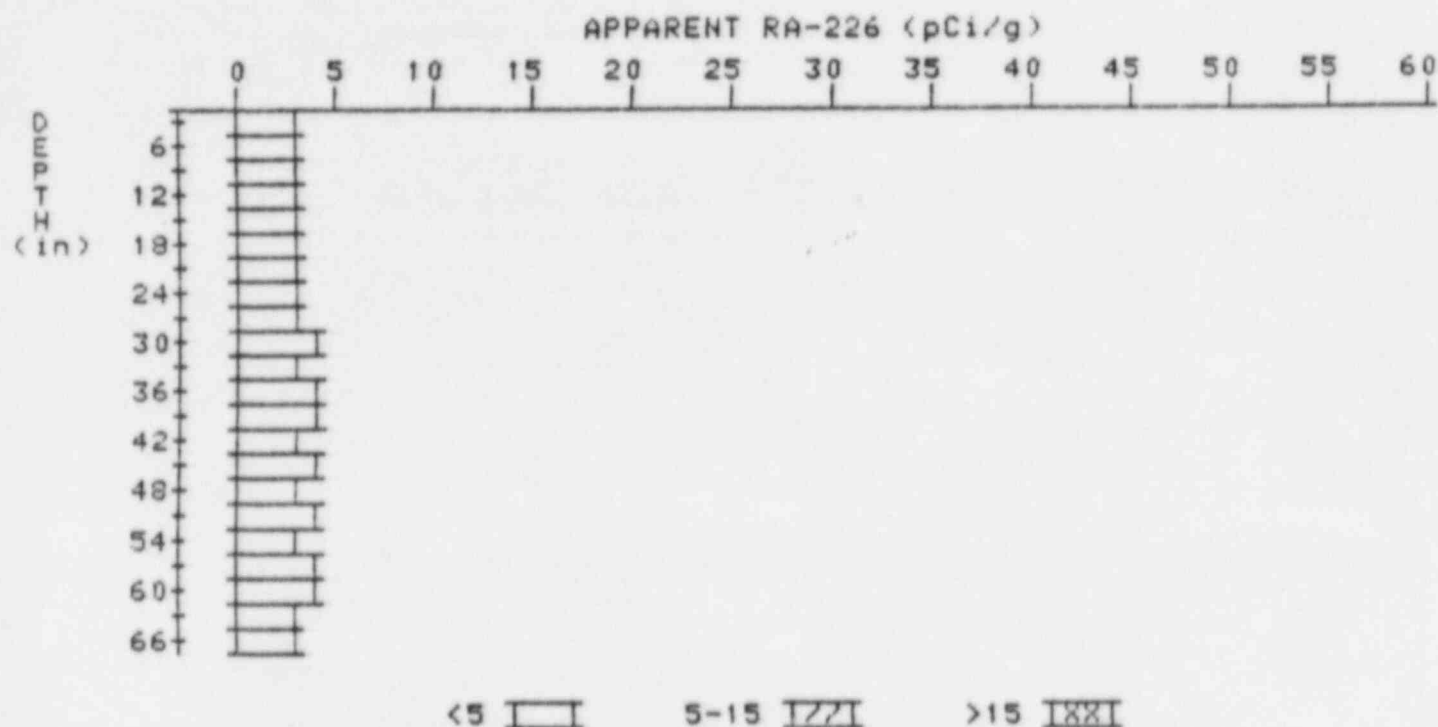
HOLE NUMBER: 12

Depth (in)	Apparent Radium-226 (pCi/g) Undeconvolved	Apparent Radium-226 (pCi/g) Deconvolved
3	2.5	2.5
6	2.8	2.8
9	3.1	3.5
12	3.2	3.2
15	3.3	3.5
18	3.3	3.3
21	3.3	3.5
24	3.2	2.8
27	3.3	3.3
30	3.4	3.8
33	3.3	2.9
36	3.4	3.6
39	3.4	3.6
42	3.3	2.9
45	3.4	3.6
48	3.4	3.2

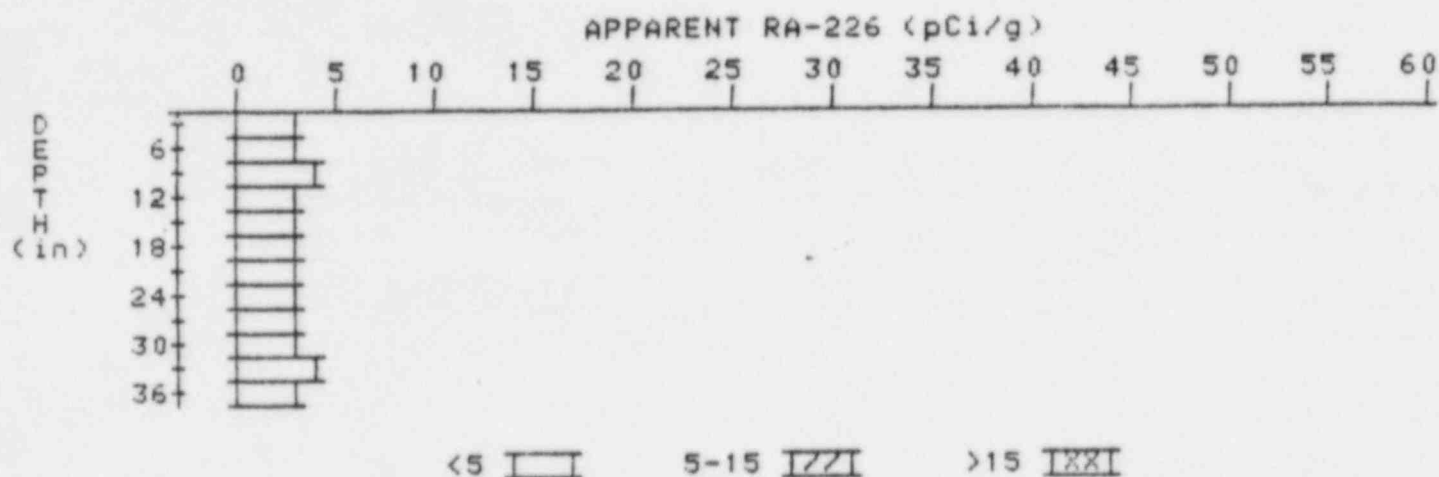
PROPERTY NUMBER: GJ-03629-RM  
HOLE NUMBER: 13  
LOCATION: 230271

Depth (in)	Apparent Radium-226 (pCi/g) Undeconvolved	Apparent Radium-226 (pCi/g) Deconvolved
3	2.6	2.6
6	2.9	2.9
9	3.2	3.7
12	3.2	3.2
15	3.2	3.2
18	3.2	3.2
21	3.2	3.0
24	3.3	3.5
27	3.3	3.5
30	3.2	2.7
33	3.4	3.8
36	3.4	3.4

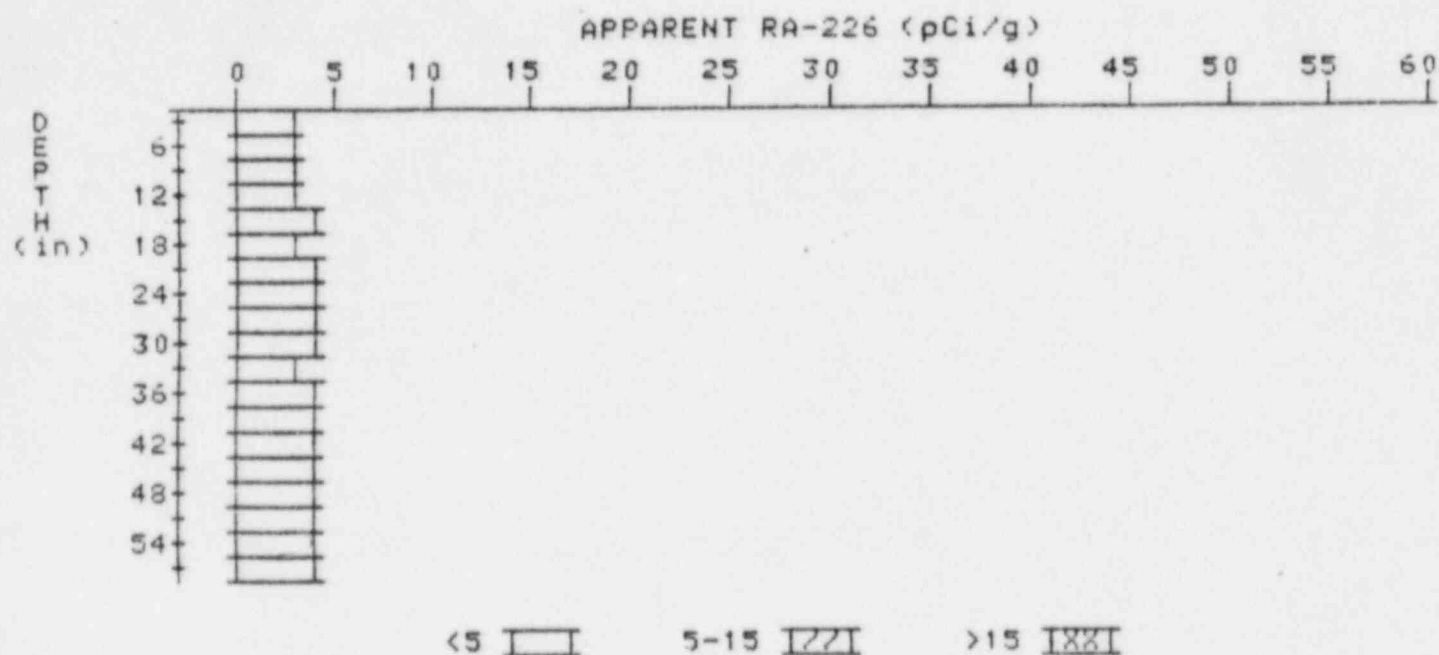
HOLE NUMBER: 14

Depth (in)	Apparent Radium-226 (pCi/g) Undeconvolved	Apparent Radium-226 (pCi/g) Deconvolved
3	2.5	2.5
6	2.9	3.3
9	3.1	3.1
12	3.3	3.5
15	3.4	3.6
18	3.4	3.2
21	3.5	3.5
24	3.6	3.8
27	3.6	3.6
30	3.6	3.6
33	3.6	3.4
36	3.7	3.9
39	3.7	3.5
42	3.8	4.0
45	3.8	3.8
48	3.8	3.8
51	3.8	4.0
54	3.7	3.5

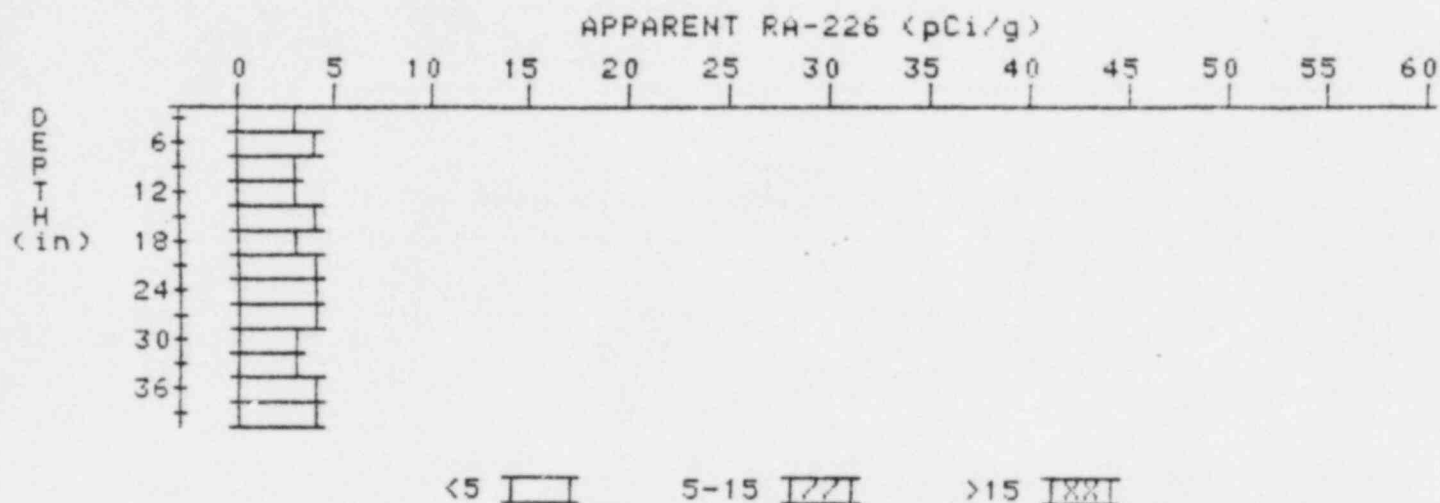
HOLE NUMBER: 16

Depth (in)	Apparent Radium-226 (pCi/g) Undeconvolved	Apparent Radium-226 (pCi/g) Deconvolved
3	2.6	2.6
6	3.1	3.6
9	3.3	3.5
12	3.4	3.4
15	3.5	3.7
18	3.5	3.3
21	3.6	3.8
24	3.6	3.6
27	3.6	3.8
30	3.5	3.3
33	3.5	3.3
36	3.6	4.0
39	3.5	3.5
