RADIOLOGIC AND ENGINEERING ASSESSMENT

DOE ID NO.: GJ-00599-RS
ADDRESS: 1944 NORTH 22ND STREET

AUGUST 1985

URANIUM MILL TAILINGS REMEDIAL ACTION PROJECT OFFICE

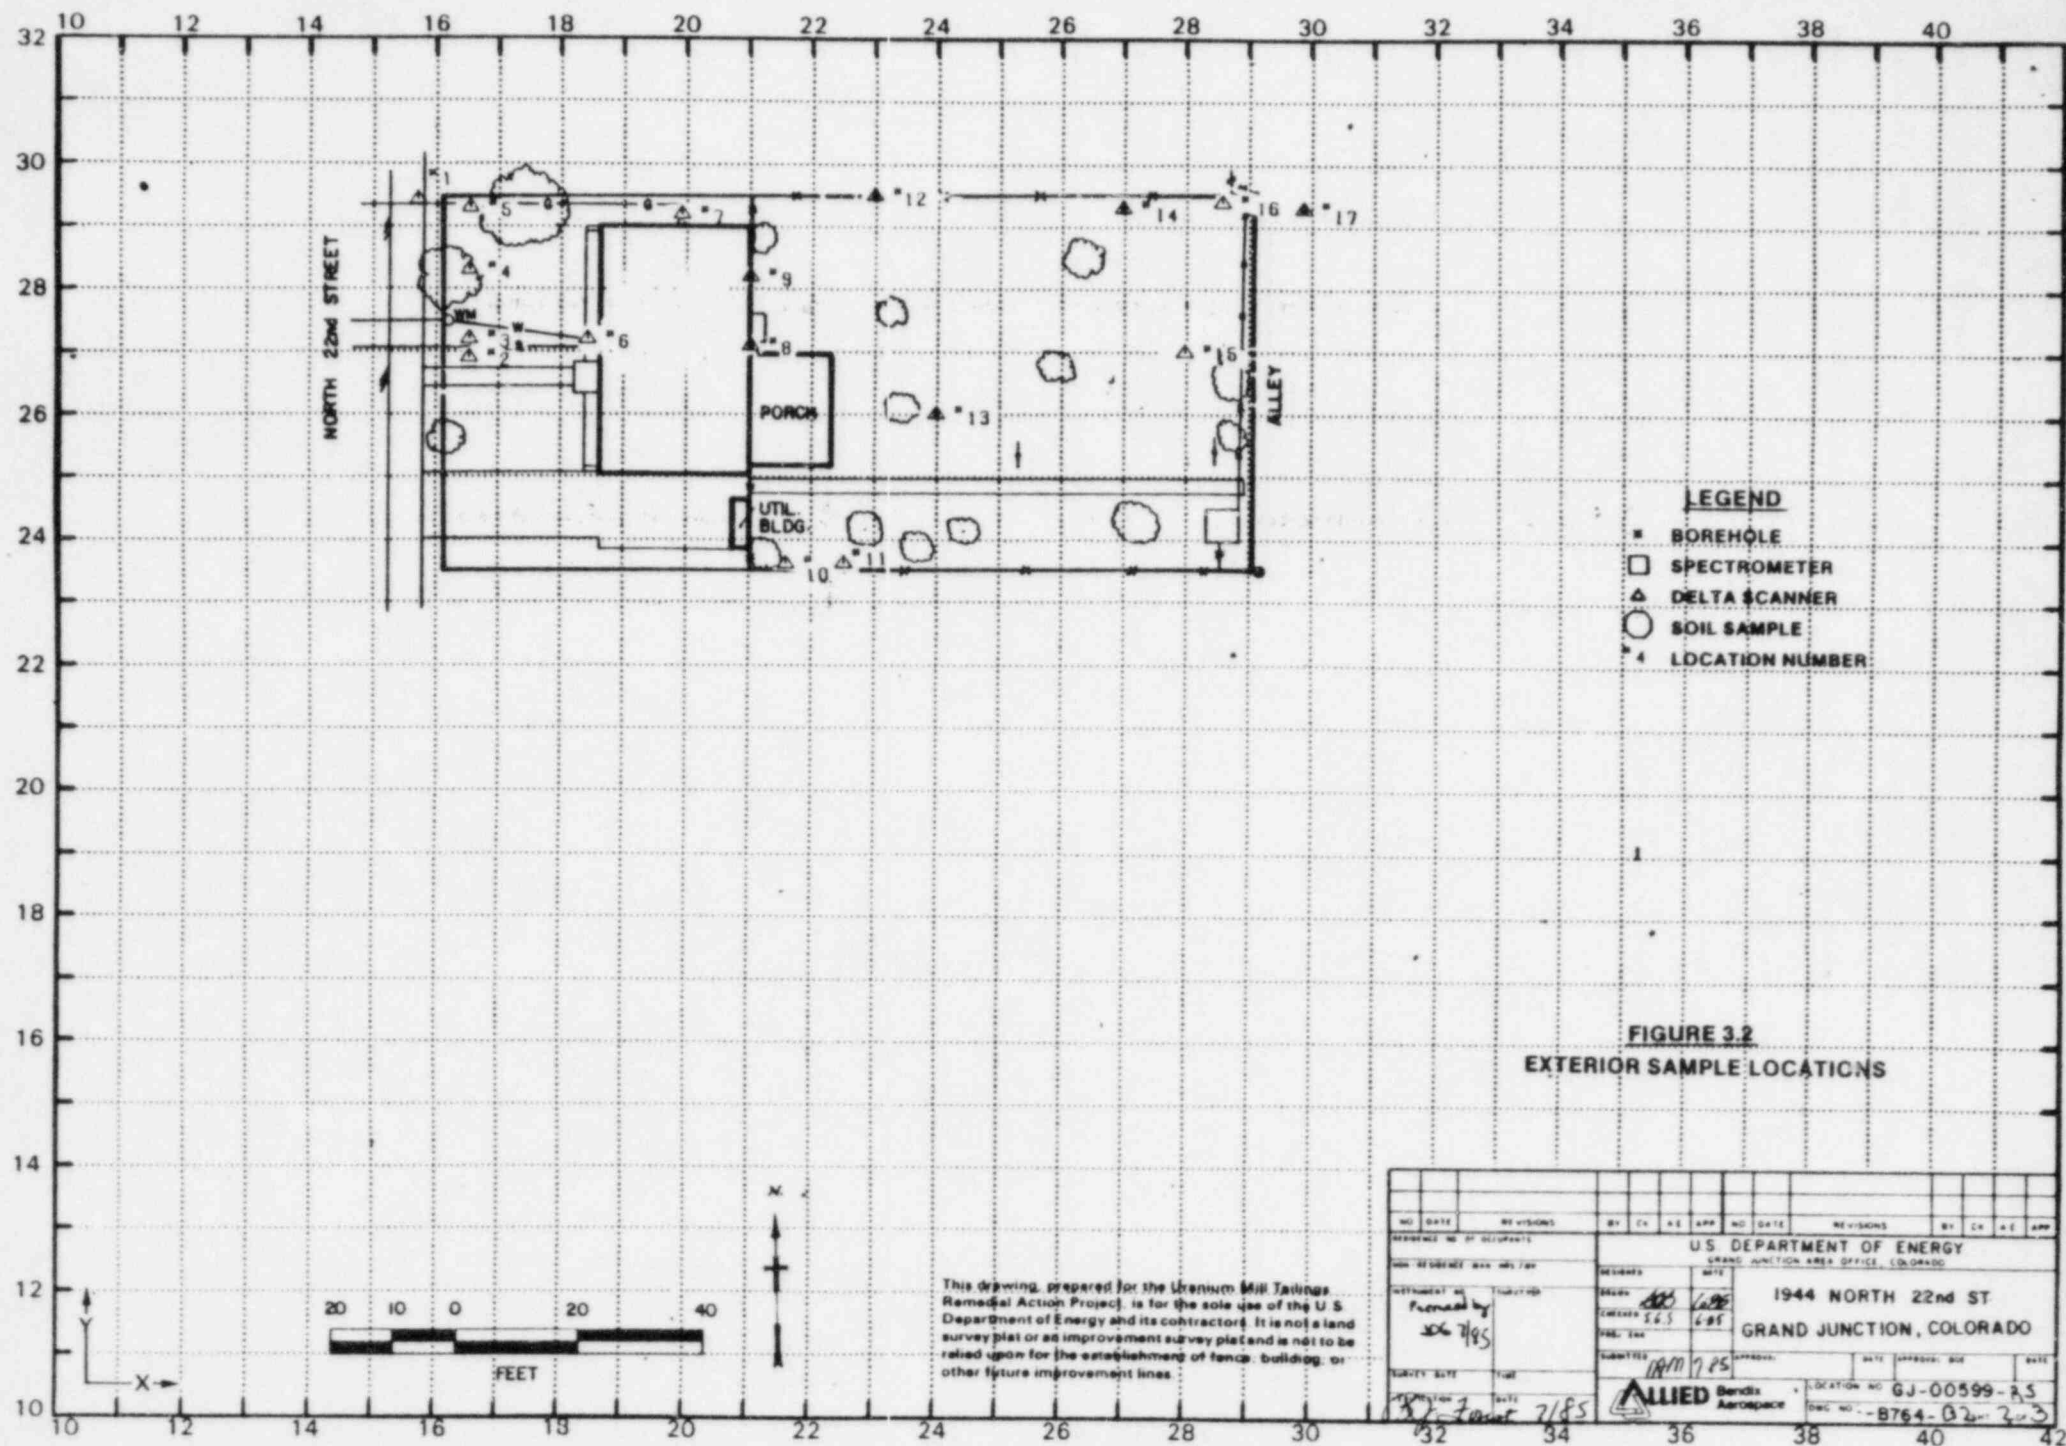
FIGURE 3.2
EXTERIOR SAMPLE LOCATIONS

Areas which displayed elevated gamma levels were further investigated; these areas are shown in Appendix Figure 3.2. Data from these investigations are included in Appendix Table 3.1.

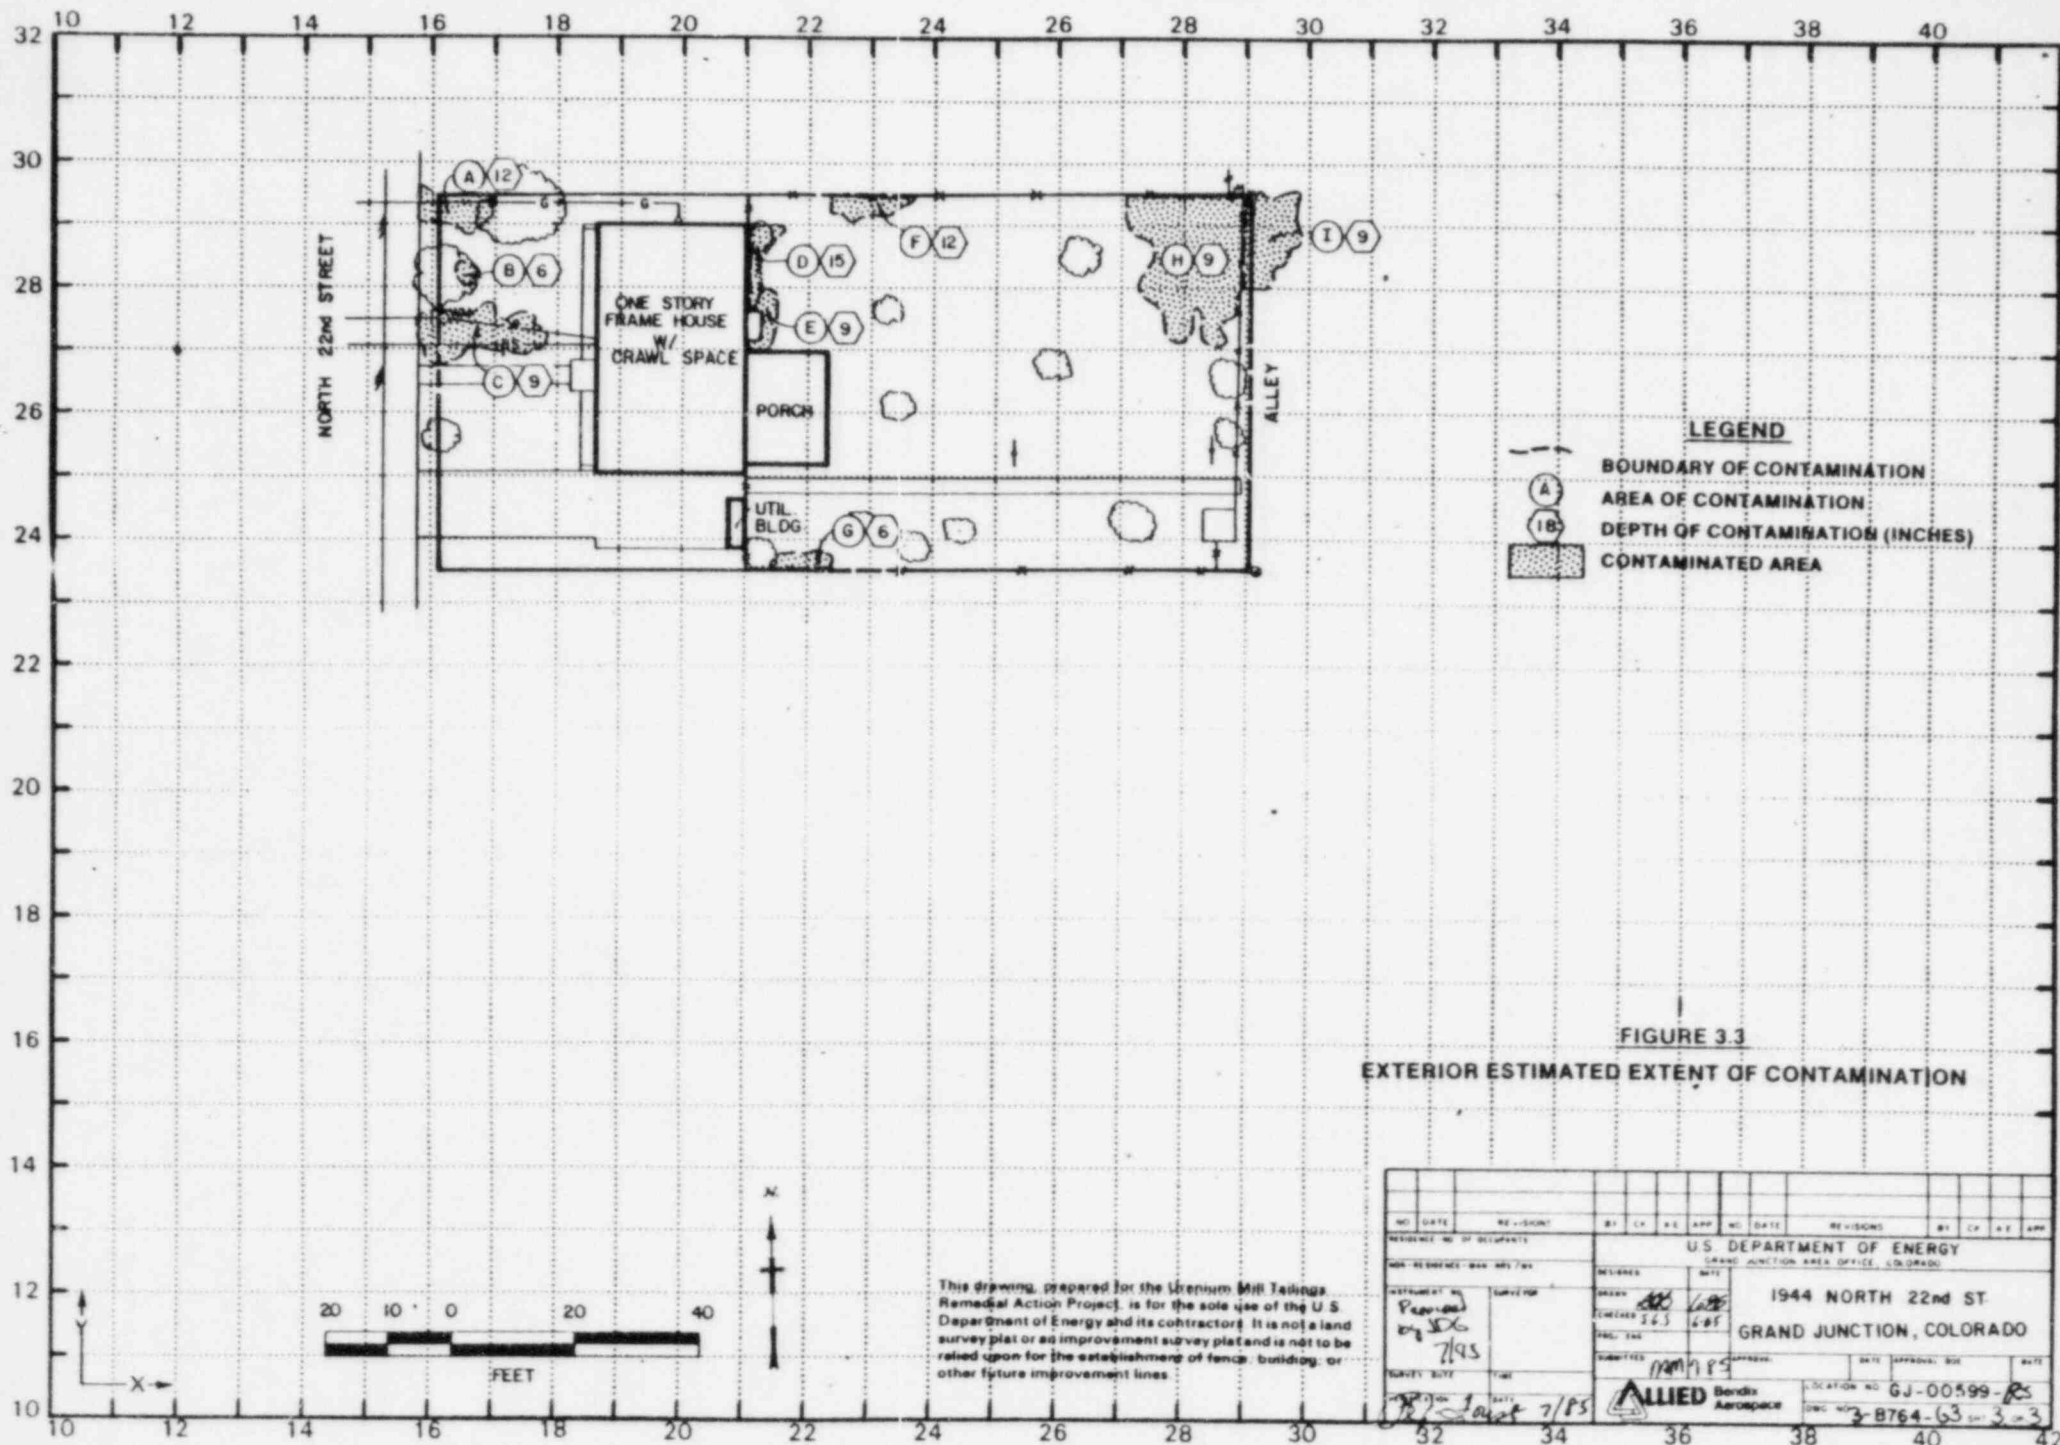
Appendix Figure 3.3 shows identified areas and estimated depths of contamination on this property, based on assessments of all measurements taken. As noted in this figure, areas recommended for remedial action that contain identified residual radioactive materials are:

- (Area A) Surface Material: Lawn
 Direction From Primary Structure: Northwest
 Other Directions: Northwest corner of property
 Total Depth of Contamination: 12 inches
 Approximate Square Footage: 72

- (Area B) Surface Material: Lawn
 Direction From Primary Structure: West
 Total Depth of Contamination: 6 inches
 Approximate Square Footage: 20
- (Area C) Surface Material: Lawn
 Direction From Primary Structure: West
 Total Depth of Contamination: 9 inches
 Approximate Square Footage: 147

- (Area D) Surface Material: Lawn
 Direction From Primary Structure: East
 Other Directions: Along east side of primary structure
 Total Depth of Contamination: 15 inches
 Approximate Square Footage: 40

- (Area E) Surface Material: Lawn
 Direction From Primary Structure: East
 Other Directions: South of Area D
 Total Depth of Contamination: 9 inches
 Approximate Square Footage: 33

- (Area F) Surface Material: Lawn
 Direction From Primary Structure: Northeast
 Other Directions: Along north property line
 Total Depth of Contamination: 12 inches
 Approximate Square Footage: 56

- (Area G) Surface Material: Lawn
 Direction From Primary Structure: Southeast
 Total Depth of Contamination: 6 inches
 Approximate Square Footage: 40

- (Area H) Surface Material: Lawn
Direction From Primary Structure: East
Other Directions: Northeast corner of property
Total Depth of Contamination: 9 inches
Approximate Square Footage: 380
- (Area I) Surface Material: Soil
Direction From Primary Structure: East
Other Directions: In alley
Total Depth of Contamination: 9 inches
Comments: The depth of contamination is based on
information gathered in Area H.
Approximate Square Footage: 136

The recommended remedial action for this property, DOE ID No. GJ-00599-RS, includes removal of all areas identified as containing radioactive material (as discussed in Section 3.5 and shown in Appendix Figure 3.3) and transport of removed material to the disposal site.

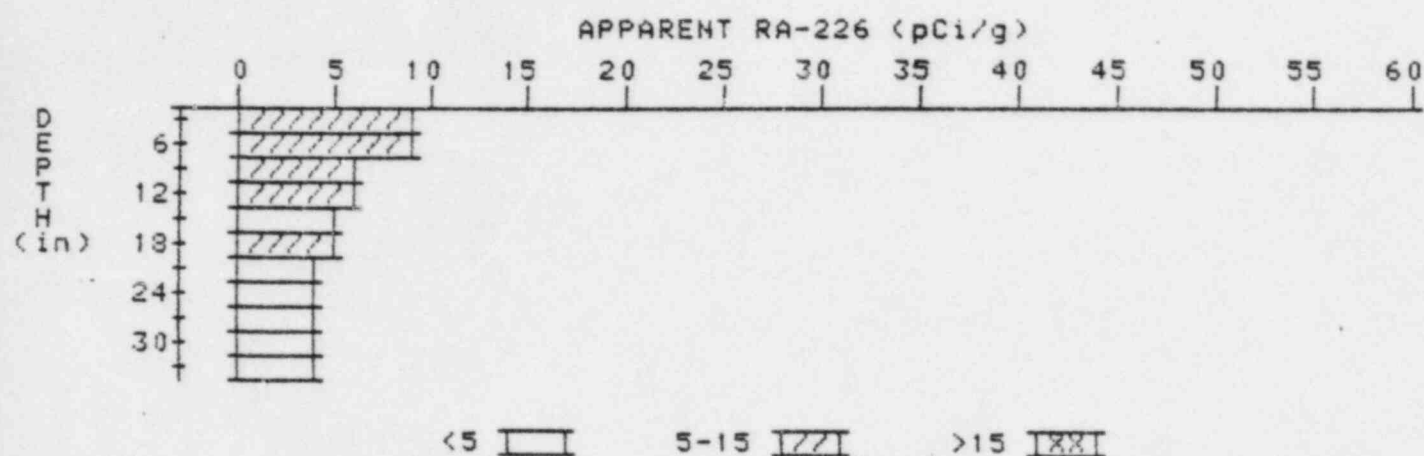
LOCATION: 210282

Loc #	Grid Location	Depth (in.)	Meas. Type	In Situ Ra-226 (pCi/g)		Chem Ra-226 (pCi/g)	Comments
				Tot. Ct	Spectr.		
9	210282	24	TC	4.2		*	
		27	TC	4.0		*	
		30	TC	3.9		*	
		33	TC	3.8		*	
10	216236	00	DS	7.4		*	
		03	DS	3.2		*	
		06	DS	2.1		*	
11	225236	00	DS	1.3		*	
		06	DS	1.9		*	
12	230295	00	DS	7.2		*	Along north fence
		03	TC	10.1		*	DC = 12 inches
		06	TC	11.4		*	Based on the
		09	TC	9.2		*	deconvolution graph
		12	TC	6.5		*	
		15	TC	5.0		*	
		18	TC	4.3		*	
		21	TC	4.0		*	
		24	TC	3.7		*	
		27	TC	3.7		*	
		30	TC	3.7		*	
13	240260	00	DS	<1.0		*	Background
		03	TC	2.7		*	DC = 0 inches
		06	TC	3.2		*	
		09	TC	3.3		*	
		12	TC	3.4		*	
		15	TC	3.4		*	
		18	TC	3.5		*	
		21	TC	3.5		*	
		24	TC	3.4		*	
		27	TC	3.4		*	
		30	TC	3.3		*	
14	270293	00	DS	1.0		*	Along north fence
		03	TC	2.9		*	DC = 0 inches
		06	TC	3.2		*	
		09	TC	3.3		*	
		12	TC	3.5		*
